Appendix E: Capital Project Modeling Results

Appendix F: Stream Assessment TM (TM4)

Stream Channel Condition Survey

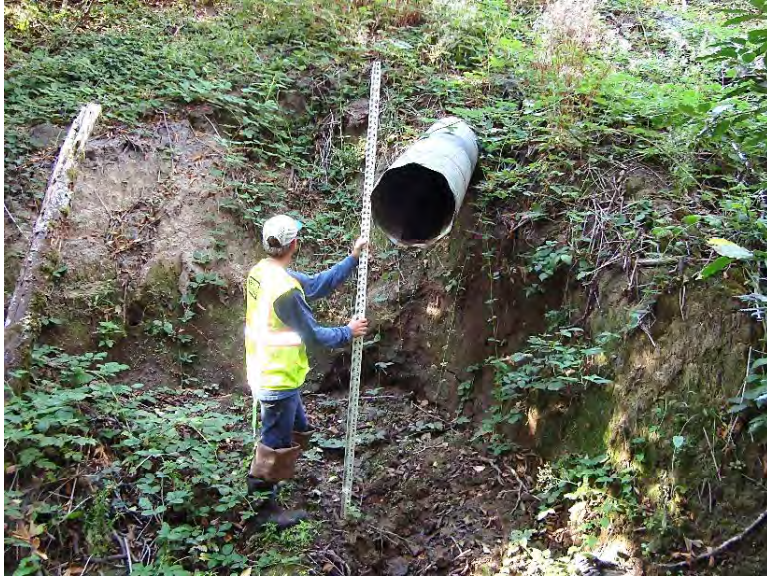
Saum Creek Reach #3 is divided by SW Blake Street. Downstream of SW Blake Street, a hillslope failure on the north side of the channel has caused the outfall that discharges stormwater piped from SW Makah Ct. to hang several feet above the stream bed (Photo 1). The hillslope failure caused several large trees to fall, resulting in a large number of branches, logs and debris in this reach. The entire north slope was saturated at the time of the site visit. Soil saturation could be a contributing factor to the slope instability in this location. The mechanisms of slope failure were not investigated in detail during the site investigation. Further investigation of the geologic condition along this slope is recommended in order to determine cause of failure and need for hillslope reinforcement.

Photo 1. Hanging culvert on north side of Saum Creek Reach #3 in location of hillslope failure (September 2017)

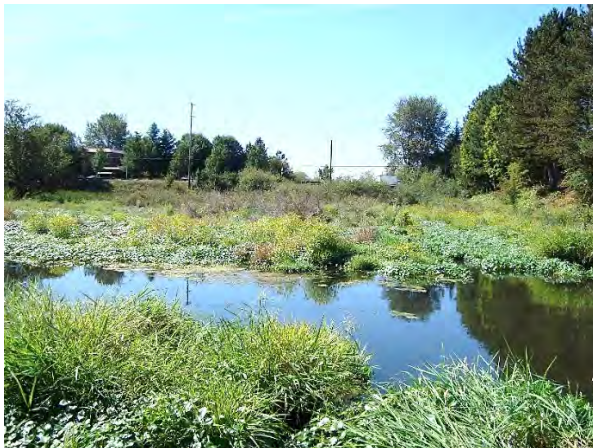
Nyberg Reach #1 and Nyberg Reach #2 were mostly lacking stream channel characteristics at the time of the stream assessment. These reaches are wetland complexes with significant open water components (Photos 5 and 6). Beaver activity is prevalent, and is likely the reason for the extensive open water in these two reaches. There was evidence of past efforts to address the beaver activity in Nyberg Creek Reaches #1 and #2. However, the beaver activity observed did not appear to be in areas of concern with regard to infrastructure or flooding. Vegetation in Nyberg Creek Reaches #1 and #2 consisted of wetland vegetation. Due to the on-going beaver activity and the changing nature of the flooded areas that currently have wetland characteristics, there is no recommendation for vegetation management.

Photo 5. Nyberg Creek Reach #1 downstream of SW 65th Avenue

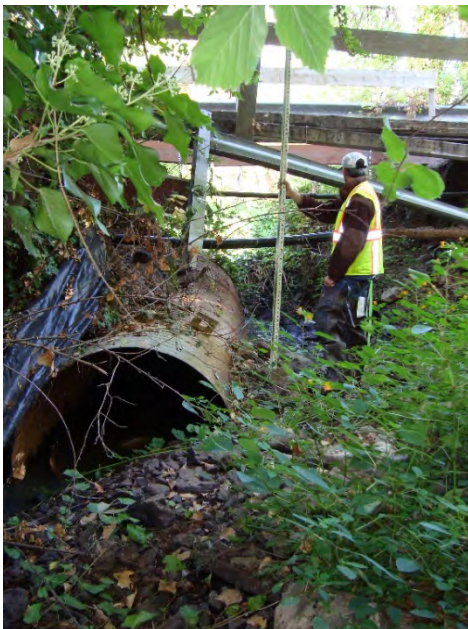
Approximately 200 feet downstream, another private structure is located on the top of the bank on the outside bend of a meander. This structure may have similar risks due to proximity to the edge of the bank. Both of these structures are east of SW Martinazzi Ave and north of SW Boones Ferry Road.

Photo 8. Culvert placed in debris from washed out bridge to convey Hedges Creek.

Stream	Reach	Approximate Location and Issue	Ownership	Recommended Strategy
Hedges Creek	#1	~500 ft. upstream of Tualatin River (washed out bridge)	Private	1. As of the writing of this report, the City is currently working with the property owner and other resource agencies to address permit compliance.
	#3A	~175 ft. upstream of SW 105 th Ave. (rock wall)	City	1. Inspect rock wall for ongoing deterioration. 2. Repair rock wall in conjunction with road project. 3. Reorient the downstream culvert to minimize flow velocity directed at embankment.
	#3A	~700 ft. upstream of SW 105 th Ave. (side channel and exposed sanitary)	City	1. Consider policies to encourage onsite retention and flow mitigation. 2. Inspect sanitary sewer manhole for ongoing exposure or deterioration.

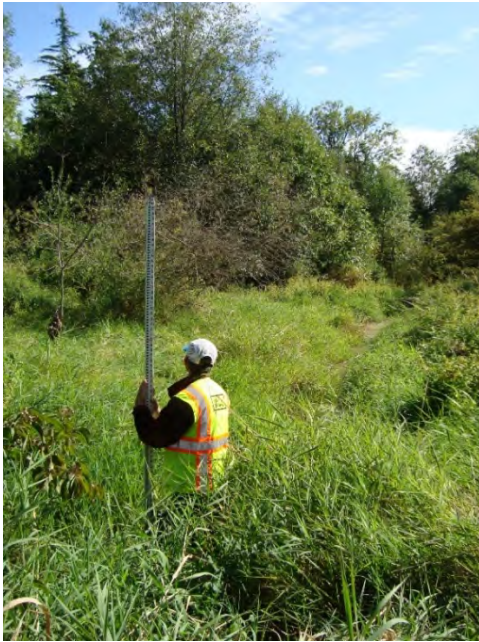
Approximately 1,200 feet upstream of the mouth, an 18-inch diameter stormwater outfall enters Hedges Creek from the south. Stormwater inputs at this location could account for some of the differences in stream characteristics upstream. Upstream of this location, in the Tualatin Community Park, the channel is mostly straight, with a wider floodplain, and a flatter gradient, and based on the channel conditions, erosive flows appear to be less frequent. No channel erosion was observed in this part of the reach. The channel is also largely overgrown with reed canary grass through this portion of the reach (Photo 9), and beaver dams were also observed. Vegetation management is needed to control reed canary grass in the Tualatin Community Park.

Photo 9. Hedges Creek Reach #1. Reed canary grass-choked channel downstream of Tualatin Road.

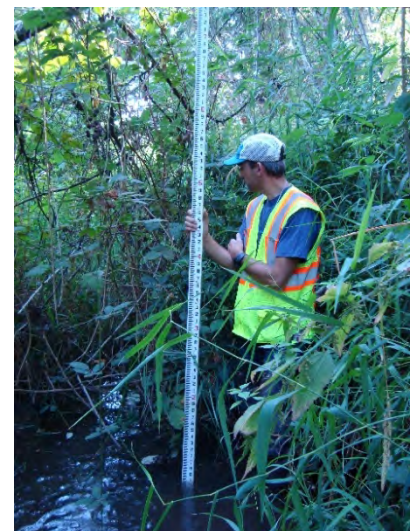
Hedges Creek Reach #2 is located between SW Tualatin-Sherwood Road and SW Industrial Way. It is surrounded by the Hedges Creek Greenway open space, a wide riparian floodplain area. Hedges Creek is relatively stable through this reach, with only minor erosion observed on the outside of meanders. The adjacent floodplain provides ample room for the channel to naturally meander and migrate. However, the entire reach needs extensive vegetation management due to observed, dense invasive plants including Himalayan blackberry and reed canary grass, as shown in Photo 10.

Photo 10. Hedges Creek Reach #2.

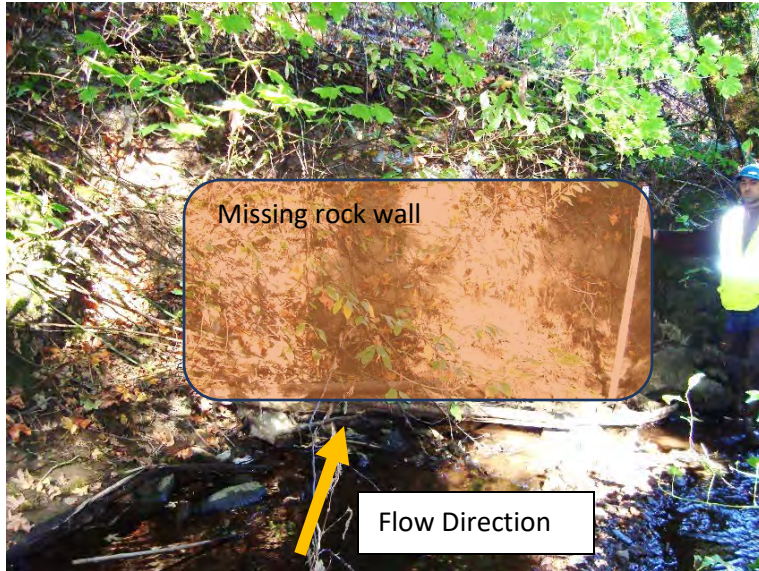
Hedges Reach #3A has a meandering characteristic and a relatively low gradient. Channel substrate consists of loose silt, hard silt, and an outcrop of bedrock present for about 100 feet of stream channel starting approximately 500 feet upstream of 105th Avenue. A rock wall protecting the bank (and presumably road embankment) 175 feet upstream and on the east side of 105th Avenue/Blake Street has been compromised, as it has been eroded by the stream (Photo 11). At this location, Hedges Creek makes a 90-degree turn, which is a point of maximum velocity and energy on the outside bend. It is recommended to reinforce/ rebuild the rock wall to ensure the road embankment is not compromised and/or reorient the culvert under 105th Avenue/ Blake Street to minimize flow velocity directed at the road embankment and wall. It is assumed that design and construction would be conducted in conjunction with the scheduled road widening project for 105th Avenue.

Photo 11. Hedges Creek Reach #3A, showing rock wall location and missing rocks.

The rock wall protecting the road embankment on 105th Avenue/Blake Street from Hedges Creek in Reach #3A was observed to be failing. Rocks have fallen into the stream, and only a few pieces of the wall remain in place. It is understood that the City plans to widen SW 105th Avenue, which will require a detailed evaluation and updated design of the road embankment and culvert crossings in relationship to the stream channel. A potential design option is to reorient the culvert in conjunction with the roadway widening project to mimic the direction of the natural stream channel and minimize flow velocity directed at the road embankment. Alternatively, reinforcement/ replacement of the existing rock wall would be needed.

It is recommended that locations of active channel erosion, in the vicinity of the rock wall and the sanitary sewer pipe, in this reach be monitored by the City to ensure that site conditions do not deteriorate. Additionally, the side channel entering Hedges Creek in Reach #3A has experienced erosion due to the flashiness of stormwater runoff from upstream. Flow control and onsite retention standards and policies are recommended for the City's consideration in Hedges Reach #3A, in the vicinity of the area west of Ibach Park, to mitigate for areas of active erosion and preserve the integrity of small streams such as this side channel.

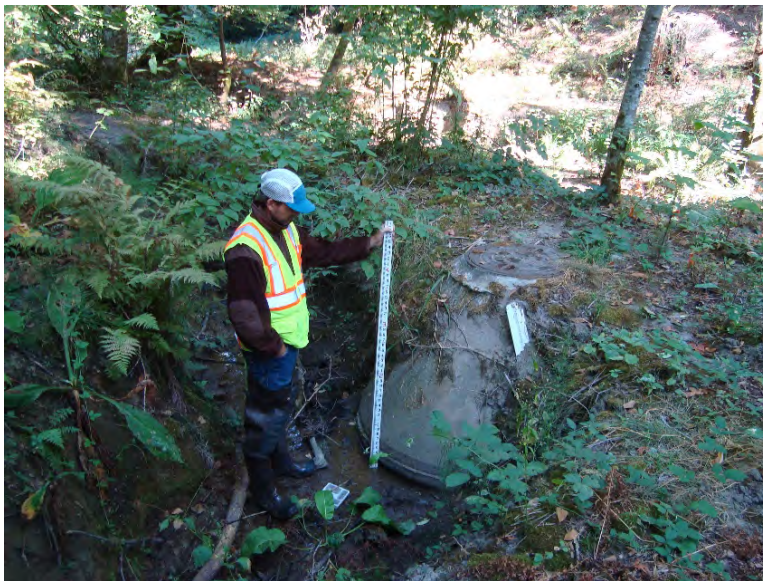
Another issue observed in Reach #3A is channel incision in a side channel entering the main channel from the south, approximately 700 feet upstream of SW 105th Avenue. The neighborhood west of Ibach Park contributes drainage to this side channel and it appears that this channel receives a large volume of water from the upstream catchment. The extreme erosion in this side channel has exposed a sanitary sewer manhole (Photo 12). This exposure, over time, may compromise the structural integrity of the manhole.

Photo 12. Side channel incision and erosion around sanitary sewer manhole.

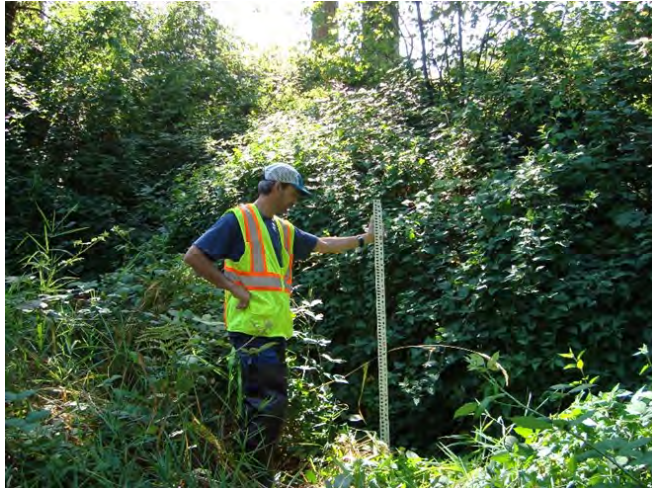
Typical photo of Hedges Creek Reach #2. Stream channel is overgrown with invasive vegetation. Channel is to the right and 4' below Ryan (standing on the bank). Photo location shown below with camera icon.

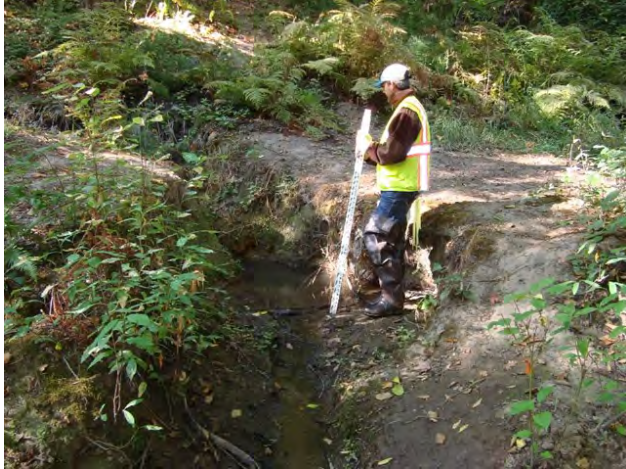
Incised side channel of Hedges Creek. Photo location shown below with camera icon.

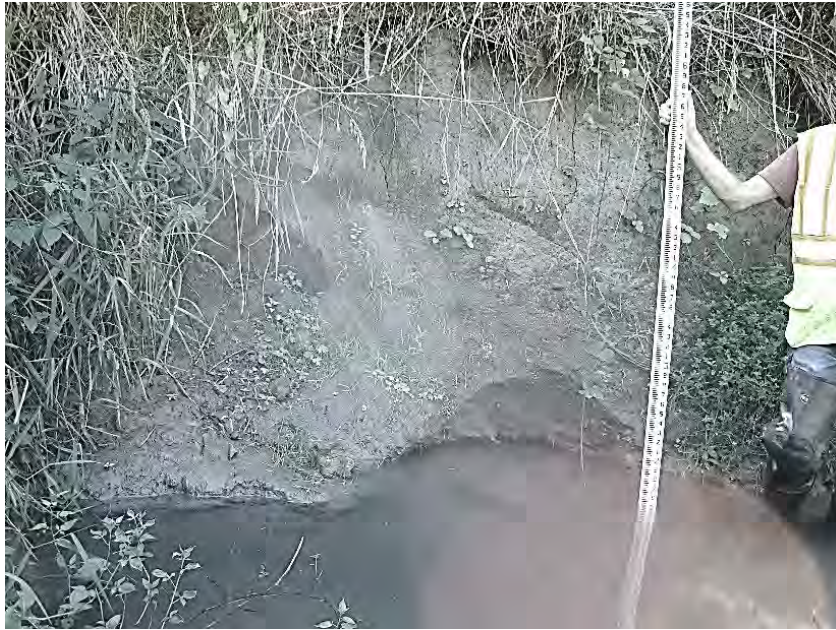
Site location: 150' downstream of SW Borland Rd.
Photo number: S1-19
Description: Left bank slump, seepage, wetland plants observed in vicinity

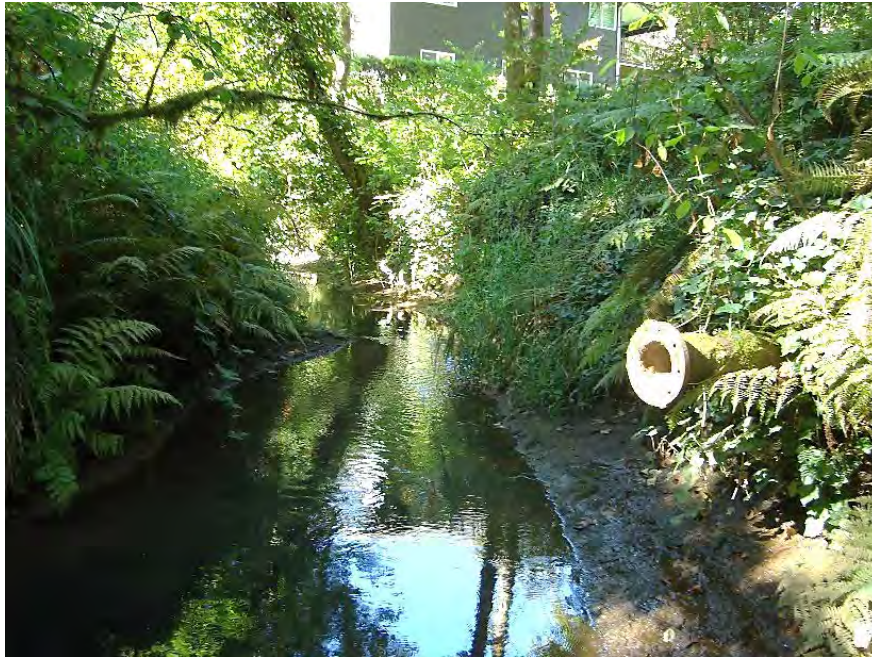
Site location: 600' upstream of SW Borland Rd.
Photo number: S1-21
Description: Broken pipe (right side of photo) on left bank, looking upstream

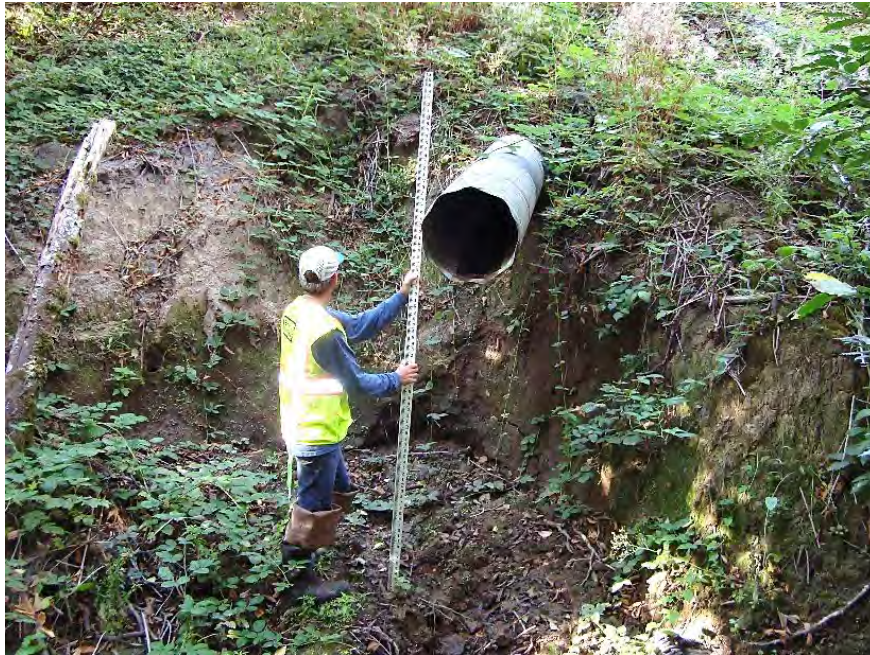
Site location: Downstream of SW Blake St.
Photo number: S3-3
Description: Perched culvert- hillslope failure on left bank

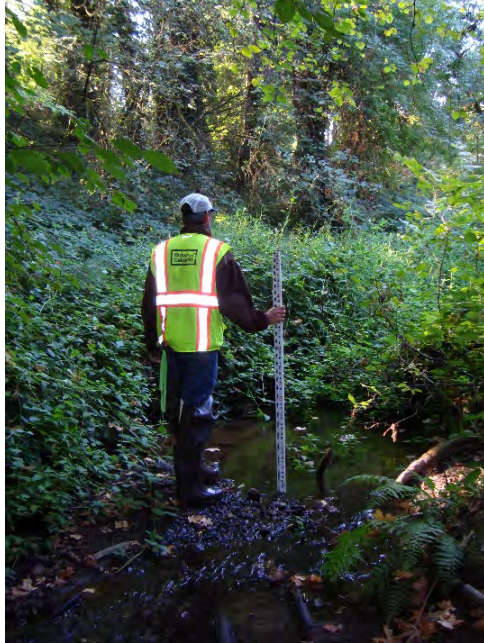
Site location: 30' upstream of SW 105th Ave.
Photo number: H3-3
Description: Right bank hillslope failures, wetland plants growing on slope (wet)

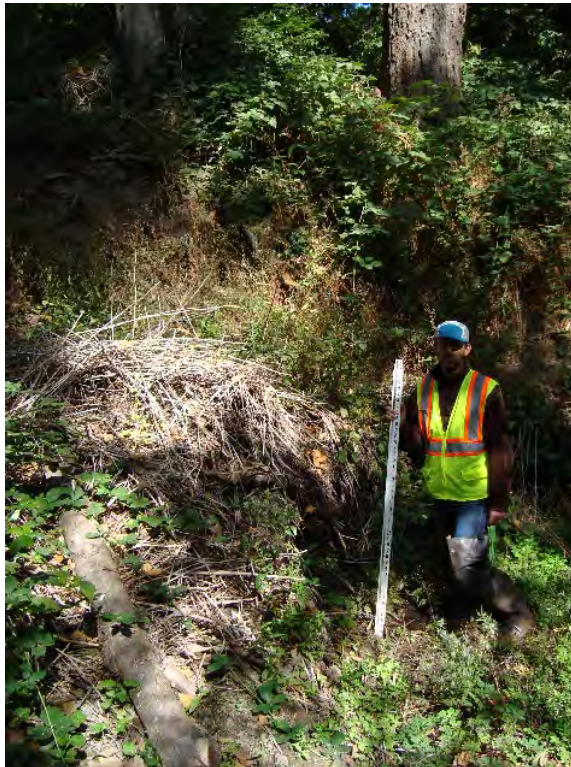
Site location: 1100' upstream of SW 105th Ave.
Photo number: H3-16
Description: Right bank slope failure, very wet

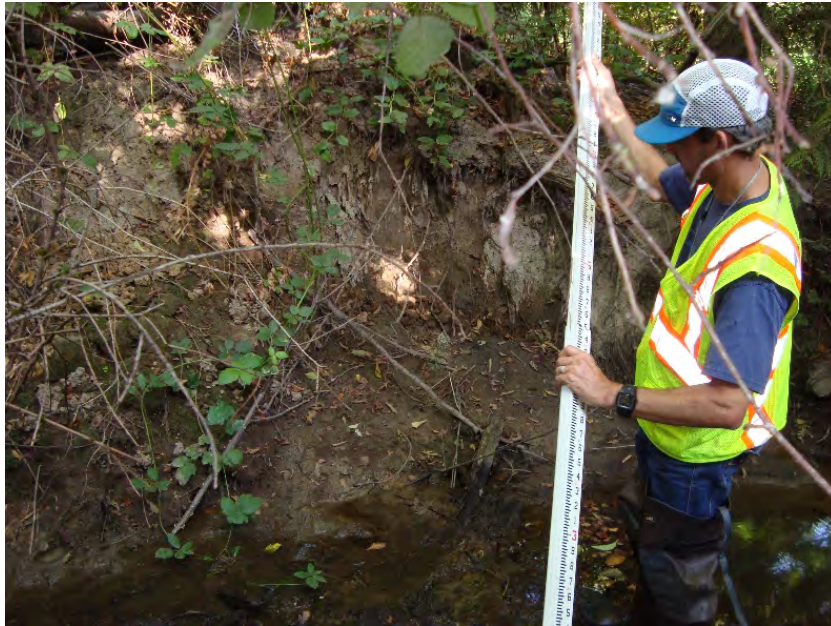
Site location: 500' upstream of confluence with S. tributary
Photo number: H3-25
Description: Left bank failure, incised channel, unstable

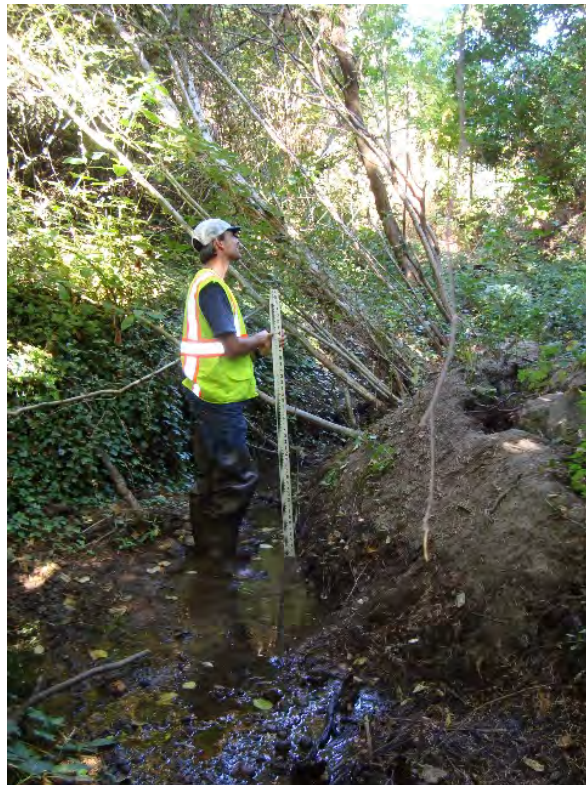
Site location: 600' upstream of confluence with S. tributary
Photo number: H3-26
Description: Left bank slumping
