TREE PROTECTION AND REMOVAL PLAN

HEDGES CREEK

PHELON DEVELOPMENT

City of Tualatin, Oregon – Hedges Creek Arboricultural Assessment and Tree Protection/ Removal Plan

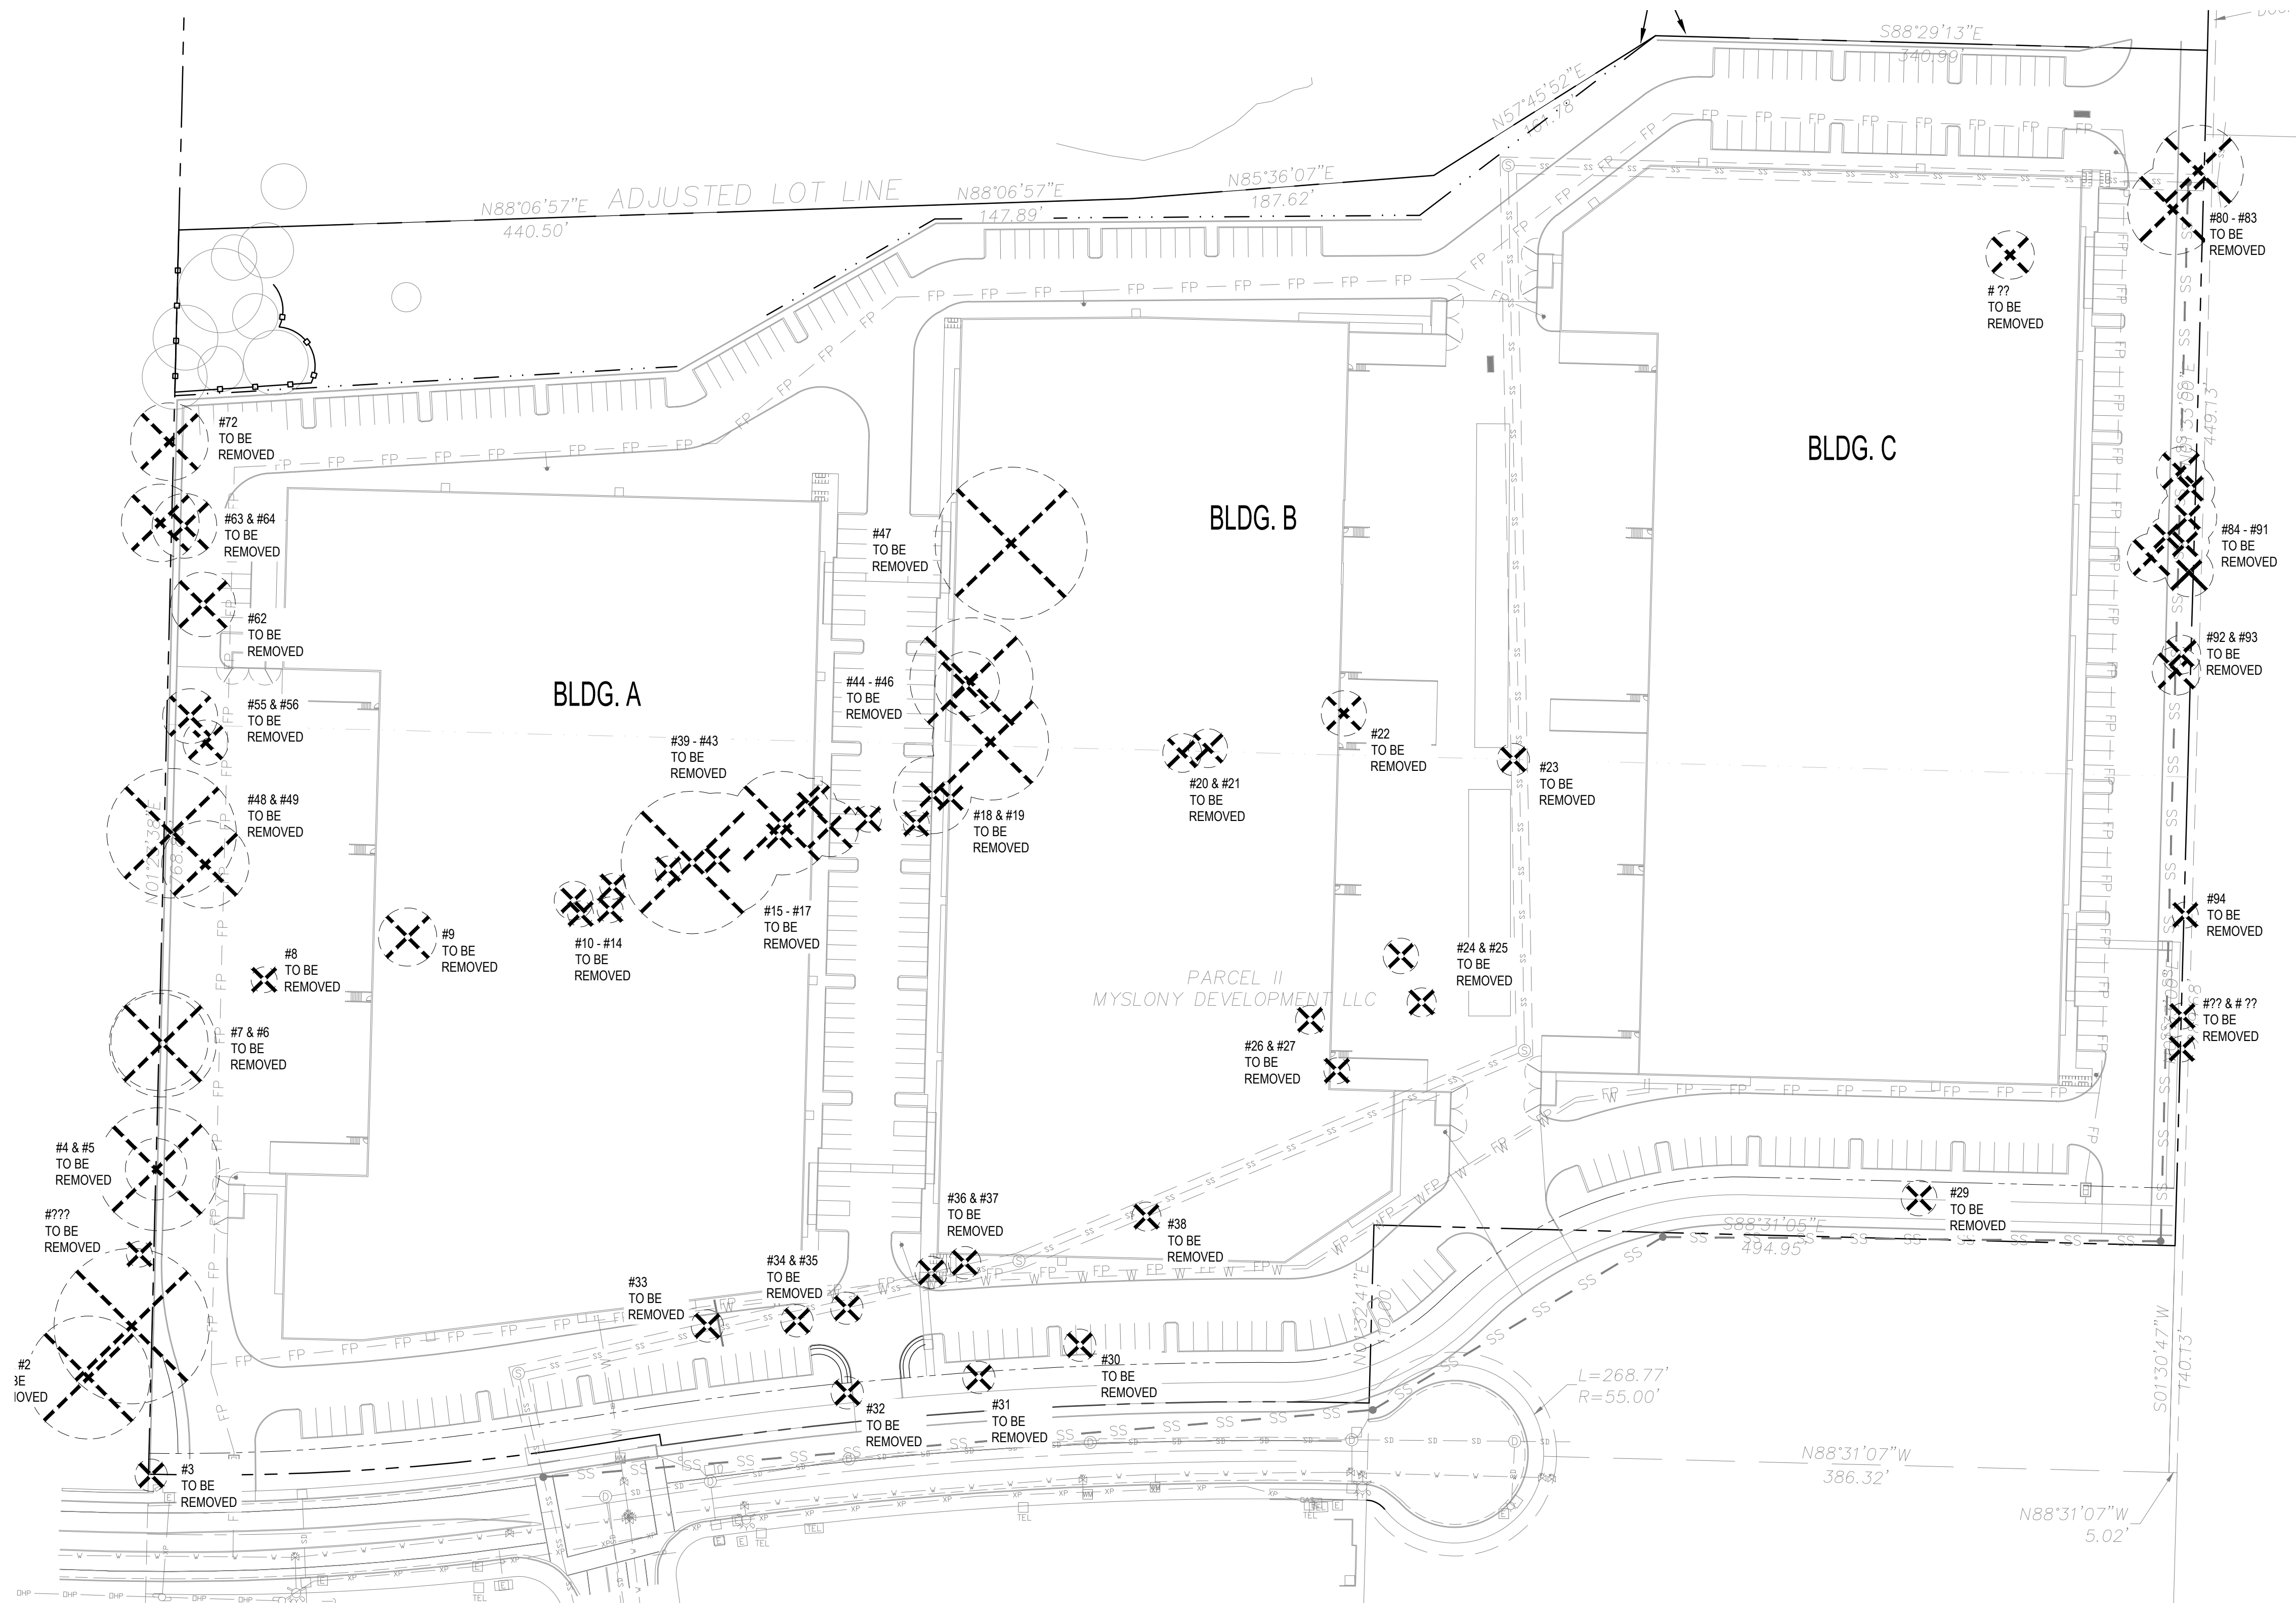
L1.0

The trees that are recommended for removal are within the direct footprint or in the vicinity of the site improvements. The trees that are not within the direct footprint of the improvements are recommended for removal due to the impacts of the project.

The trees are proposed for removal because the proposed parking lot encroaches on the root systems of the trees located along the creek. The likelihood of failure post construction will be magnified due to grade changes and subgrade amendment. The proposed layout would likely require the removal of large roots which could make the trees hazardous due to the increased rotational failure potential.

The trees are in the direct footprint of the proposed building.

Tree 92 is dying. Tree 94 is in poor condition.

The trees are in the footprint of the parking lot and the proposed building.

The Fencing Shall Be Placed as Prescribed in Appendix C. Refer to the inventory for CRZ (Critical Root Zone) distances.

The tree protection fencing shall be placed at the edge of the critical root zone of trees 73, 74, 78 and 79 in circumference of the tree on the east side of the creek.

The trees on the east side of the property to be retained shall be protected by placing fencing 5-feet from the proposed edge of the parking lot asphalt. The fencing shall be placed at tree 93 and from tree 91 through 85. The fencing should be placed from dripline to dripline running north to south.
