Public Works and Utilities Feasibility Study October 2021

PURPOSE: To begin a feasibility study for the relocation of the Public Works facility, known as the "shop" currently located at 360 Falmouth St.

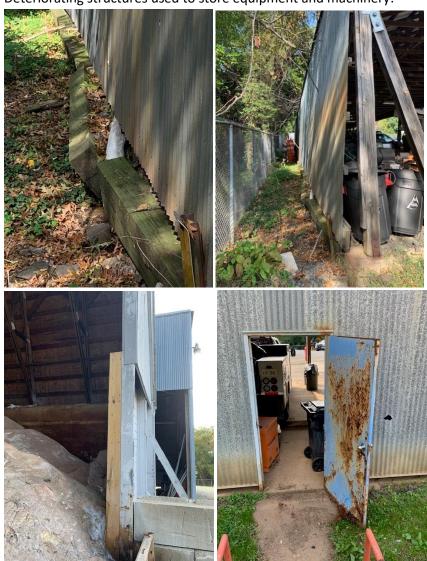
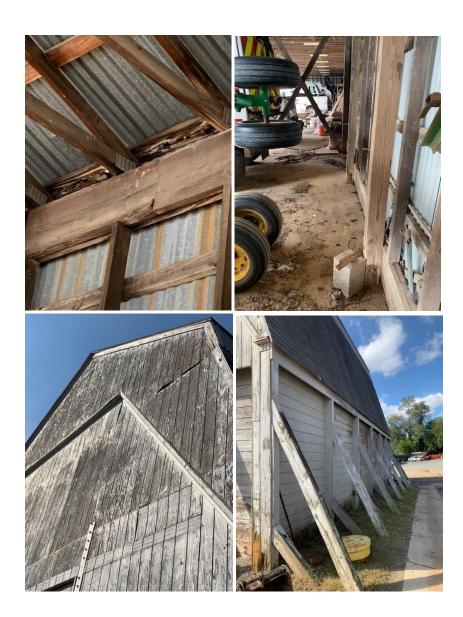
• Deteriorating structures used to store equipment and machinery:

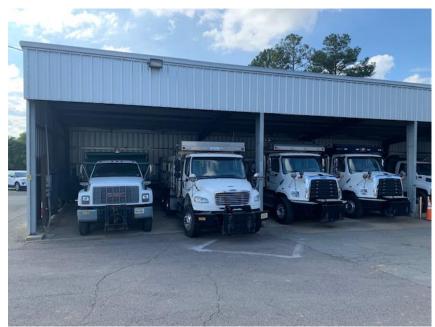
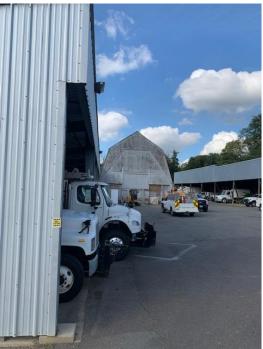
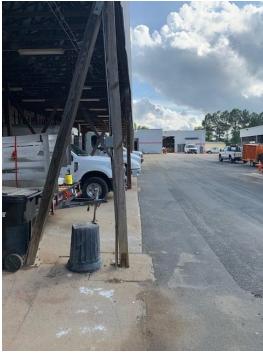
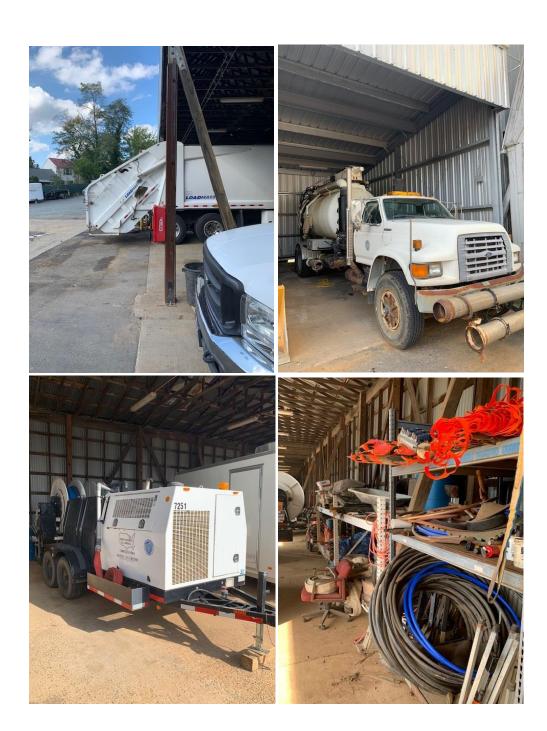
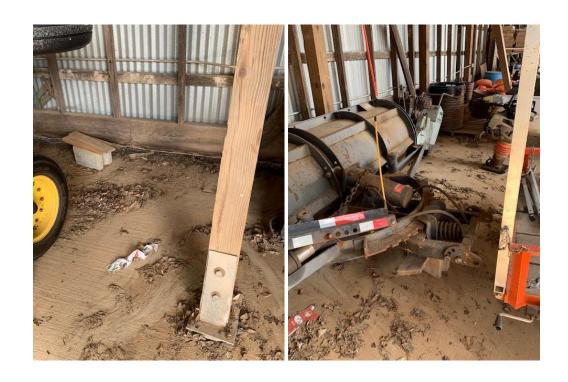
• Existing structures are undersized and improperly equipped to protect equipment and machinery from the environment effectively:

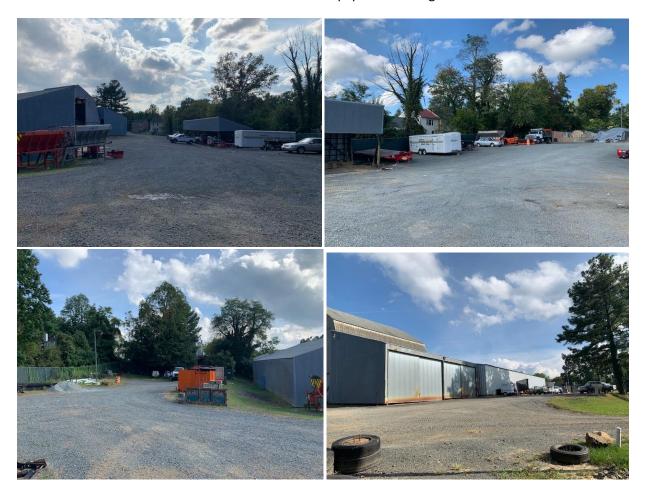
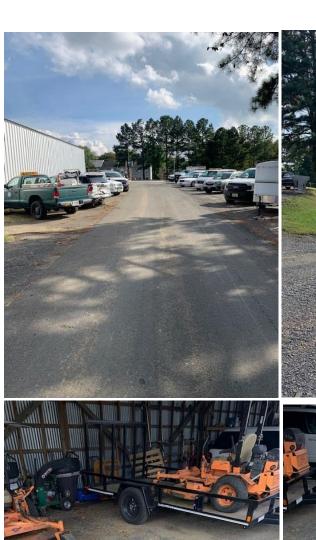
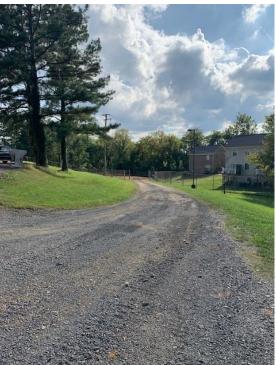
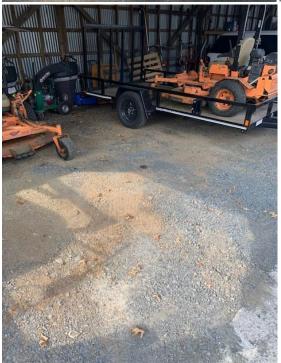
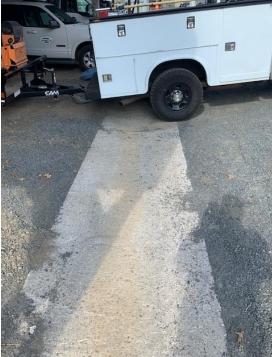
• The grounds are gravel, stone, and dirt material which are a continuous maintenance issue for the surfaces as well as the equipment driving over it:

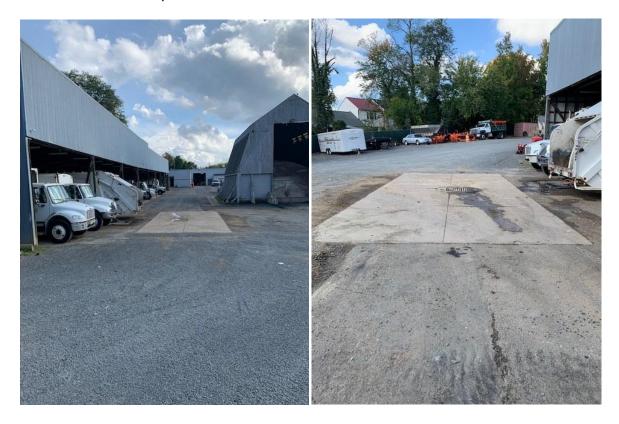
• The only truck wash is outside:

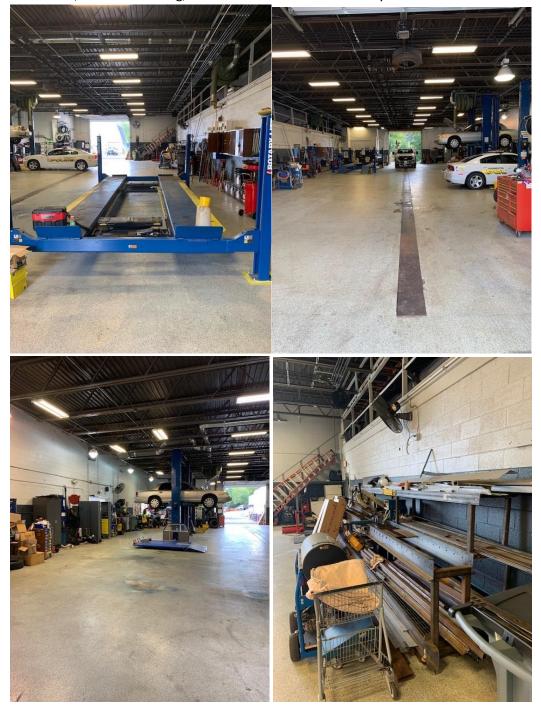
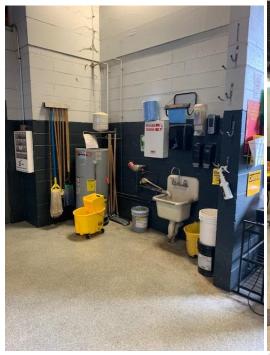
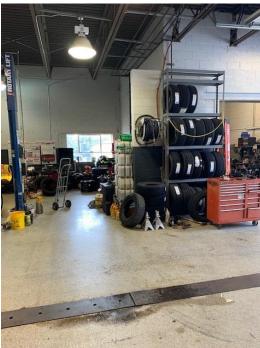
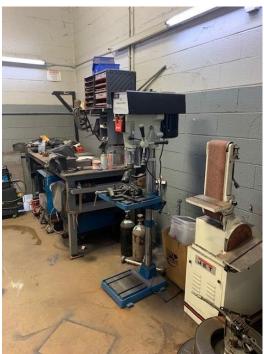
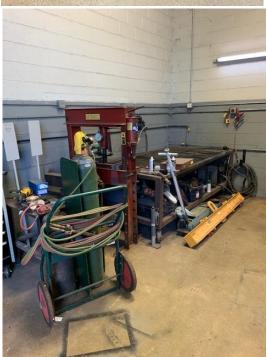
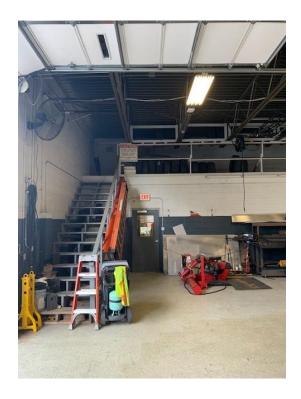
The fleet garage is a multi-use area for storage, maintenance, meetings, welding, fabrication, vehicle outfitting, and other functions as necessary.

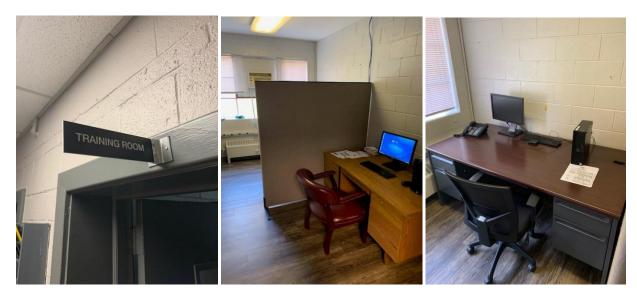
• Inadequate training room- Two stations:

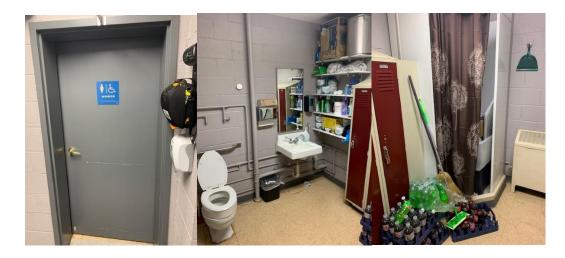
Ladies Room:

• The bathrooms are in poor condition; there is no ladies locker room; the men's locker room is in poor shape; and the men's room does not have air conditioning.

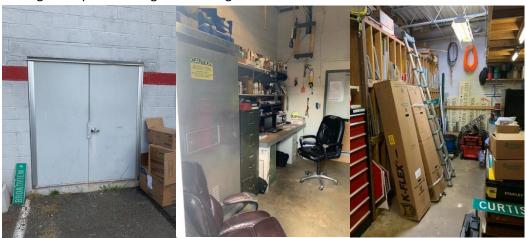
• The sign "shop" is nothing but a storage room:

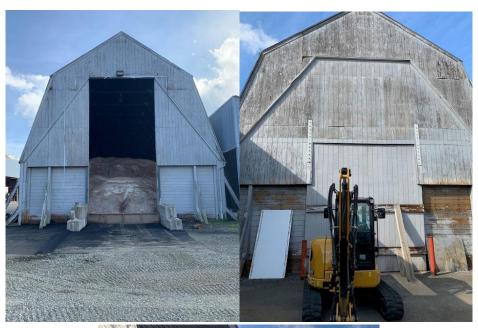
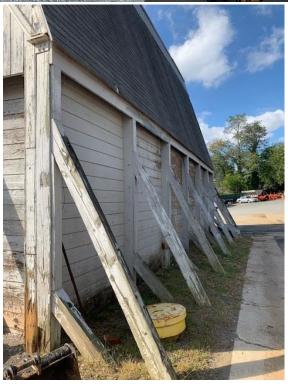
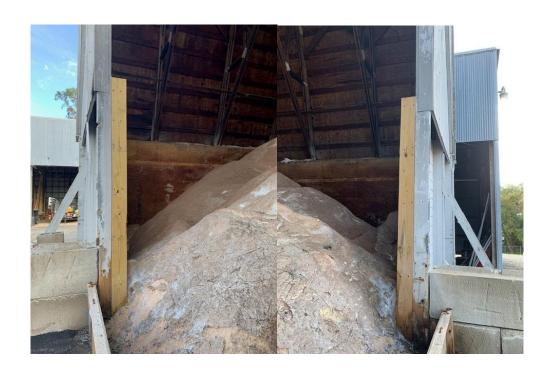
•	The salt barn needs repairs and is not properly situated or improved to meet DEQ standards.

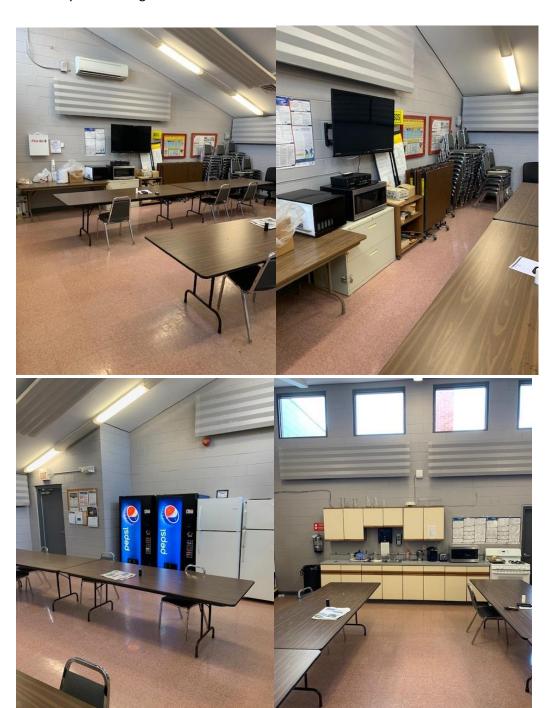
• The lunchroom is a multi-use room and does not provide adequate space or equipment for a truly functioning lunchroom for the number of staff.

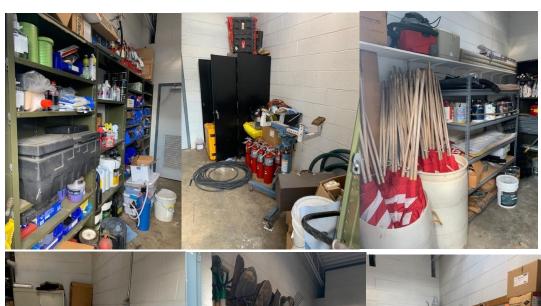
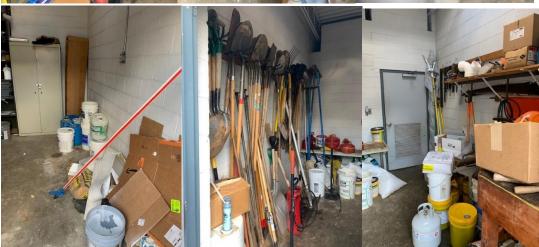
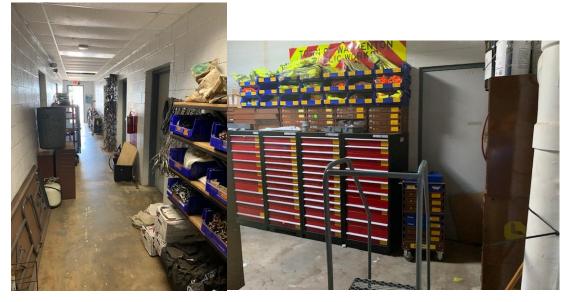
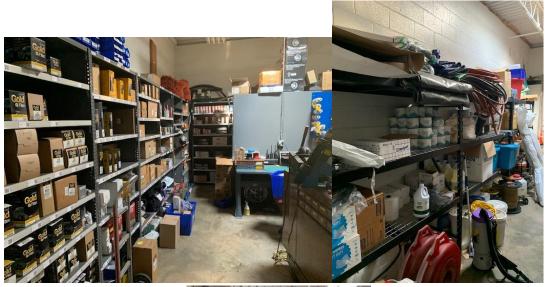
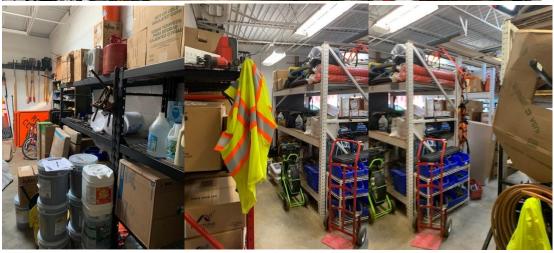
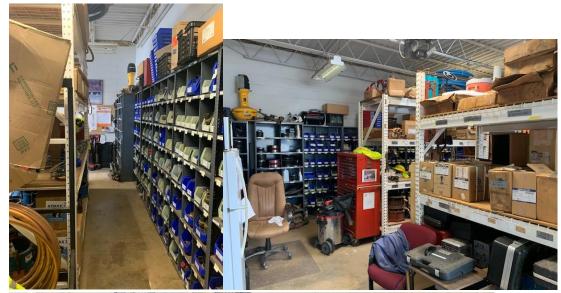
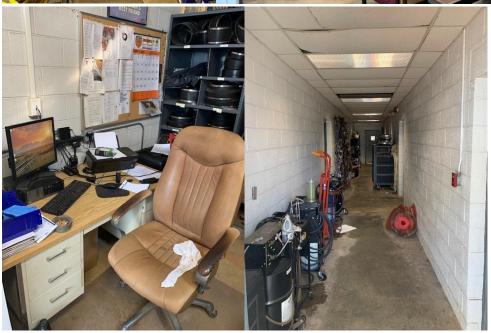
• Inadequate storage rooms- rooms are separated and create a tracking challenge; halls used for extra storage space:

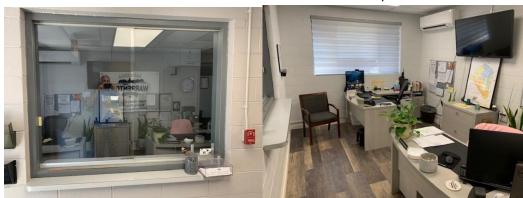
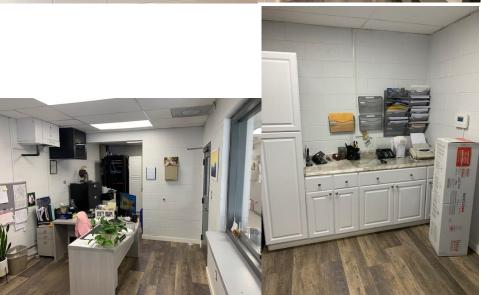
• Front counter and administration area is small and serves multiple uses:

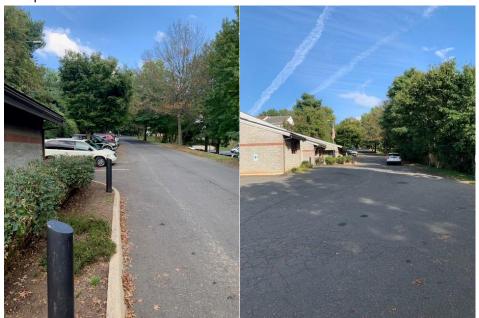
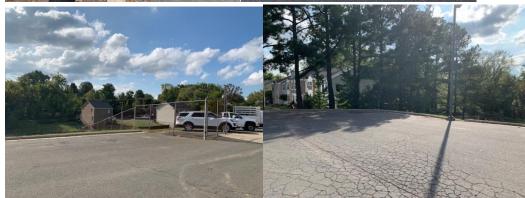
Inadequate employee parking: parking is adjacent to residential uses adding to the disruption:

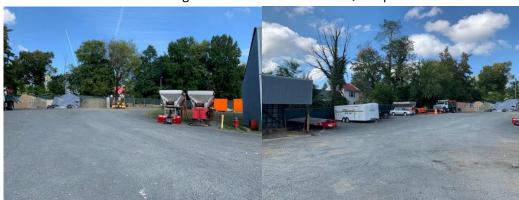
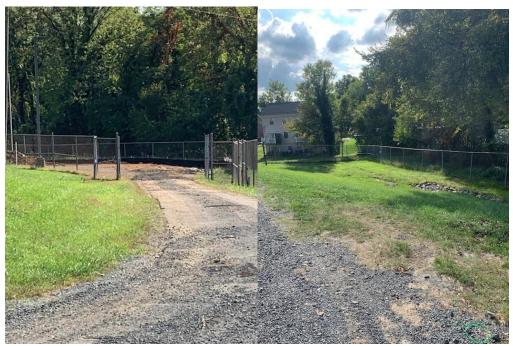
• The site overall creates challenges on several levels for DEQ compliance:

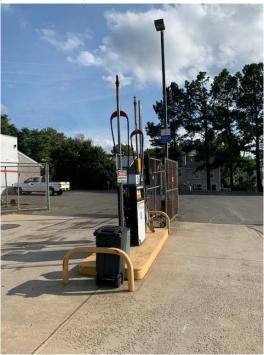
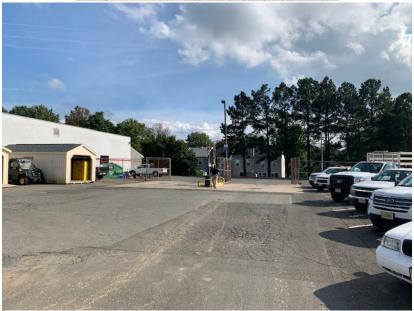
• Fueling station does not have any cover; pumps are outdated; poorly situated at the main entrance of equipment to the yard:

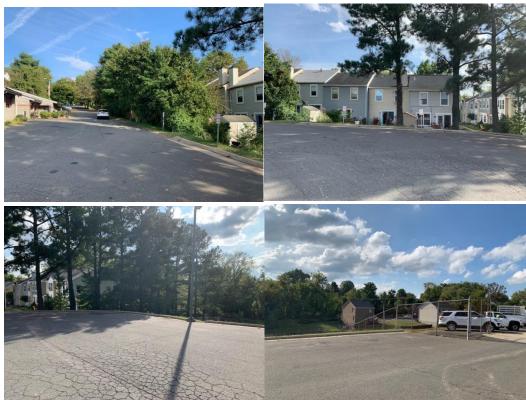
• The location of the shop creates noise and disrupts the residential aspects of the surrounding properties, especially during an emergency response or night long responses to snow and ice.
