604 W Main Street

Rear Door

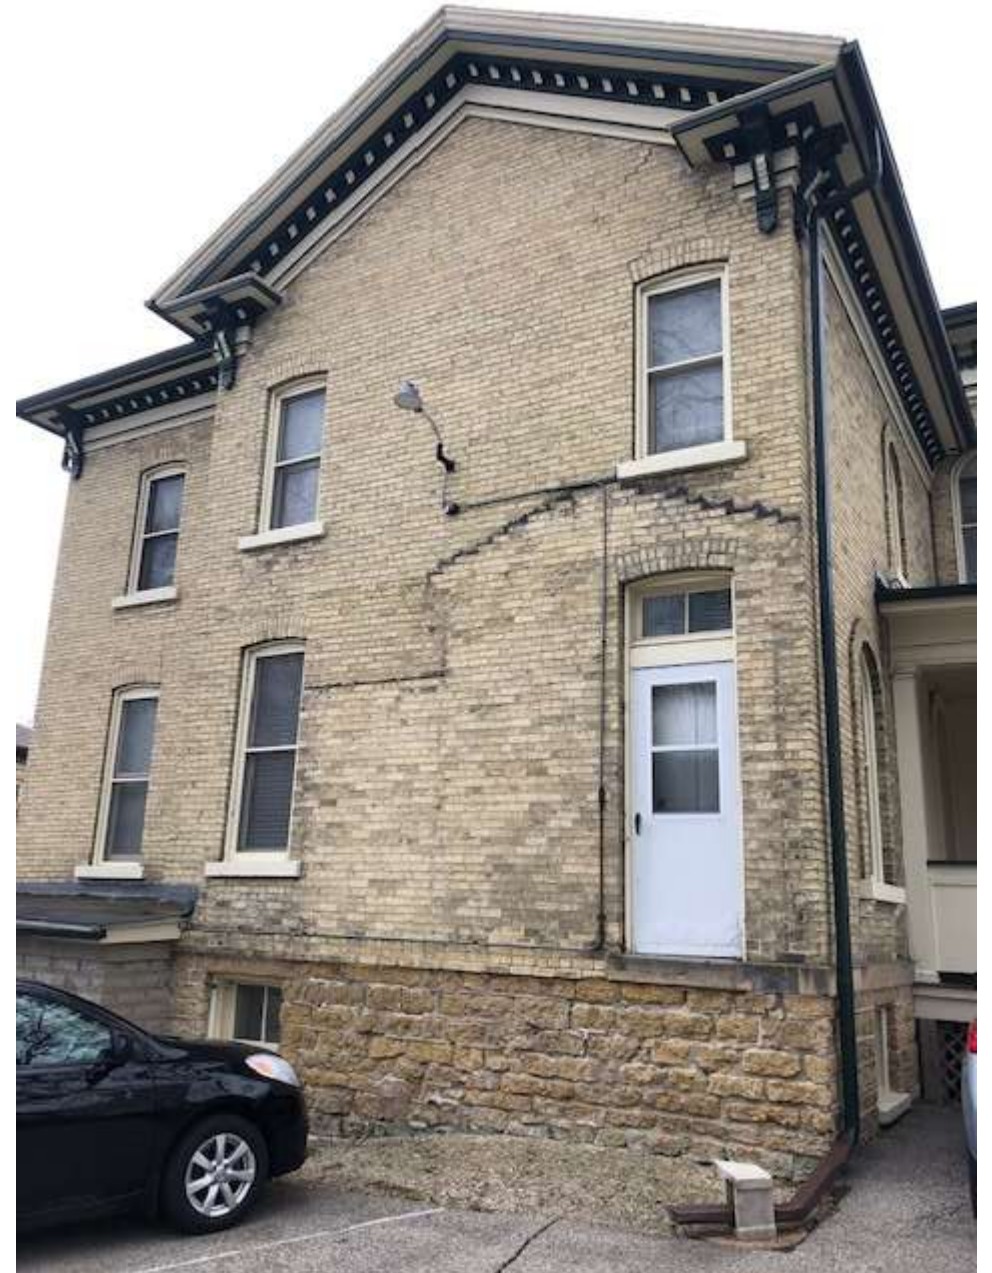
- Rear storm door is rotting and needs to be replaced.
- Door is no longer used:
 - No outside stairs
 - Inside, permanent closet built in front of opening

- Replace storm door with an insulated fiberglass door, no windows
- No hardware
- Paint either off white or green
- Leave transom as is

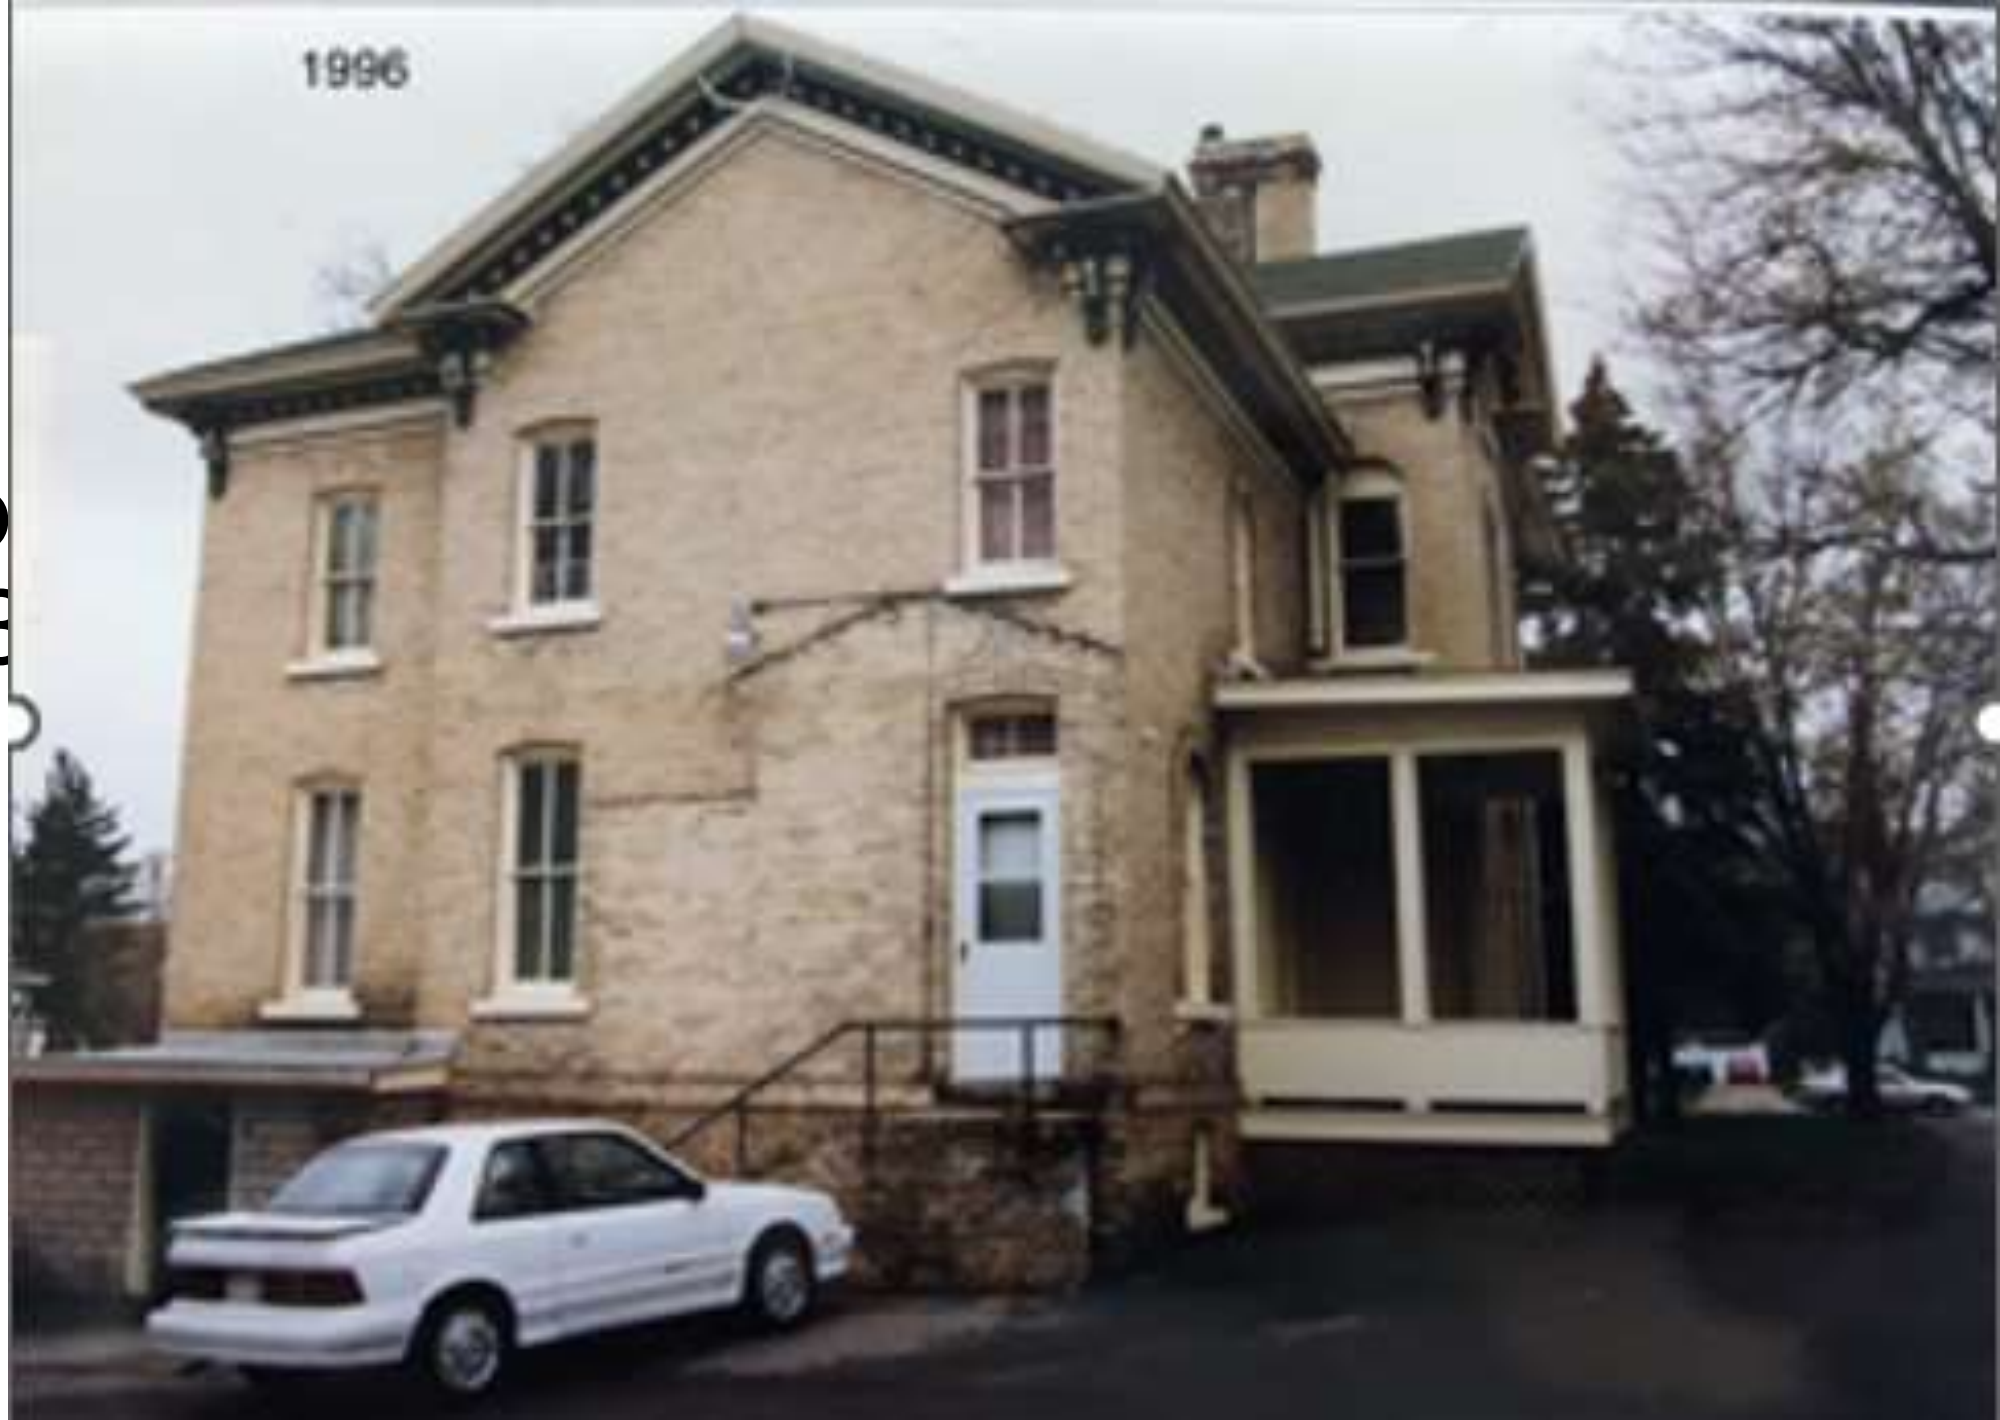
Existing door
is at least 3
years old
