US 89 Road Safety Audit

June 2026

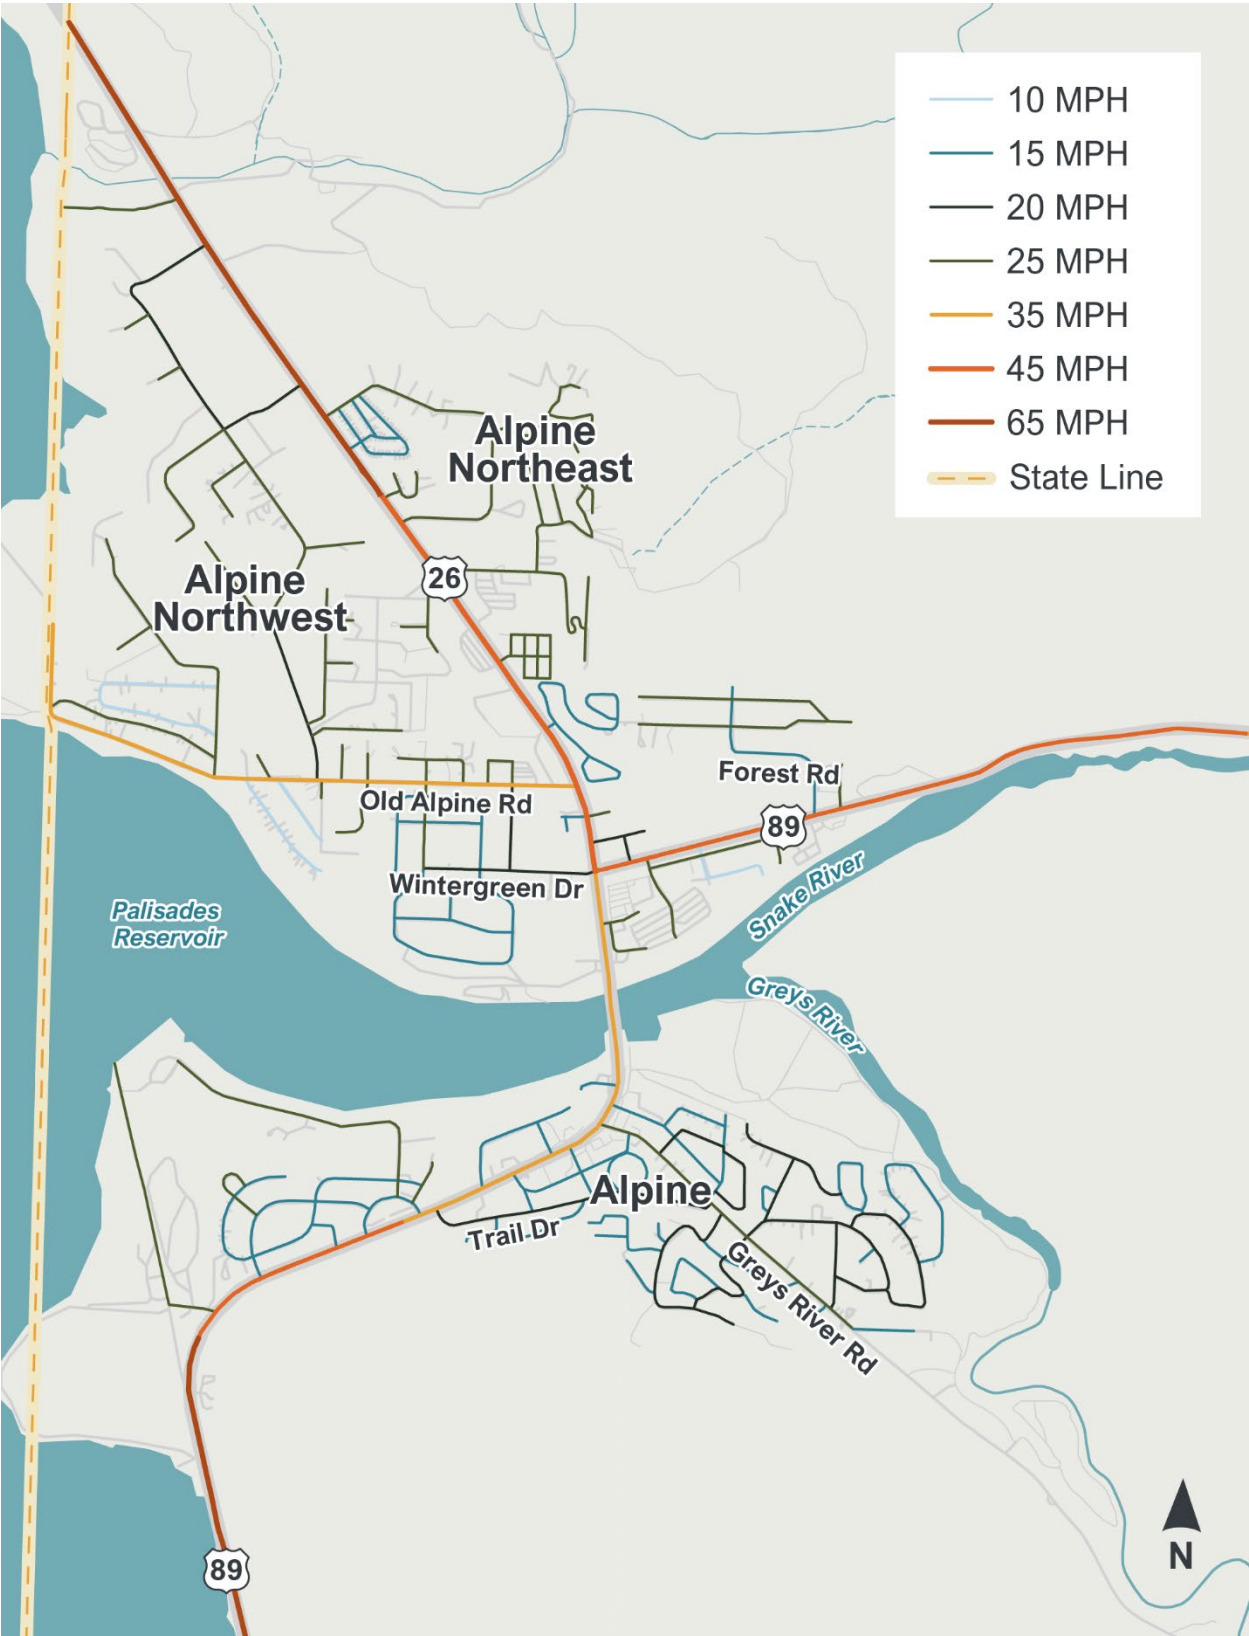
Figure 1. Map of Posted Speed Limits

A sidewalk runs along a portion of the corridor from Morning Star Drive to the Yankee Doodle Café's access drive north of 2nd Street. Street lighting is limited in the downtown area. A map of posted speed limits is shown in **Figure 1**. Posted speed limit ranges from 35 mph to 65 mph along US 89 within the study area. A map of the Annual Average Daily Traffic (AADT) volumes is shown in **Figure 2**. US 89 has 6,182 vehicles per day.

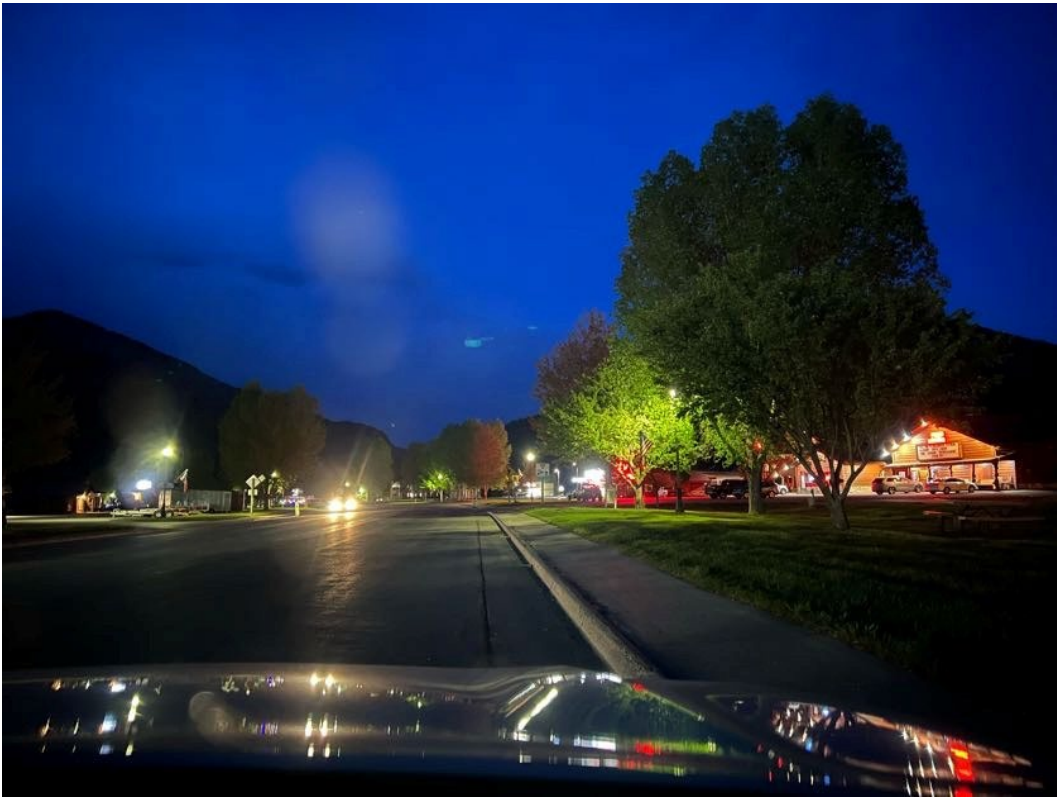
Figure 4. US 89 Crosswalks at Night

Location	Observations	Potential Recommendations
US 89 at Trail Drive	The skatepark is heavily used (probably most used facility in the town) and there are no sidewalks nearby or crosswalk along US 89.	Consider installing sidewalks or multi-use paths to access the skatepark.
Crosswalk at US 89 and Center Street	Pedestrian crossing needs upgrading. Poor retroreflectivity and lighting. See Figure 4 .	Enhance the existing crossing with RRFBs, curb bulb-outs, and updated signage.
		Consider relocating the existing crosswalk to the south to midblock with an RRFB, curb bulb-outs, and updated signage.
Crosswalk US 89 and Greys River Road	Right turning vehicles from Greys River Road are not looking for pedestrians in crosswalk.	Enhance the existing crossing with an RRFB, curb bulb-outs, and updated signage.
		Consider relocating the existing crosswalk south to midblock with an RRFB, curb bulb-outs, and updated signage.

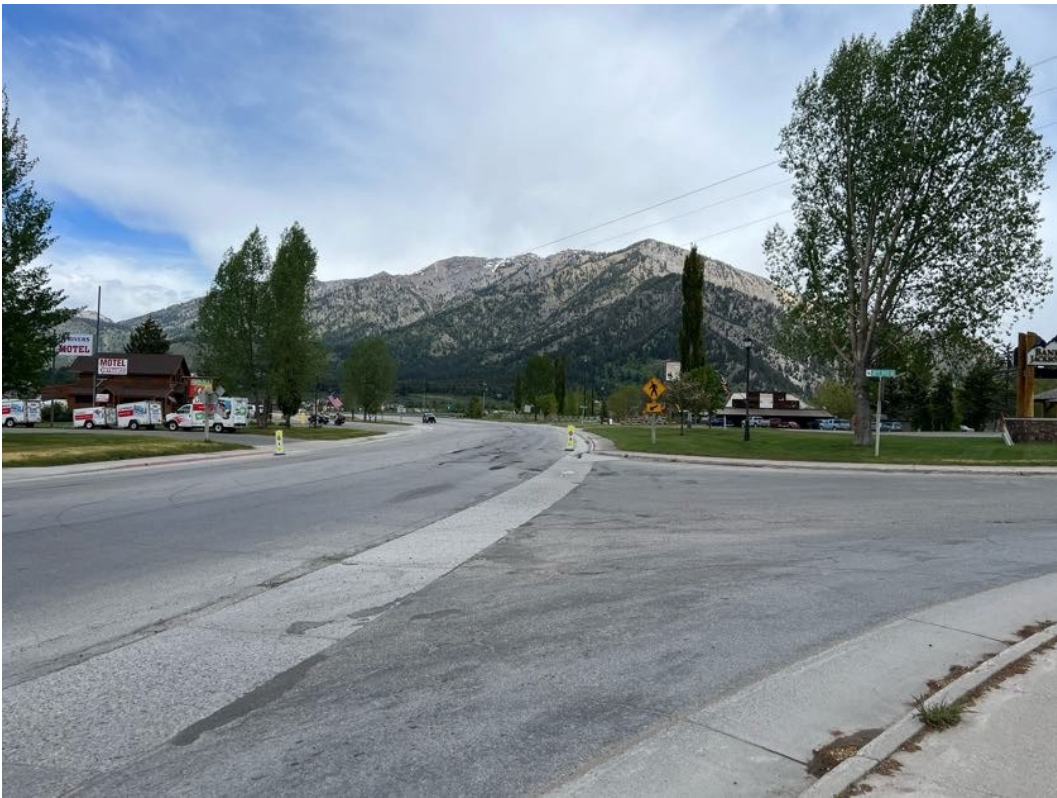
Figure 5. US 89 / Greys River Road Intersection

Greys River Road at US 89	Wide turning radius to Greys River Road. No stop bar for traffic exiting Greys River Road. See Figure 5 .	Consider reconstructing the intersection to include tightening the truck apron and marking turn lanes.
ACE Hardware/Gas Station Driveways	Driver confusion due to lack of delineation in parking lot, driveways, and Greys River Road. See Figure 6 .	Consider installing delineation features, such as sidewalks, defined driveways, and curb and gutter to create a more defined street edge.
US 89 Bridge	Need for a pedestrian/snowmobile crossing separate from the vehicular traffic on the bridge.	Consider a pedestrian bridge across Snake River that could be used as a snowmobile path in winter. This path could also be used for emergency vehicle travel.
US 89 Bridge	No lighting on the bridge. See Figure 7 .	Consider an illumination study for lighting across the Snake River bridge.

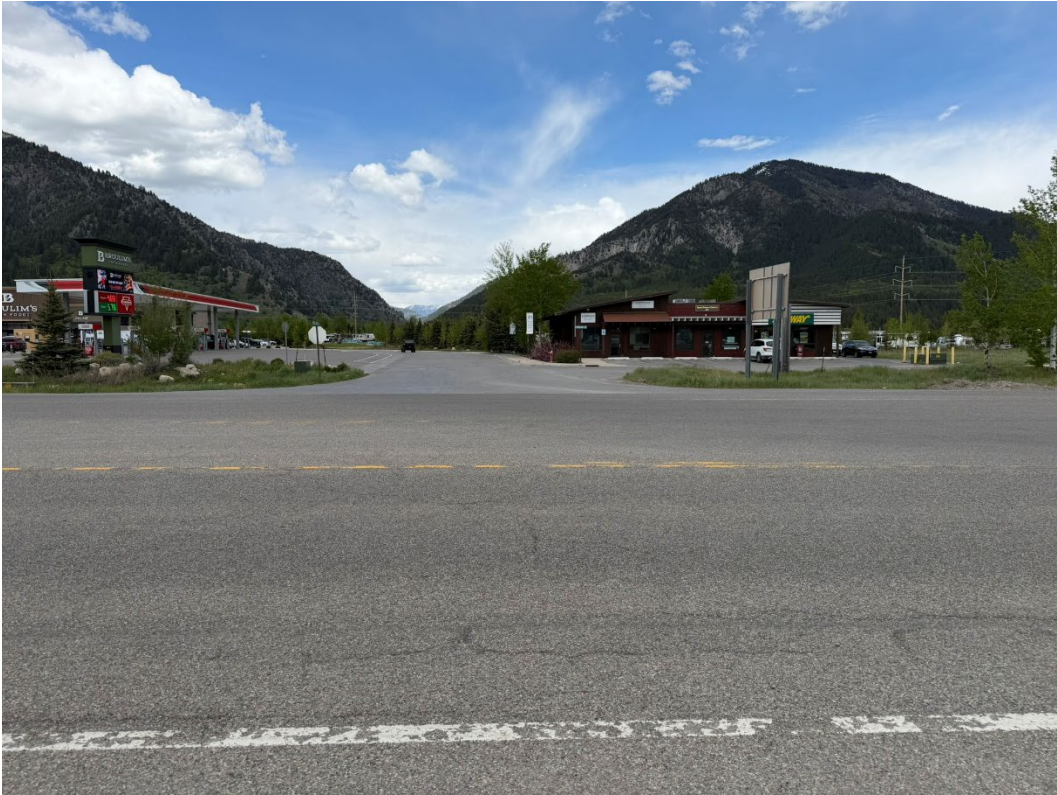
Figure 8. US 89 / Broulims Driveway

US 89 Bridge	Sidewalk is closed in winter and jersey barrier installed for snowmobile traffic across the bridge; In an ideal world, a pathway under the bridge would be nice but likely expensive.	Consider feasibility of a pedestrian pathway running under the Snake River bridge.
US 89 at Broulims driveway	Near miss crash location. See Figure 8 .	Consider adding a right-turn pocket into Broulims.

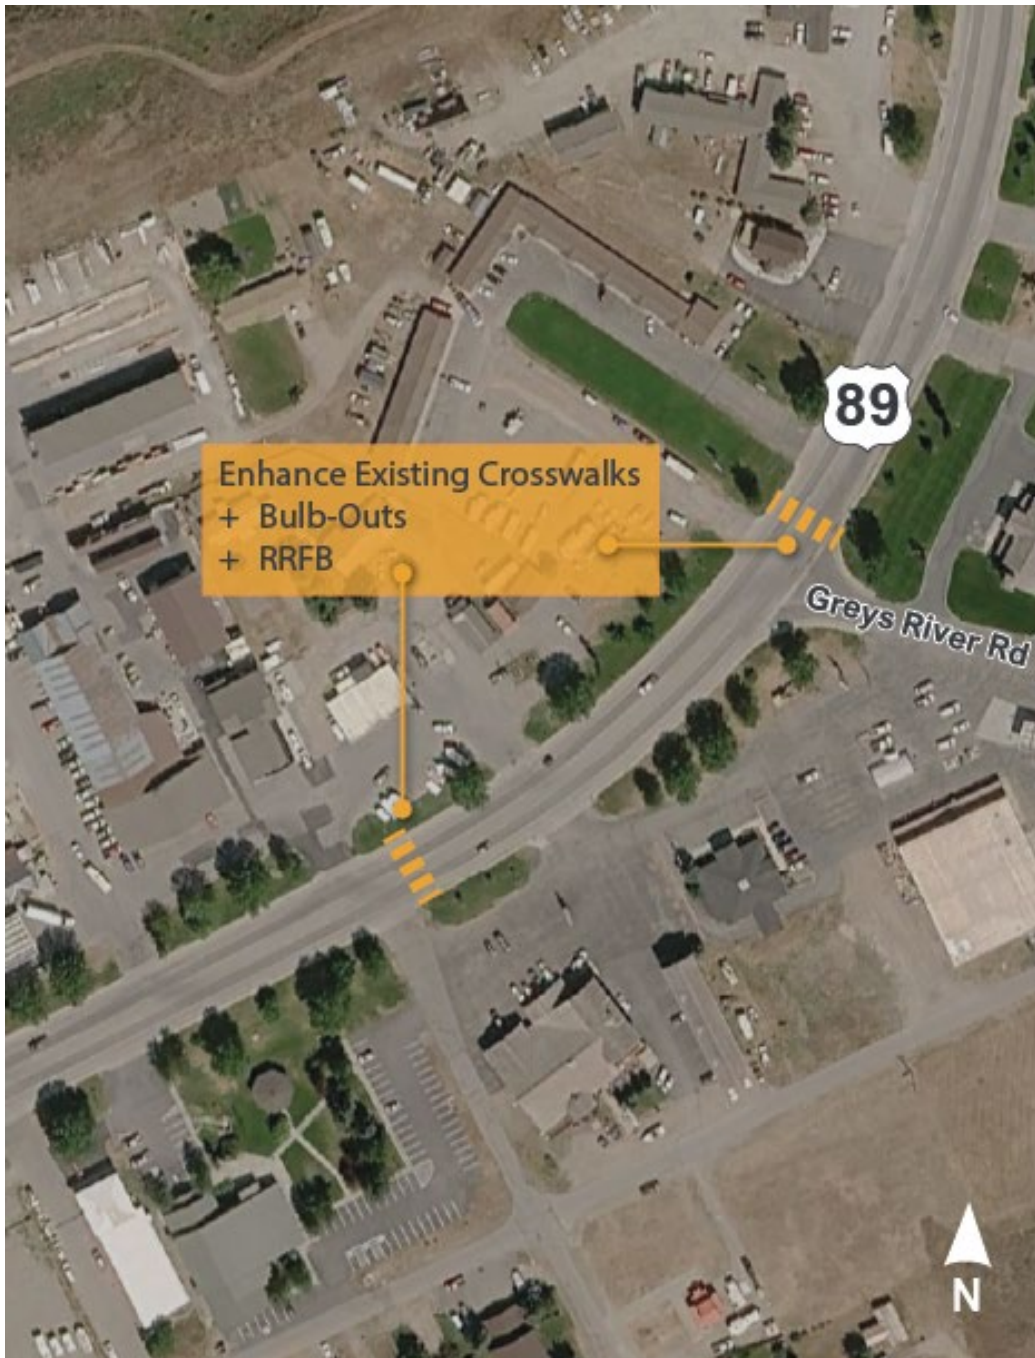
Figure 9. Project Alternative 1 - Enhanced Crosswalks with Bulb-Outs and RRFBs

Alternative 1 enhances the two existing pedestrian crossings by incorporating curb extensions, or bulb-outs, to reduce the crossing distance of US 89 and enhance pedestrian visibility. The project would install temporary rectangular rapid-flashing beacons (RRFBs) and pedestrian crossing warning signs to indicate where drivers should yield to pedestrians at each crossing to increase driver awareness and improve pedestrian safety. The project location is illustrated in **Figure 9**. An example of a temporary bulb-out is shown in **Figure 10**. An example of an RRFB is shown in **Figure 11**. Crosswalk visibility enhancements is one of the Federal Highway Administration’s proven safety countermeasures as illustrated in **Figure 12**.

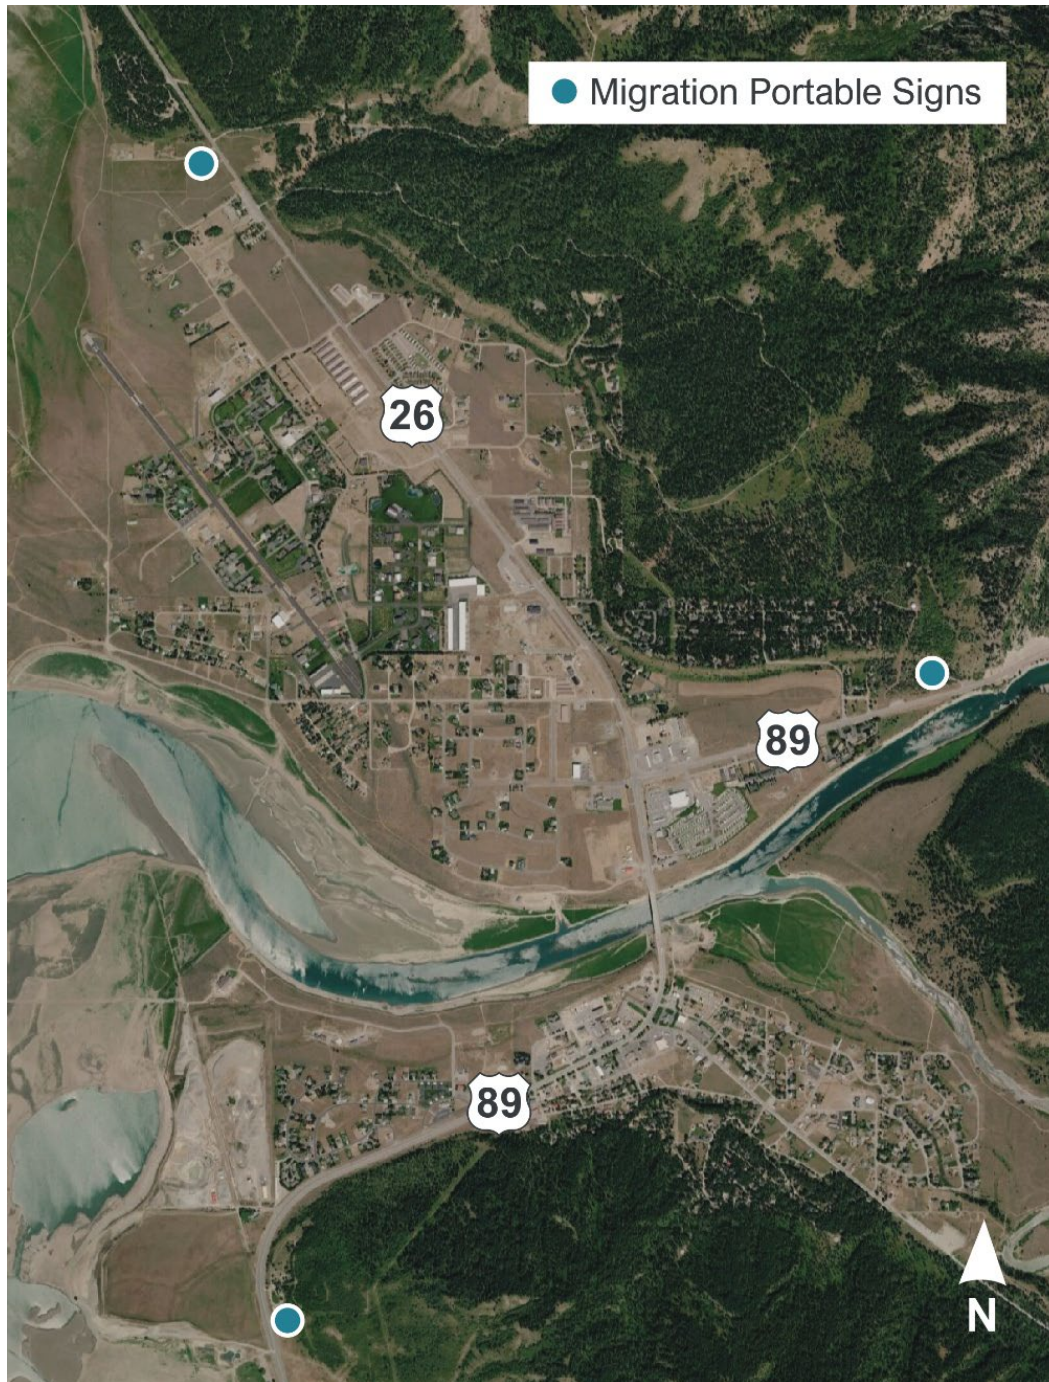
Figure 13. Project Alternative 2 - Migration Portable Signs

Alternative 2 is to install portable wildlife migration warning signs along US 26 and US 89 at key locations to increase driver awareness of wildlife crossings and reduce the potential for collisions. The project location is illustrated in **Figure 13**. An example of a portable message sign is shown in **Figure 14**.

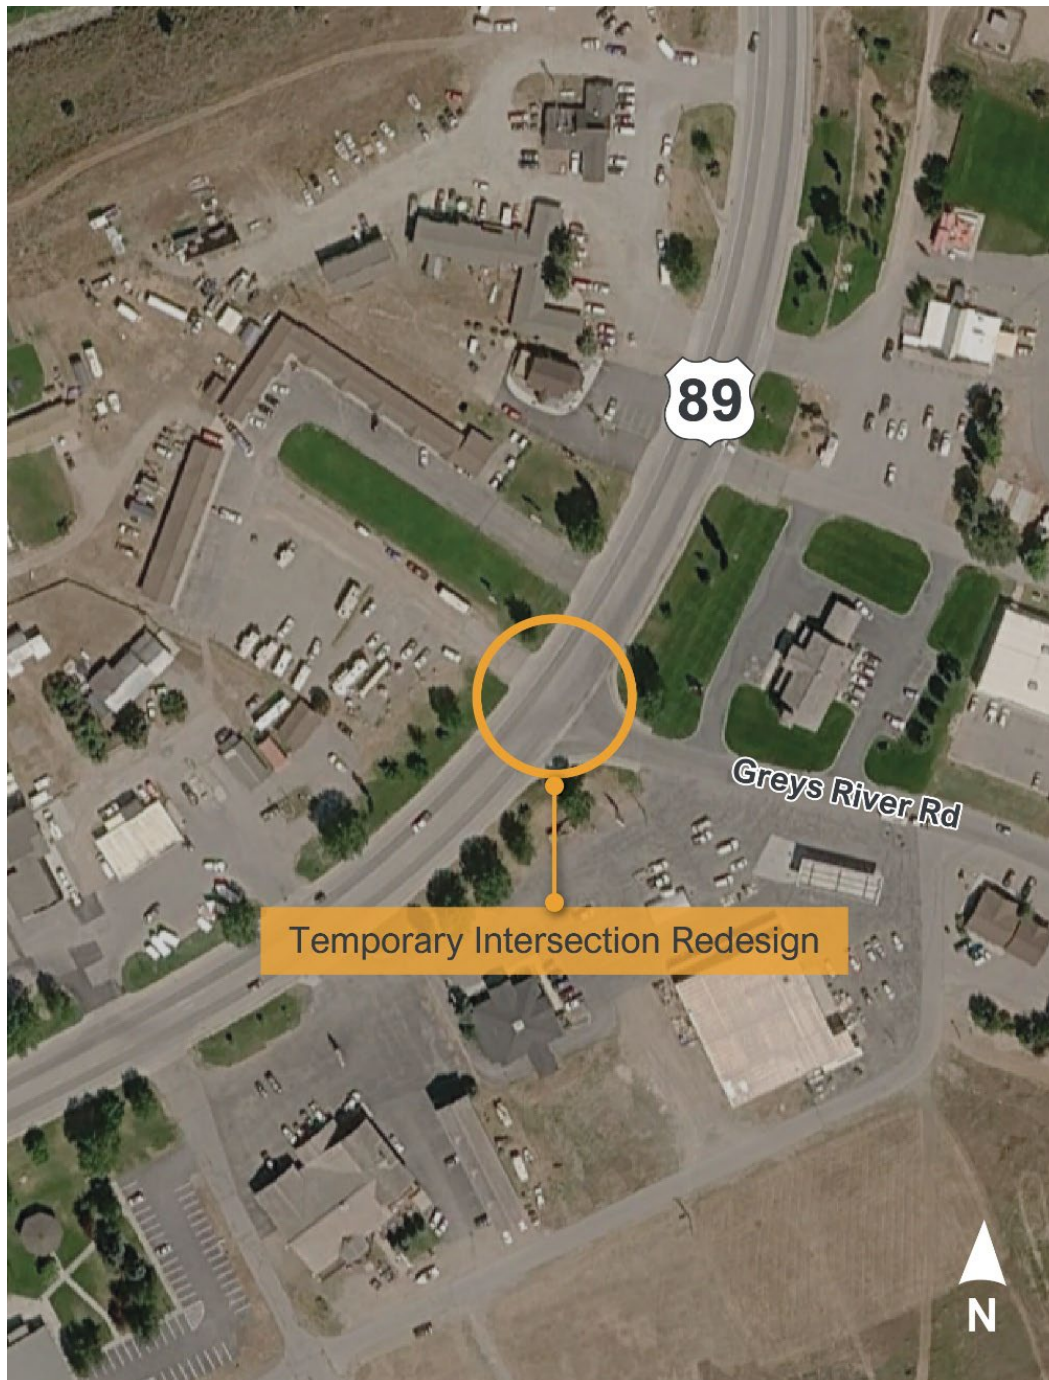
Figure 15. Project Alternative 3 - Intersection Redesign

Alternative 3 is a temporary redesign of the intersection of US 89 with Greys River Road to improve visibility and enhance safety, particularly for turning vehicles and pedestrians. The project location is illustrated in **Figure 15**. Potential redesign could include restriping the intersection, installing temporary flexible delineators installing a temporary roundabout. An example of temporary flexible delineators is shown in **Figure 16**. An example of a temporary roundabout is shown in **Figure 17** and **Figure 18**.
