Cay Court/Colony Drive: This drainage system collects water at the back of the cul de sac's and conveys the water through open ditches all the way East to TXDOT drainage on Highway 35. The areas depicted below needed maintenance that was achieved during the months of August/September. This project took 8 working days to complete. However, due to weather conditions this was stretched out over a 3-week period. There is also no maintenance berm or road in these drainage areas. The area must be completely dry to mobilize our equipment. The length of this entire system is approximately 2,265 ft. Based on this the crew can cut approximately 250 to 300 feet per day.

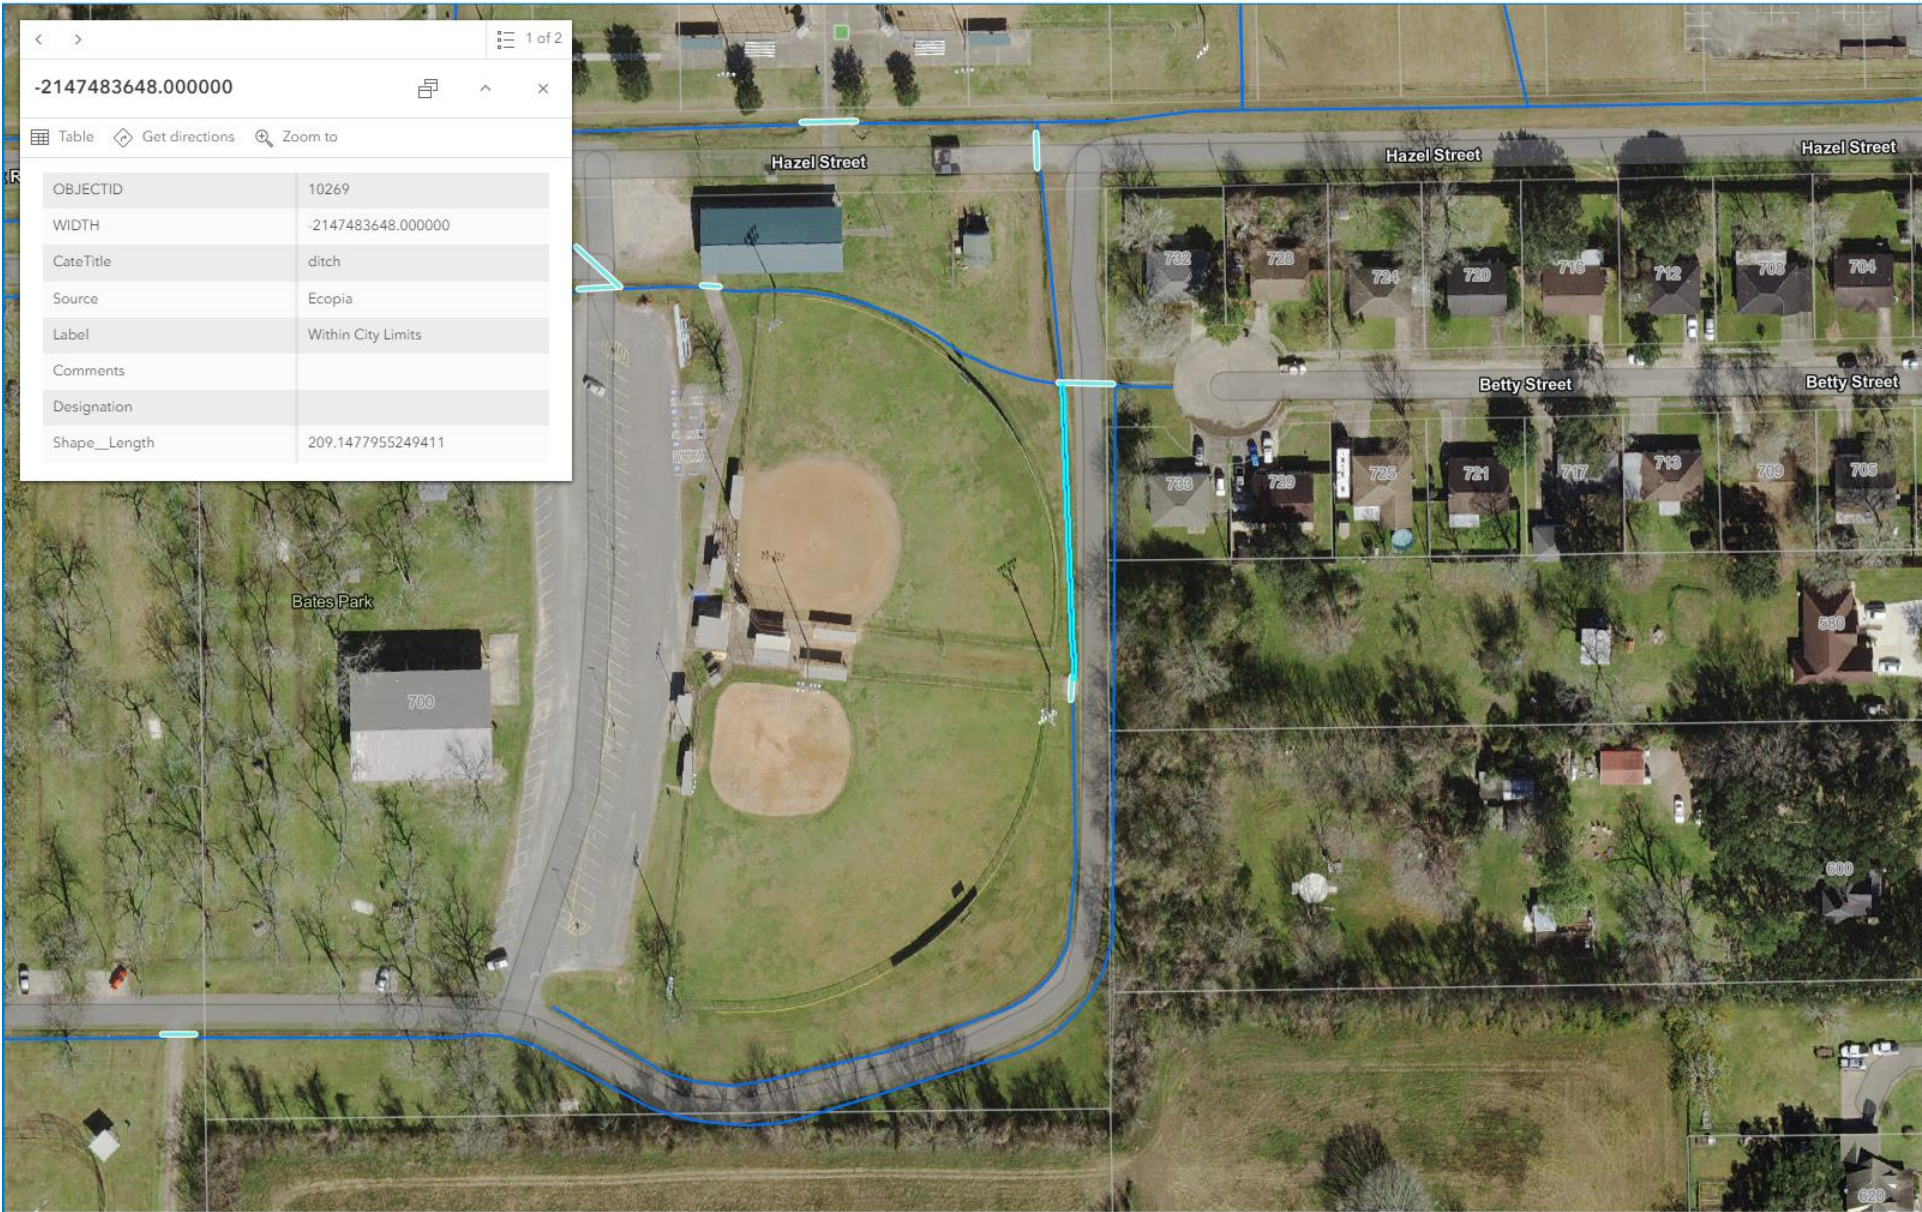
Bates Bark Area: The open drainage ditch areas around Bates Park also had maintenance performed on them. The end of Betty collects water and then meters out into this drainage system that exits through the west of the park into ADD drainage ditch. Regarding the ditches in this area, that will positively affect Betty Street. This was an approximate 500 feet, that took 2 full days to complete. However, this was over a weeklong period due to weather and equipment issues. This is approximately 250 feet per day.
