Re: Freedom Park & Windrose Green Tree Replacement  
City of Angleton

RE: **Heritage Tree Analysis**

This Memorandum serves as Concourse Development's understanding, analysis and conclusion on the City of Angleton's Code of Ordinance 23-60, Heritage Tree Protection requirement as applied to the Freedom Park and the Windrose Green development clearing projects.

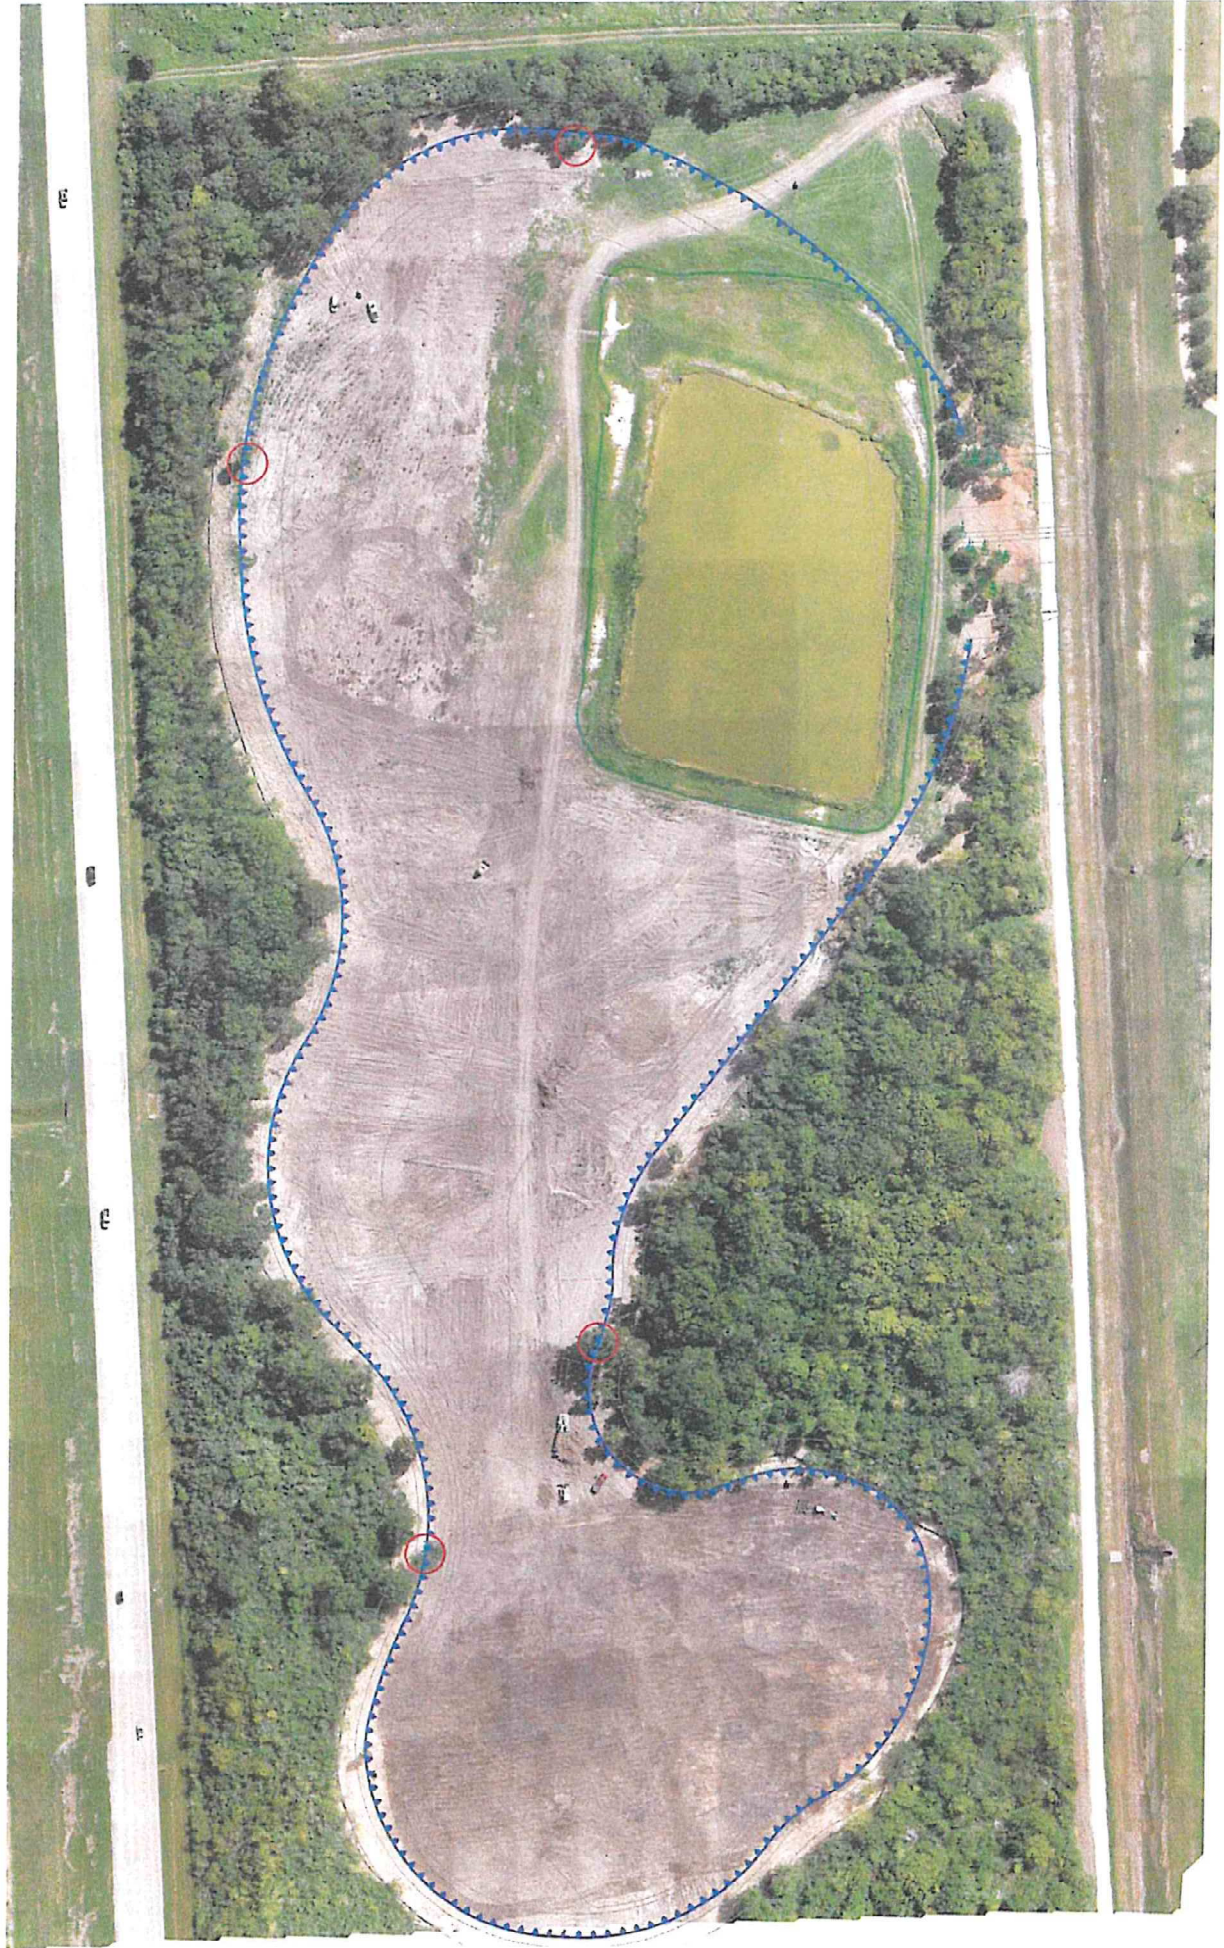
EXHIBIT "B-2"

At the final walk of the clearing project with the city staff there were 4 trees that were identified as being extremely close to the future excavation area and may need to be removed (**see Exhibit “B-2”**). It was agreed not to remove them under the current clearing contract, but to address those trees along with any other trees removed in the detention construction contract.
