**AN ORDINANCE TO ADOPT ADDITIONAL SUSTAINABILITY STANDARDS FOR VERIDEA**

# **Environmental Enhancement Plan**

## **Veridea**

## **Apex, NC**

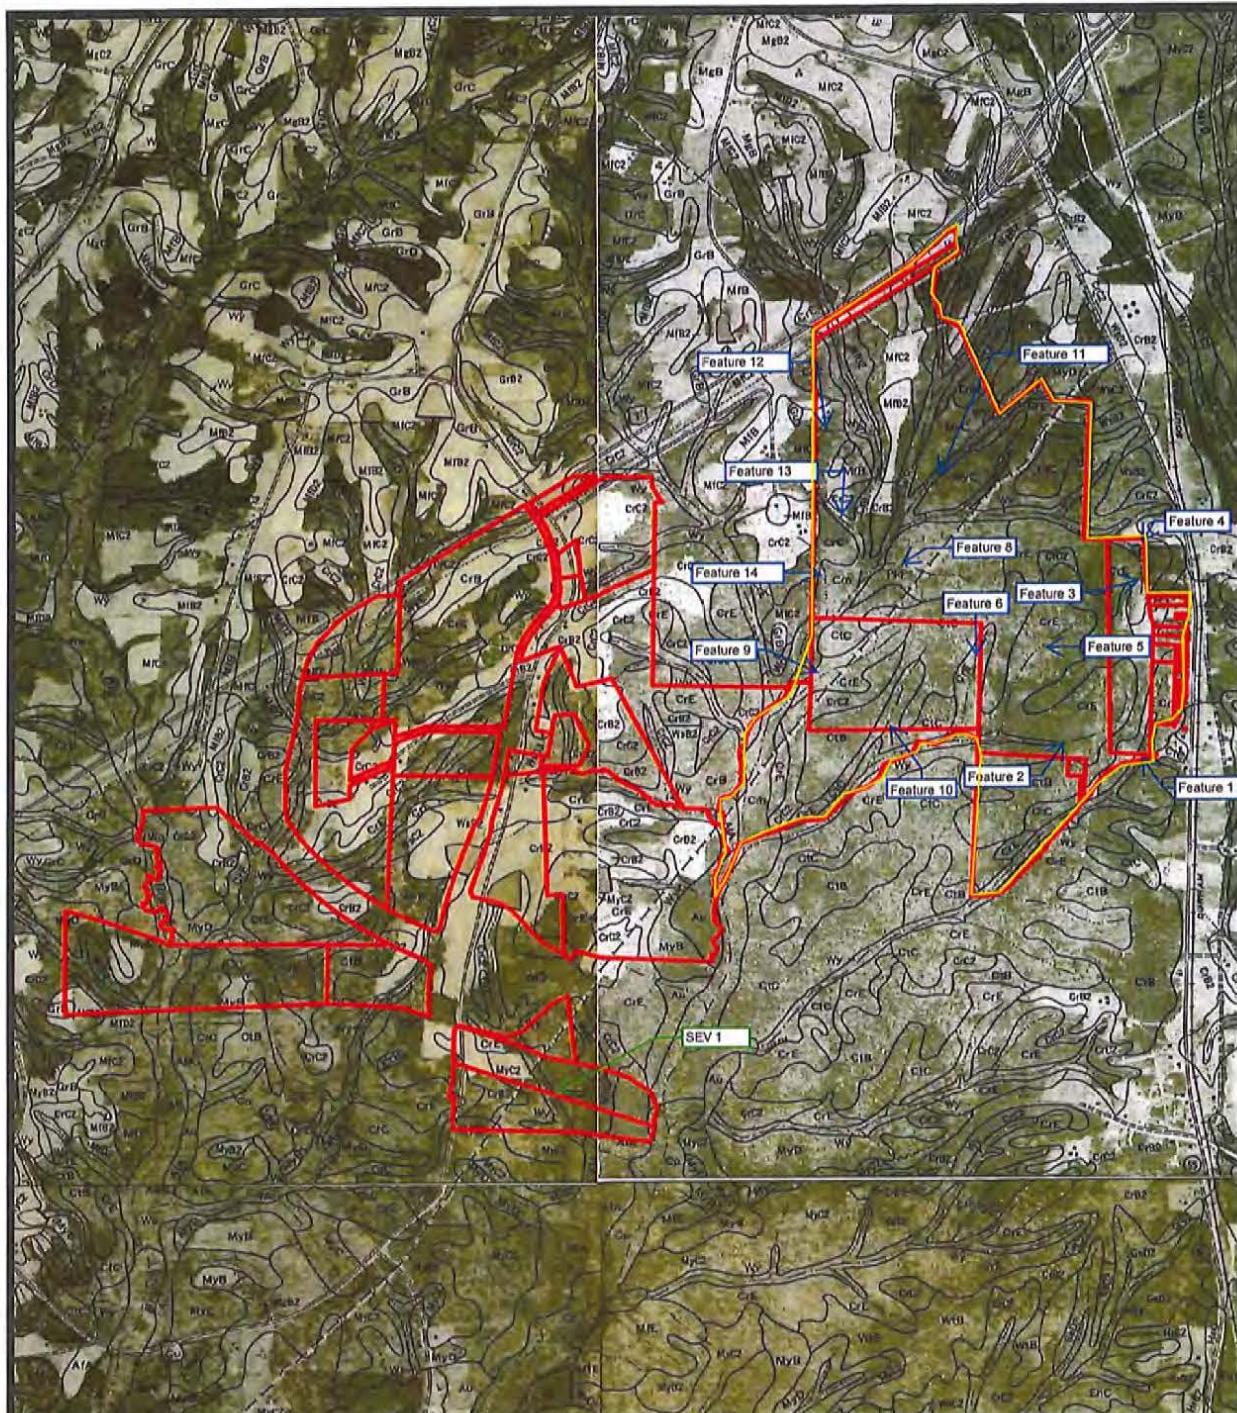
Project Number:	11065.W4	Map Title:	SS Map Veridea Wake County, NC	0 1,750 3,500 Feet	N

SOILS = Inf  
VS62 = NP
