ADA Transition Plan

01.18.2022 FINAL

To improve access, safety, and accessibility of all Apex citizens, the Town is conducting an ADA Assessment and developing an ADA Transition Plan for twenty-seven (27) Town-owned facilities. To ensure that the Town's facilities are accessible for persons with disabilities, Tindale Oliver's review covers facility entrances and exits, accessible routes, curb ramps, handrails, existing indoor and outdoor facilities, doors, restrooms, signage, as well as other building amenities as provided by the Town.

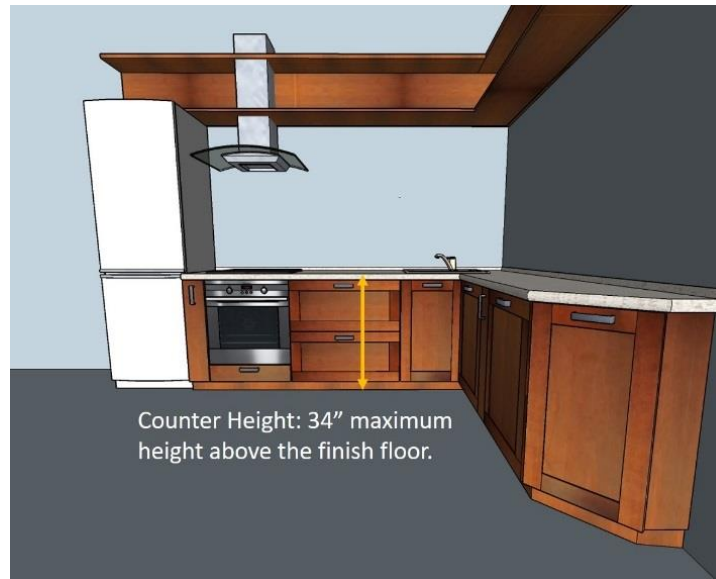
Figure 2.17 Accessible Dining and Work Surface

- Clear floor space complying with §305 positioned for a forward approach shall be provided.

- The tops of dining surfaces and work surfaces shall be 28" minimum and 34" maximum above the finish floor or ground.
- Accessible dining surfaces and work surfaces for children's use shall comply with §902.4.
