Project Type & Review Standards			
	YES	NO	N/A
Historic use/reuse and minimal change to distinctive materials, features, etc.			X
Historic character retained; removal or alteration distinctive materials avoided	X		
No changes that create a false sense of historical development	X		
Changes that have acquired historical significance in their own right will be retained	X		
Distinctive materials, features, examples of craftsmanship, etc. will be preserved	X		
Repair deteriorated historic features; new features will match old in design			X
Chemical and physical treatments will be as gentle as possible			X
Protect and preserve archeological resources in place			X
New construction will not destroy historic features that characterize property and will be differentiated from the old; new work is compatible with size, scale, massing, etc	X		X
New construction can be removed without destroying essential form & integrity	X

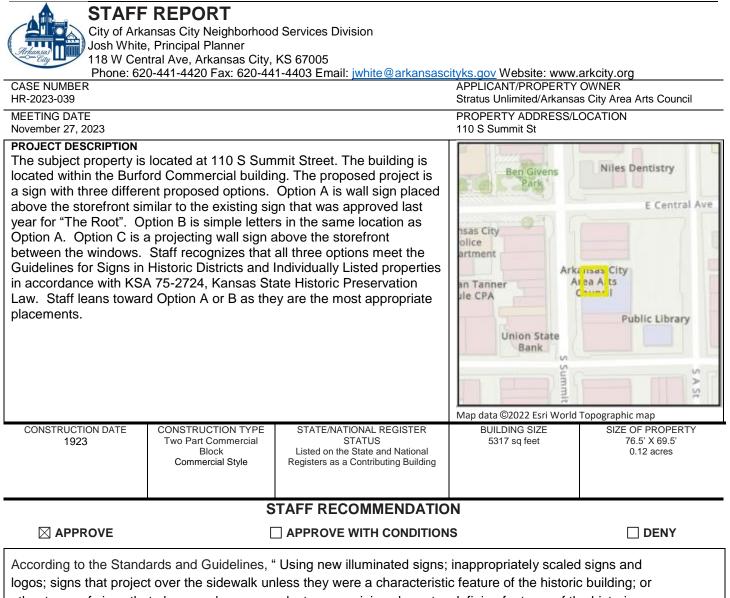
other types of signs that obscure, damage, or destroy remaining character-defining features of the historic building" is not recommended. Options A & B appear appropriately scaled and are placed on the very narrow sign board which appears to be the appropriate placement. Option C is similar to another sign placed on the Burford Building and would also be acceptable. In the past, signs have been on awnings or projecting but there is no historical evidence of where signs were placed prior to 1998. Any of the options would meet the Standards and could be approved per KSA 75-2724.

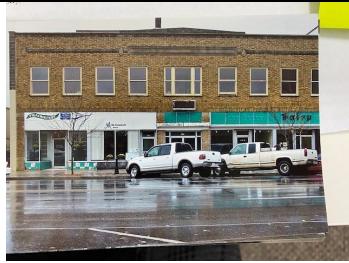
Undated photo provided by the Burford. It would have been taken shortly before the renovations began. The "sign board" existed at this time but it is likely that the windows were behind it as can be seen in the green panels to the south.
