Emergency Memo - Augusta Municipal Building

SITE OBSERVATION REPORT

REPORT#: 001

PROJECT TITLE: Augusta Municipal Building Leak Investigation Jos #: PZL233

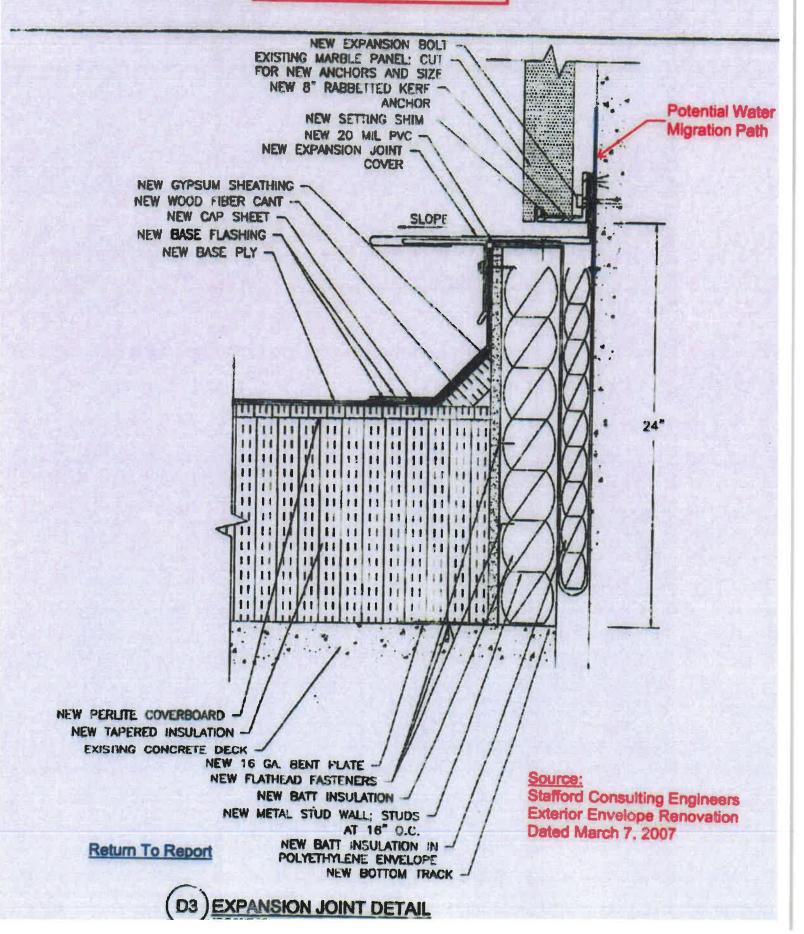
ATTACHMENT B

- 4. After the site visit, the City provided background drawings to JLA on August 3rd, 2023 that contained information on an Exterior Envelope Renovation project by Stafford Consulting Engineers, dated March 7, 2007. These background drawings contained a renovation detail that defined the building components at this expansion joint location that may indicate a potential leak path as noted (Attachment B).
