# ALTERNATIVE CONSTRUCTION & ENVIRONMENTAL SOLUTIONS, INC.

Project: Indoor Air Quality Inspection and Spore Count Analysis  
The Boathouse Community Center  
101 Riverfront Drive  
Augusta, GA  
Report Number: 2006-113-002

## 2.0 SITE/VISUAL INSPECTION

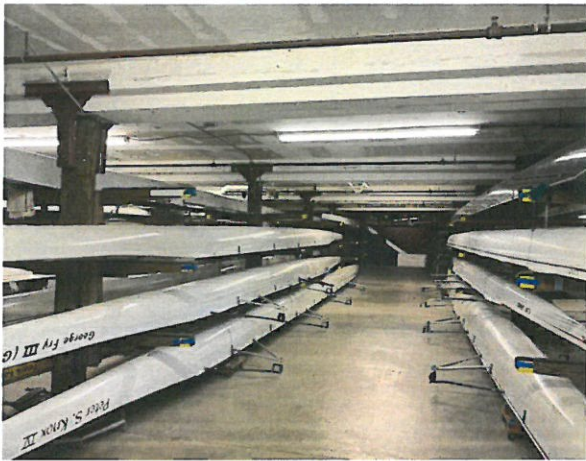
1, Basement, Rowing Club Facility

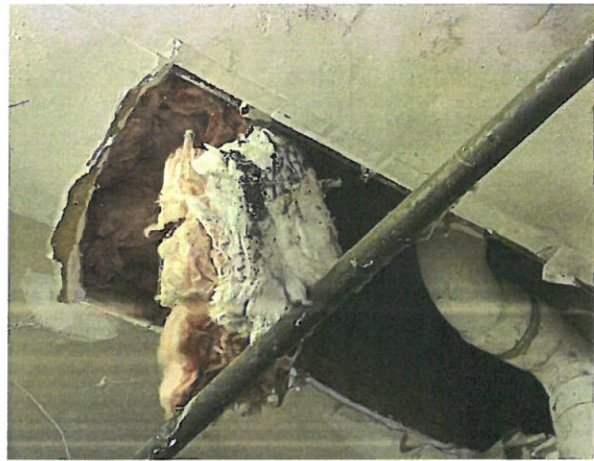
There was visible staining indicative of mold growth found on visible surfaces inside the project area. These included ceiling tiles, walls and insulation backing in the kitchen. Although spore count samples were not collected from the basement (Rowing Club facility), visual staining indicative of mold colonization was observed and photographed on the ceilings throughout. No destructive or invasive inspecting was performed.

2, Staining Indicative of Mold Colonization on Insulation

If any materials are found in the future with visual mold growth or damaged appearance, they should be cleaned or removed/discarded as per EPA guidelines published in "Mold Remediation in Schools and Commercial Buildings" (EPA 402-K-01-001). (ref. 4)

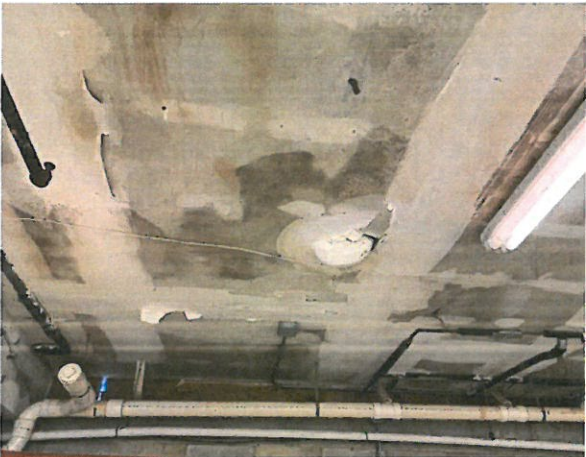
3, Evidence of Water Intrusion and Damage to Drywall

It should be noted that microbiological growth can and probably will reoccur if any source of moisture is not corrected and maintained as appropriate. Many spores are naturally-occurring and will grow again with proper moisture, temperature and food source.

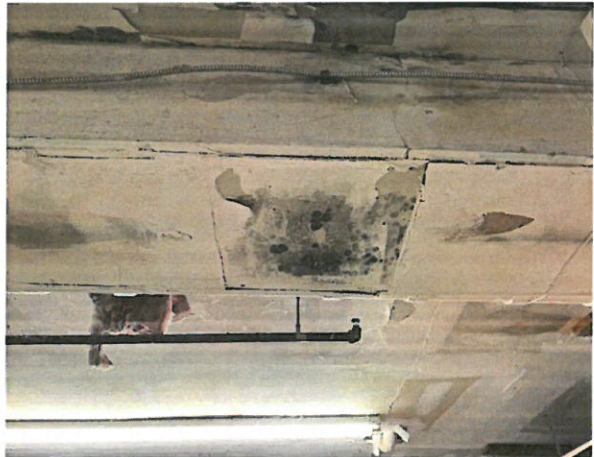
4, Staining Indicative of Mold Colonization Drywall Ceiling

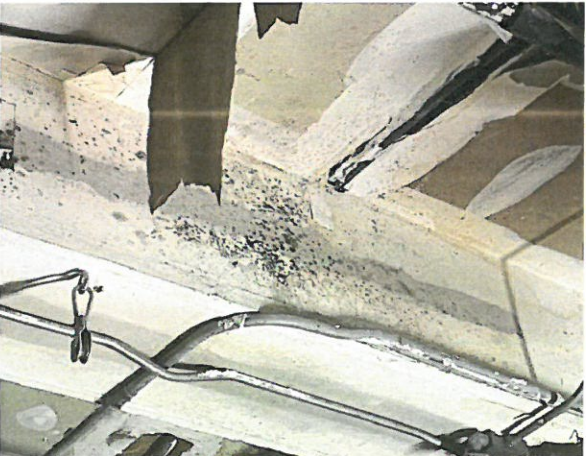
5, Staining Indicative of Mold Colonization on Ceiling Beam

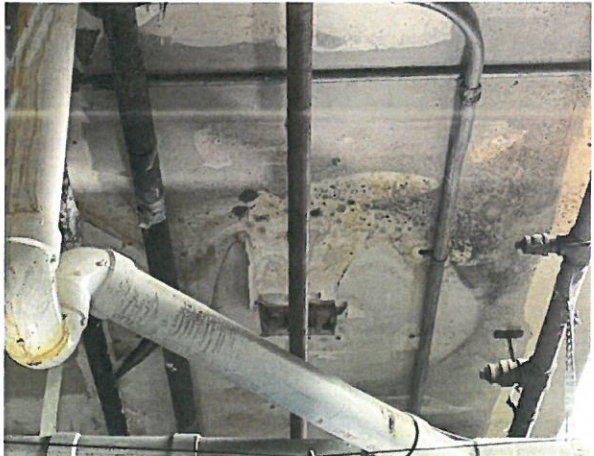
6, Staining Indicative of Mold Colonization Drywall Ceiling
