CITY OF BASTROP
Hunter's Crossing Channel Outfall Drainage Analysis

SCOPE OF WORK

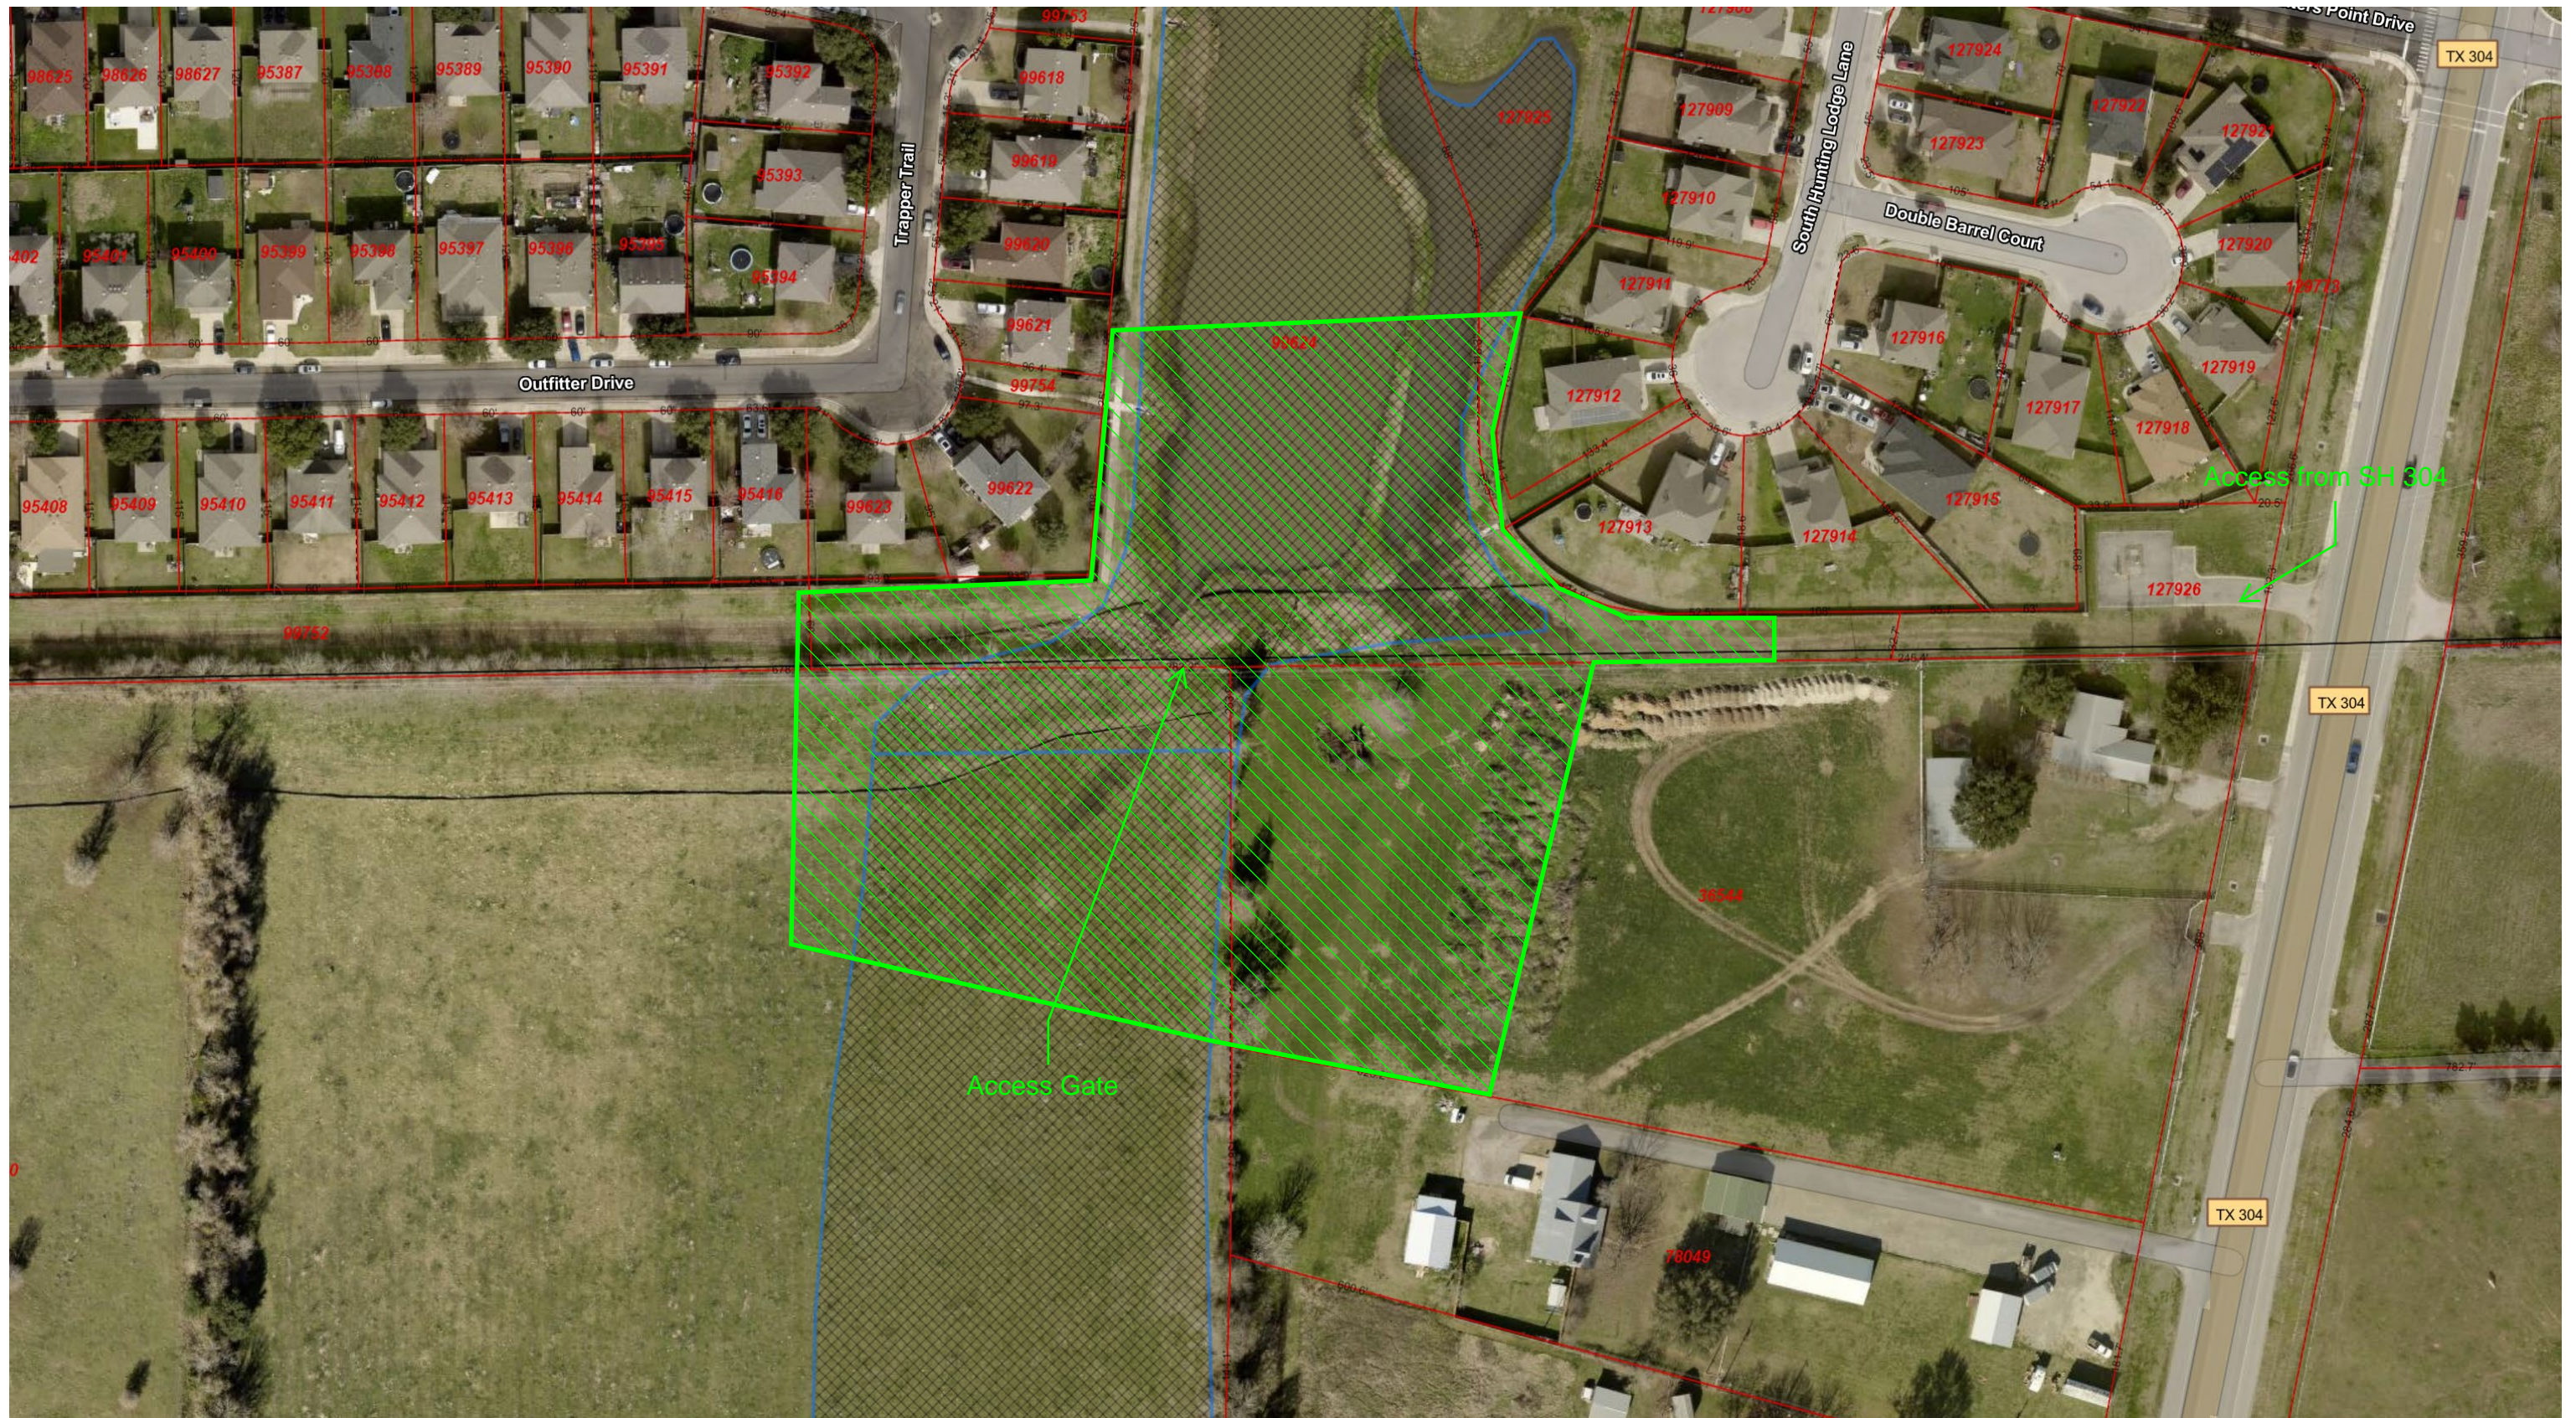
- Take topographic elevation shot of water elevation in retention channel on Parcel ID 99624.
- Take topographic elevation shots at Top of Bank (TB) of the retention channel in area shown in Area of Work.
- Show the perimeter and depth of existing gabion wall at southernmost end of retention channel. Include pictures of condition.
- Show existing utilities/fences/areas of interest.
- Create a topographic surface with a high level of detail within Area of Work. 25' x 25' grid topo shots for flat areas and break the grid to catch Low Points (LP) and High Points (HP) where spotted. Base line of the grid should be along the East-West property line separating Parcel ID 99624 from the other two parcels.

Professional survey services for the drainage analysis of Hunter's Crossing Channel outfall. The outfall is circled in blue as Parcel ID 99624. We have permits to enter Parcels 23660 & 36544 just south of the circled parcel. The purpose of this survey is to determine where flooding occurs when the water in retention in the circled parcel overflows and surface runoff runs to the south. FEMA floodplain shows flooding occurs through Parcel ID 23660 but actual storm events flood the parcels to the east (36554, 78049, 37407, 37528, etc.) instead. The bottom picture shows actual flooding during a storm in 2015. Location map with Area of Work and access information attached to end of document.
