## MEMORANDUM

RE: Cypress Drive and Greenwood Road - Bus Stop Red Flashing Lights Stop  
Compliance  
SEH No. BAXTE 183117

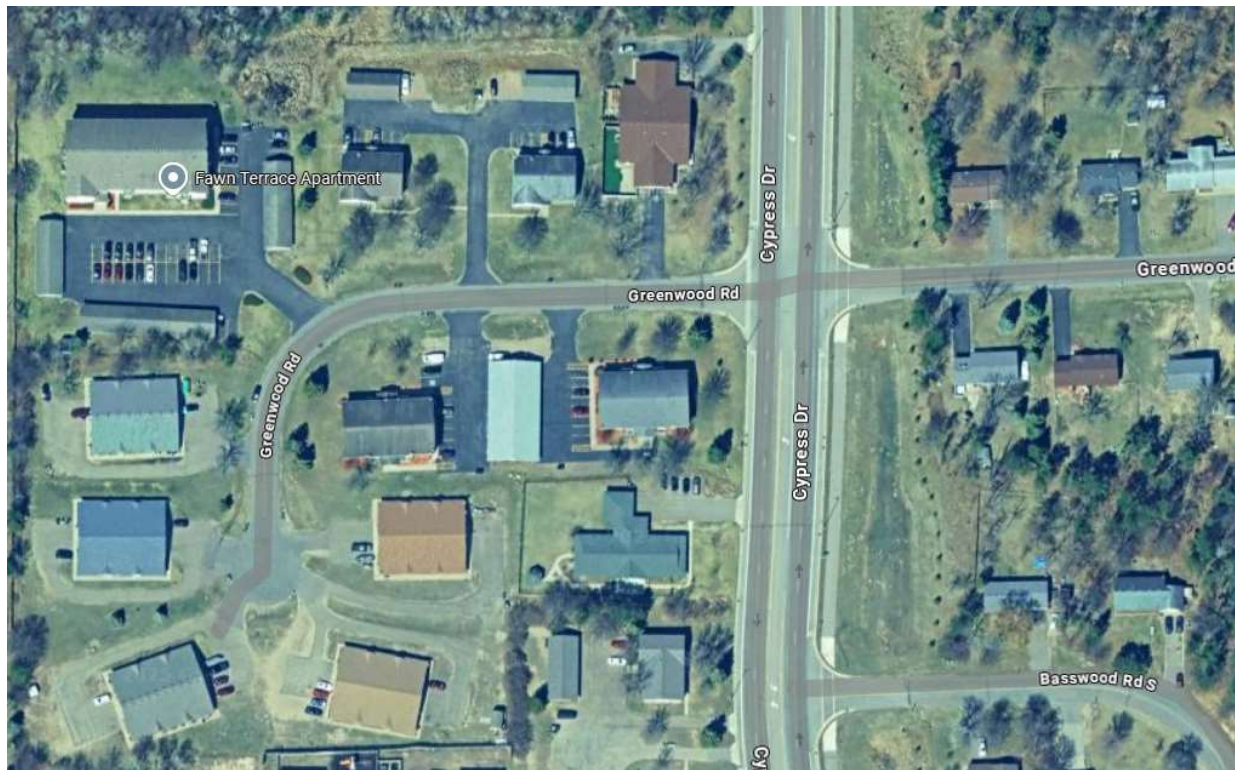
**Figure 1 – Intersection Location**

At this location, Cypress Drive is a 5-lane roadway with two travel lanes in each direction and a two-way center left turn lane. The speed limit on Cypress Drive is 40 mph and has a daily traffic volume of approximately 3,200 vehicles per day based on a 2023 traffic count. The intersection of Cypress Drive and Greenwood Road currently operates under minor street stop control, with Greenwood Road traffic being required to stop. Under the minor stop control, drivers on Cypress Drive generally do not have to stop at the intersection under normal conditions. **Figure 1** shows the intersection and surrounding area.

Currently, school buses stop at the intersection of Cypress Drive and Greenwood Road along southbound Cypress Drive to pick-up and drop-off children living in the multi-family residential units on Greenwood Road, west of Cypress Drive. No children cross Cypress Drive from the east side to get to the bus stop on the west side of the roadway. The bus stop cannot be relocated onto Greenwood Road, west of Cypress Drive, because the existing cul-de-sac on Greenwood Road is not large enough for buses to turn around.

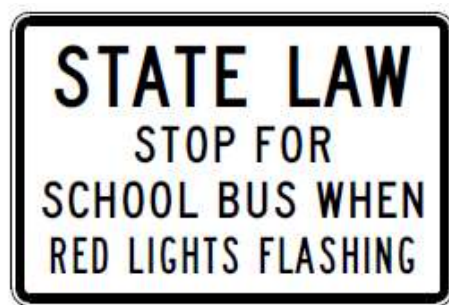
**R16-X1**

- “State Law Stop for School Bus When Red Lights Flashing” sign (R16-X1)
- School Bus Stop Ahead sign (S3-1)

**Figure 2 – MnMUTCD School Bus Stop Signage**

Based on Chapter 2B of the MnMUTCD, these signs “*should be installed along State Highways following State Entrance signs. Their intent is to inform motorists entering into Minnesota of some of the common motor vehicle laws*”. However, engineering judgement could be used to place these signs in other locations. Therefore, it is recommended that “State Law Stop for School Bus When Red Lights Flashing” Signs (R16-X1) be placed in advance of the intersection of Cypress Drive and Greenwood Road for both directions of Cypress Drive traffic to improve stop compliance for the school buses stopping at the intersection. If compliance issues remain, a custom plaque saying “Both Sides of Road” or “Both Directions of Travel” could be added.

Based on review of MnMUTCD guidance, it is recommended that “State Law Stop for School Bus When Red Lights Flashing” Signs (R16-X1) be placed in advance of the intersection of Cypress Drive and Greenwood Road for both directions of Cypress Drive traffic to improve stop compliance for the school buses stopping at the intersection. If compliance issues remain, a custom plaque saying “Both Sides of Road” or “Both Directions of Travel” could be added.
