WETLAND DELINEATION REPORT FOR:

Lot 384R, 97 Subdivision, Resubdivision of Lot 384 and 385

285 Engineering, Inc
Jennifer D. Migliorato
P.O. Box 1048
Conifer, CO 80433

August 19, 2019

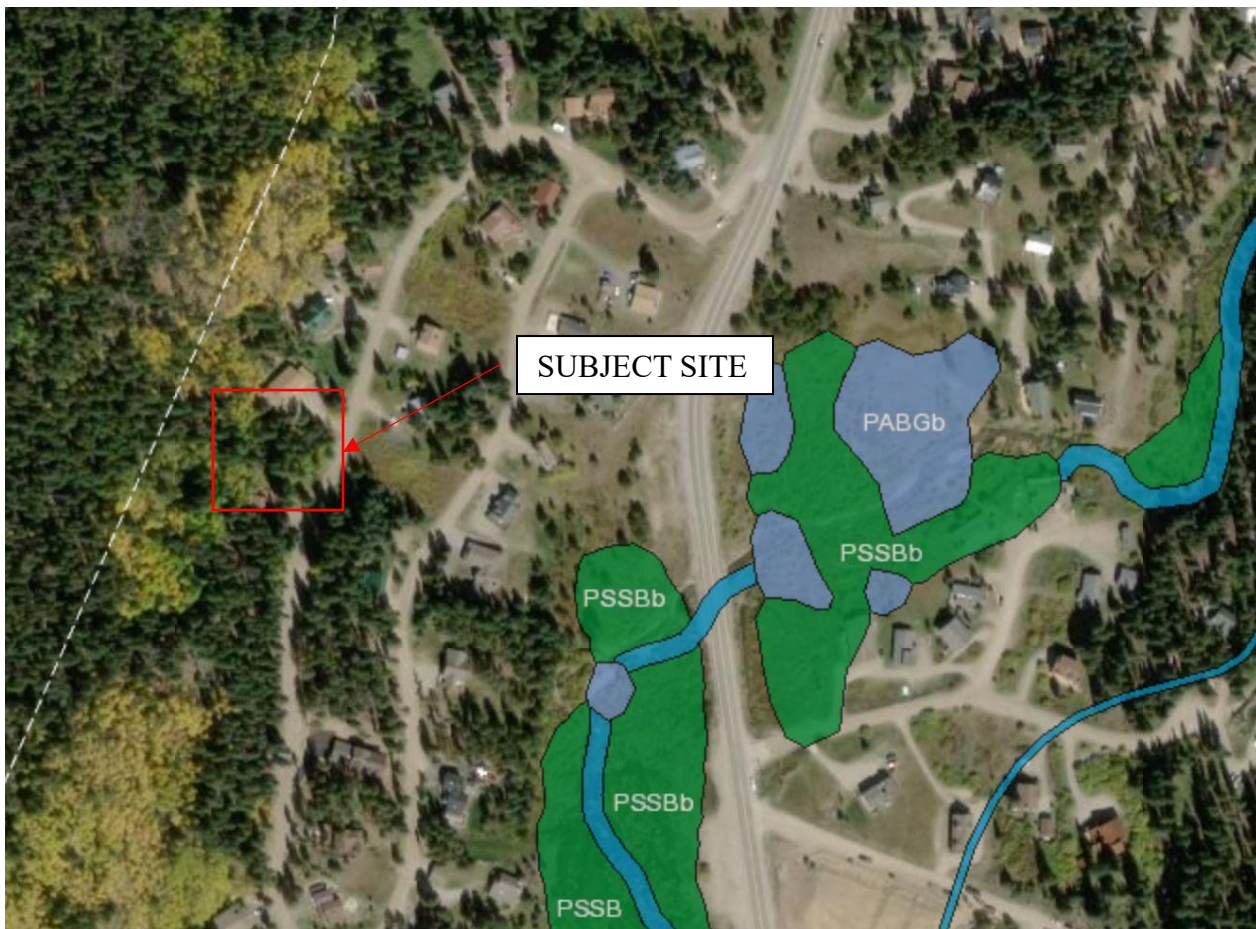
Figure 1 – National Wetland inventory map

On July 24, 2019 a site visit was performed at the subject site to determine if/ and where wetlands were present on the subject site. During the site visit several soils samples were obtained and the vegetation and hydrology of the site were logged. The vegetation, soils and hydrology of two separate locations were documented through the use of Army Corps of Engineers approved data forms. Several other locations were tested throughout the wetlands present on the subject property. A search of the National Wetland Inventory (NWI) mapping, concluded no NWI designated wetlands on the subject site. The wetlands on the site are herbaceous wetlands, associated with seeps and springs.

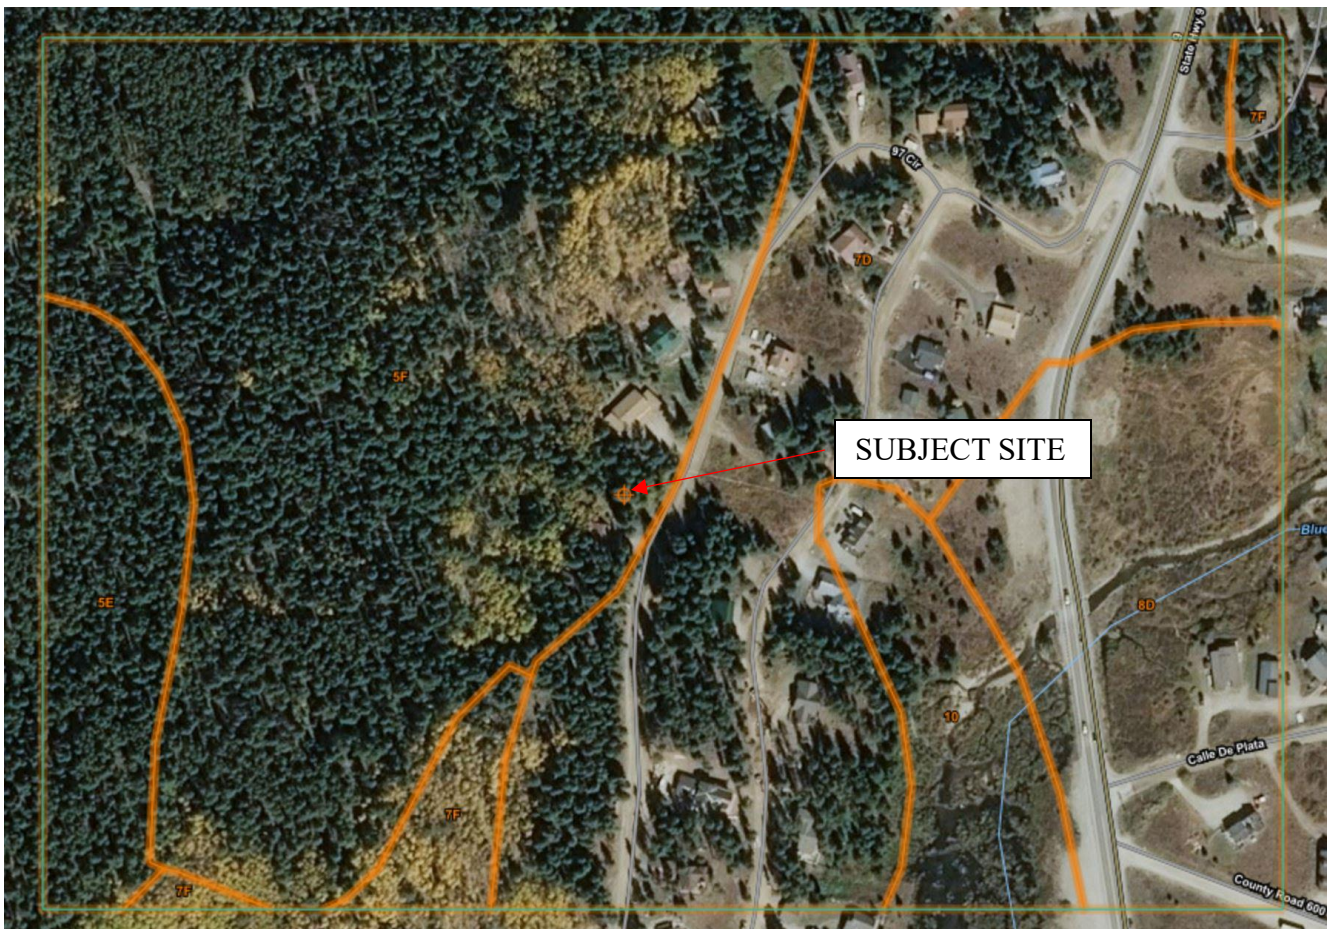
Figure 2 – USDA Web Soil Survey Mapping

Hydric soils were encountered within the wetlands. The hydric soils generally consisted of saturated soils with low chroma and value and redoximorphic features. Sandy hydric soils were also encountered at the site. See attached data forms for more specific information regarding soil types. According to NRCS soils map data, the wetland areas of the project are located within the mapping unit 5F – Frisco-Peeler Complex with 25% – 65% slopes.

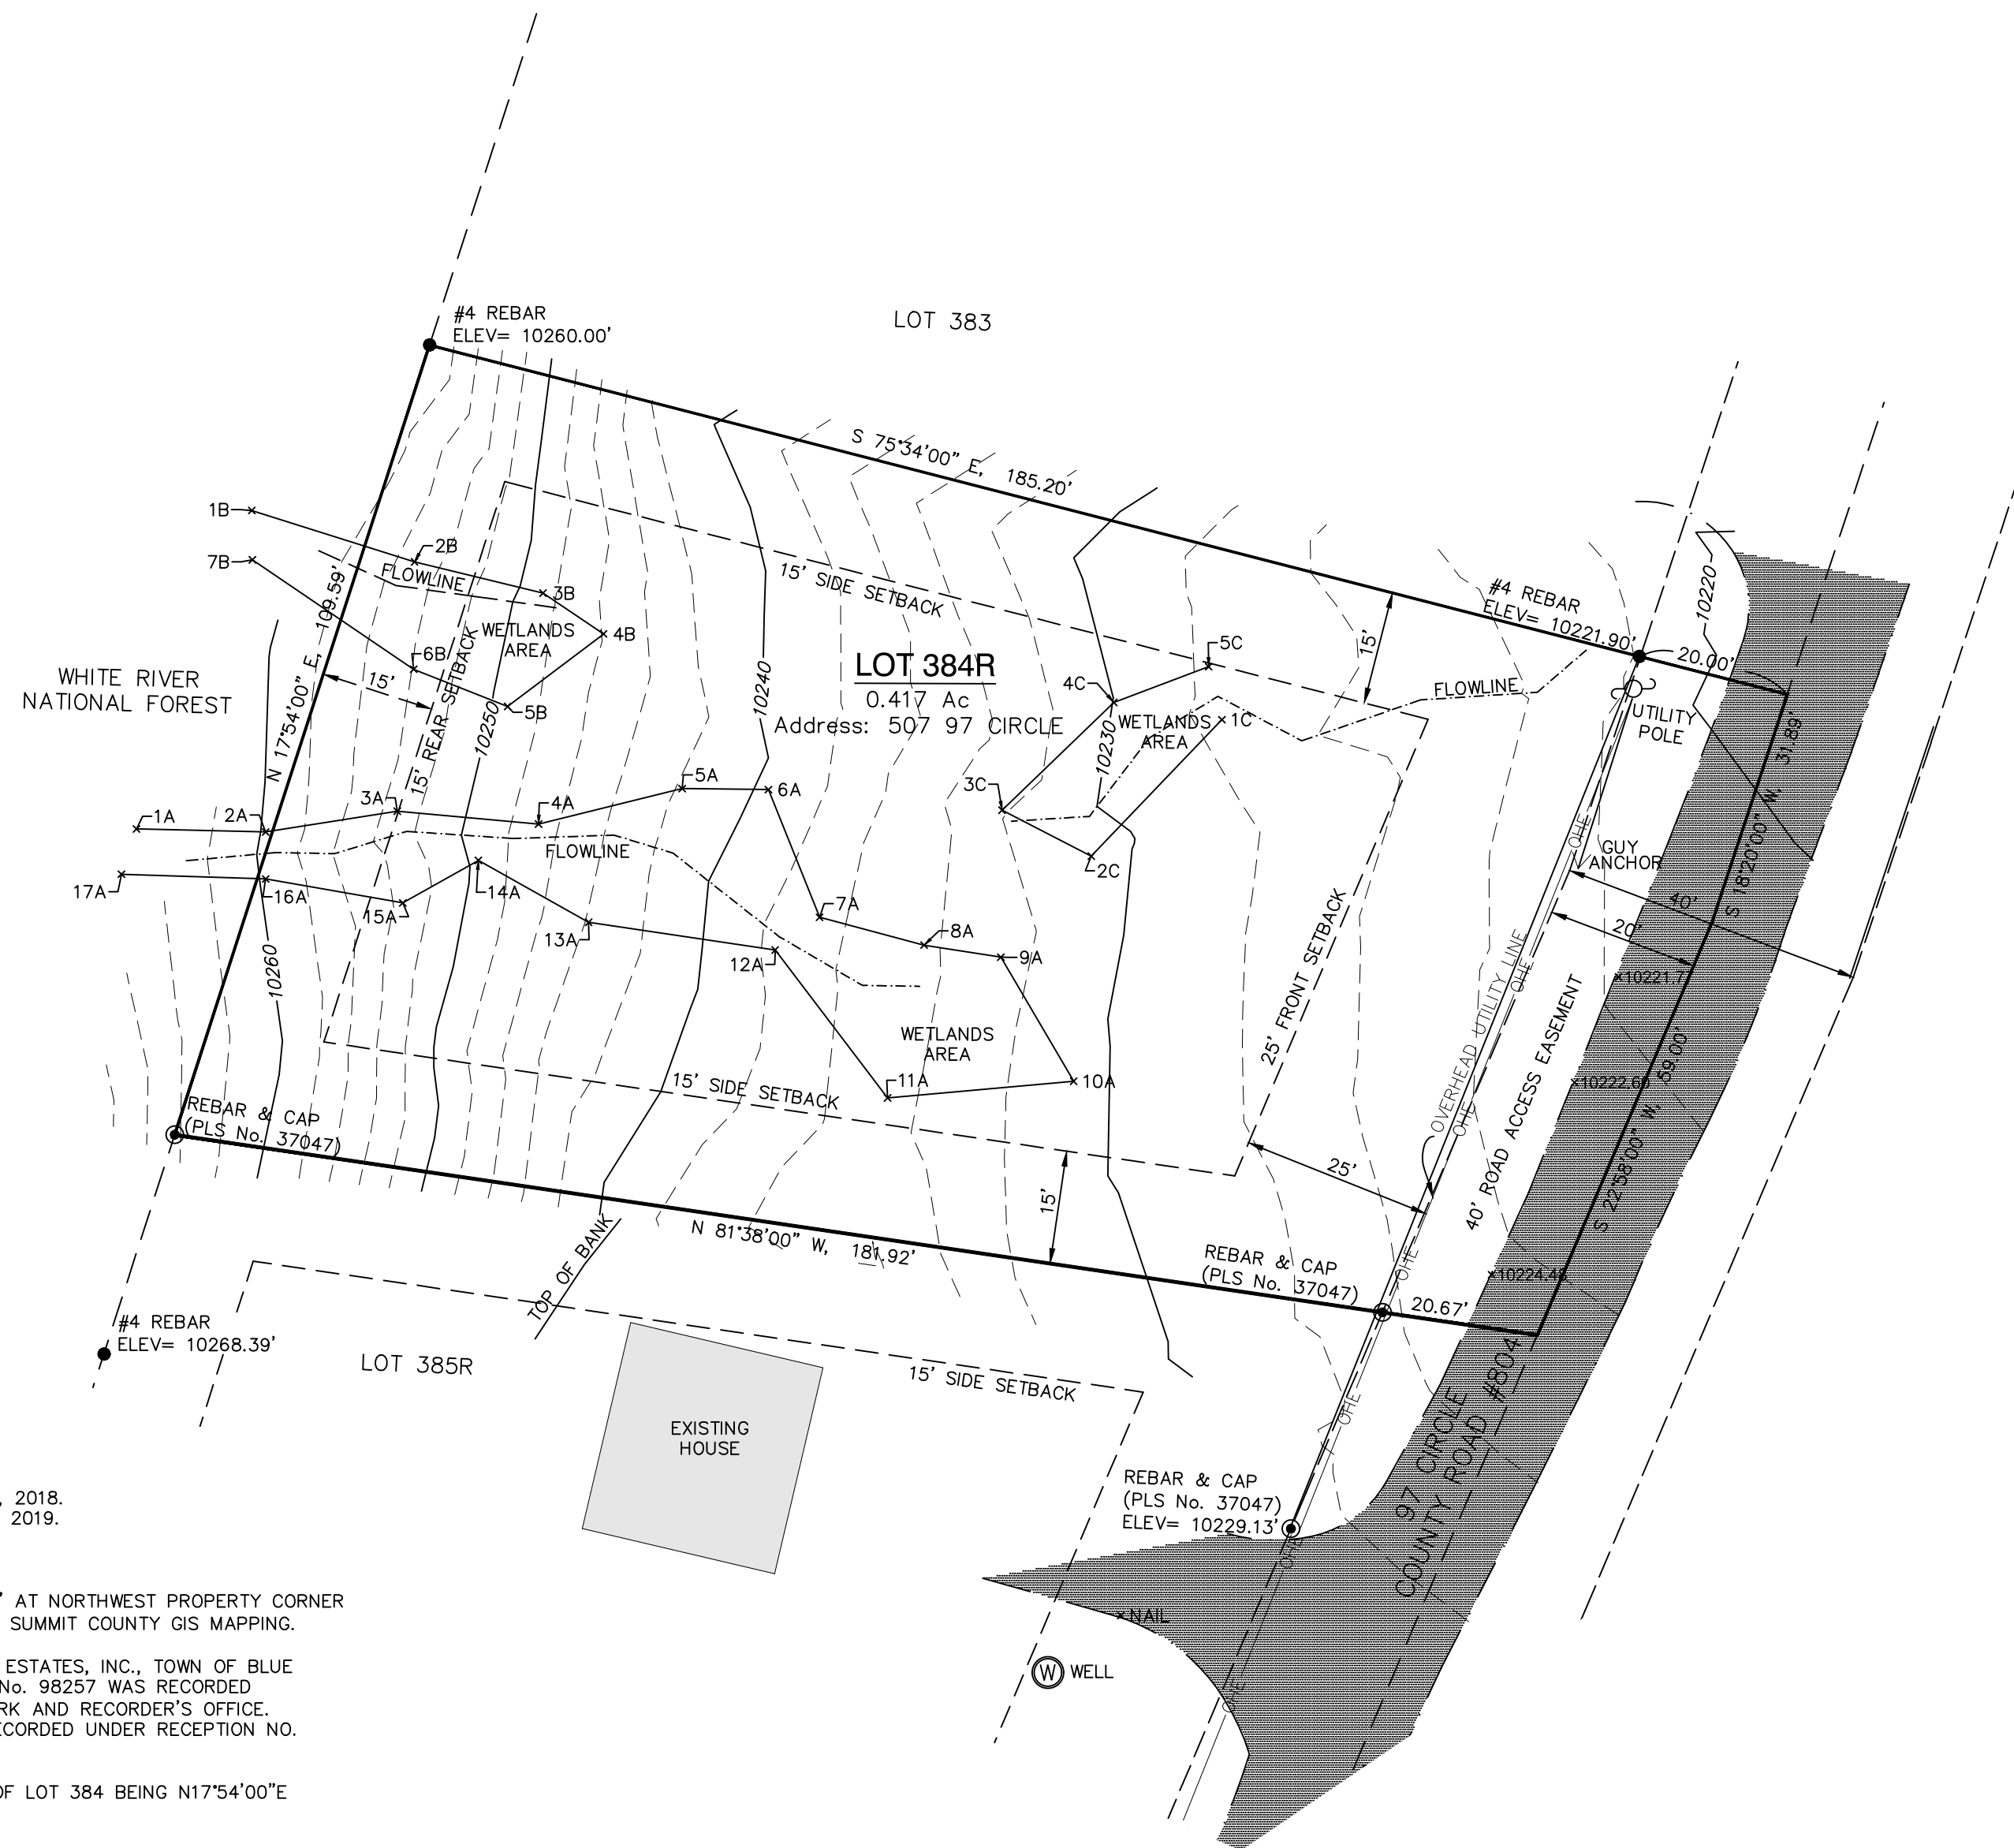
A TOPOGRAPHIC SURVEY WITH WETLANDS
LOT 384R, THE '97 SUBDIVISION-THE BLUE RIVER ESTATES

The wetland boundary was marked with pink delineation flagging. During the site visit the flagging was surveyed and a copy of that survey is attached to this report.
