Baseline IAQ Mold Assessment Report

34 Thomas Heyward Residence
Bluffton, SC
VC24-06

Subject: **Baseline IAQ Mold Assessment Report**
Residence at 34 Thomas Heyward
Bluffton, South Carolina 29910
VC24-06

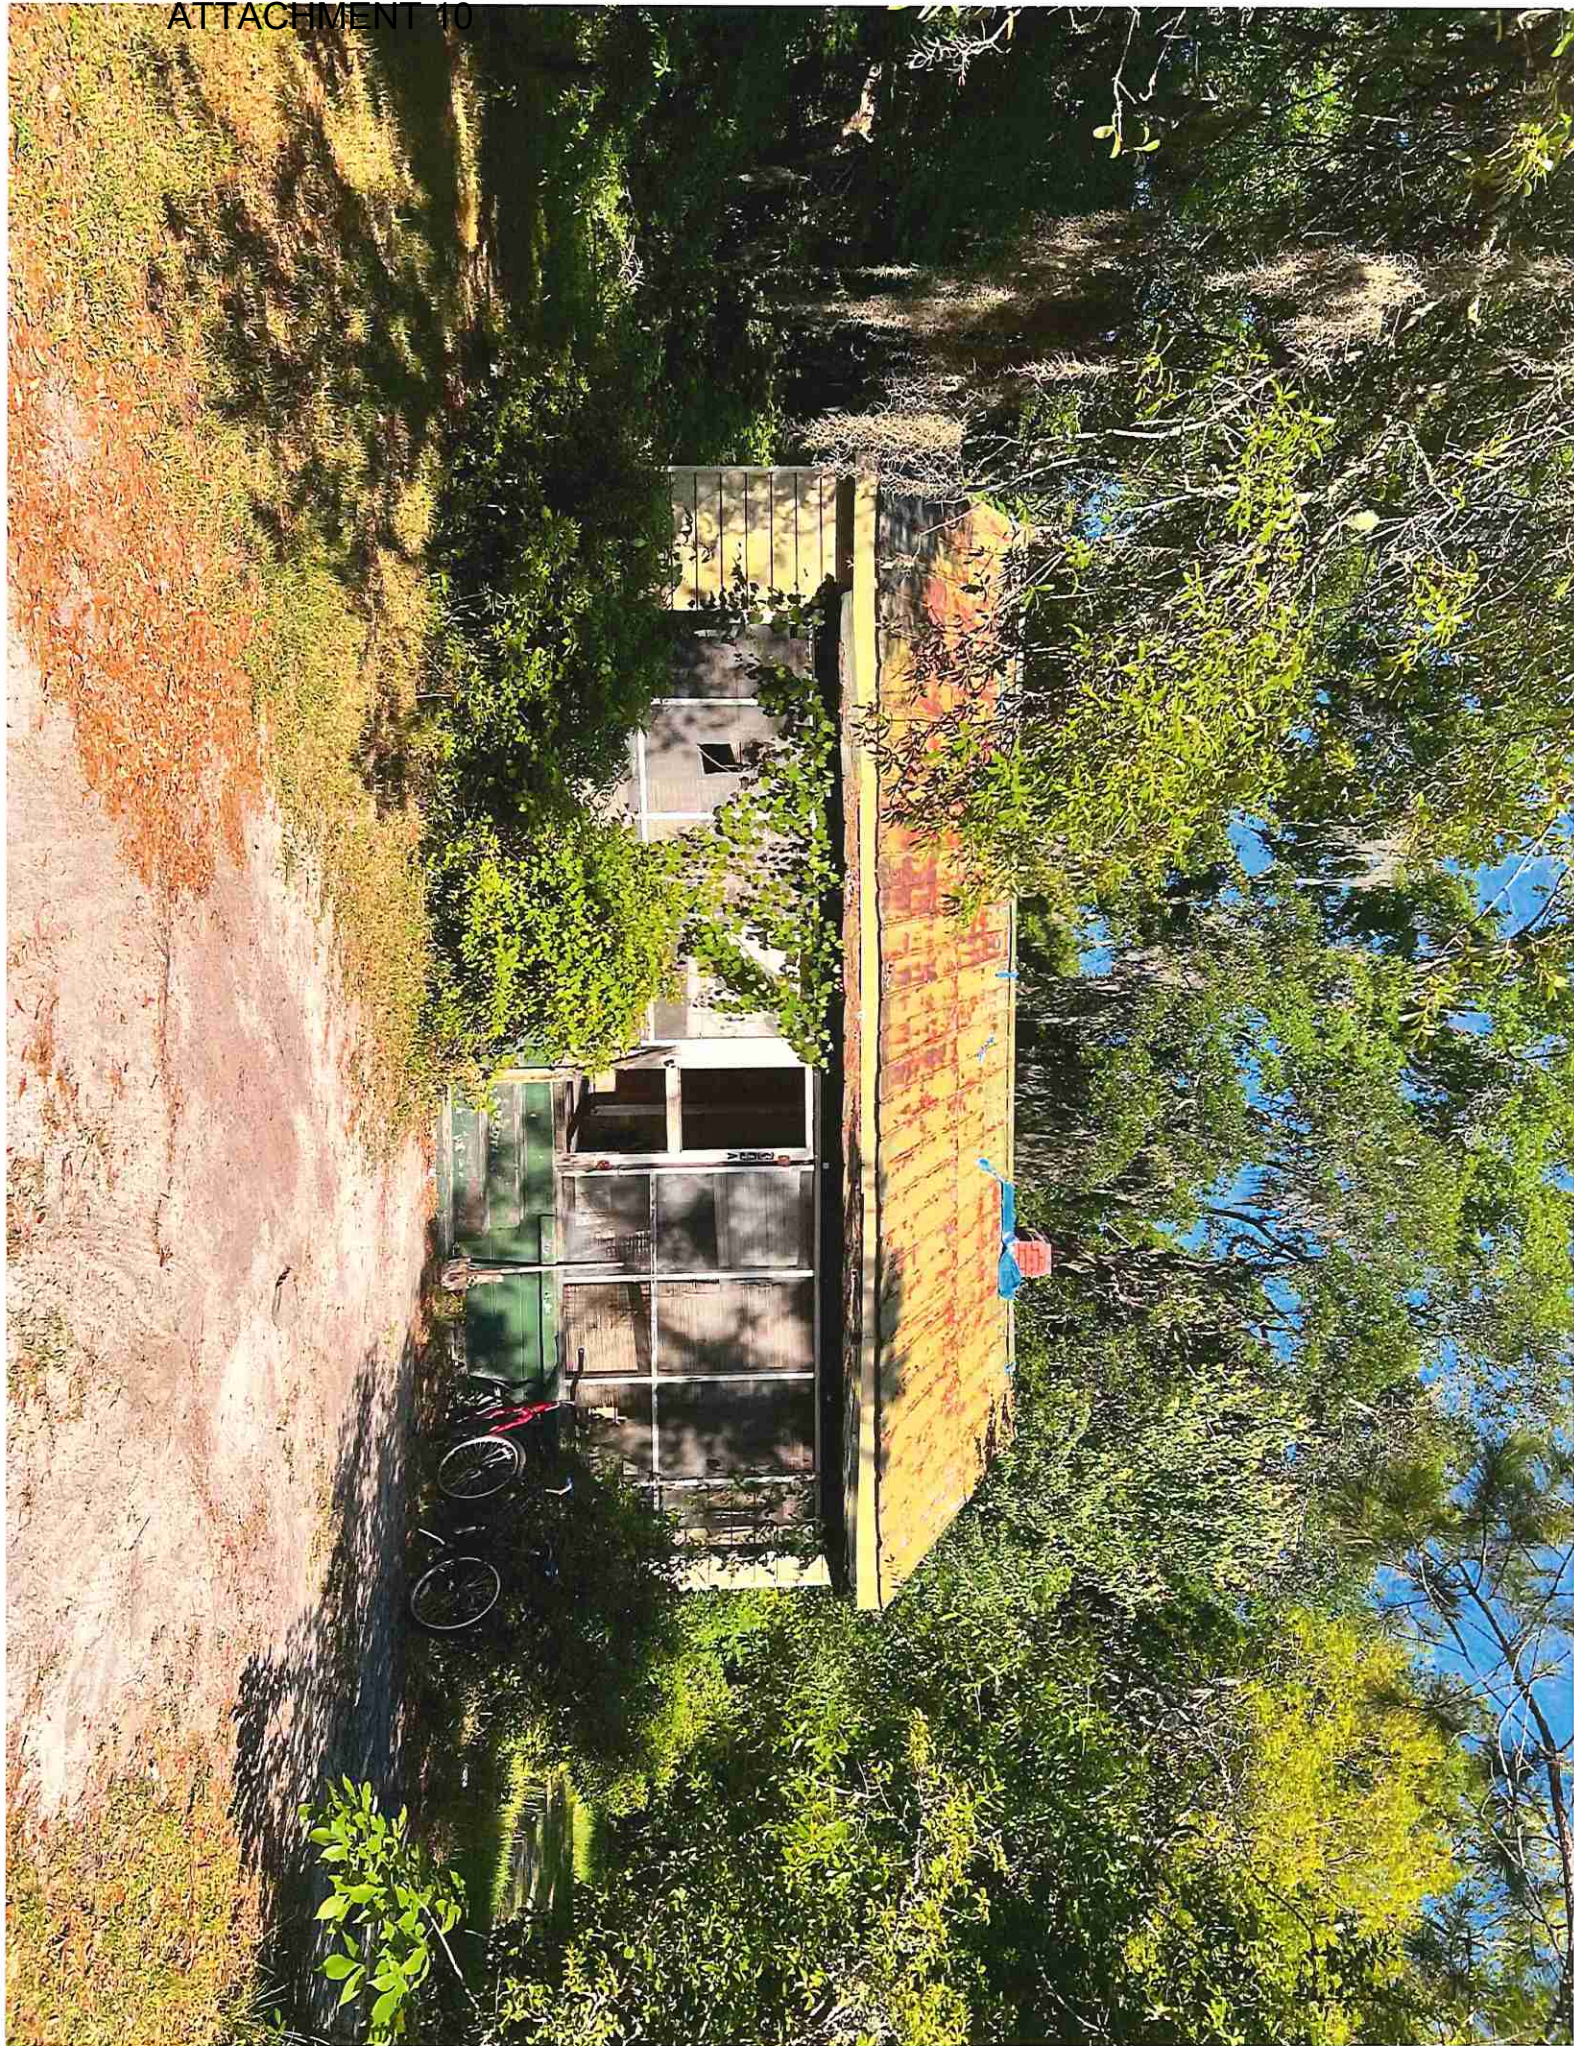
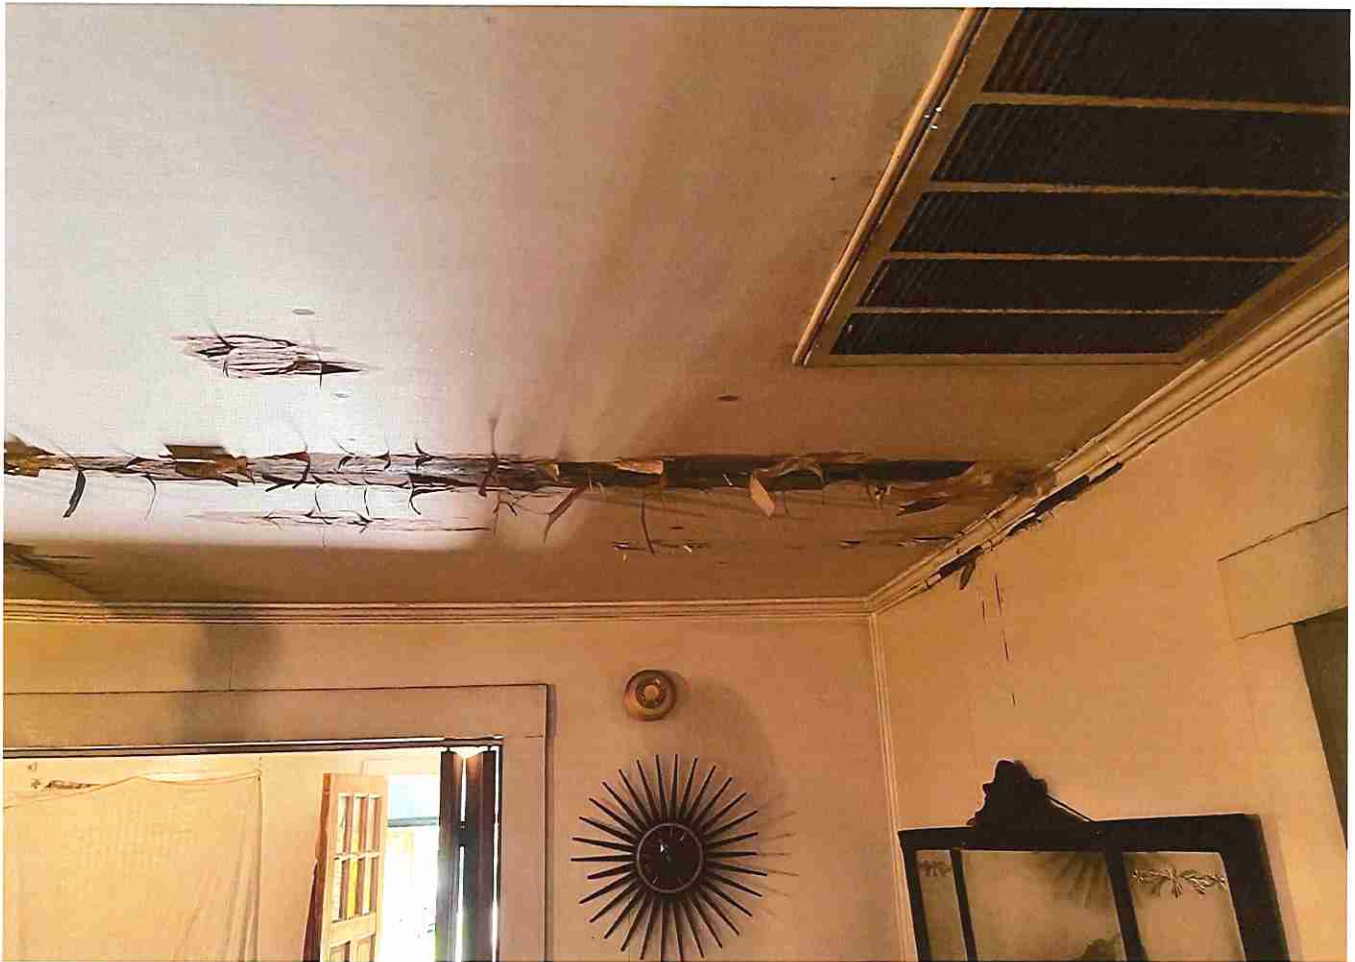
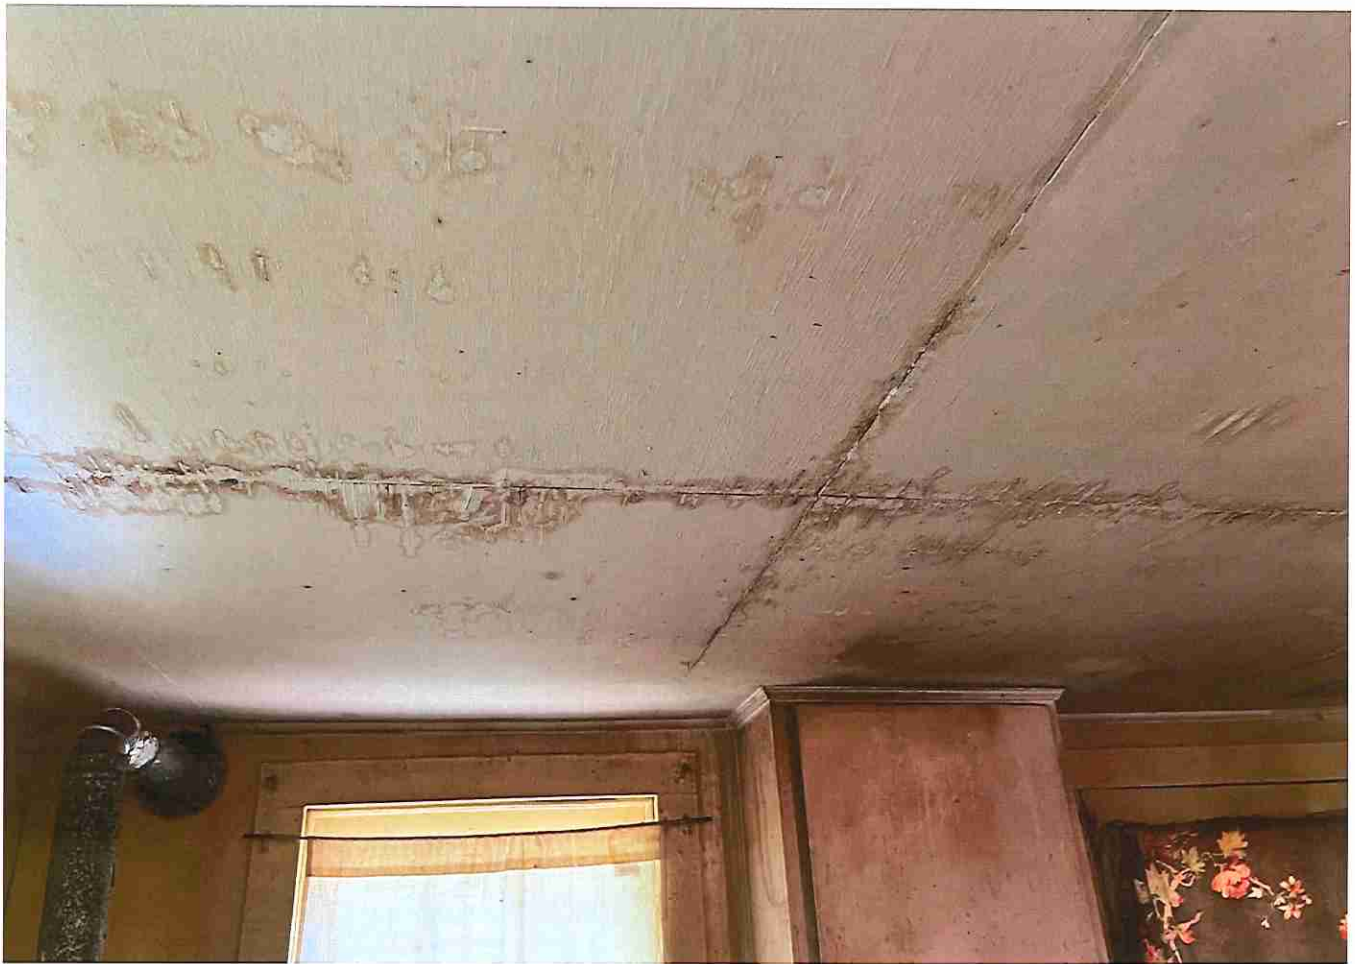
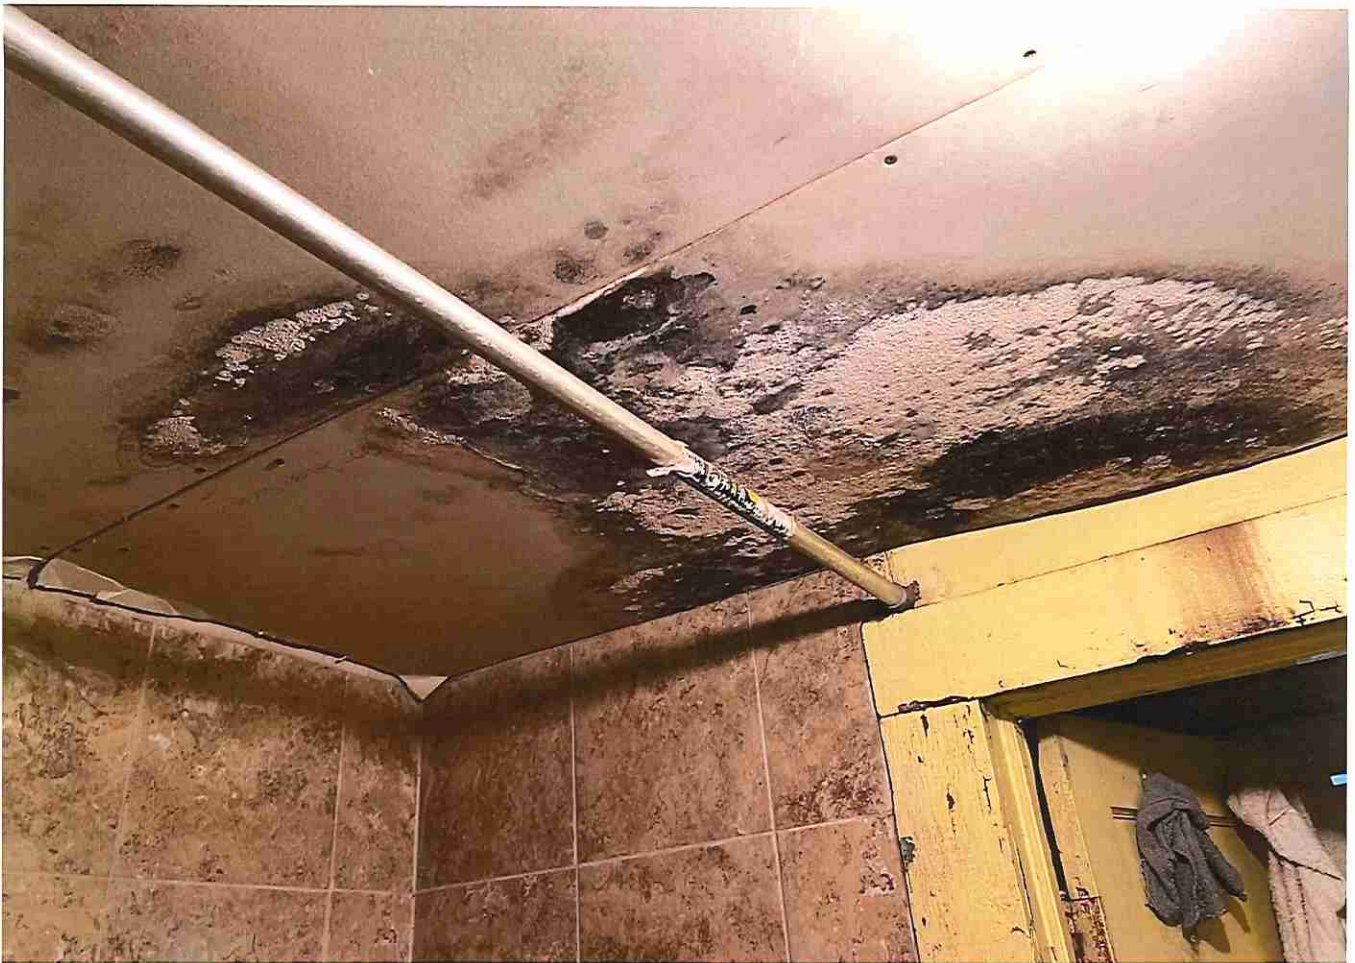
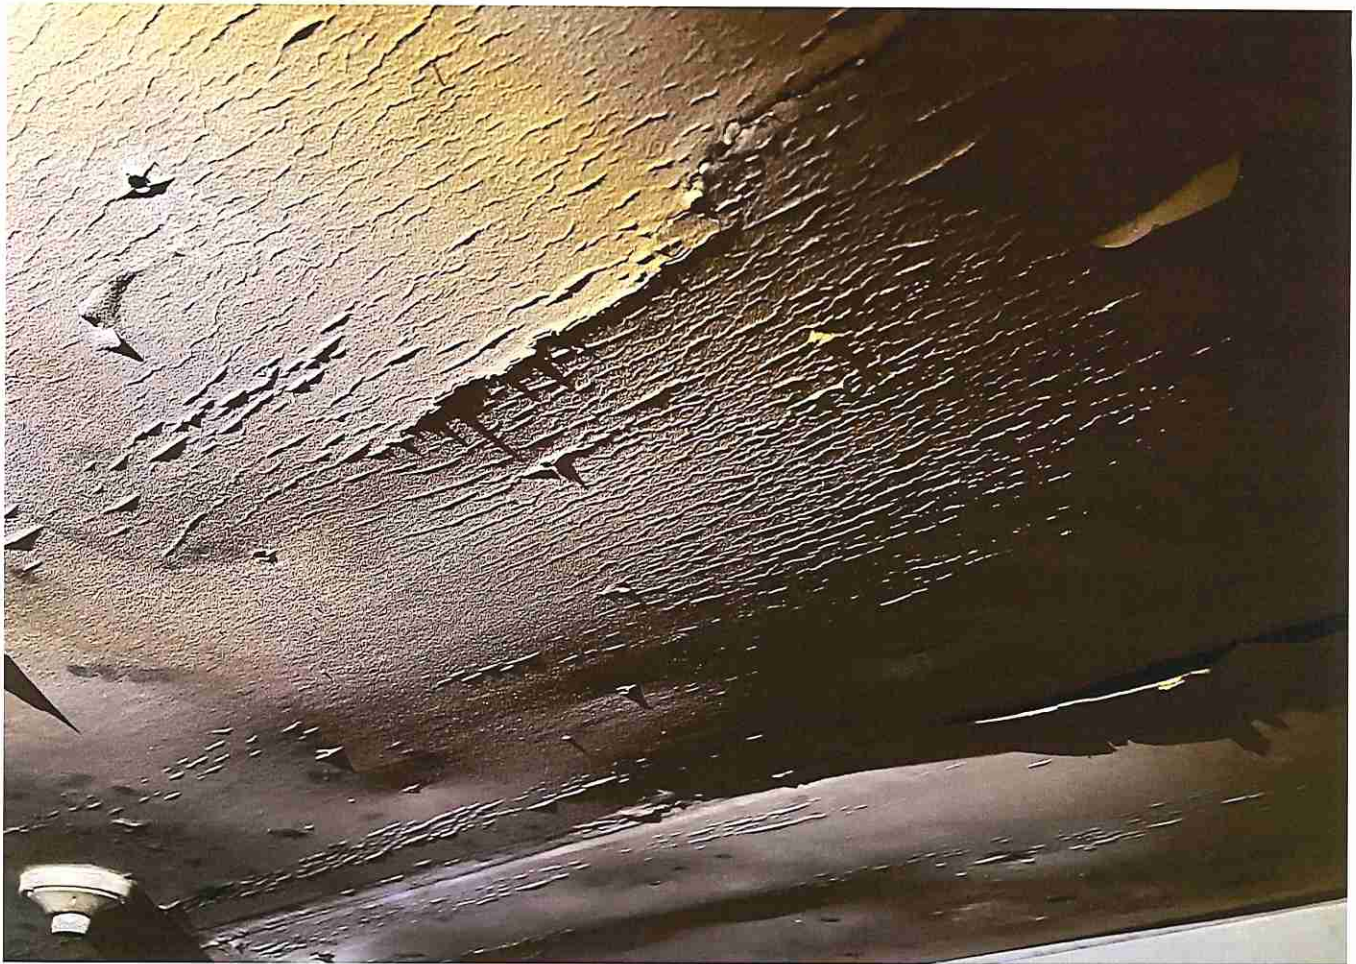
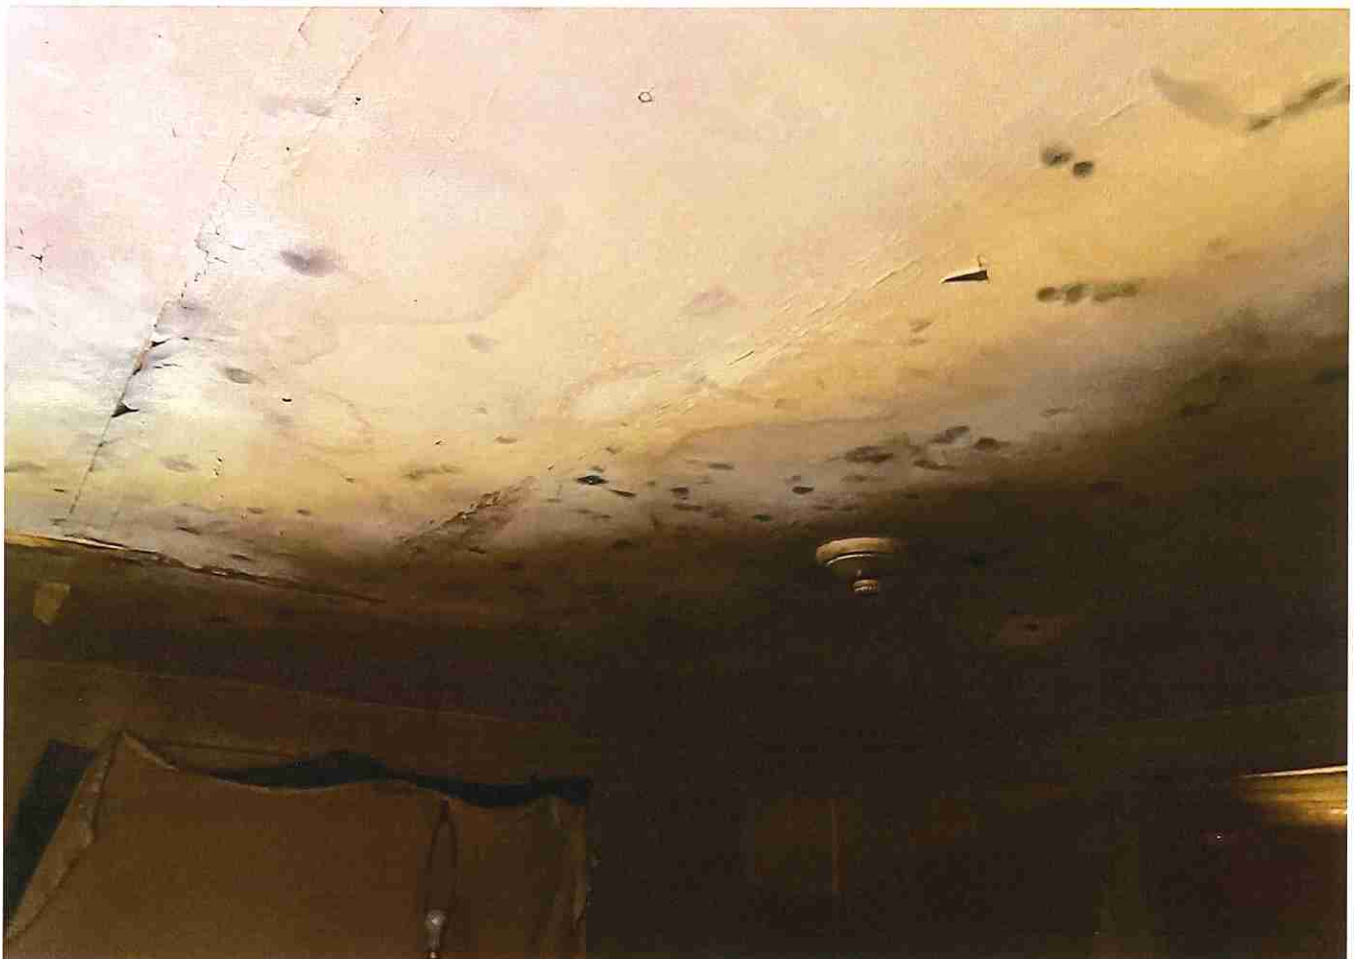
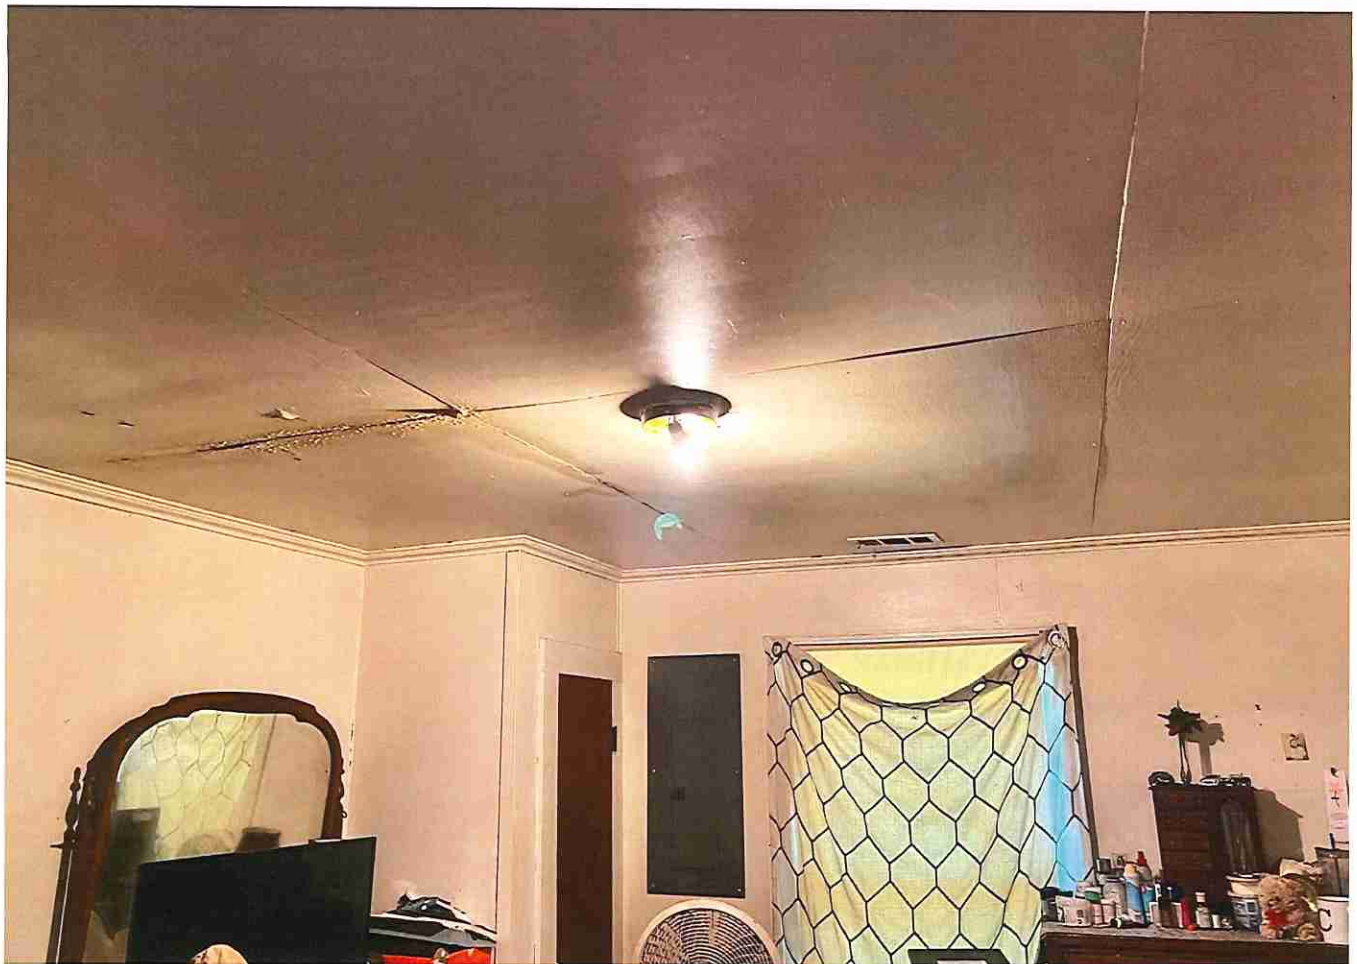
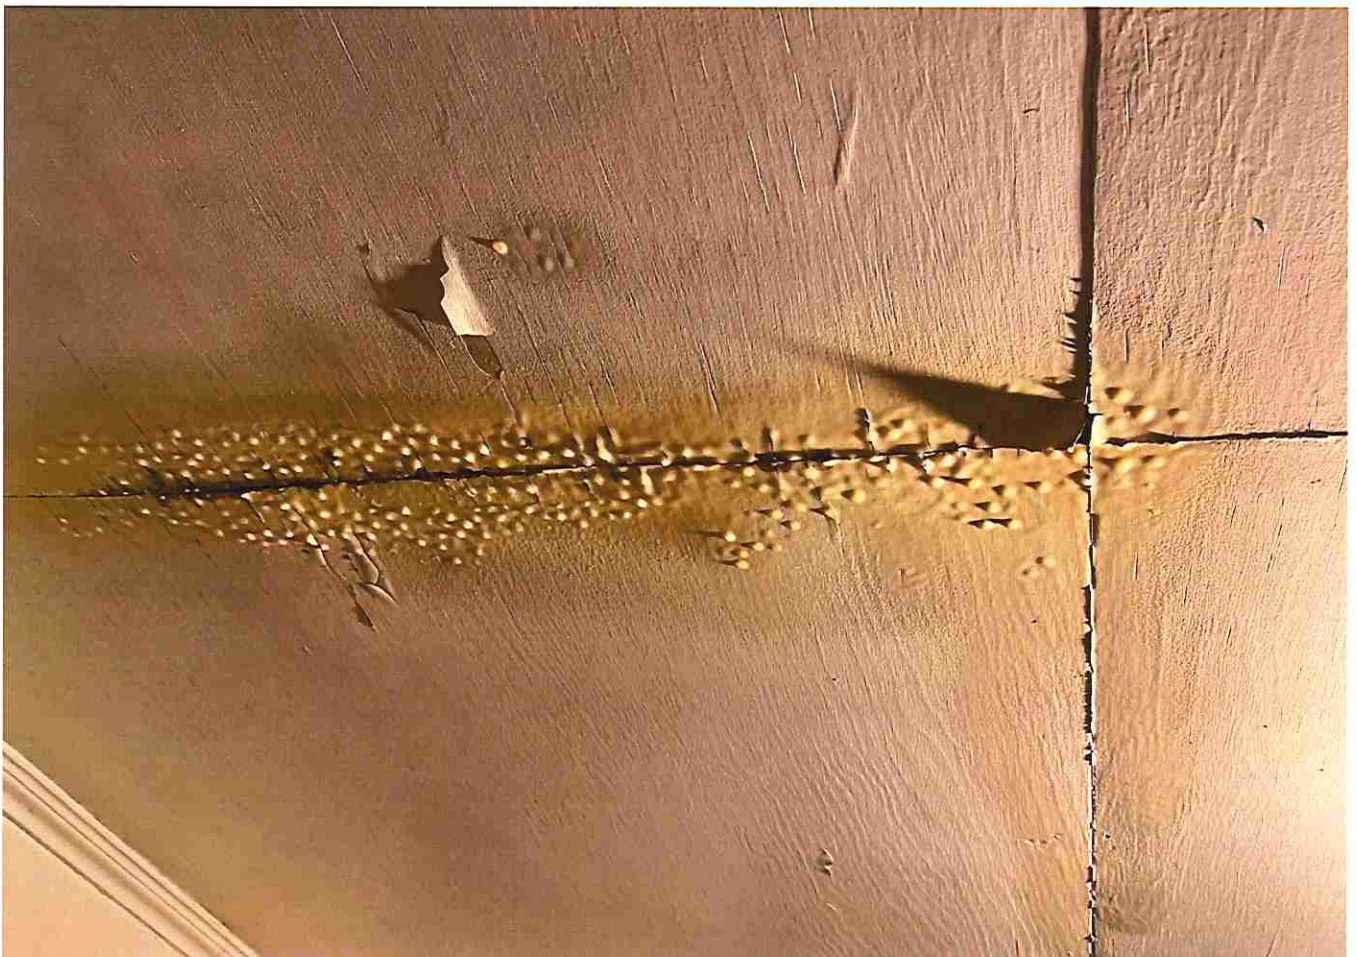
APPENDIX A

Visual Inspection: Our observations of the interior building components (i.e. walls and ceilings) revealed evidence of water damage, water staining and heavy fungal growth throughout the interior. Water damage and fungal growth was most present on the interior ceilings, which would suggest the exterior roof assembly has been severely compromised, see photographs in **Appendix A**.

In our professional opinion, we would not advise individuals to occupy or enter the home located at 34 Thomas Heyward as these current mold conditions and their concentrations are **unhealthy**. Any individual that occupy or enters the home are likely to be exposed to elevated fungal spores or other possible microorganisms that could impair human health or affect sensitive individuals. However, whether or not allergenic symptoms develop in individuals is dependent upon the nature of the fungus, the amount of exposure (i.e. inhalation, physically contacted (dermal exposure) or ingested), and the susceptibility of the exposed person. As indoor air quality consultants, we cannot evaluate the individual's health exposures or risks associated with these different microorganisms, exposure, or their concentrations.
