31 PRESERVATION BRIEFS

Mothballing Historic Buildings

Sharon C. Park, AIA

U.S. Department of the Interior
National Park Service
Cultural Resources
Heritage Preservation Services

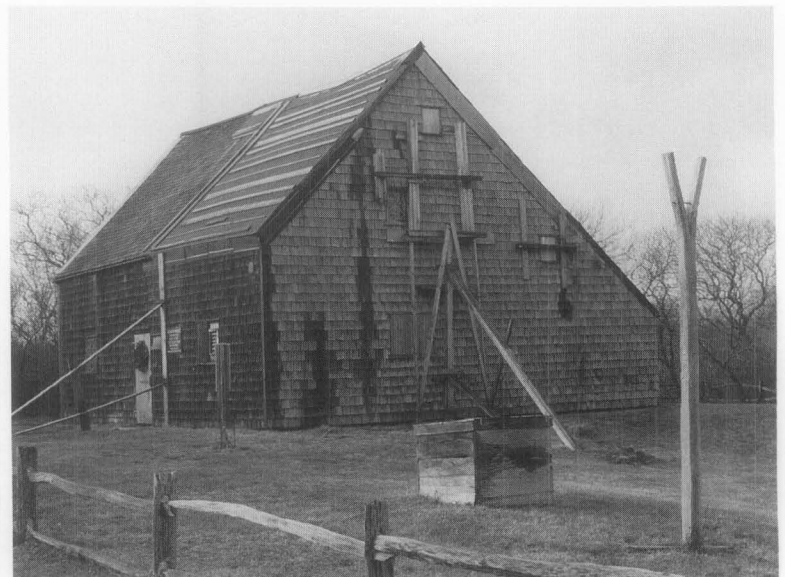
Figure 3. Buildings seriously damaged by storms or deterioration may need to be braced before architectural evaluations can be made. Jethro Coffin House. Photo: John Milner Architects.

to be structurally unsound until the condition of the structure can be fully assessed (see fig. 3). If pigeon or bat droppings, friable asbestos or other health hazards are present, precautions must be taken to wear the appropriate safety equipment when first inspecting the building. Consideration should be given to hiring a firm specializing in hazardous waste removal if these highly toxic elements are found in the building.
