Renovations for the Outbuildings of:  
**Kay Stanley & Curt Seymour**  
127 Bridge Street  
Bluffton, S.C.

Cook's  
Cottage

ATTACHMENT 6

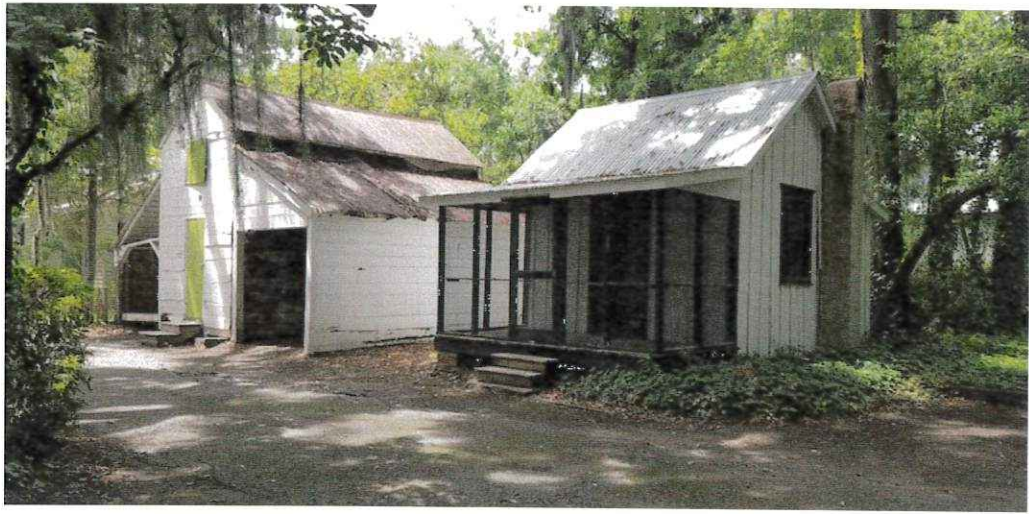
FRONT ELEVATION

REMOVE PAINT WHERE SURFACE DETERIORATION, PREPARE FOR REPAINTING  
PAINT ALL WOOD IN MATCHING COLOR, WHITE SIDING, BLACK WINDOWS, DOORS TO BE BLACK  
PEST MANAGEMENT PLAN HAS BEEN IMPLEMENTED  
REPAIR DAMAGED WOOD COMPONENTS IN PLACE WHERE POSSIBLE. REPLACE IN KIND, EXTENSIVELY DETERIORATED OR MISSING BOARDS. MATCH THE OLD IN MATERIAL, DESIGN, SCALE AND FINISH  
CLEAN AND REPAIR EXISTING WINDOWS AND CASING. PROTECT AND RETAIN HISTORIC GLASS  
REPLACE FRONT STEPS

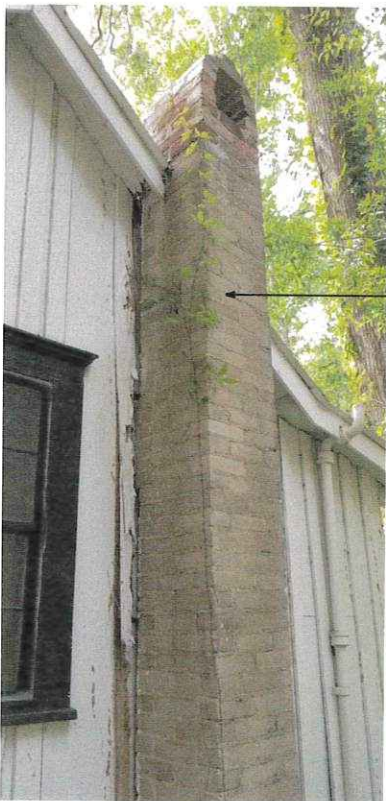
CHIMNEY

NO LONGER THERE
