I SINCE 1993

VALUE
INNOVATION
COMMUNICATION
EXPERIENCE

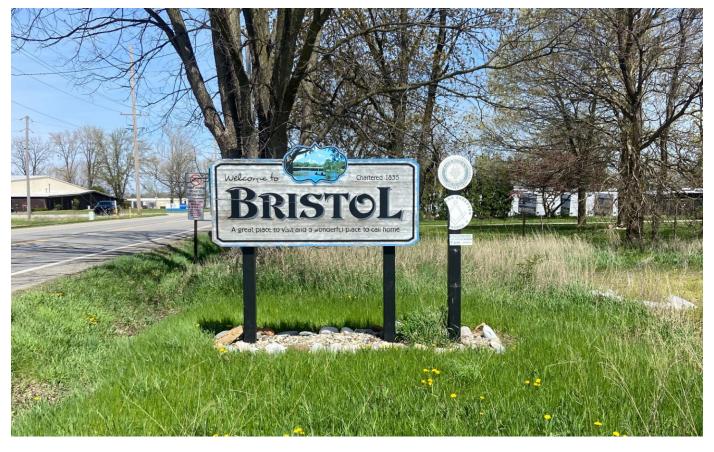
Sign location: South of Town driving North on SR 15.
Wood carved sign face is 40" x 95" with 6"x6" posts overall height about 88"
Sign face is faded, vinyl peeling, and has large crack.

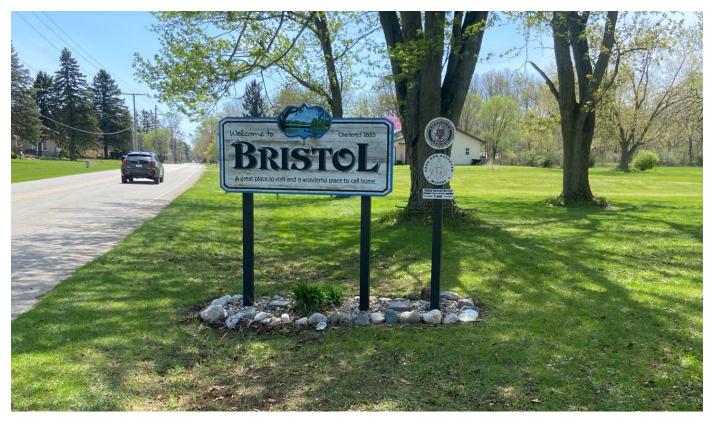
Sign location: North of Town driving South on CR 23. Near corner of CR 23 & CR 104 Wood carved sign face is 30" x 71" with 4"x4" posts overall height about 75" Sign face is faded vinyl starting to peel.

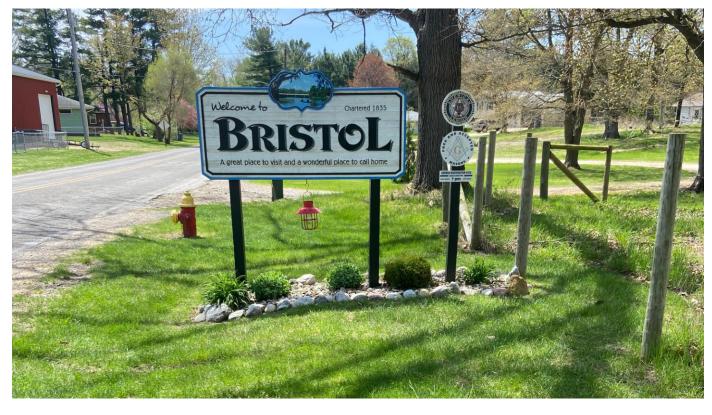
Sign location: North of Town driving South on CR 25.
Wood carved sign face is 30" x 71" with 4"x4" posts overall height about 69"
Sign face is starting to show some fading.

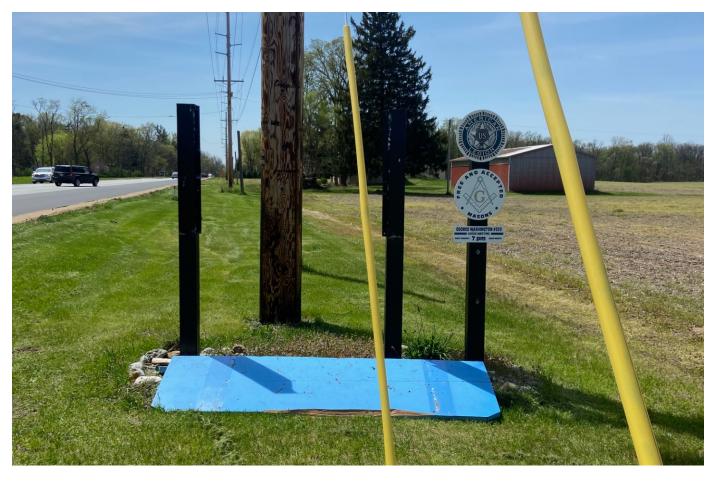
Sign location: North of Town driving South on SR 15.
Wood carved sign face is 40" x 95" with 6"x6" posts overall height about 88"
Faced broken off post.

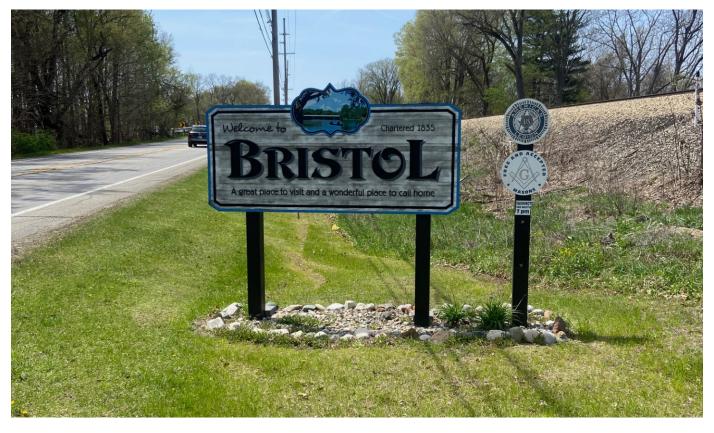
Sign location: East of Town driving West on SR 120.
Wood carved sign face is 40" x 95" with 6"x6" posts overall height about 88"
Sign face is faded and vinyl peeling/cracked.

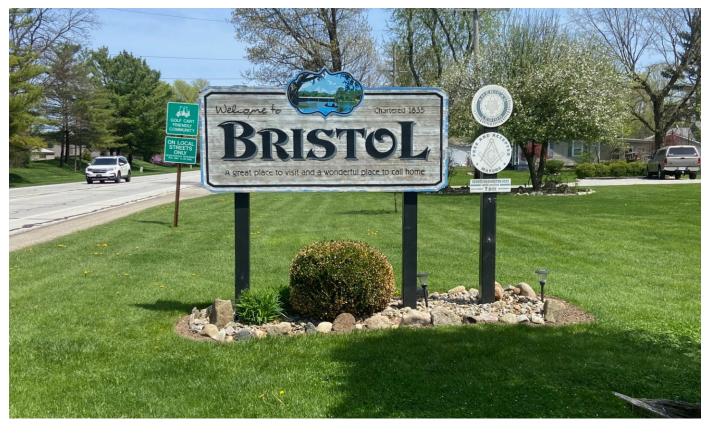
Sign location: West of Town driving East of SR 120.
Wood carved sign face is 40" x 95" with 6"x6" posts overall height about 87"
Sign face is faded and vinyl is peeling/cracked.

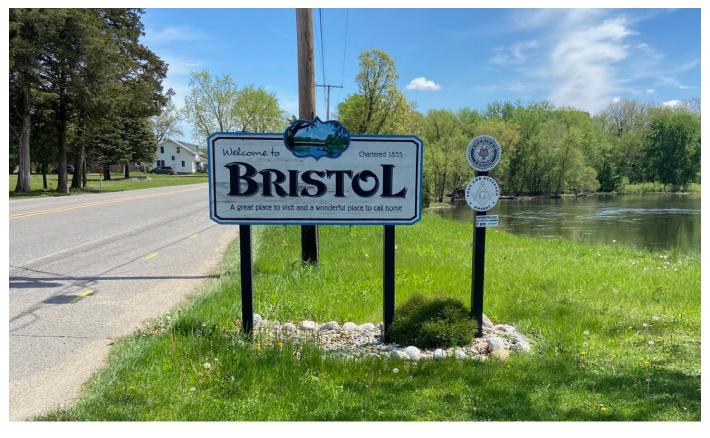
Sign location: West of Town driving East on North River Road.

Wood carved sign face is 30" x 71" with 4"x4" posts overall height about 69"

Sign face is starting to show some fading.

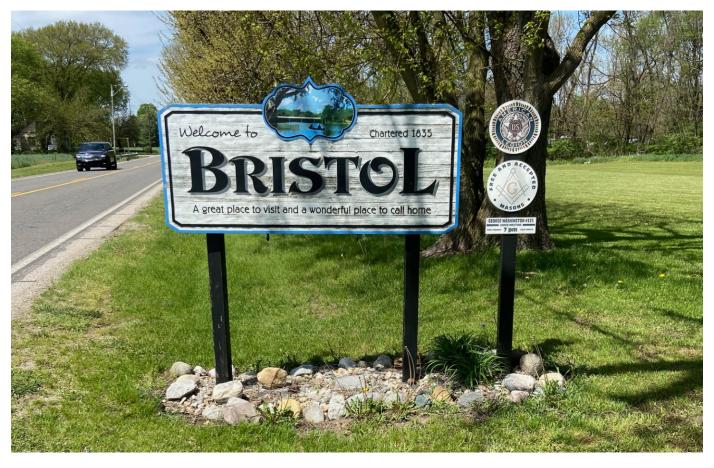
Sign location: East of Town driving West of C R 8.
Wood carved sign face is 30" x 71" with 4"x4" posts overall height about 69"
Sign face is starting to show some fading.
