# Main Lift Pump Station

WPCD - BRISTOL

AGENDA

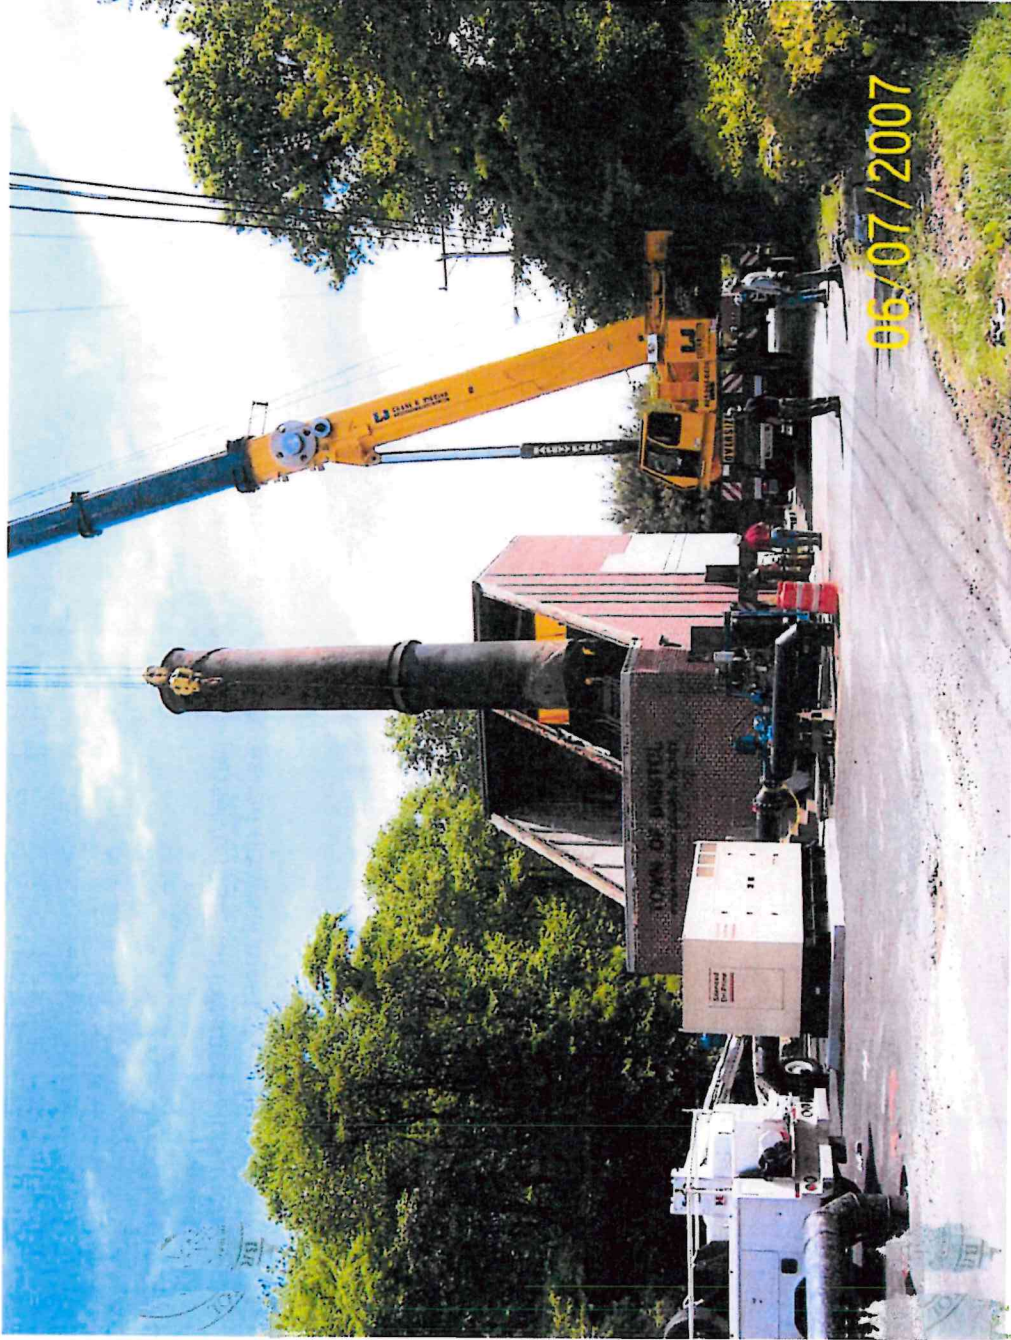
# 2007 Replacement

- \$1.8 M
- Hart Engineering
- Construction:
  - Roof Removal
  - Bypass Pumping Provisions
  - Full Time Bypass Pumping

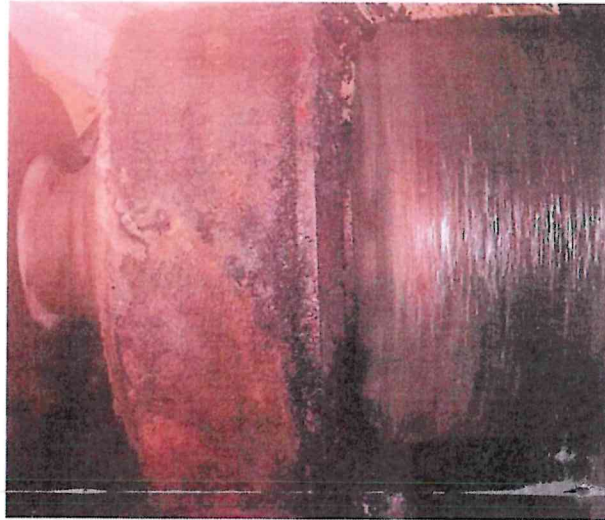
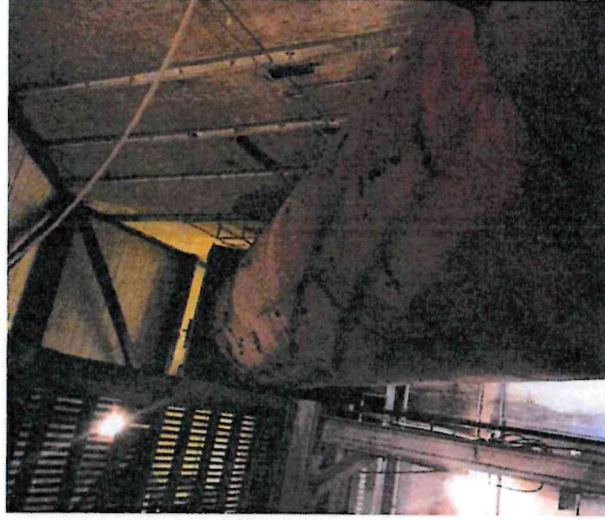
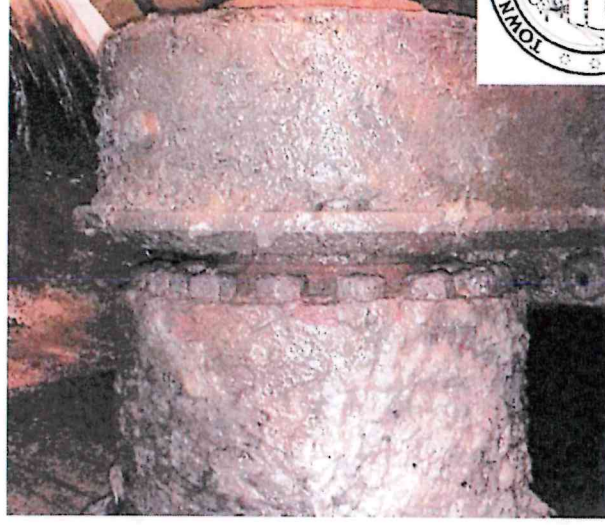
# 2017 Screw Pump Evaluation

"The upper bearings, motors, and gearboxes all have serious corrosion issues but these have such a massive material thickness, it is more of an aesthetic issue than a mechanical issue. Once again, any of these corrosion areas that are addressed now will most likely last longer now with the better air handling system."

"Overall, I have seen many screws that are in much worse condition than these two that are still operating as well. Maintenance here is one of the best I have seen for any facility and all operators and mechanics are conscientious about the operation of ALL their equipment here at the facility."

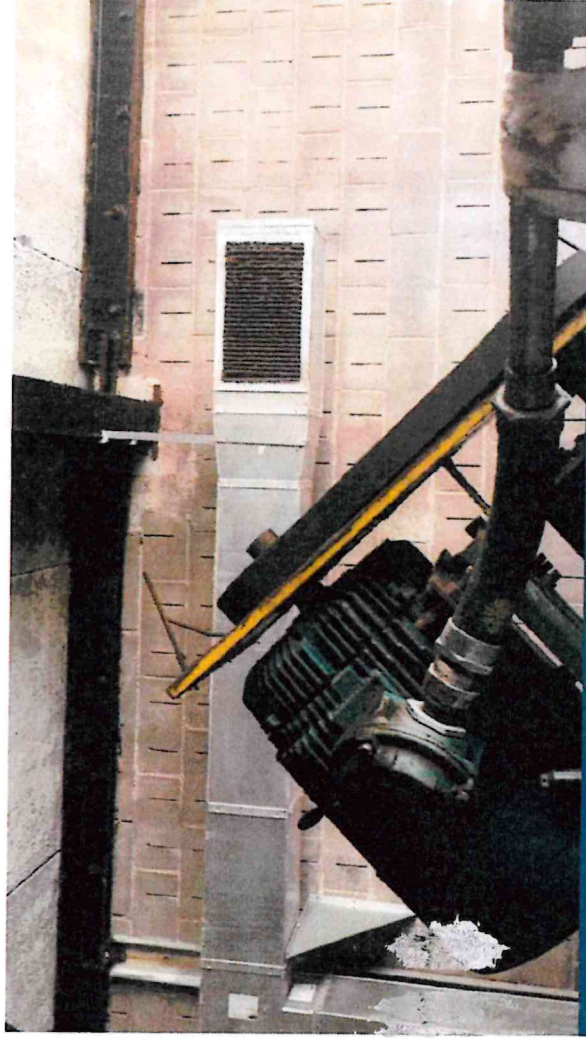
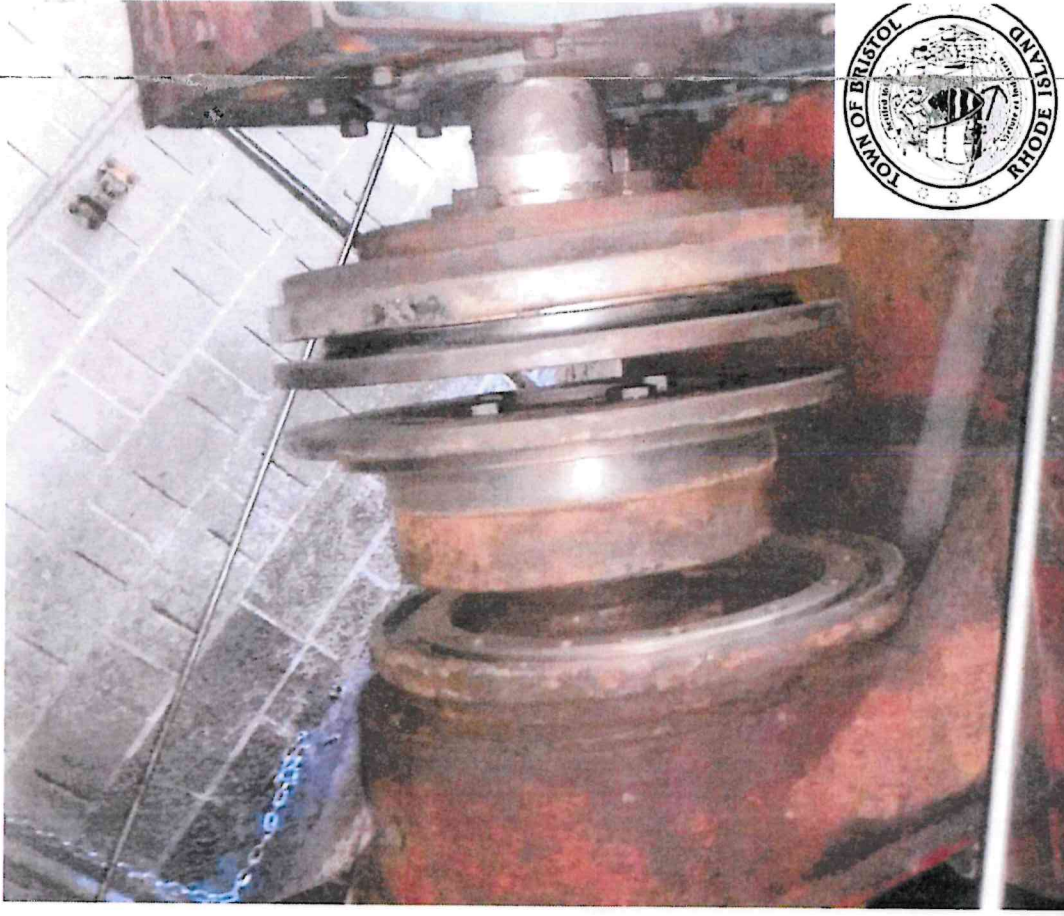
## Screw Pump Maintenance 2018

- Pump 1 – North Pump (2018)
  - Replaced Gear Box – Utilized Spare
  - Replace Paraflex Coupling

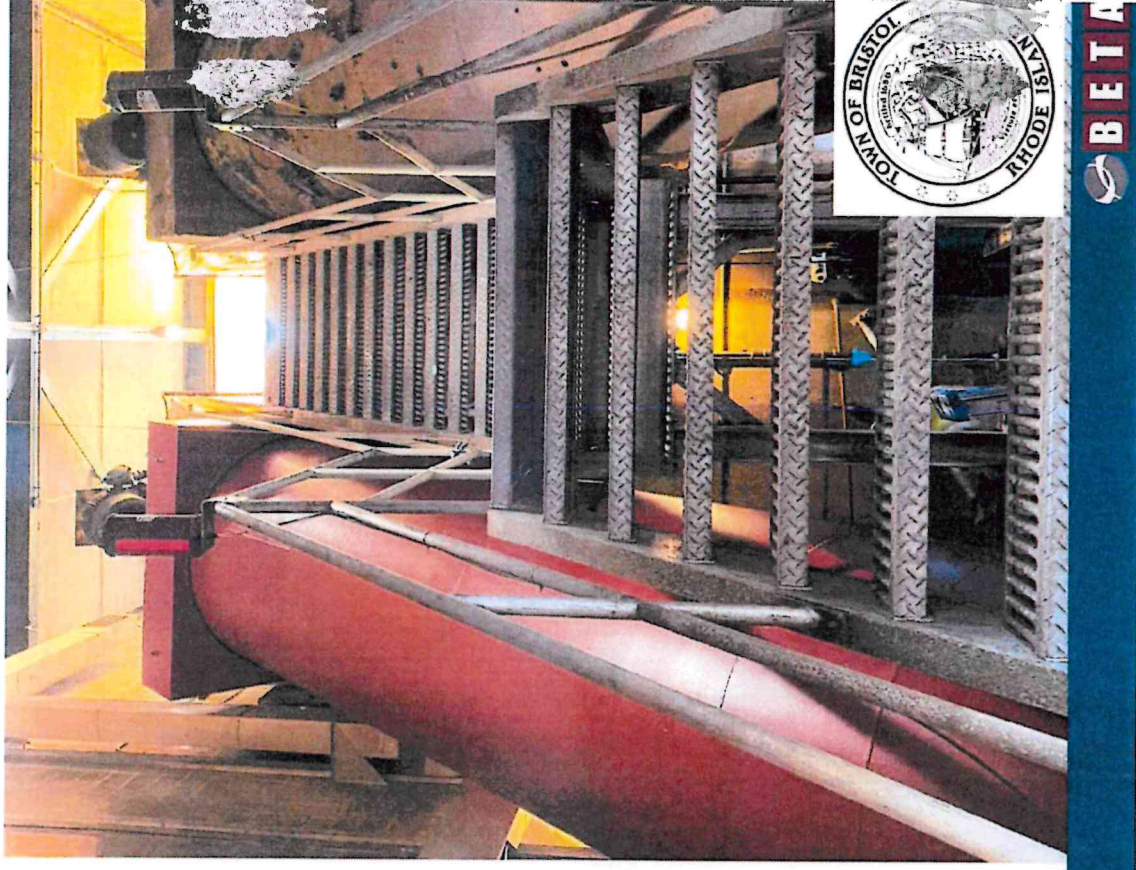
# Screw Pump Maintenance 2020

- Pump 1 & 2 – North Pump and South Pump
- Resurfaced (Painted) Body of Screw

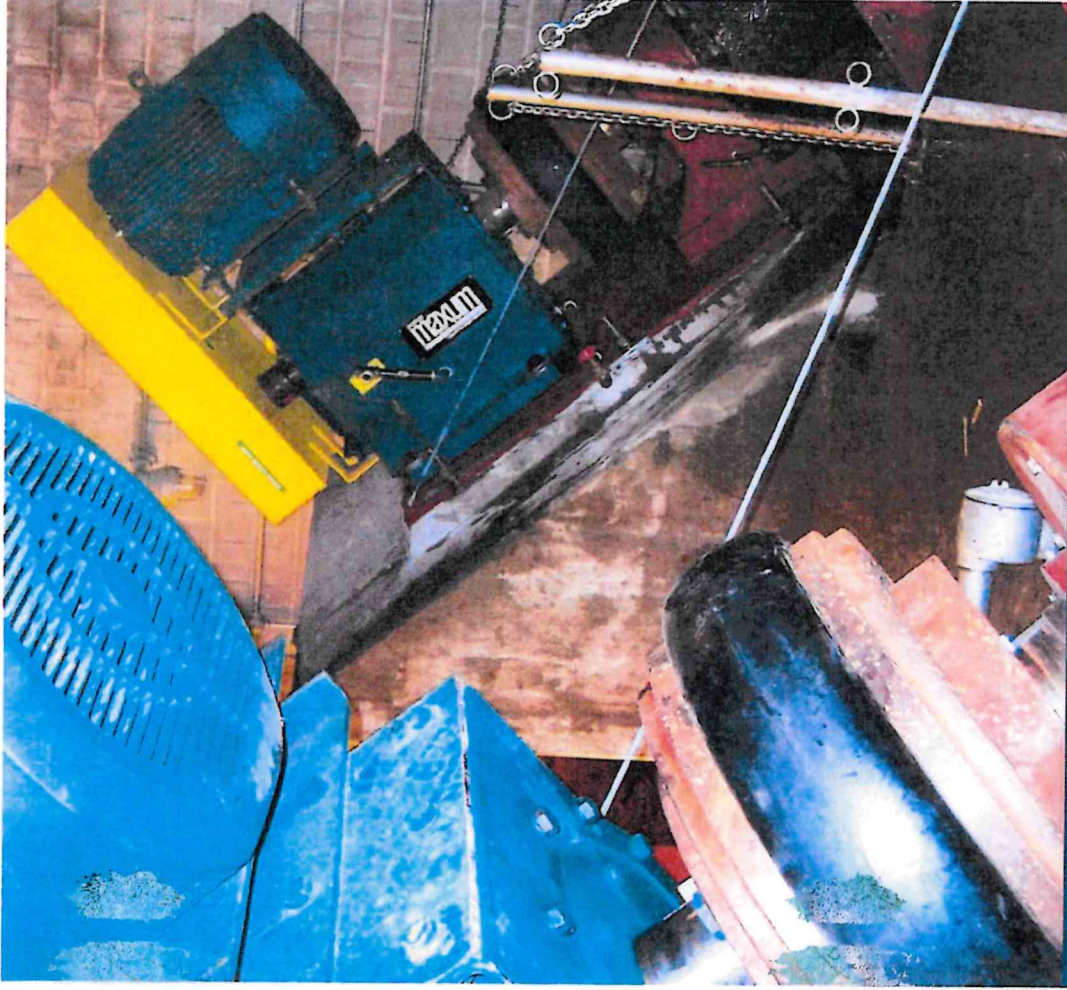
# Project Challenges

- ACCESS and ACCESS
- Ability to Support Pump and allow removal / replacement of Upper Bearing
- New Equipment Upgrades require concrete modifications
- Bypass Pumping
