1 State Street, Bristol RI
SCOPE OF WORK FOR
BRISTOL HISTORIC DISTRICT COMMISSION

Built in 1884, this building is known as the Holmes Block. This is a 2-1/2 story masonry Second Empire Style building that stands at the Northeast corner of Thames Street and State Street.

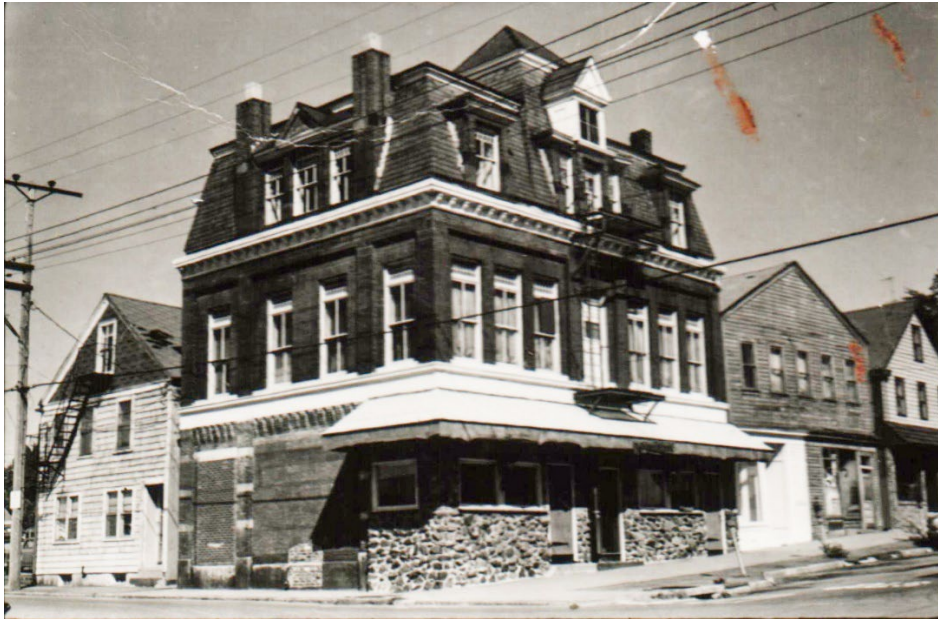
Historic Image 1 – This image is from the Bristol Historical Preservation Society archives and was most likely taken at some point in the 1970s during the architectural survey performed in town at that time. It shows the conditions of the building and its architectural features during that time. The field stone façade was not original to the building and was most likely added at some point in the mid 20th century. The original 4 pane window can be seen in the upper story of the State Street façade.

The final scope of work includes the reconstruction of the tower window on the upper story of the State Street Façade. Currently this window opening is boarded up with plywood. A historic photograph from the 1970s during the architectural survey around town shows a square 4 pane window in the opening. This window style is consistent with what would have been seen during the Second Empire architectural style. Exploratory investigation in the tower space showed a light which would illuminate the window at night. A wooden replicated 4 pane window is proposed to be installed in the opening like that of the historic photograph.

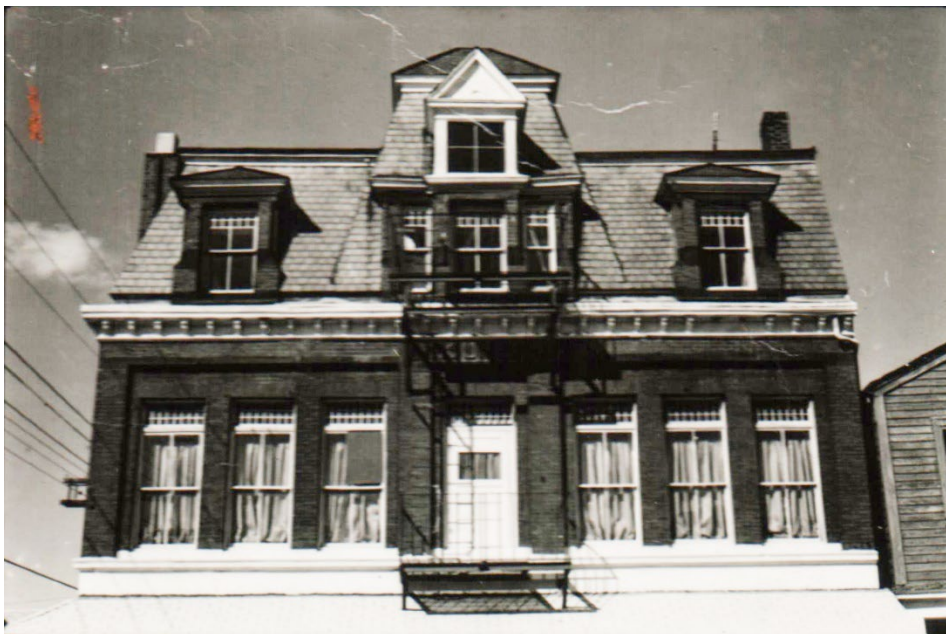
Historic Image 2 - This image is from the Bristol Historical Preservation Society archives and was most likely taken at some point in the 1970s during the architectural survey performed in town at that time. It shows the conditions of the building and its architectural features during that time. The original 4 pane window can be seen in the upper story of the State Street façade.

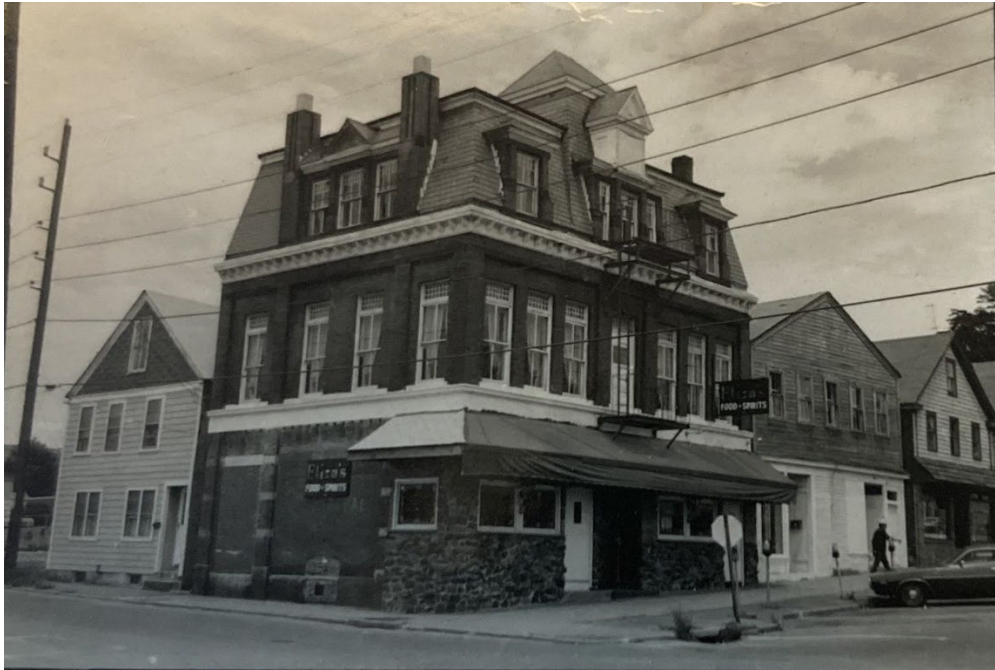
Historic Image 3 - This image is from the Bristol Historical Preservation Society archives and was most likely taken at some point in the 1970s during the architectural survey performed in town at that time. It shows the conditions of the building and its architectural features during that time. The field stone façade was not original to the building and was most likely added at some point in the mid 20th century. The upper story window opening on the State Street façade can be seen boarded up in this image which gives a strong possibility that this is a later photo than the previous.

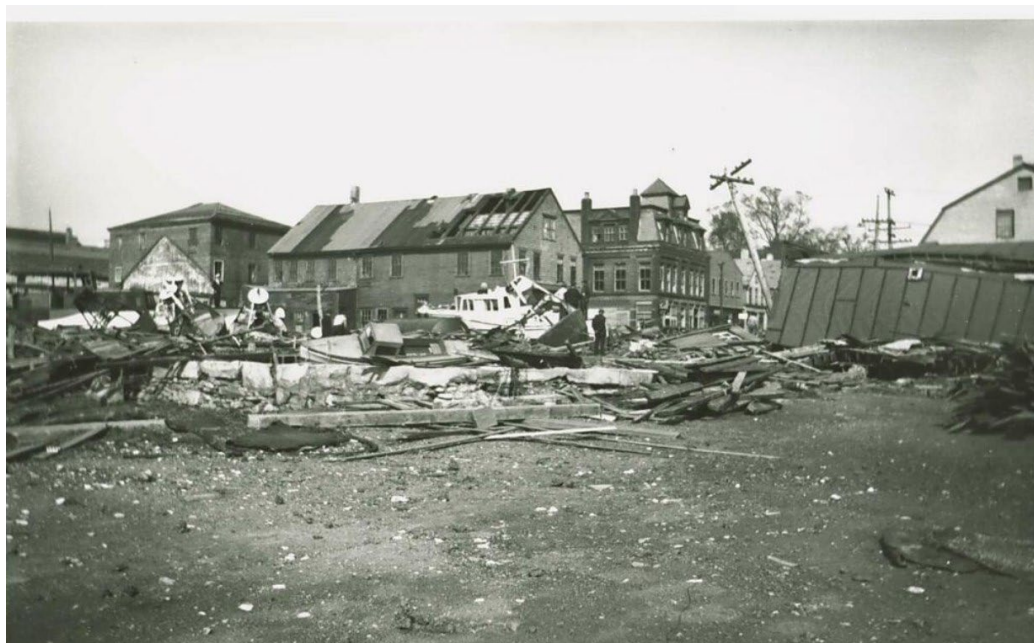
Historic Image 4 – This image from the 1938 hurricane damage shows the 1 State Street building in the distance in the center of the frame and is one of the oldest images showing this building.

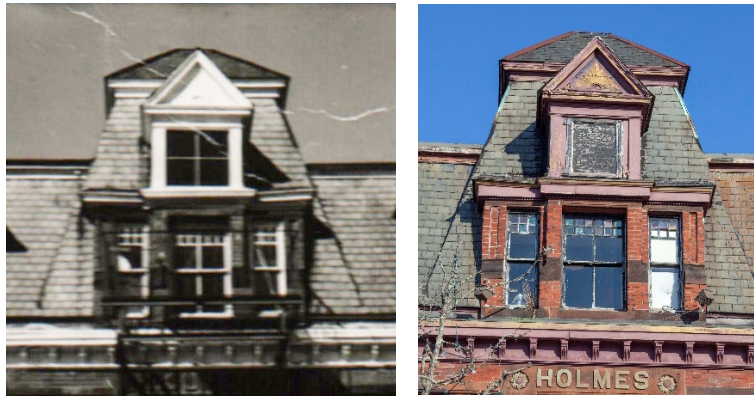
Historic Image 6 – *These images show a side by side comparison of what the upper story tower looked like at some point in the 1970s and what it looks like in present day 2024. The only difference is a 4-pane window in the upper portion of the tower. This window is proposed to be replicated and reinstalled.*

- **Reconstruction of Missing Windows-** There are 2 window openings that are boarded up, 1 on the North façade and 1 on the East façade. These windows are proposed to be replicated and reinstalled in their original openings. Both windows are proposed as 2 over 2 sashes which match in kind with the building. The North façade window sashes appear to still be in the opening but will need restoration. The State Street upper story window in the tower space is proposed to be reinstalled per the historic photograph as a 4-pane sash.

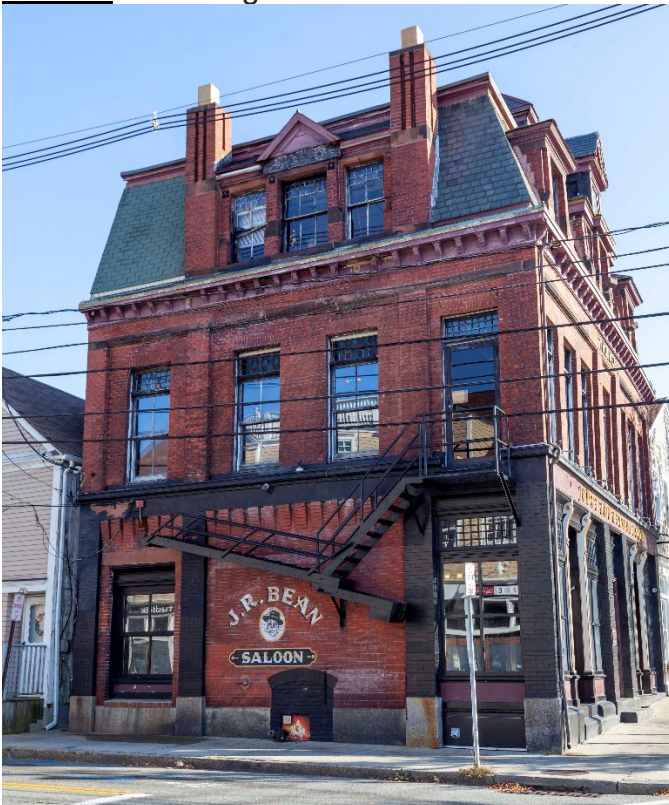
Photo 1 – Existing State Street Facade

Photo 2 – Existing Thames Street Facade

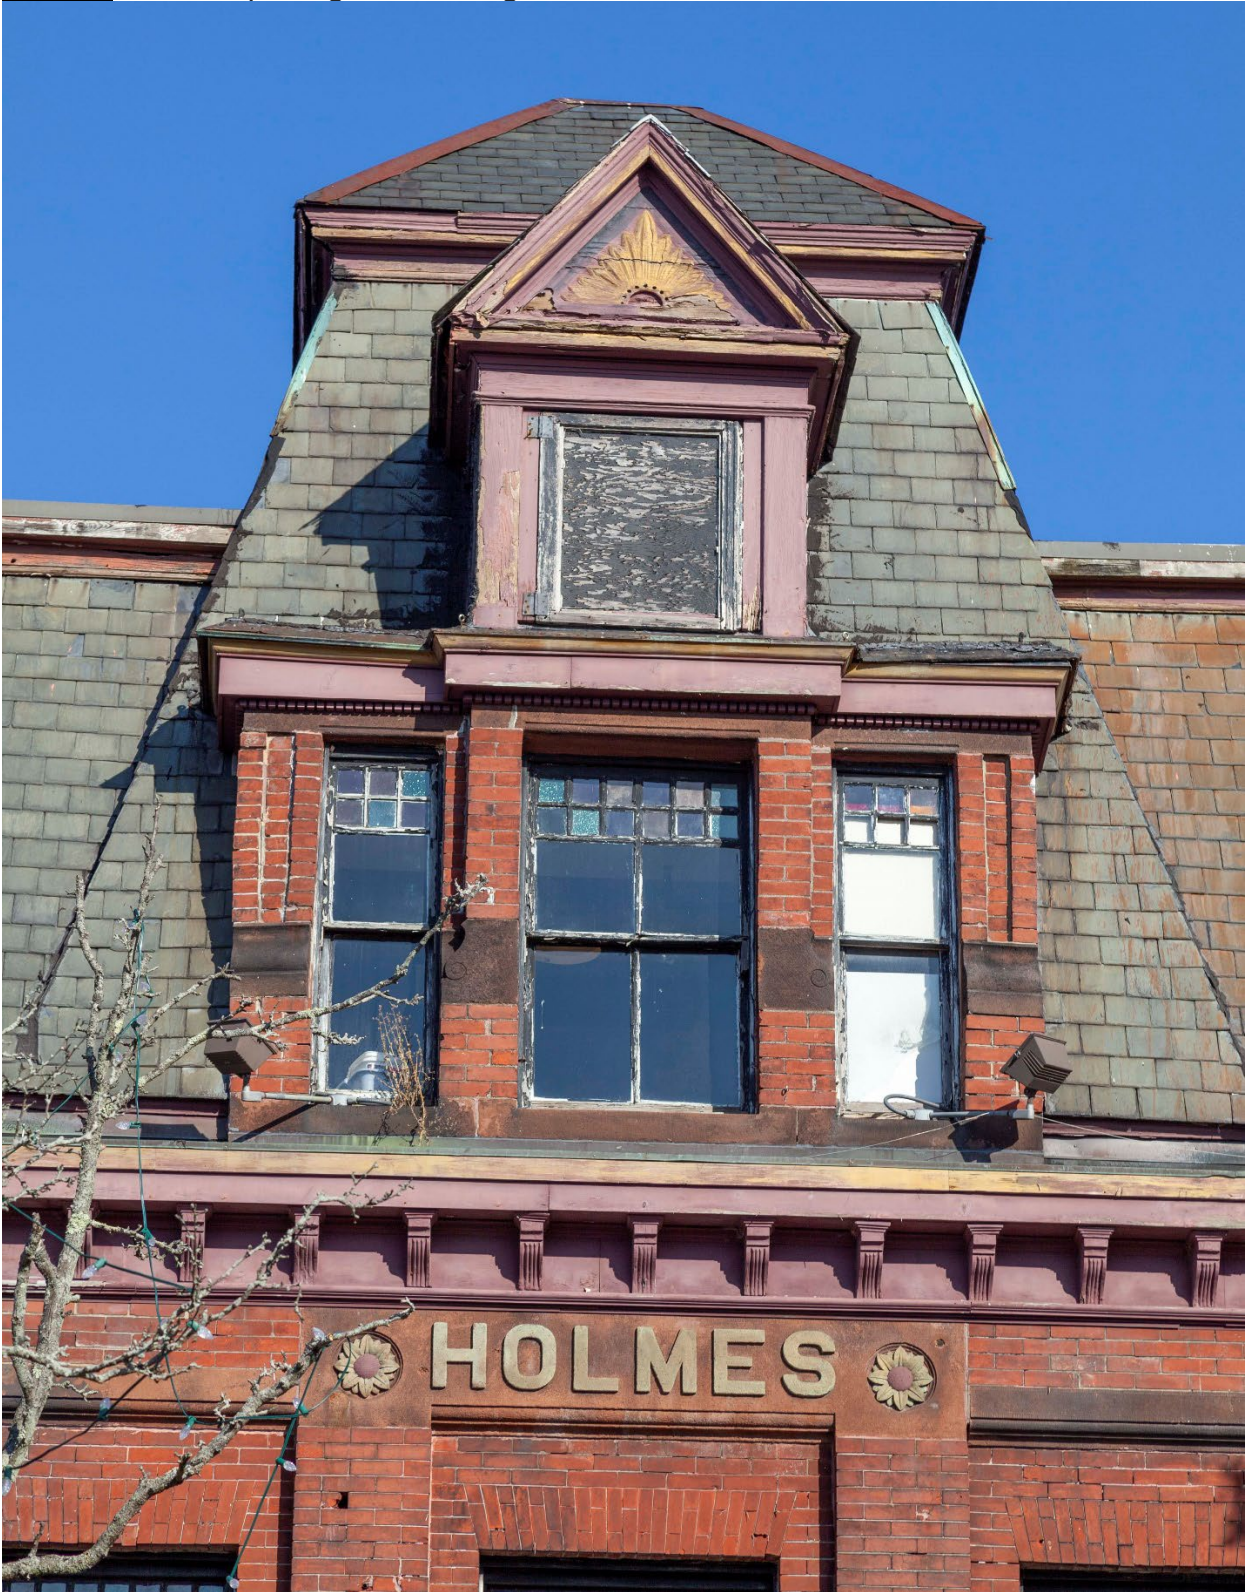
Photo 3 –Close up Image of Existing State Street Tower condition.

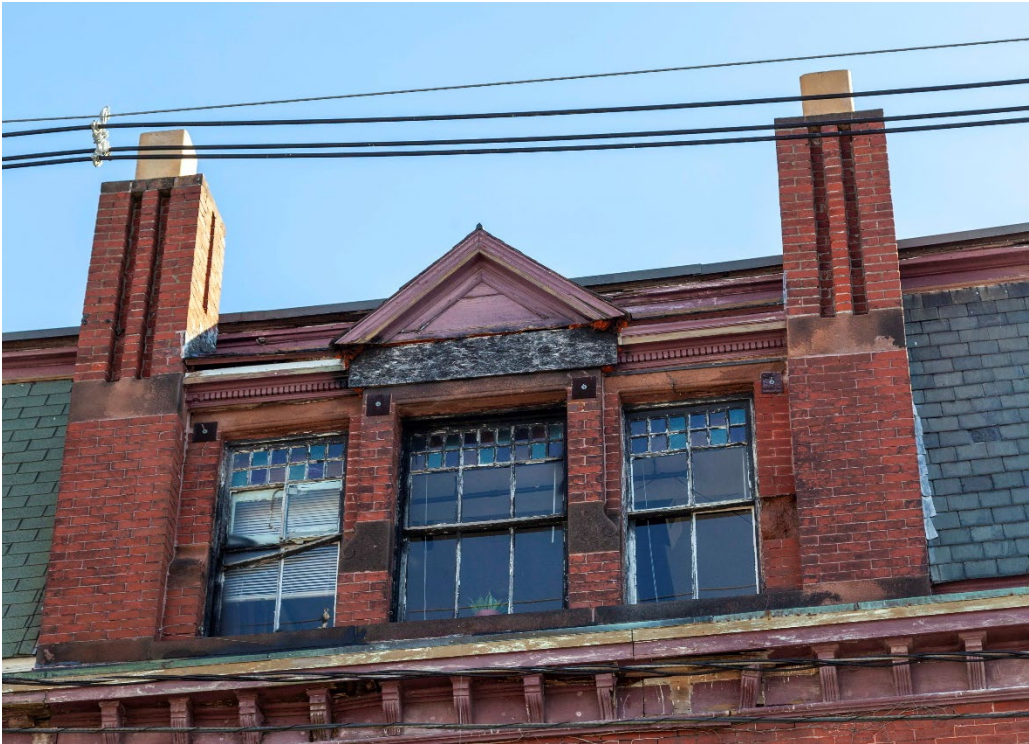
Photo 4 – Close up of Thames Street upper story windows and pediment.

- **Restore Pediment Relief/Paintings –** Both the State Street and Thames Street facades upper stories have wood pediments. The State Street pediment has a sunflower relief that is proposed to be restored. The same relief is proposed to be installed on the Thames Street pediment.

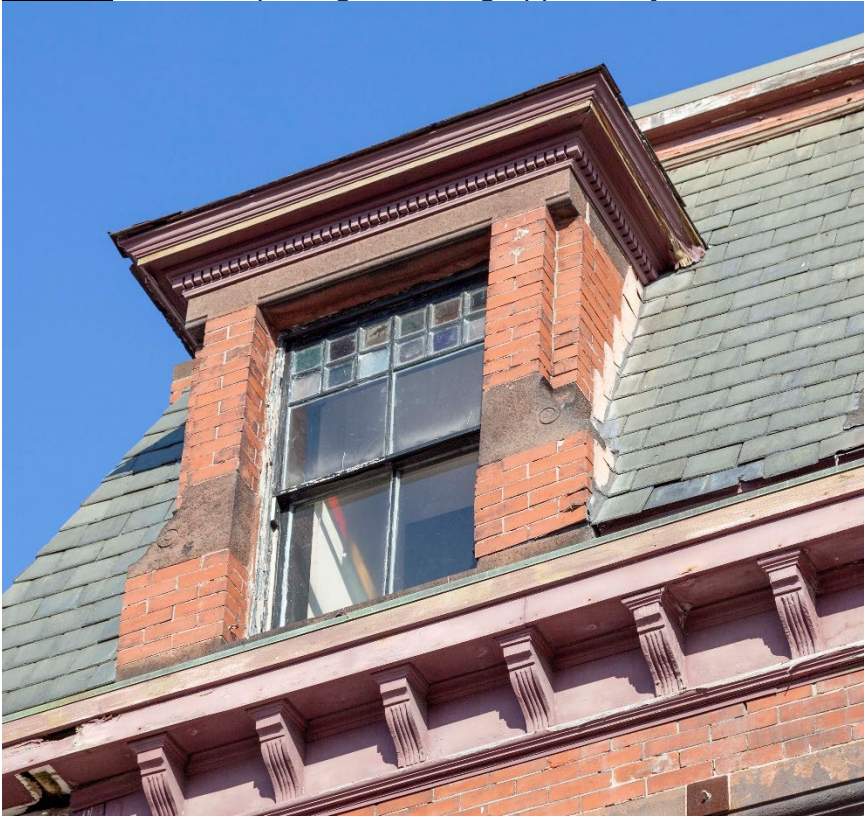
Photo 5 – Close up image showing upper story of State Street window condition.

- **Repair & Replace Slate Roof Shingles as Needed-** Various slate shingles on the roof are damaged and need to be replaced in kind.
- **Restore Historic Windows-** Original wood sash windows on the third floor are proposed to be restored and reglazed.

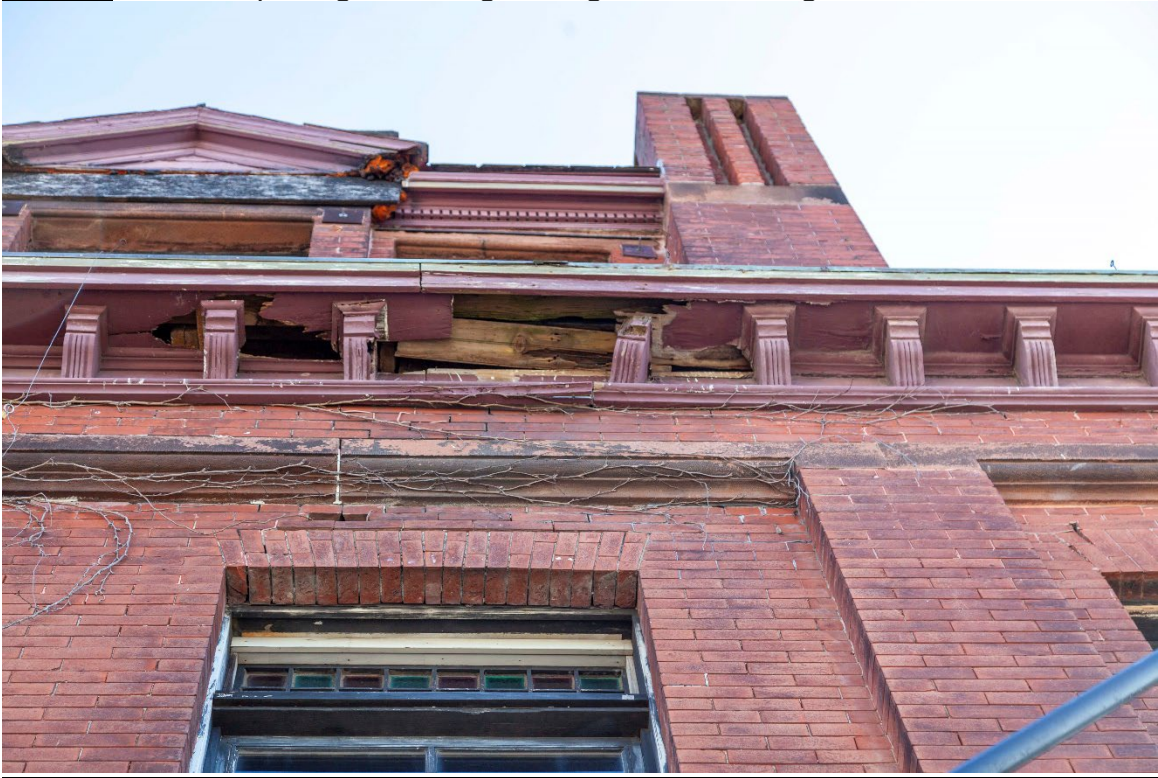
Photo 6 – Close up image showing damaged and missing wood elements.

- **Repair & Replace Missing Wood Elements -** There are a number of areas where there is rotted trim, missing brackets, or other various wooden architectural details. These areas are proposed to be repaired when possible and replaced in kind with wood where needed.

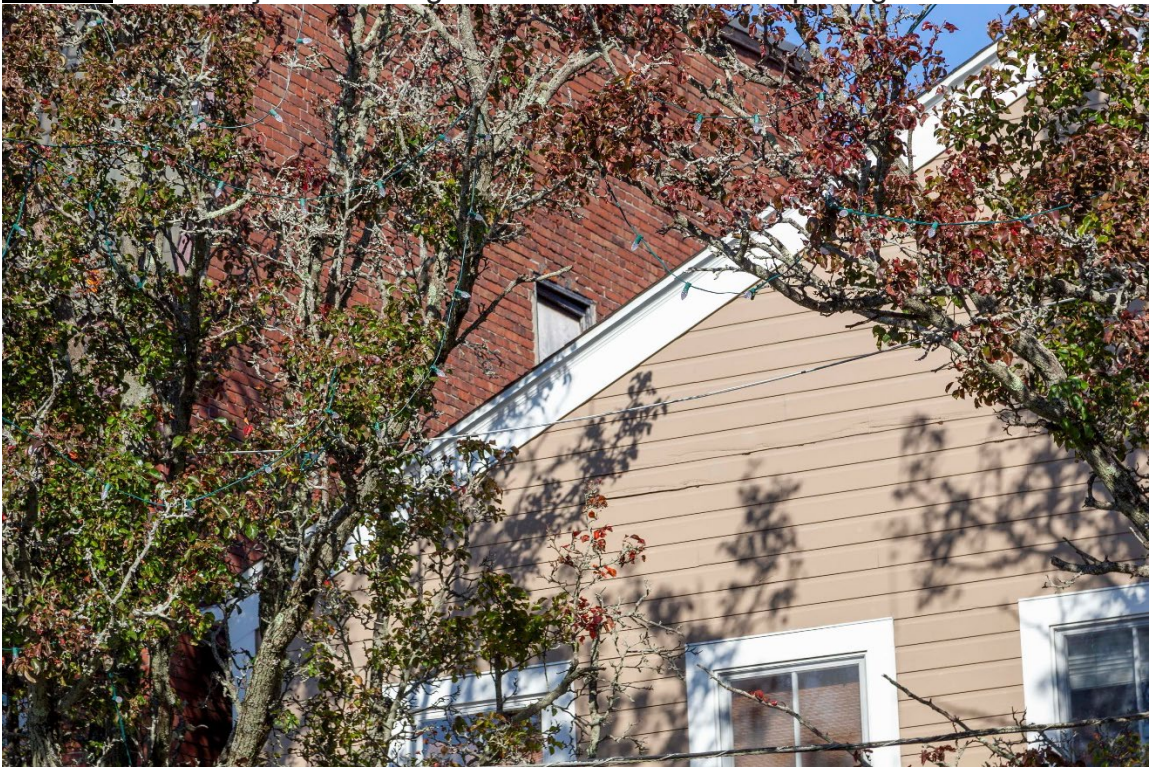
Photo 7 – East façade showing visible view of window opening to be restored.

There are two window openings that are to be restored to their original sashes. One is located in the alleyway on the East side of the building, and one is located in the alley way on the North side of the building. The North side has a wooden 2 over 2 sash which is proposed to be restored and reglazed. The East side opening is proposed to have a wooden 2 over 2 window which would have been appropriate in the opening. The upper story wooden sash windows on both the State Street and Thames Street are to be restored and reglazed.

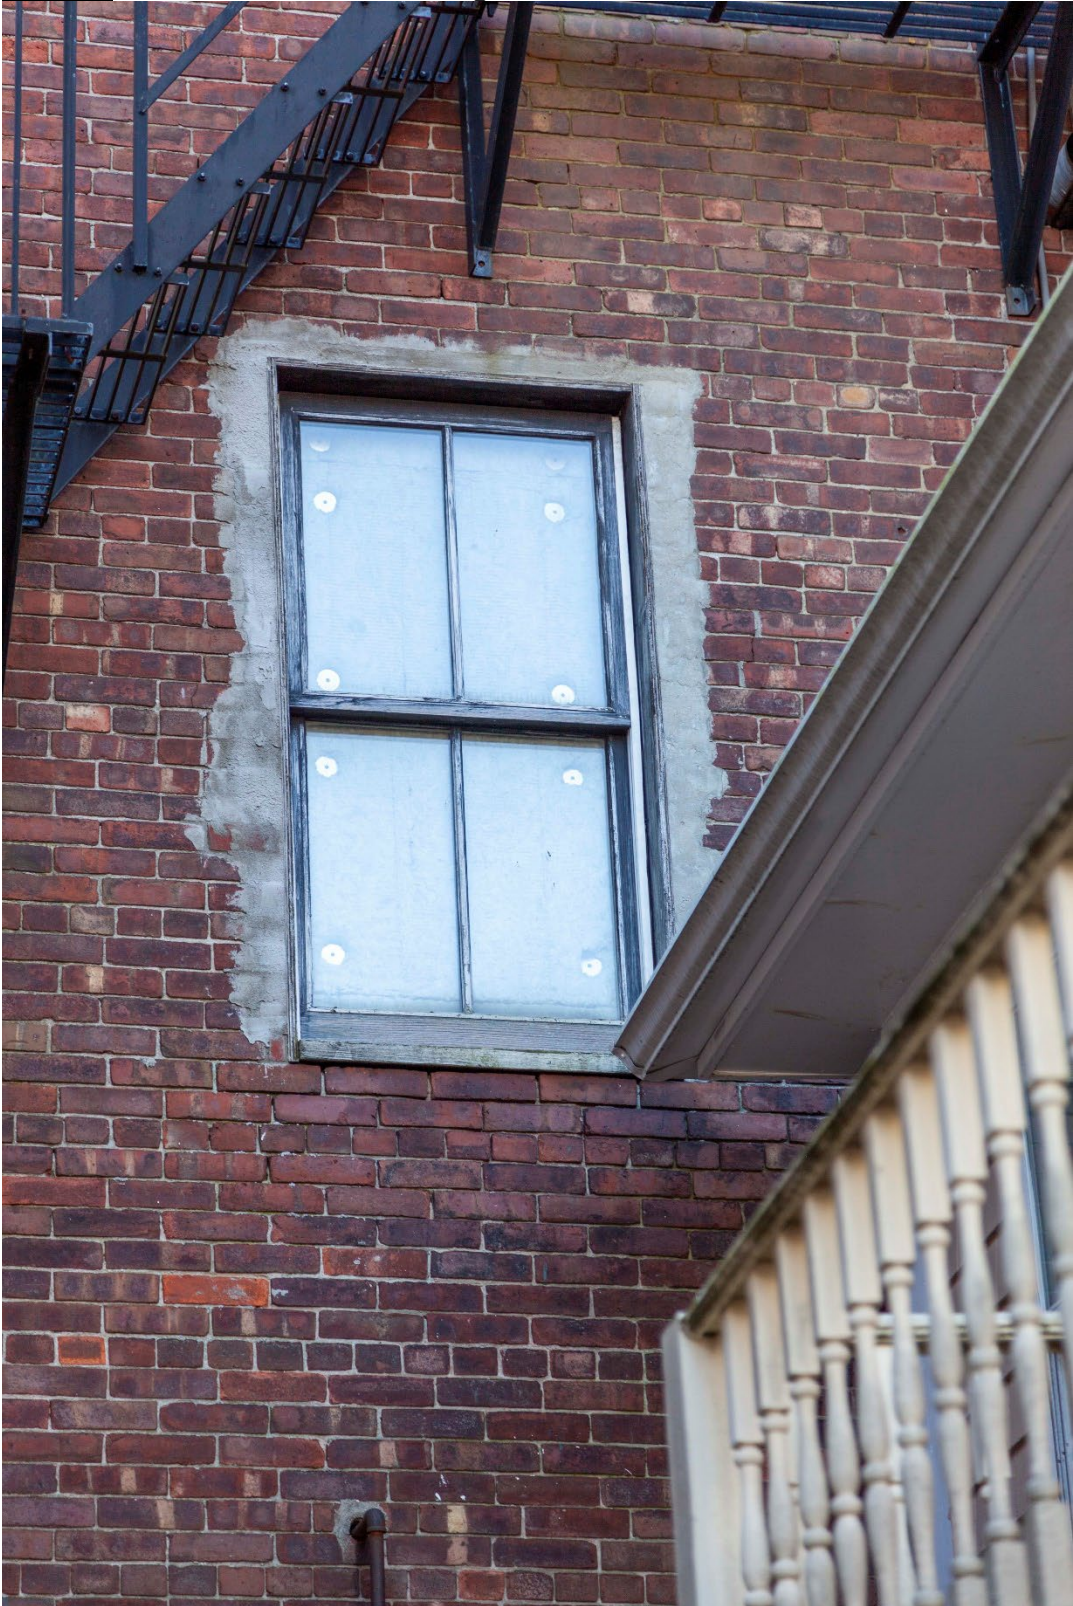
Photo 8 – North elevation showing window to be restored.
