467 Hope Street, Bristol RI
SCOPE OF WORK FOR
BRISTOL HISTORIC DISTRICT COMMISSION

RECONSTRUCTION AND NEW CONSTRUCTION SCOPE OF WORK.

Exhibit A - Photos (Photographs Taken on October 16, 2024)

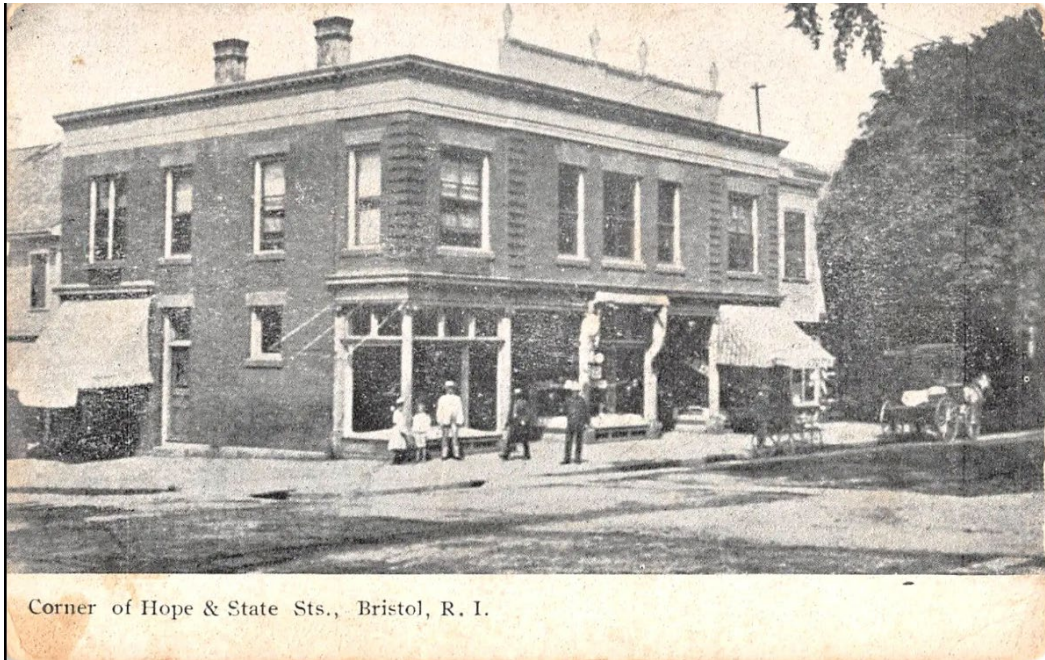
Historic Image 1 – This is the front of an undated postcard published by W.J. Fish. The image shows the brick building which currently sits on the corner of Hope Street and State Street. The second story over the current barber shop can be seen to the right of the image. It appears to be set back slightly from the brick façade and has a similar window proportion to the brick building.

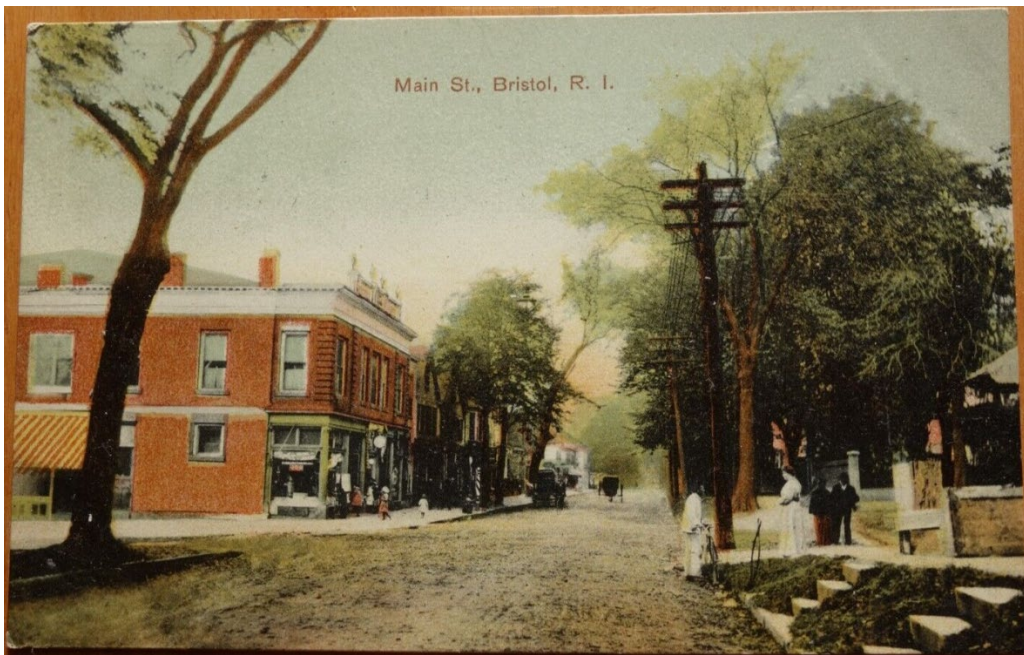
Historic Image 2 - This is the front of a postcard with an unknown publisher and date. The image shows the brick building which currently sits on the corner of Hope and State Streets. The small portion of the second story over the current barber shop can be seen to the right of the brick building. It appears to be set back slightly from the brick façade and has a different material treatment. A tall barber pole can be seen on the sidewalk in front of the shop.

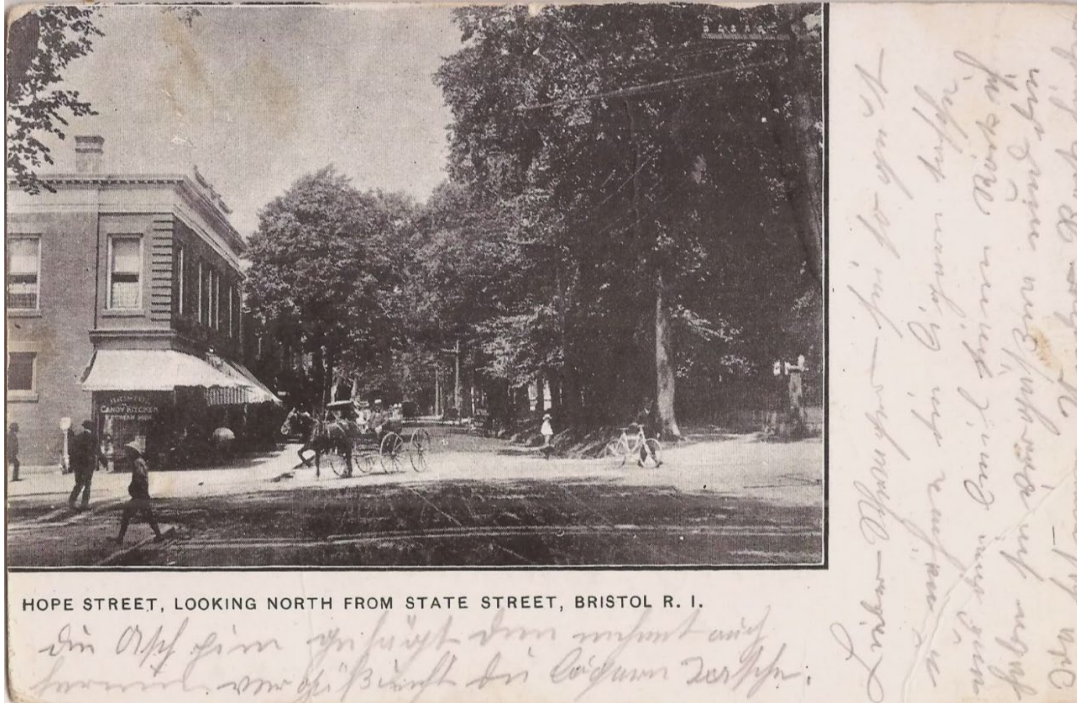
Historic Image 3 - This is the front of a postcard published by Stevens and Co., Jewelers in Bristol RI. The back of the post card was stamped in year 1909 making this an early view of the building within the first decade of its construction. The image shows the brick building which currently sits on the corner of Hope and State Streets. The small portion of the second story over the current barber shop can be seen to the right of the brick building. It appears to be set back slightly from the brick façade and has a different material treatment. A tall barber pole can be seen on the sidewalk in front of the shop.

Historic Image 4 & 5 – These postcard images show a rooftop balustrade over the center of the brick portion of the building. It appears to stretch the length of the 3 middle bays of the building and sits slightly setback of the roof cornice. There appears to be 4 earns sitting above the solid walled balustrade which is typical of these architectural details and can be seen in both Linden Place and the Four Eagles House on Hope Street.

- **Rooftop Balustrade Reconstruction** - Reconstruction of balustrade over the main portion of the brick building as seen in historic postcard views. Similar balustrades can be seen on Linden Place and the Four Eagles house both on Hope Street.

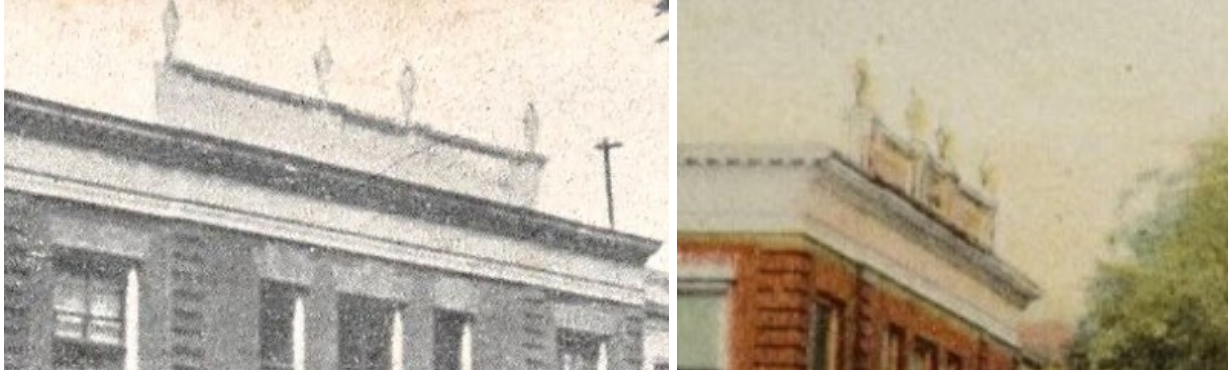
Historic Image 6 – This image is the clearest picture of the non-surviving portion of the building. The image is from a local architectural resource book by an unknown publisher. The barber shop can be seen on the first floor of the building and the second floor can be seen directly above with the façade in the same plane. You can clearly see the 2 over 2 window style and the clapboard siding from this image. The section of the building appears to have a flat roof and a simple cornice. The brick building appears taller and sits proud of the clapboard façade.

- **Reconstruction of Front Façade and Infill-** The portion of building that is non surviving is proposed to be rebuilt through new construction to accurately depict what was originally over the barber shop. Clapboard siding is proposed to be the exterior siding for the reconstruction. A double hung window with the same size and proportion as the adjacent brick building is proposed to be installed with a 2 over 2 pattern. A simple cornice is proposed on the reconstructed section of the building as depicted in one of the postcard views. (See Drawing Set Showing Proposed Design Solutions)

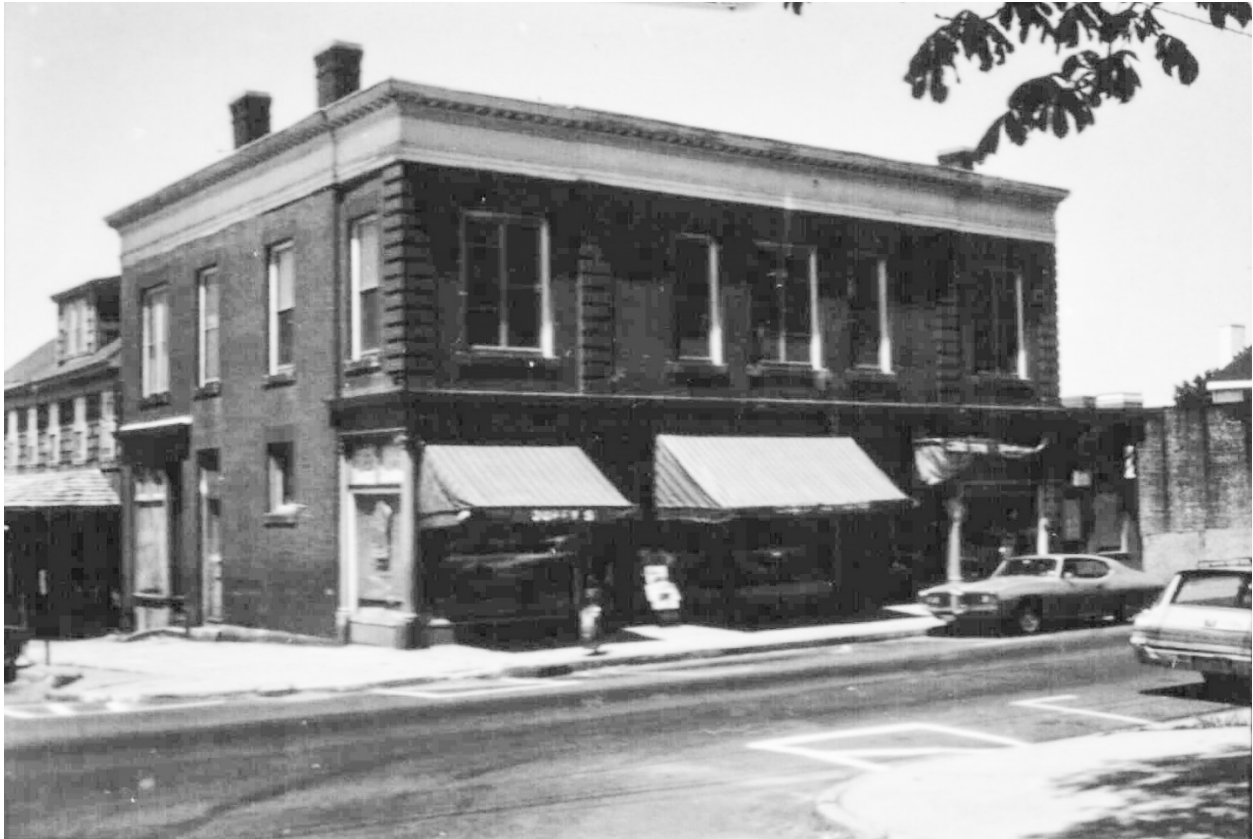
Historic Image 7 – This image is from the Bristol Historical Preservation Society archives and was most likely taken at some point in the 1970s during the architectural survey performed in town at that time. It shows the conditions of the building after another fire took out the building to the right of the barber shop. The second floor of the barber shop appears to have been taken out during that fire as well. The first floor of the barber shop survived the fire. A large gap in the street front just North of the barber shop can be seen in this image.

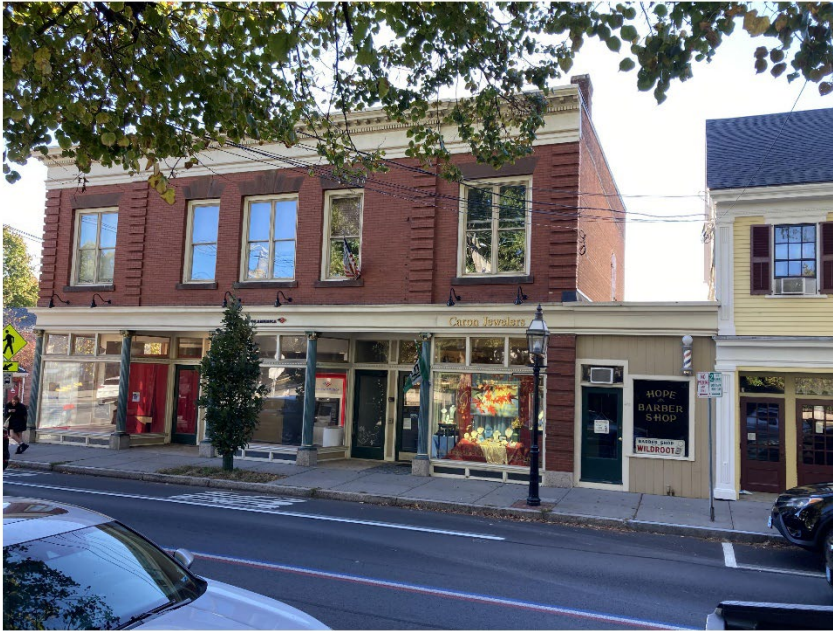
Photo 1 – Existing Hope Street Facade

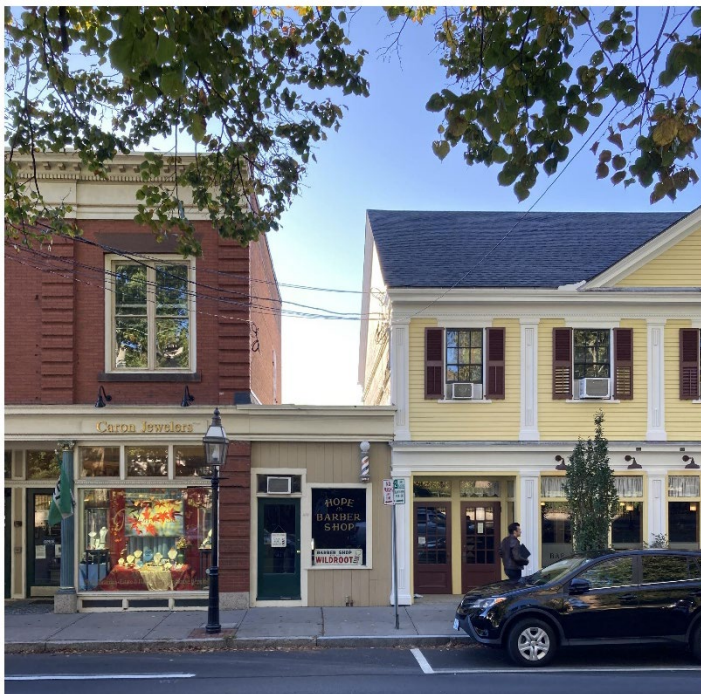
Photo 2 – Hope Street façade showing the empty space above the current Hope Barber Shop.

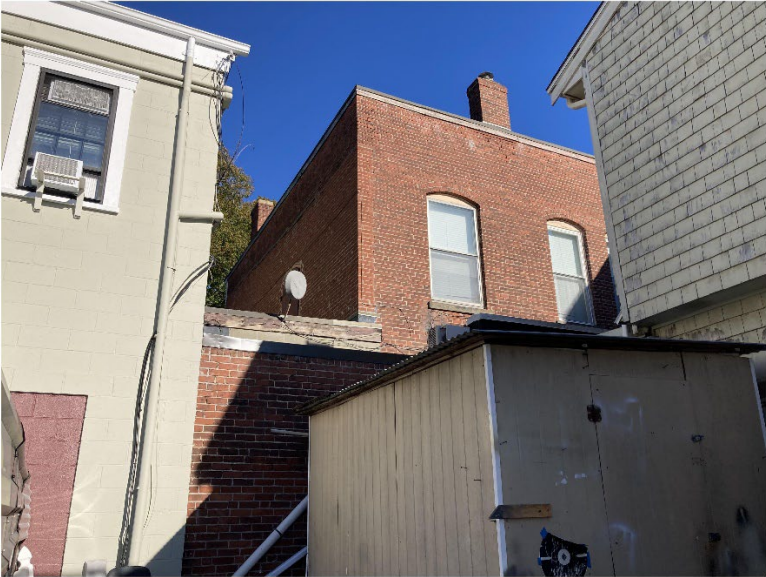
Photo 3 – View of the rear portion of the building from the private rear parking lot.

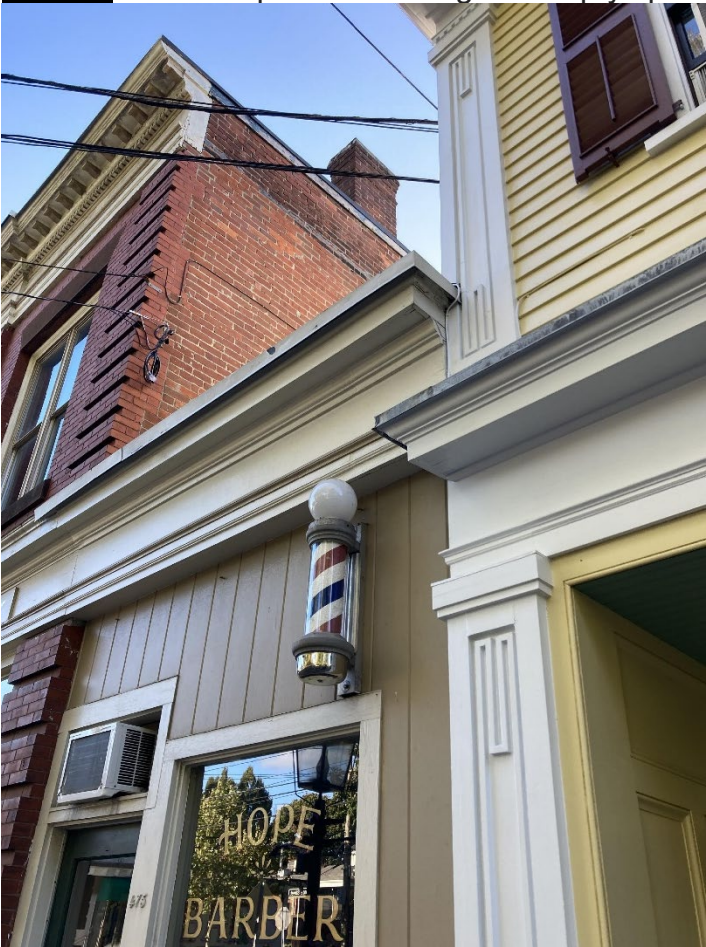
Photo 4 – Close up view showing the empty space above the Hope Barber Shop.

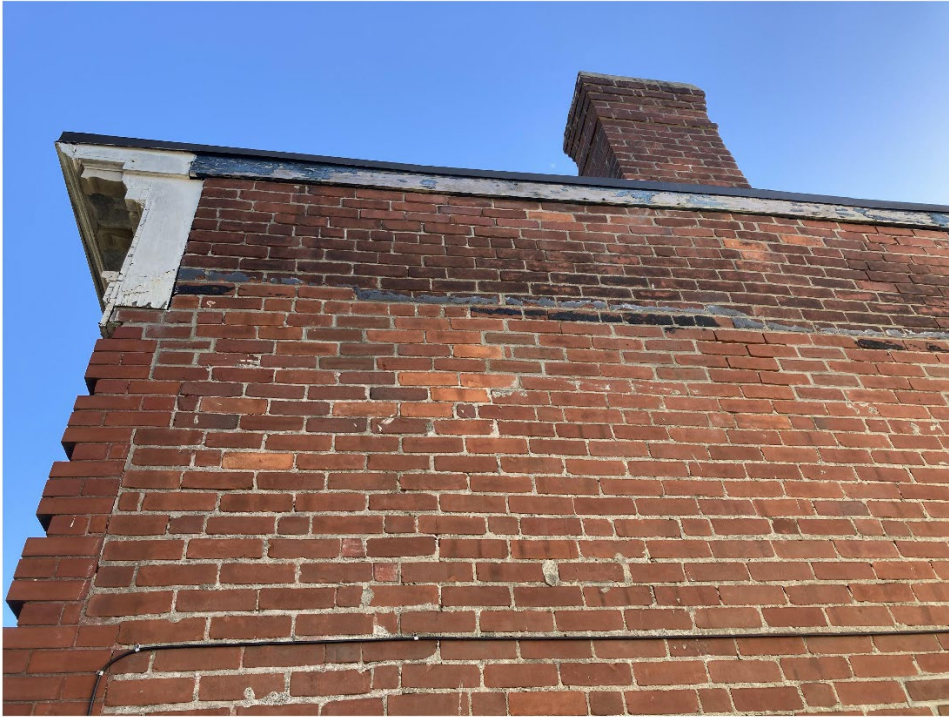
Photo 5 – Remnants on the brick showing location of non surviving roofline.

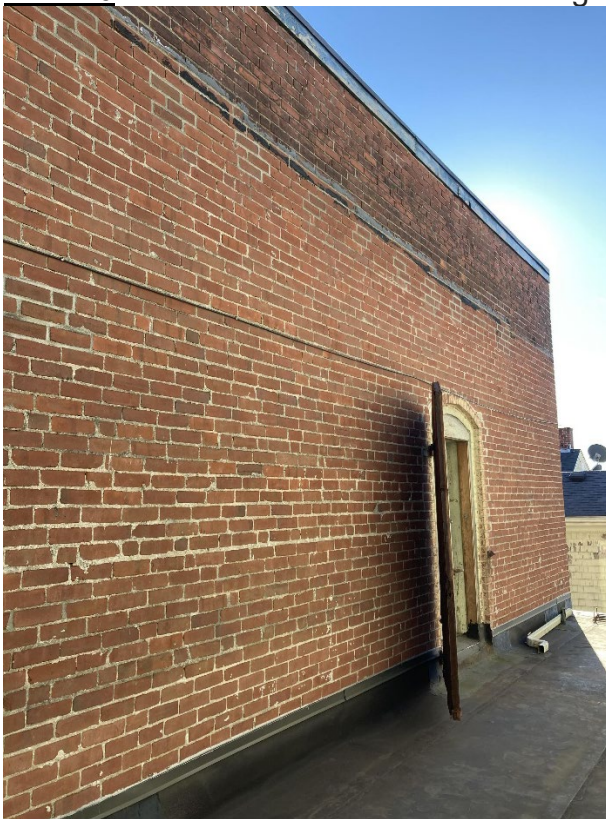
Photo 6 - Remnants on the brick showing location of non-surviving roofline.

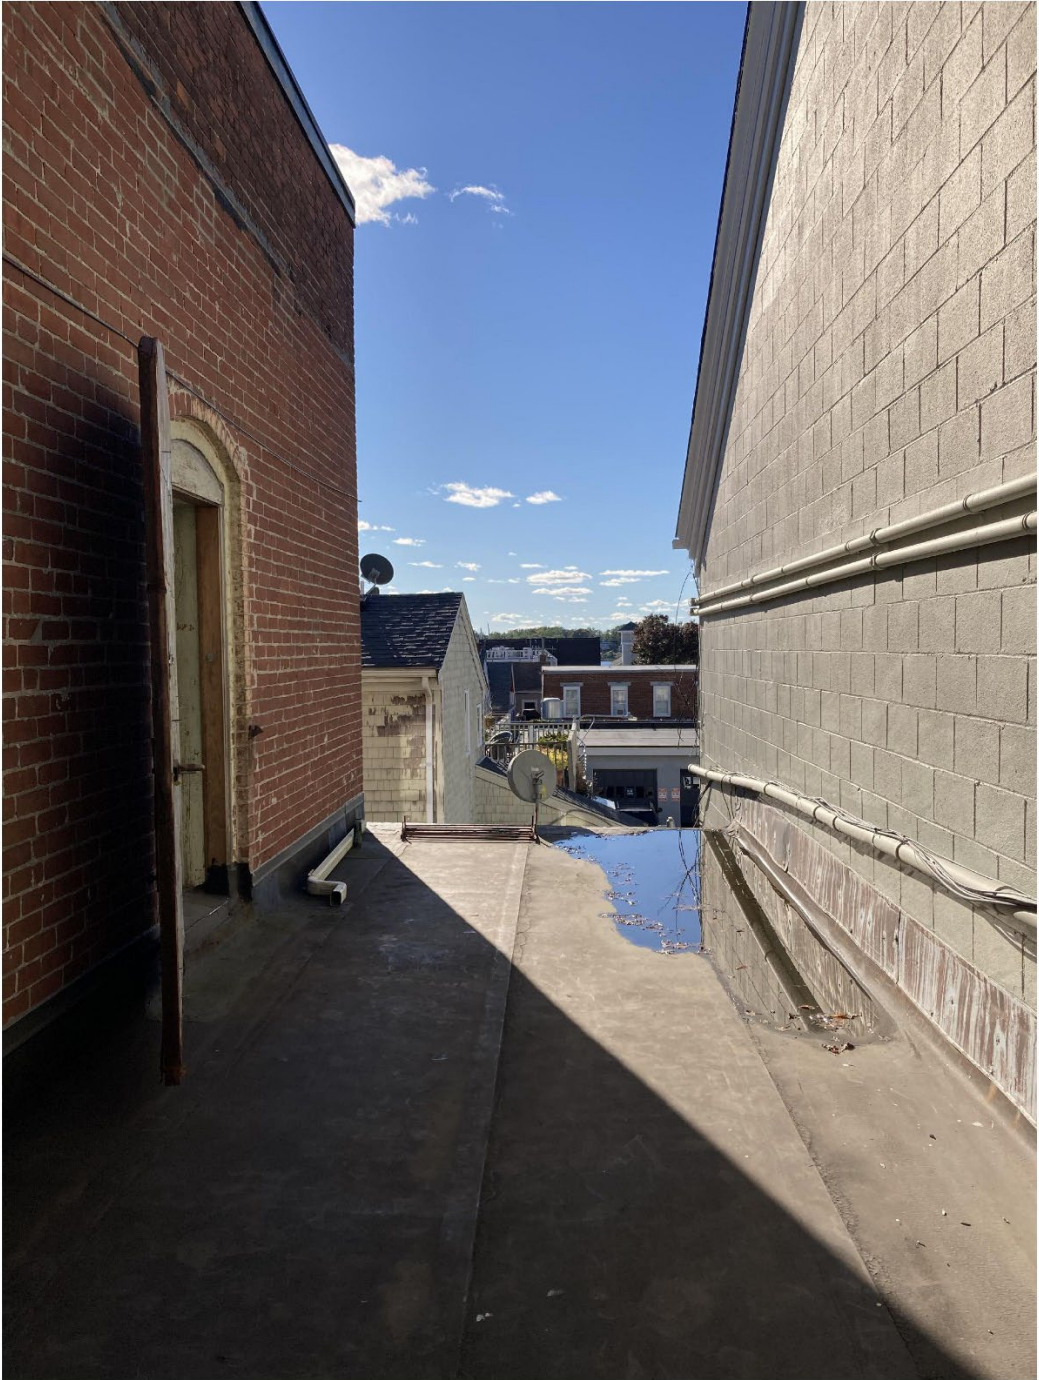
Photo 7 – Looking West. 467 Hope Street to left (brick building) Adjacent building 483 Hope Street to right (CMU building).

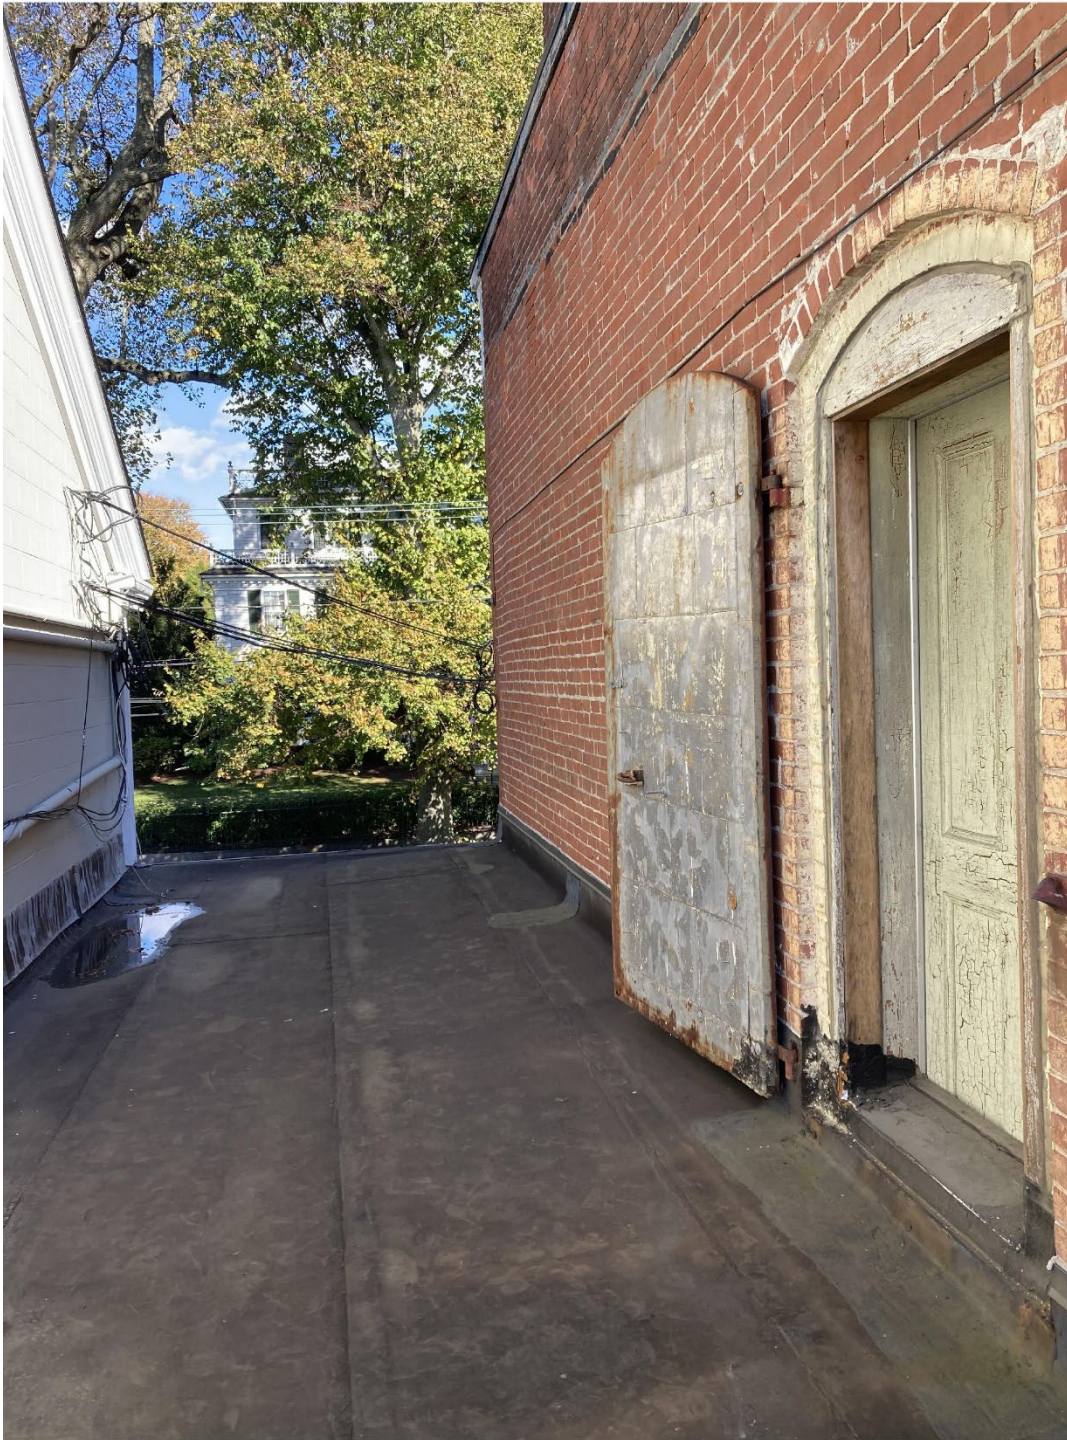
Photo 8 - Looking East. 467 Hope Street to right (brick building) Adjacent building 483 Hope Street to left (CMU building). Image showing metal fire door and wood panel door.

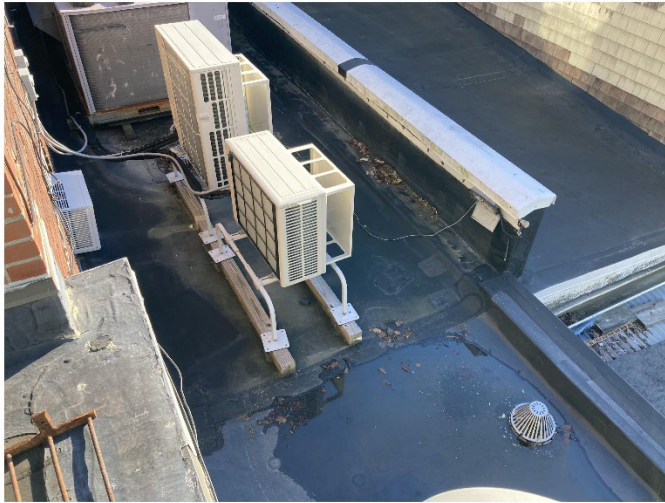
Photo 9 – Image showing rear lower roof over single story section of building where the current mechanical units are located.

- **Rear Deck and Spiral Staircase-** A wood deck is proposed to be built on the rear of the building over the single story brick section of the building as seen in the drawings. This deck will be accessed from both the existing brick building and the reconstructed portion of the building. A metal spiral staircase is proposed to be installed on the rear deck which will give access to a rooftop deck over the reconstructed portion of the building.

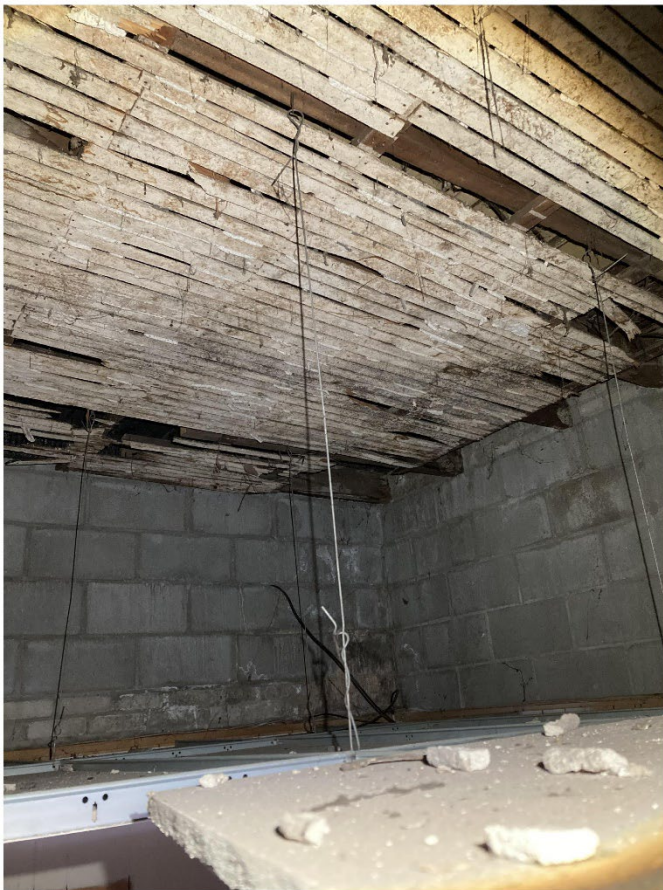
Photo 10 – Image taken above drop ceiling in Hope Barber Shop showing evidence of fire damage from the second floor portion being burned and the first floor surviving.

A fire around the 1970s destroyed the building just to the north which abutted walls. The second story over what is now 'Hope Barber Shop' appeared to have been burned as well but the ground floor tenant space survived. Evidence of the fire can be seen above the drop ceiling in the barber shop. The brick wall just above the barber shop which is assumed to have been one of the interior walls of that second story space has evidence of an existing roof line that can still be seen. Historic images and postcards depict images of what the Hope Street façade of that space looked like prior to the fire. Currently the space sits as an empty rooftop with an EPDM rubber roof. This jog in the façade creates a 'missing tooth' in the street scape which creates a sense of inconsistency and a loss of history. The adjacent building just to the North was designed and rebuilt by Lombard Pozzi, a prominent Bristol Architect, who took inspiration from surrounding buildings to construct a building that was different but compatible with its surroundings.
