Herreshoff Marine Museum
Burnside Building Rehabilitation - Phase 3
One Burnside Street
Bristol, Rhode Island

HERRESHOFF MARINE MUSEUM
BURNSIDE BUILDING REHABILITATION - PHASE 3

PHASE 3 DRAWING LIST

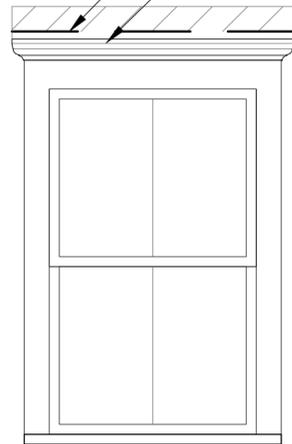
W101

New cap flashing
Replicate deteriorated/missing
cap trim and returns

Annex Window Restoration Notes:

Catalog and label location of all sash as they are removed.

Use stockpiled sash, glass, or hardware to replace, repair damaged or missing units.

Remove all loose paint, remove all glazing compound, sand exposed surfaces

Prime all surfaces, reset any loose glass panes

Replace all broken, cracked or missing glass panes

Re-glaze all sash completely

Paint all sash, 2 coats

Reinstall all sash into existing frames.

Install new meeting rail sash locks at all operable windows.

Wax all jambs, replace all parting beads and stops

with new mahogany components to match original

Install new storm windows at all locations in project

area. units to be triple track units with screens.

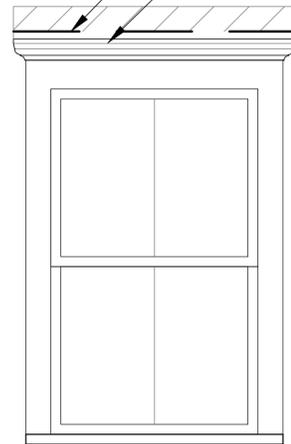
W102

New cap flashing
Replicate deteriorated/missing
cap trim and returns

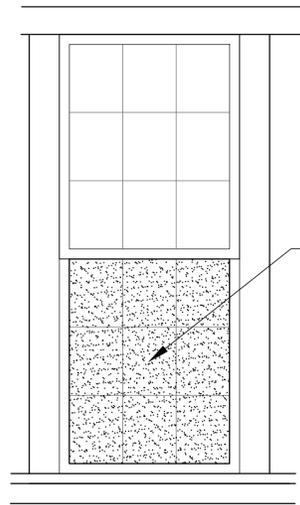
W244

Remove paint
from glass

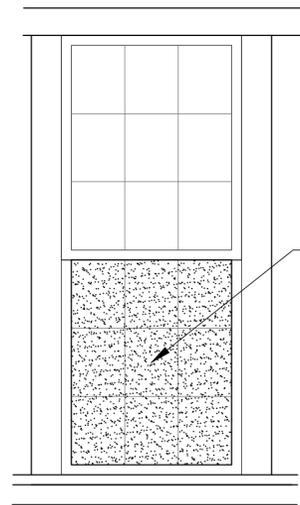
W247

Remove paint
from glass

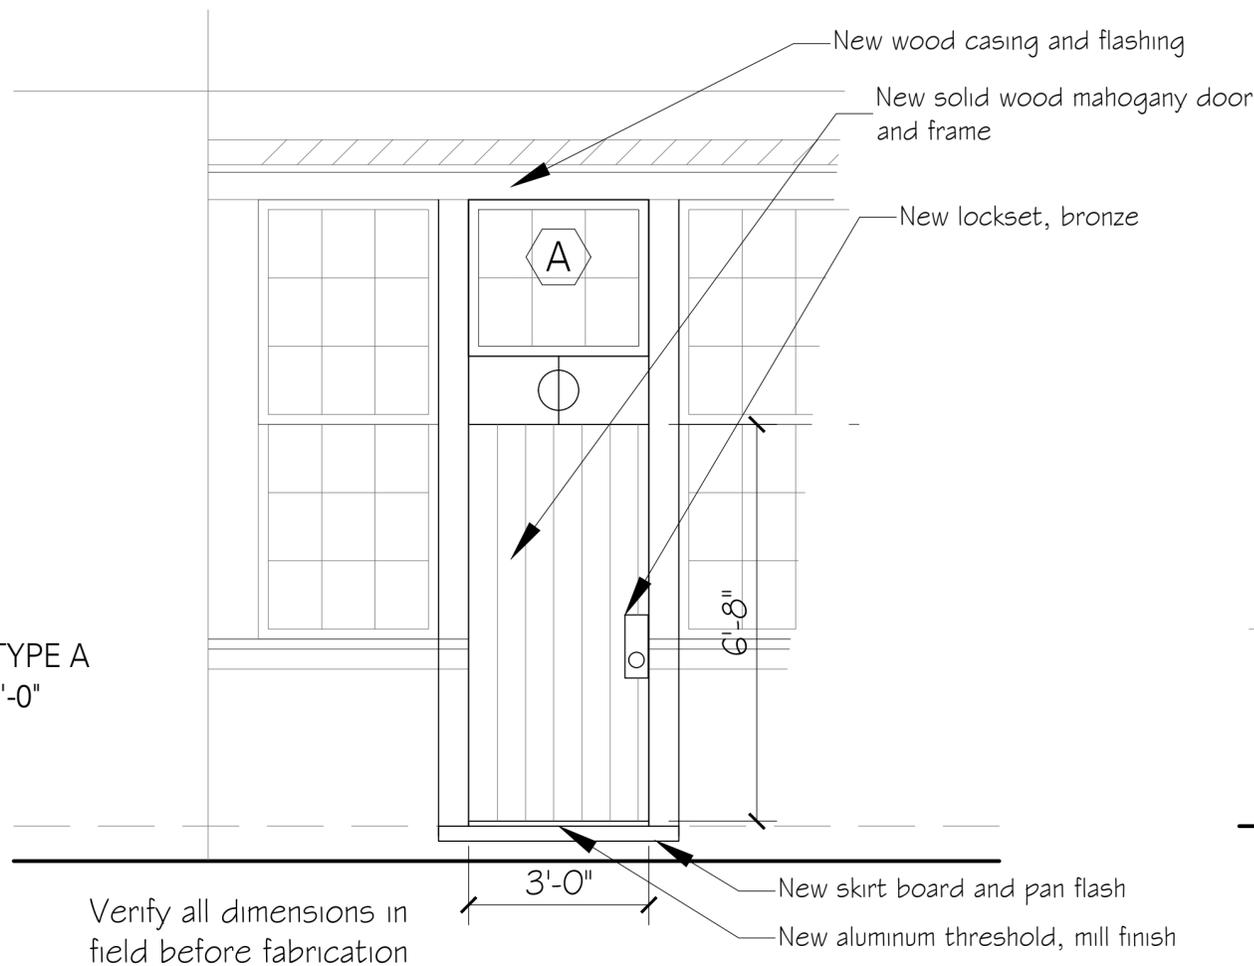
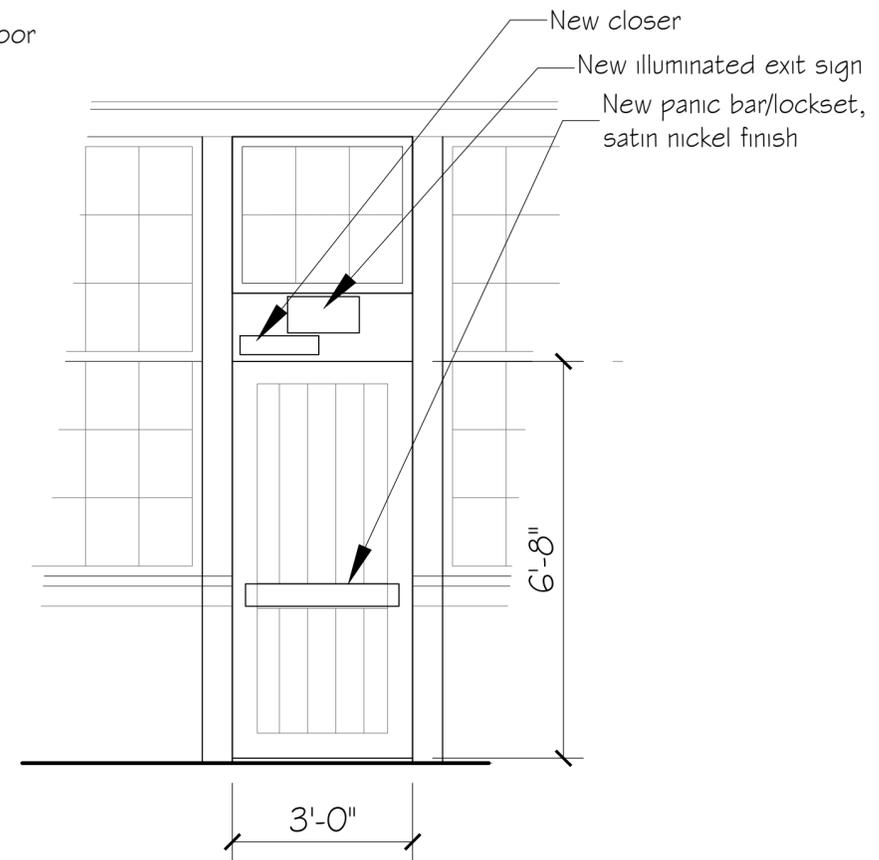
NEW DOOR TYPE A
 Scale 1/2" = 1'-0"

Verify all dimensions in field before fabrication

Exterior View

Interior View

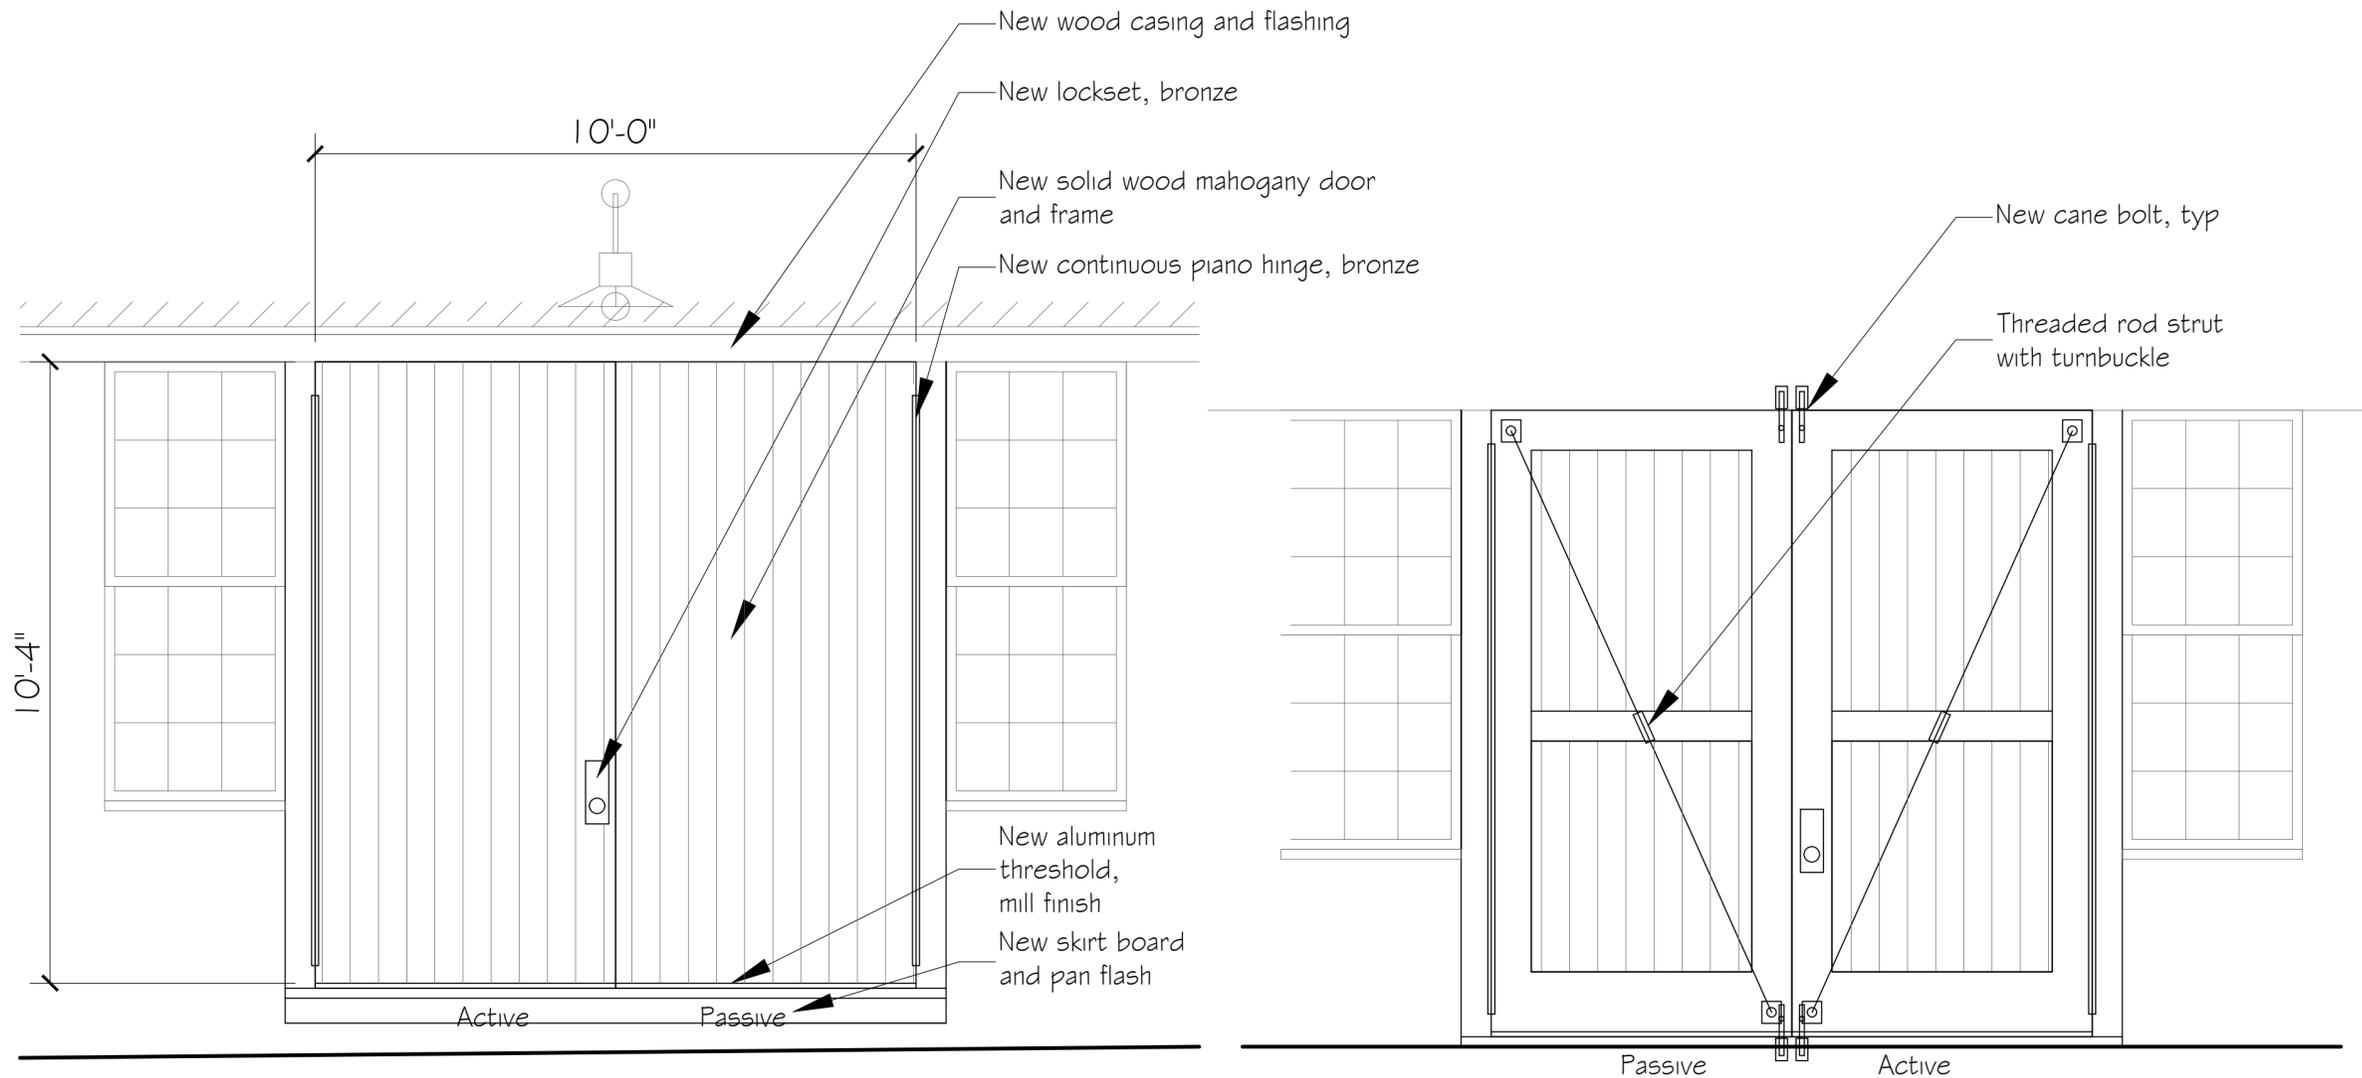
NEW DOOR TYPE B
Scale 1/2" = 1'-0"

Verify all dimensions in field before fabrication
Exterior View

Interior View

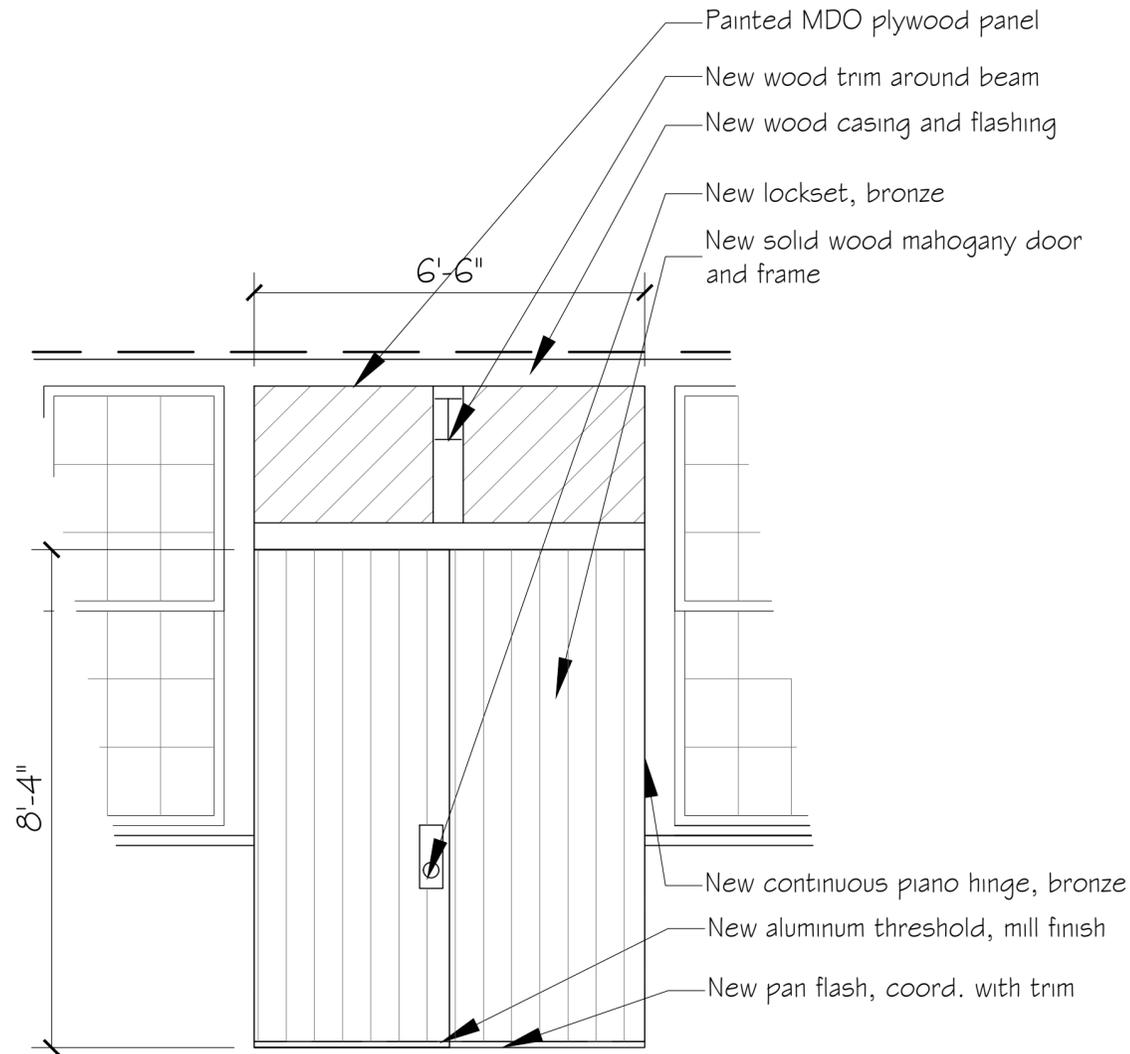
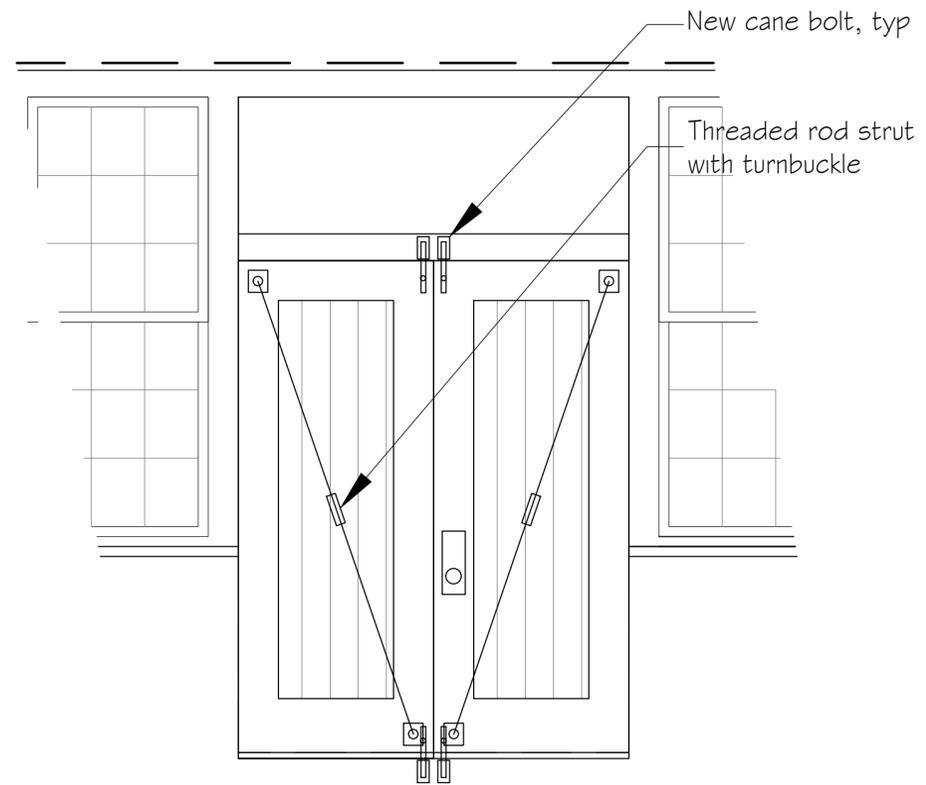
NEW DOOR TYPE C
Scale 1/2" = 1'-0"

Verify all dimensions in field before fabrication

Exterior View

Interior View

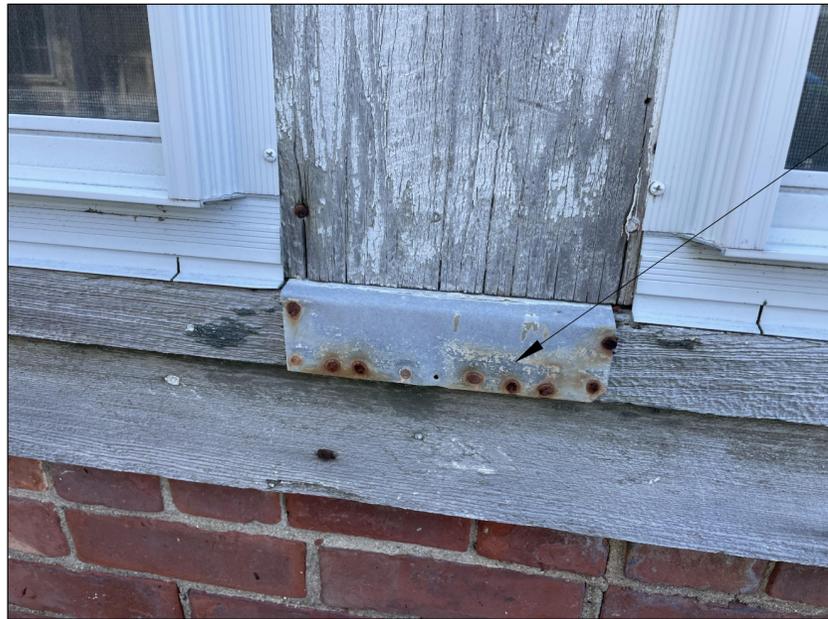
Window sill joint flash photo with
notes

Re-nail loose
flashing, Replace
missing flashing.

Repair / replace sill joint flashing prior to installing storm windows

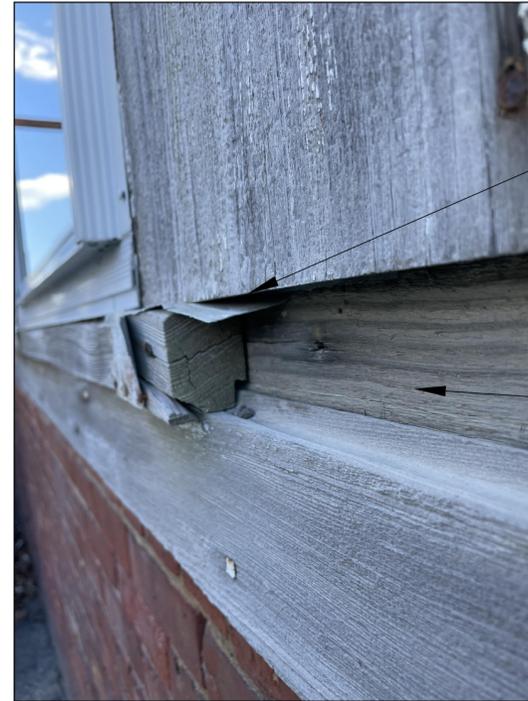
Window sill joint flash photo with
notes

Insert new flash
under casing.

Install new sill
board over
rabbeted trim.
