Tanyard Brook

2023 Engineering Excellence Award

Reconstruct a 4,500 foot culvert starting at the State Street Reservoir, ending at the outfall at Walker Cove.

Tanyard Brook Culvert Replacement Project
Bristol, Rhode Island

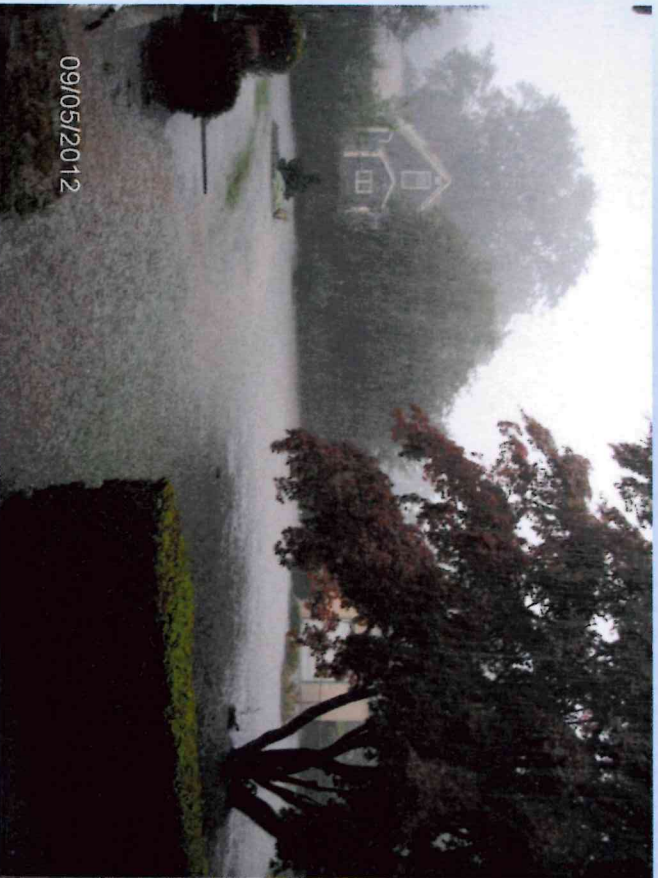
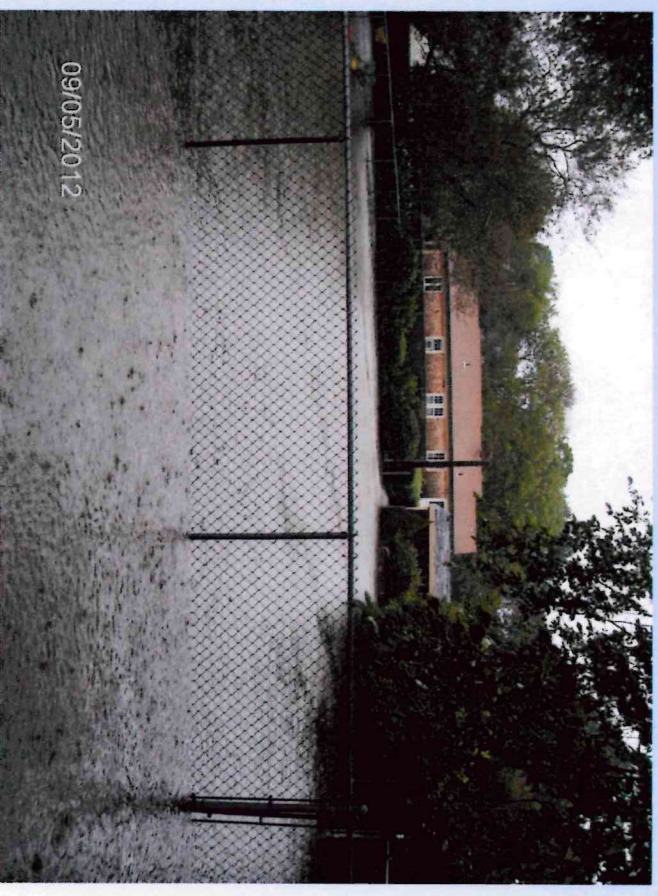
Due to a number of causes – collapsed culvert, debris, and other blockage
- Tanyard Brook was unable to divert water during significant rain events,
creating overflow onto nearby properties.

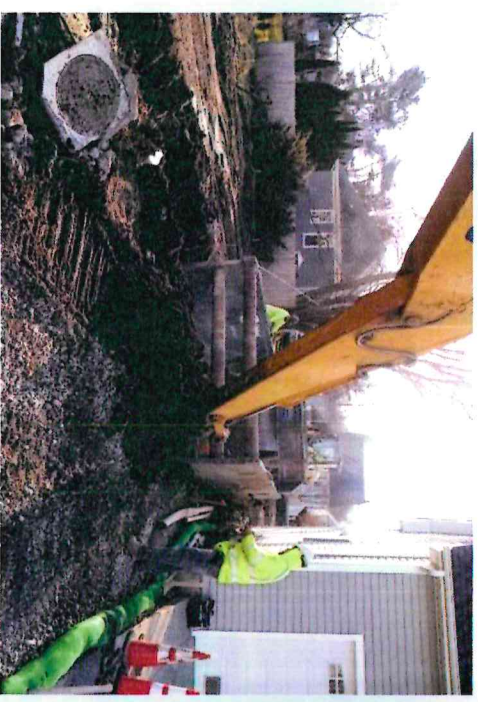
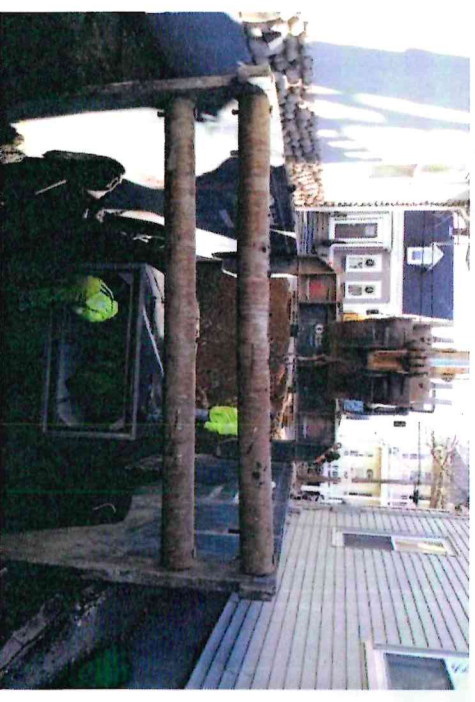
- replacing the culvert alongside existing structures (top photo)
- maneuvering between existing foundations (bottom photo)

The project involved installing a large box culvert through private property and in close proximity to house foundations. This was done while maintaining and conveying stormwater flow generated in the 500-acre watershed. For example, there were only 12 feet between house foundations along Charles Street where the culvert had to be installed. The Town had to obtain 40 easements from the property owners before the project could begin. A collaborative effort with the Town, BETA, and the contractor was necessary to ensure that the residents were well informed of the major construction effort that would be occurring, literally in their backyards. Constant coordination with Bristol Water Pollution Control Division, Rhode Island Energy and Bristol County Water was necessary due to the number of utilities and service connections (sewer, gas and water) that needed to be relocated to facilitate construction.

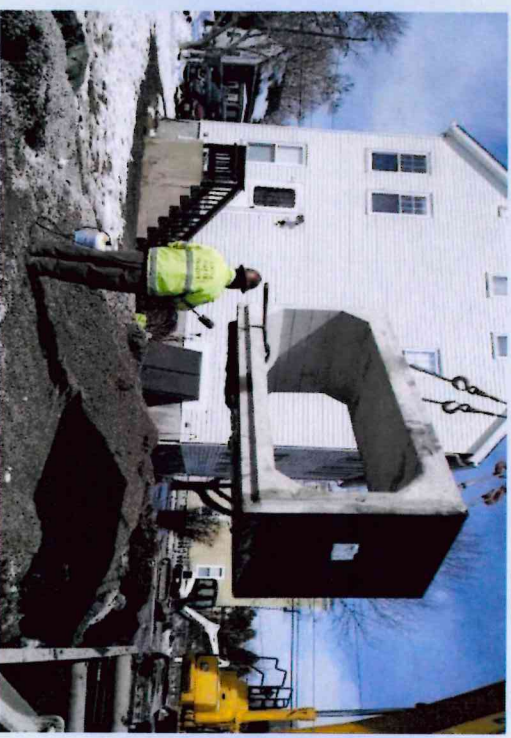
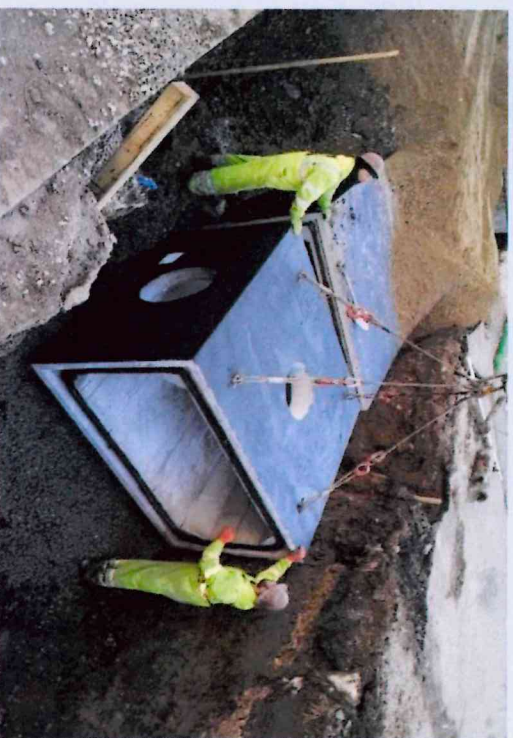
The new box culvert consists of rectangular concrete structures that allow free flow of water.

Once lowered into the excavated ditch, the sections are linked together to create a 'tunnel'.

The excavated area around the installed structures are backfilled and covered.

The project was completed in three phases. The new culvert, which ranged in size from 3 feet deep x 8 feet wide to 4 feet deep x 9 feet wide, conveys the 10-year design storm. Each property owner along the alignment was given the opportunity to connect one or more yard drains within their parcel to the culvert. Flooding within the roadways and the residential properties has been mitigated as a result of the replacement of the culvert and the additional drainage improvements.

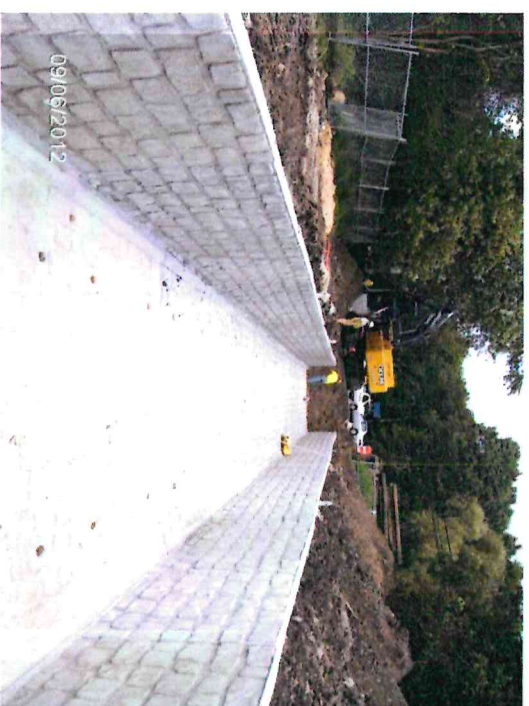
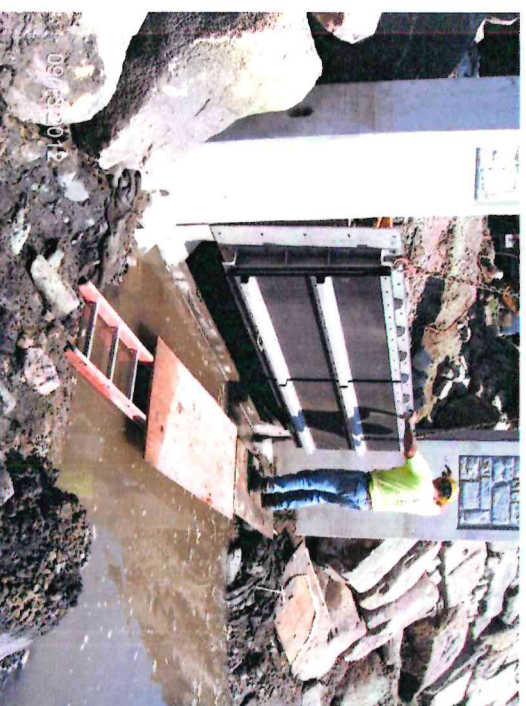
The culvert discharges via an aqueduct that extends from High Street to Hope Street across from the Water Pollution Control facility.

The ability for water to discharge at the outflow at Walker Cove is influenced by the tide.

During periods of high-tide, water rushes into the culvert, preventing outflow and adding to the flooding issues.

To mitigate the tidal influence, a tidal gate was installed at the outfall.

This feature blocks sea water from entering the culvert during high tides while allowing stormwater to exit into the bay.

The outfall of Tanyard Brook at Walker Cove is tidally influenced. Under existing conditions during high tide, the outfall is fully submerged and sea water enters Tanyard Brook. This exacerbates the flooding issues during significant storm events. This project included the installation of a tide gate at the outfall. Although this prevents seawater from entering the Brook, flow cannot discharge through the outfall when it is submerged. The segment of the Brook immediately upstream of the outfall, between Hope Street and Wood Street, is an open channel. Adjacent to this section of open channel is an area of green space owned by the Town. As part of the design, this area was graded and planted to allow flood storage should peak storm flow coincide with high tide and a submerged outfall condition. When this occurs, stormwater purposely overtops the open channel and flows into the "wetland area" until the tide and/or peak flow subsides and then the stormwater reenters the open channel and is discharged to Walker Cove through the outfall. This has promoted flood mitigation along Hope Street and Wood Street.

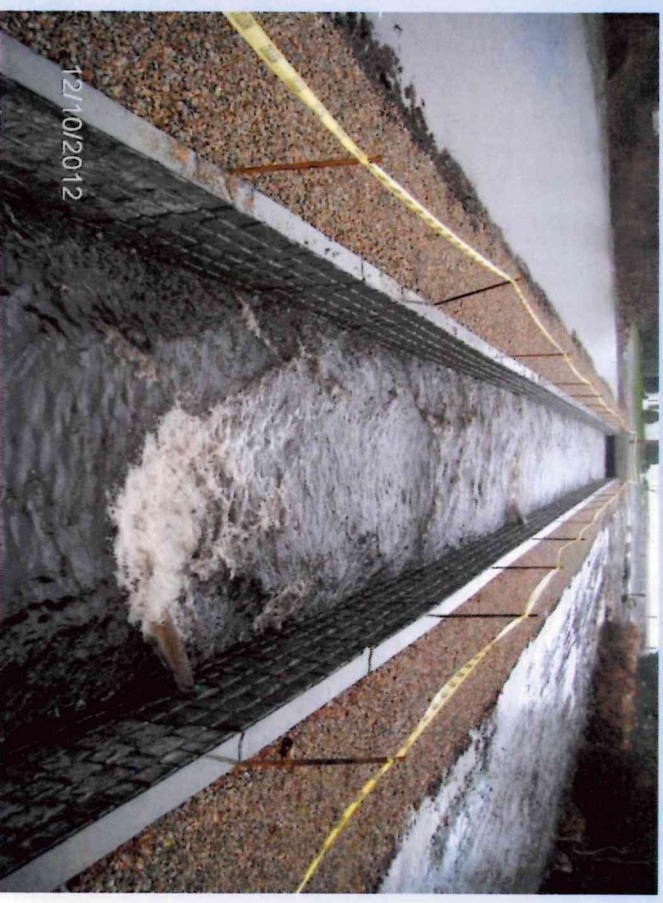
The successful Tanyard Brook project is evident in residential neighborhoods where the impact of flooding is no longer detrimental to private and public property.

With the tidal gates in place and the unobstructed culvert channeling water to the bay, excessive water moves freely to the outfall.

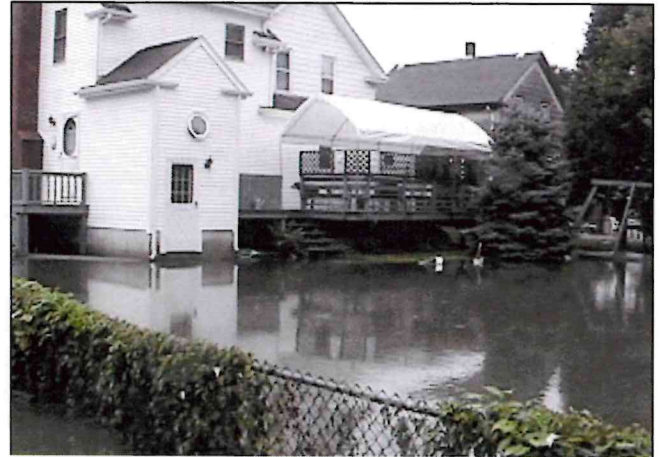
Residential property flooding caused by Tanyard Brook

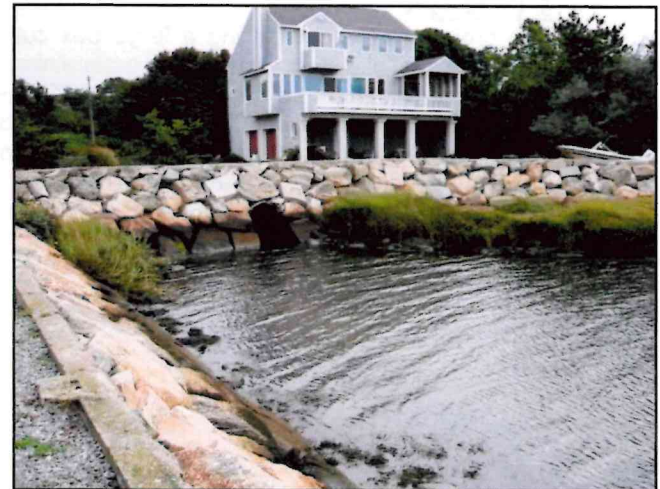
Tanyard Brook outfall at Walker Cove
