# TOWN OF BRISTOL, RHODE ISLAND

Subject: Comments re Application #22-0264 - Council  
Concerns and Additional Information

The Town of Bristol retained the services of BETA Group, Inc. to complete a drainage study of the Silver Creek watershed. The 2-square mile watershed extends from Tupelo Street near the Town's northerly border discharging into Bristol Harbor under Route 114 and the East Bay Bicycle Path. The study is one of several projects currently underway to identify existing drainage facilities within the Town and to improve the storm water infrastructure. The primary objective of the study was to determine the causes of flooding within the watershed, and to identify remedial projects which the Town may advance as money becomes available either through grants or bonds.

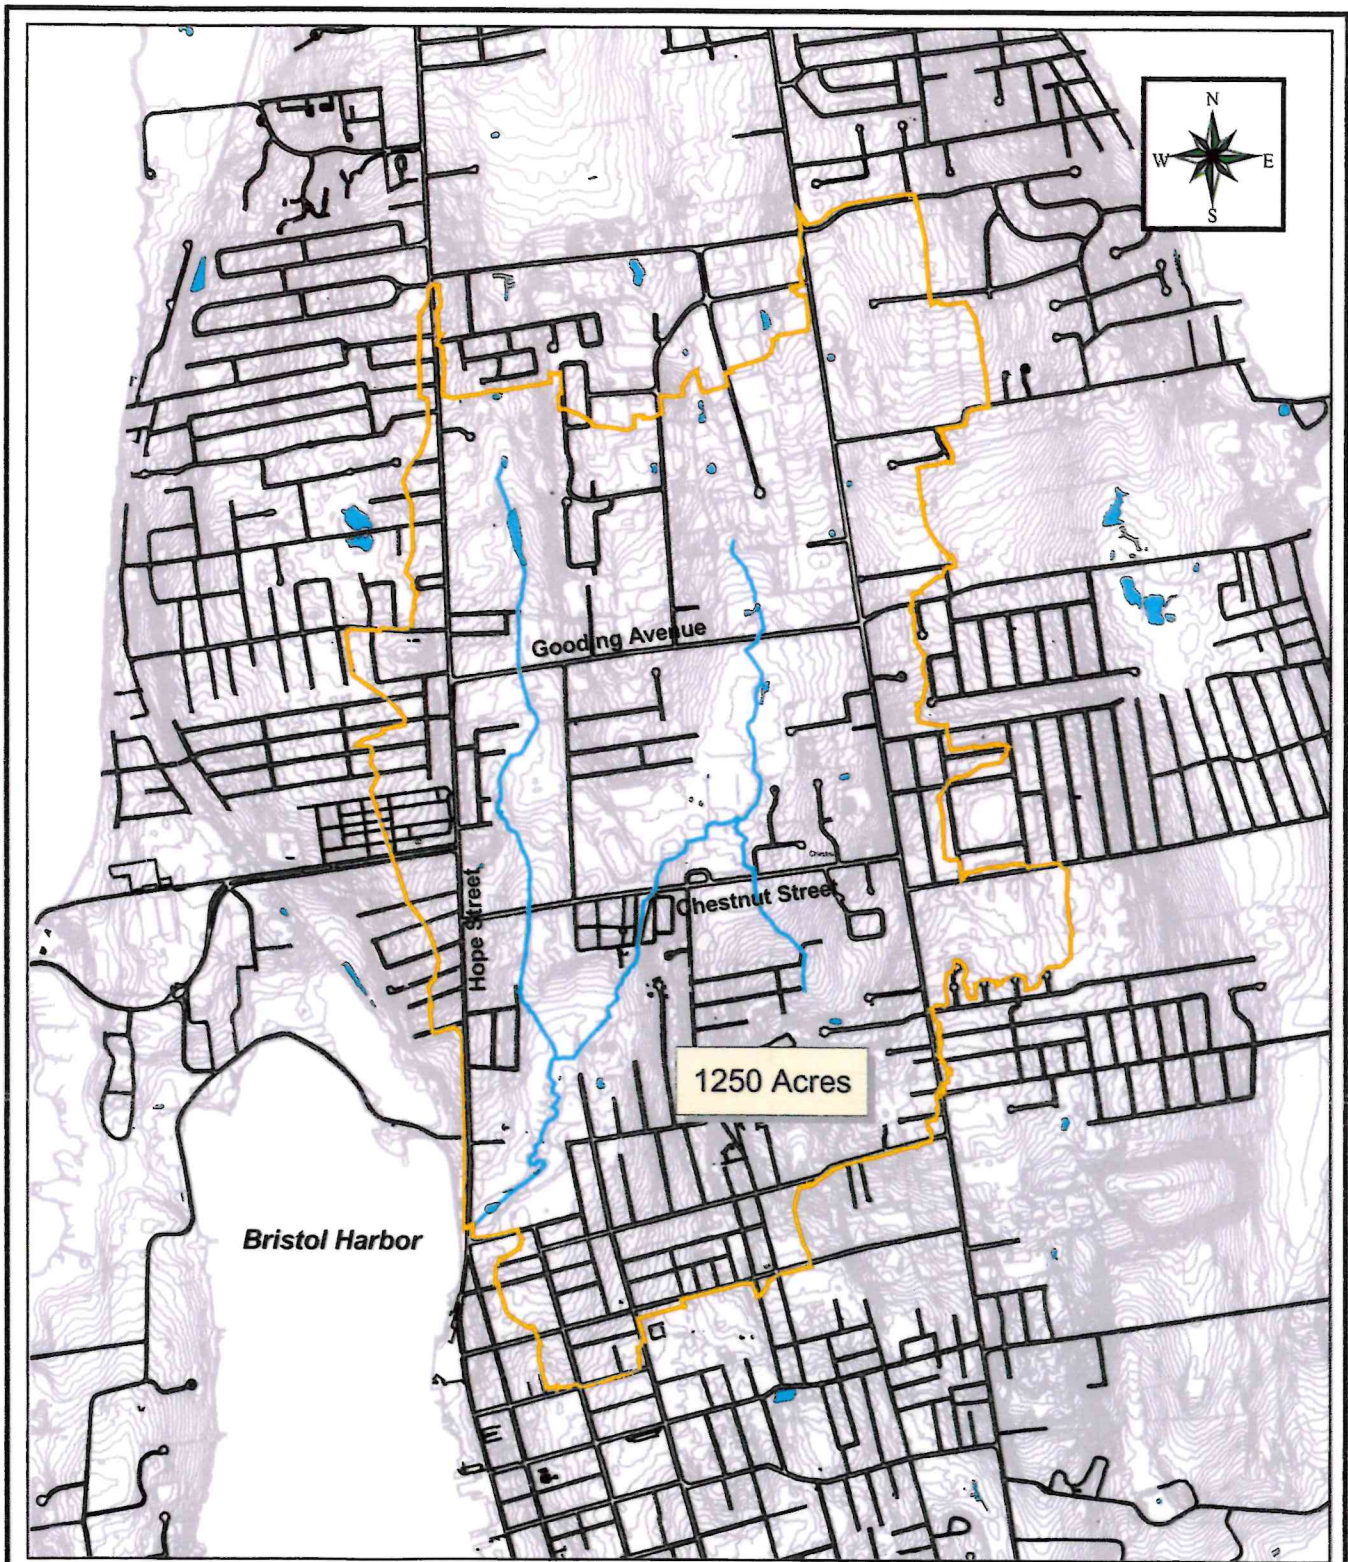
**Figure 1**  
Silver Creek Watershed

stream channels. Silver Creek begins as two (2) separate channels, identified as the East Branch and the West Branch, which merge into one creek south of Chestnut Street in the large marshy area north of the Guitaris School. The boundaries of the watershed were determined through the use of GIS, dry-weather opening of the drainage structures, and field observations of the wet-condition overland flows. The watershed is identified in Figure No. 1. The Silver Creek watershed falls under the jurisdiction of both the Coastal Resources Management Council (CRMC) and the Rhode Island Department of Environmental Management Freshwater Wetlands Section (RIDEM). The RIDEM regulates the wetlands within the watershed north of Chestnut Street and east of Sherry Avenue. Figure No. 2 illustrates the boundaries of the two (2) regulatory agencies.

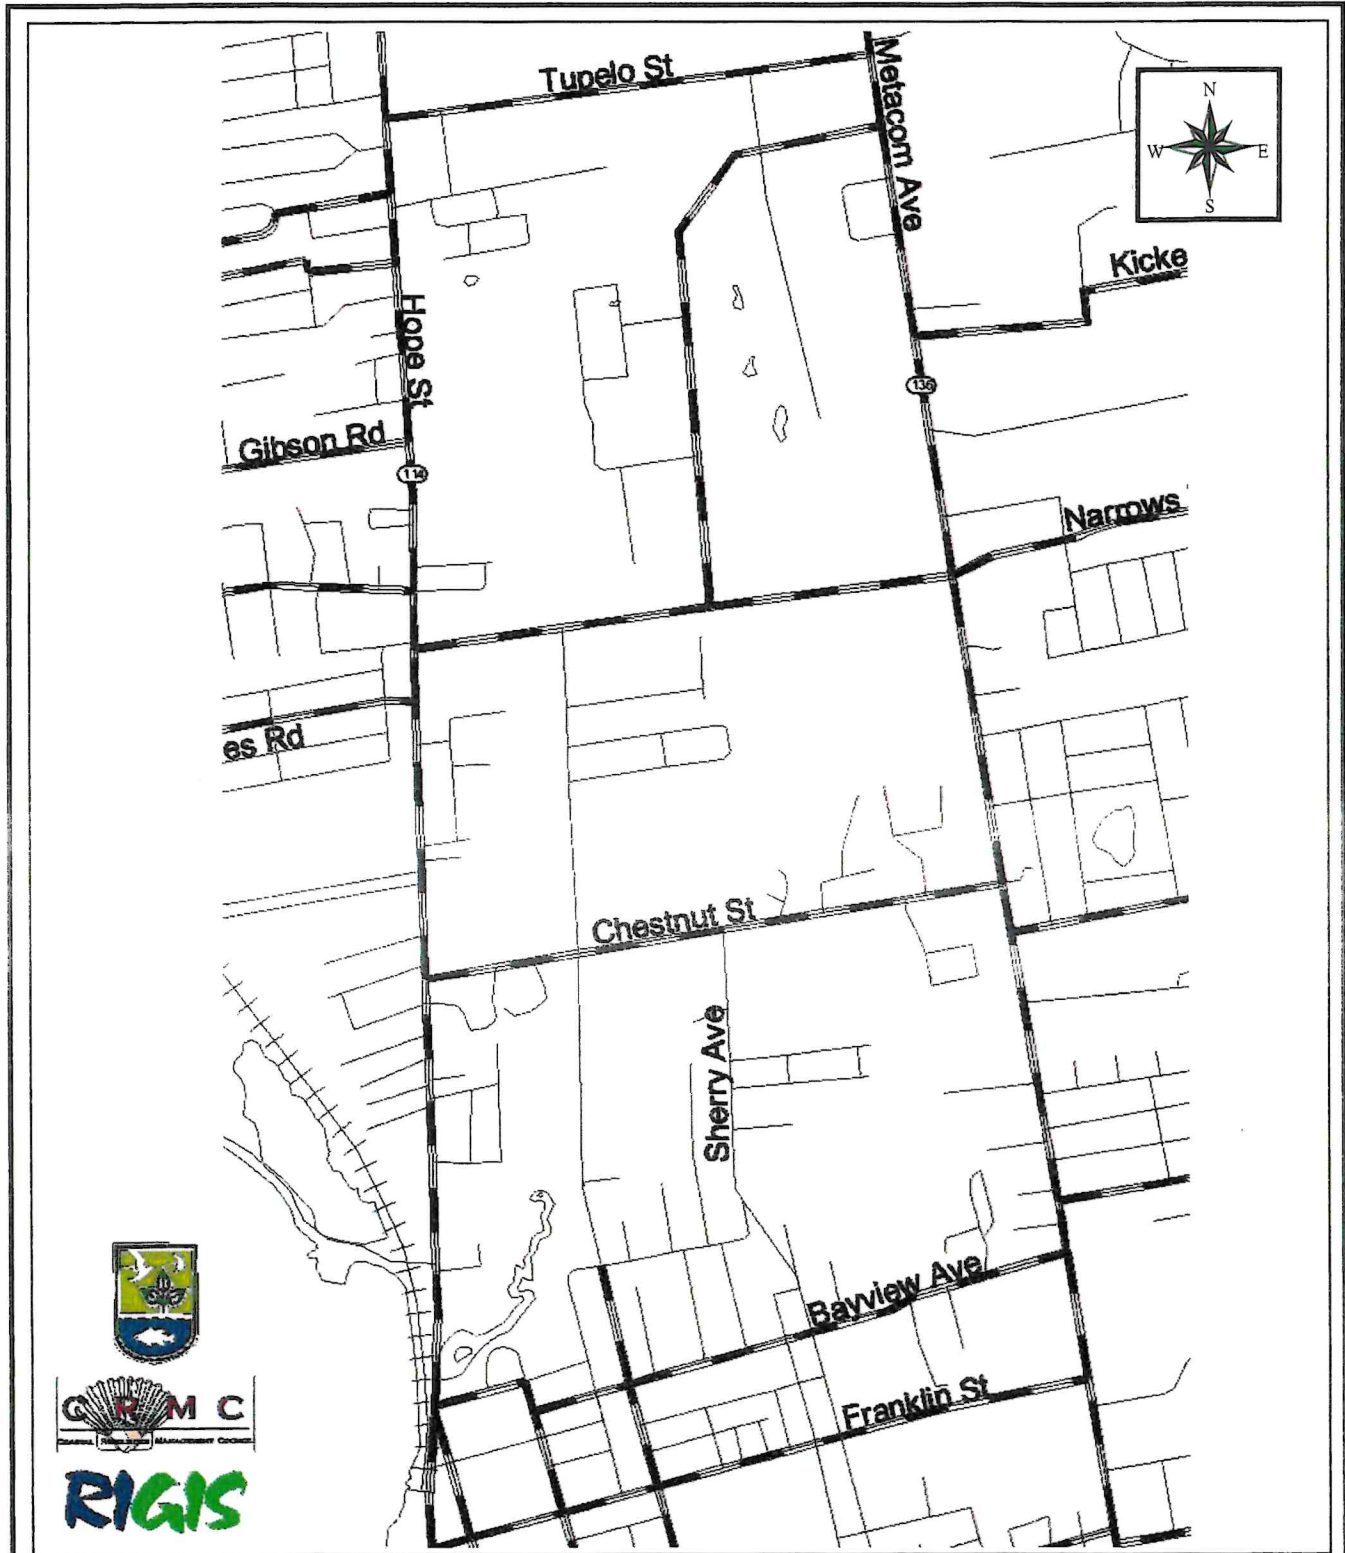
Silver Creek  
*NOT TO SCALE*

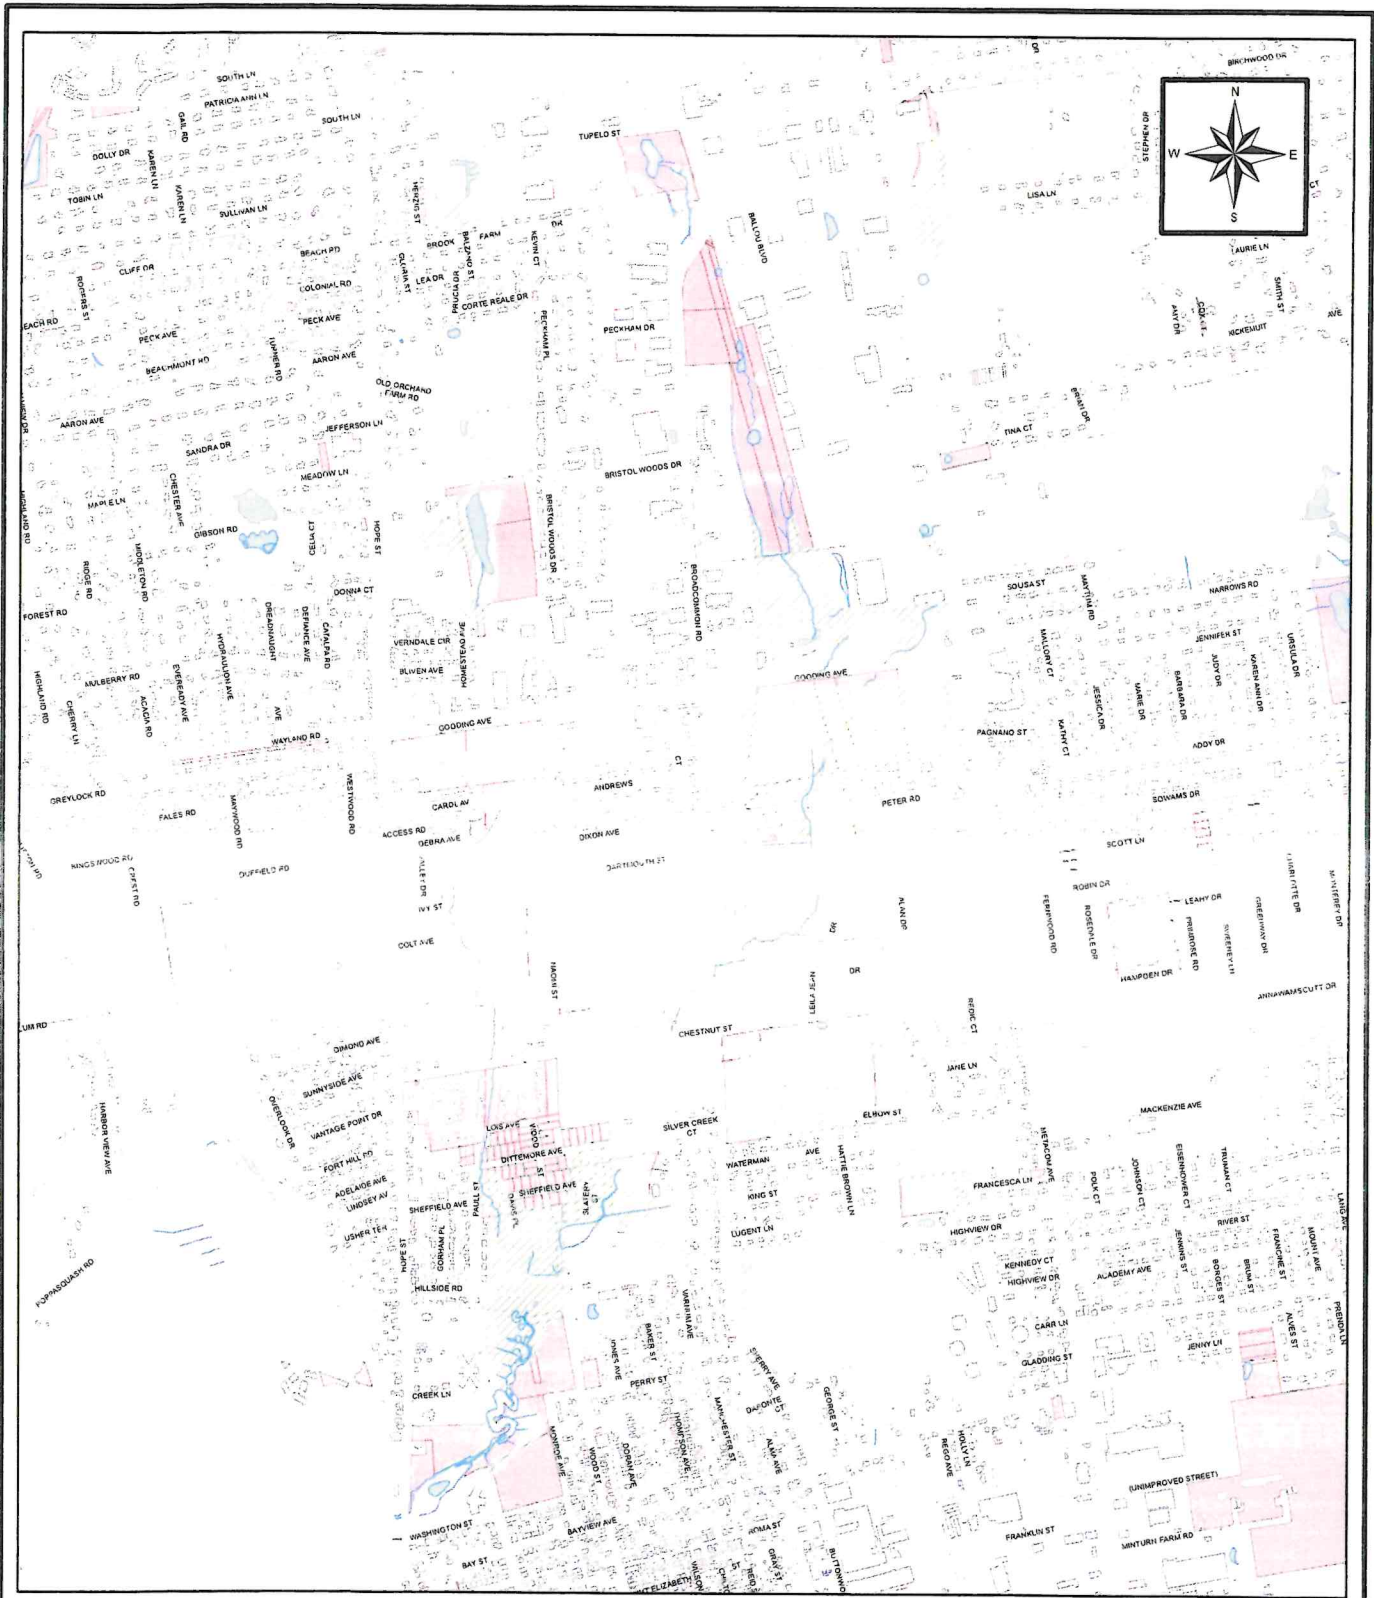
**Figure 3**  
Town-Owned  
Property

Figure 3 illustrates the town-owned parcels within the study area. This map is important in that it provides potential areas where improvements can be made without the acquisition of private property.

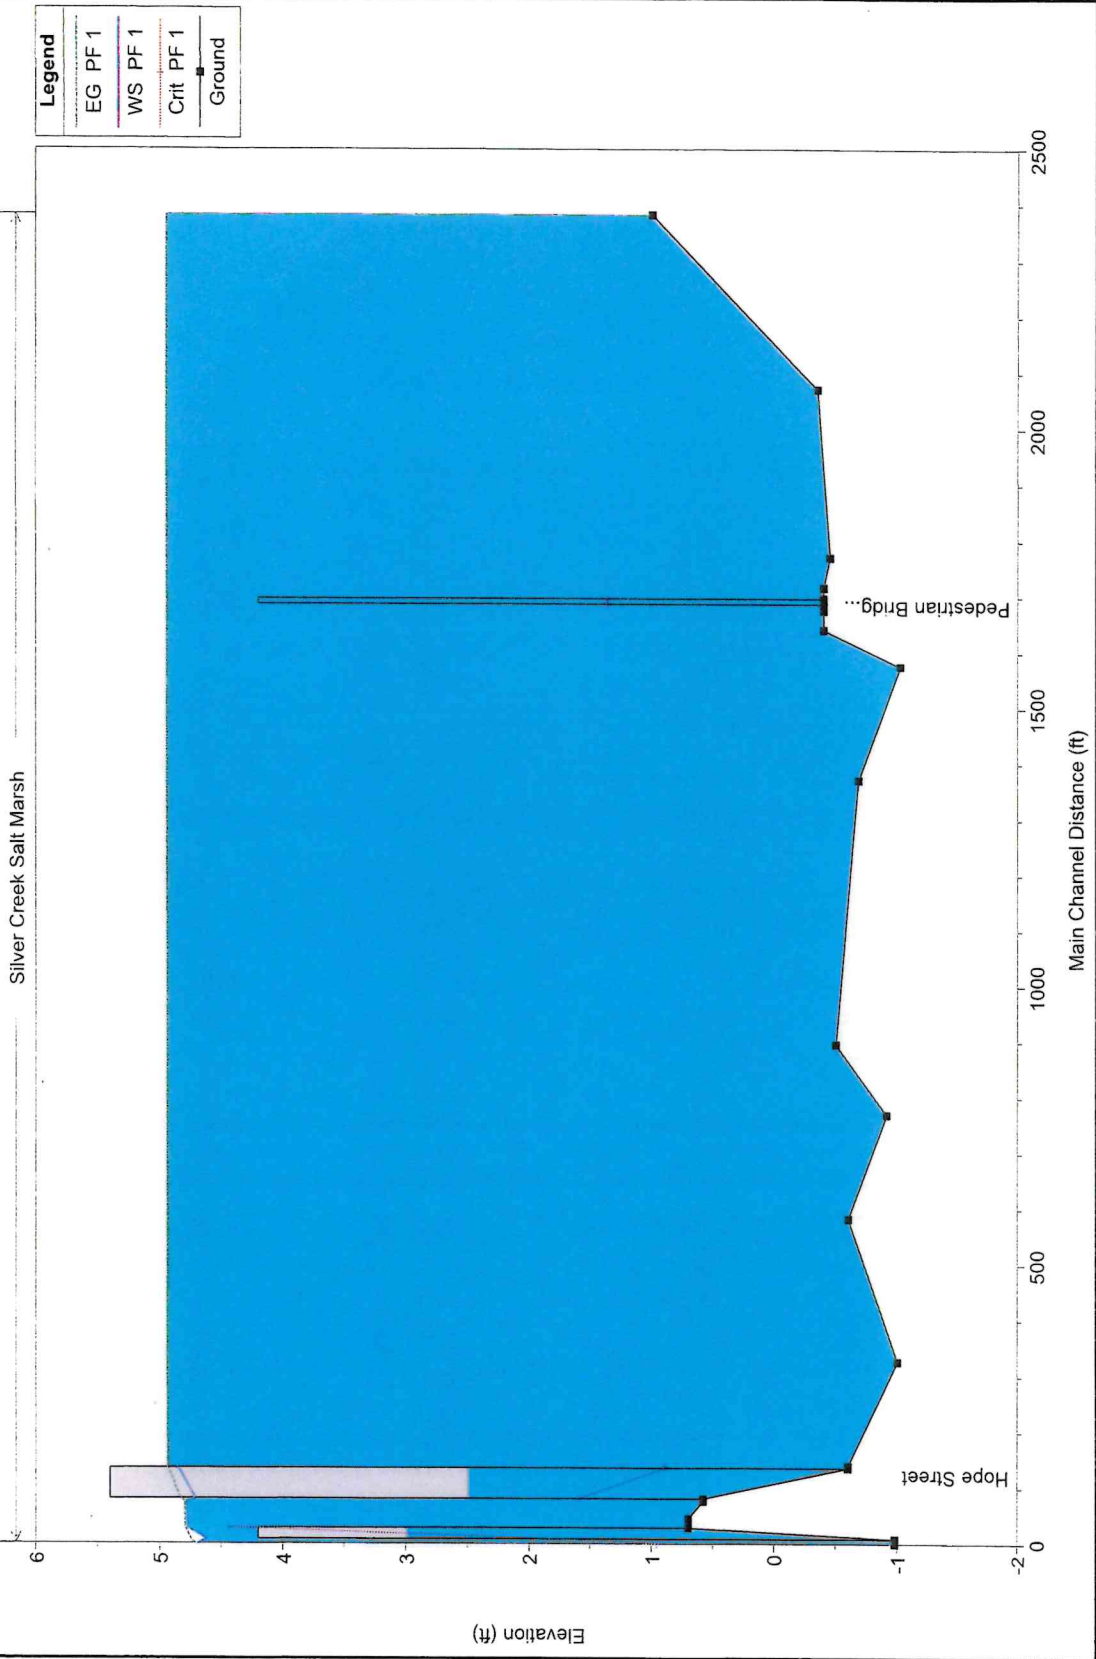
# Silver Creek Geom: Marsh Sediment Removal Flow: 2 Year - With Tailwater Figure 20

water surface level in the marsh is 0.10 feet lower than the existing condition, setting the elevation at 4.9 as opposed to 5.0 feet. As shown in Figure 20, the bike path bridge does flood.

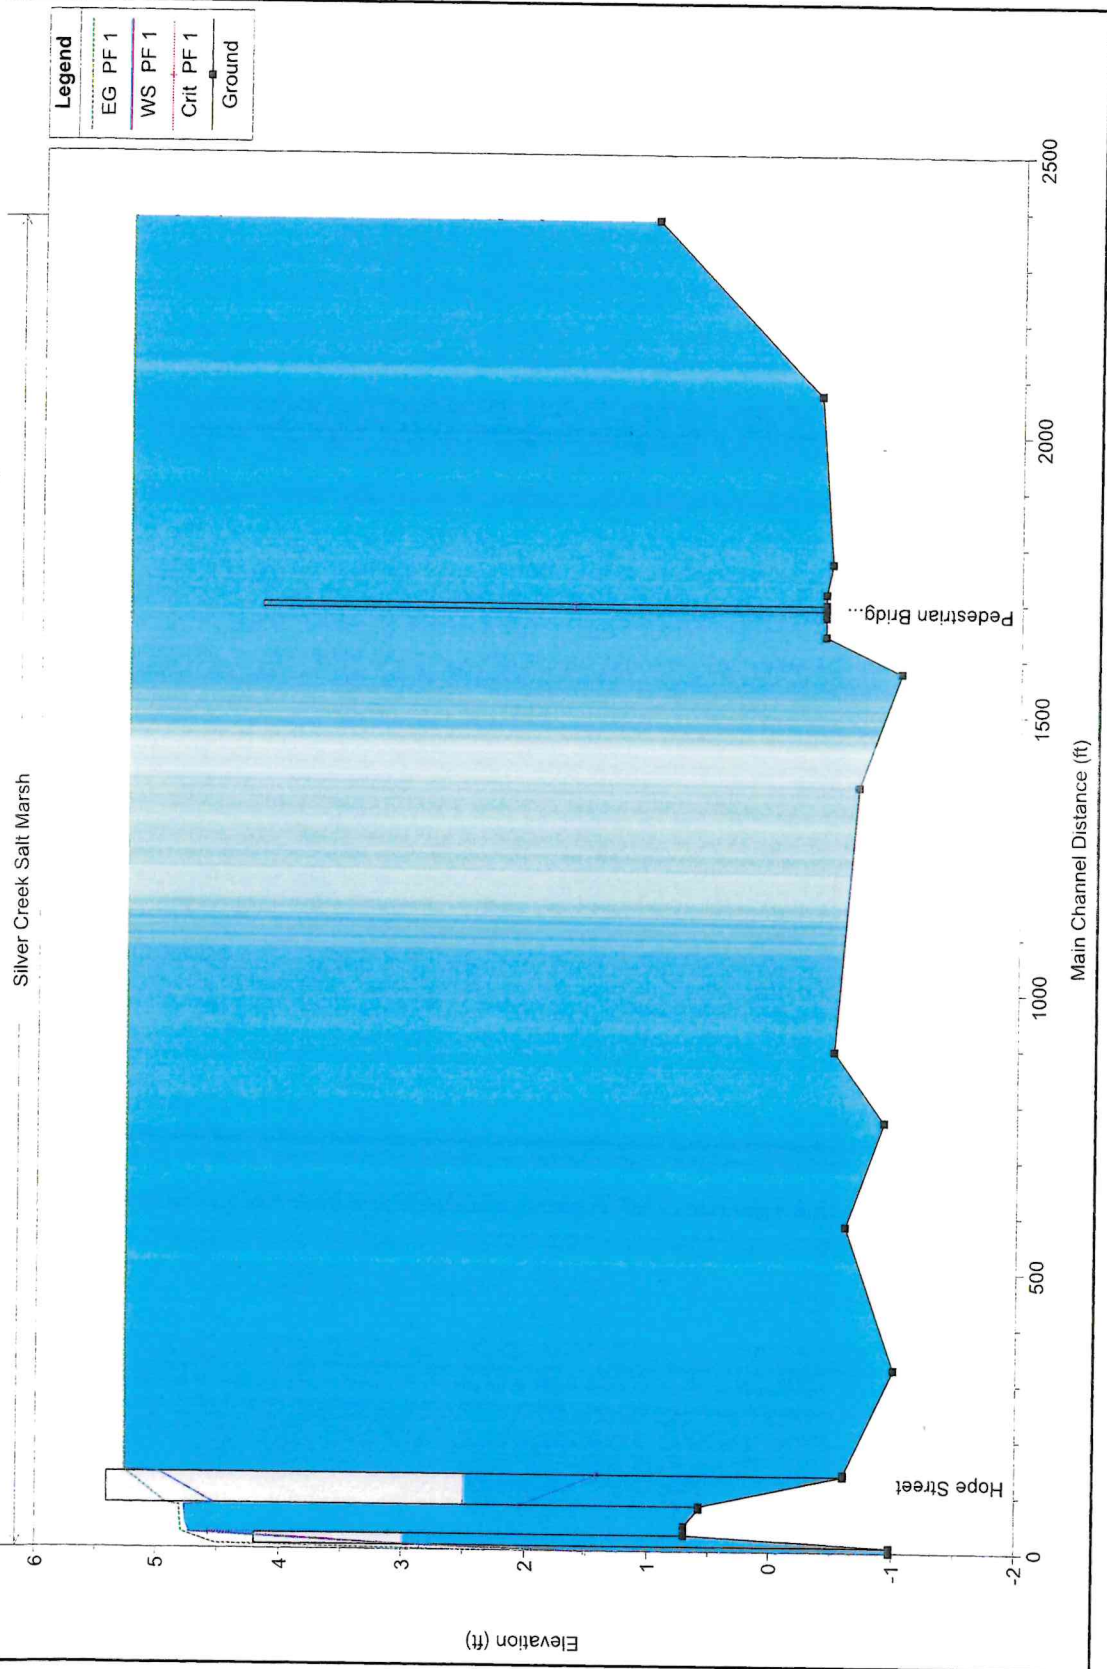
Geom: Marsh Sediment Removal Flow: 10 Year - No Tailwater Figure 21

As shown in Figure 21, the ten-year design storm without a tailwater condition does not overtop the bike path or Hope Street with the sediment removed. The level in the marsh does rise to 5.25 feet which is 0.05 feet above the existing condition elevation. When the tailwater condition is simulated, neither the bike path nor Hope Street are overtopped and therefore neither structure acts as a weir and the culverts are restrictions. This causes the water surface elevation in the marsh to rise to 5.74 feet which is 0.44 feet higher than the existing conditions. So Hope Street will not flood, but the level in the marsh will rise for a short period of time. This is also illustrated in Figure 22.

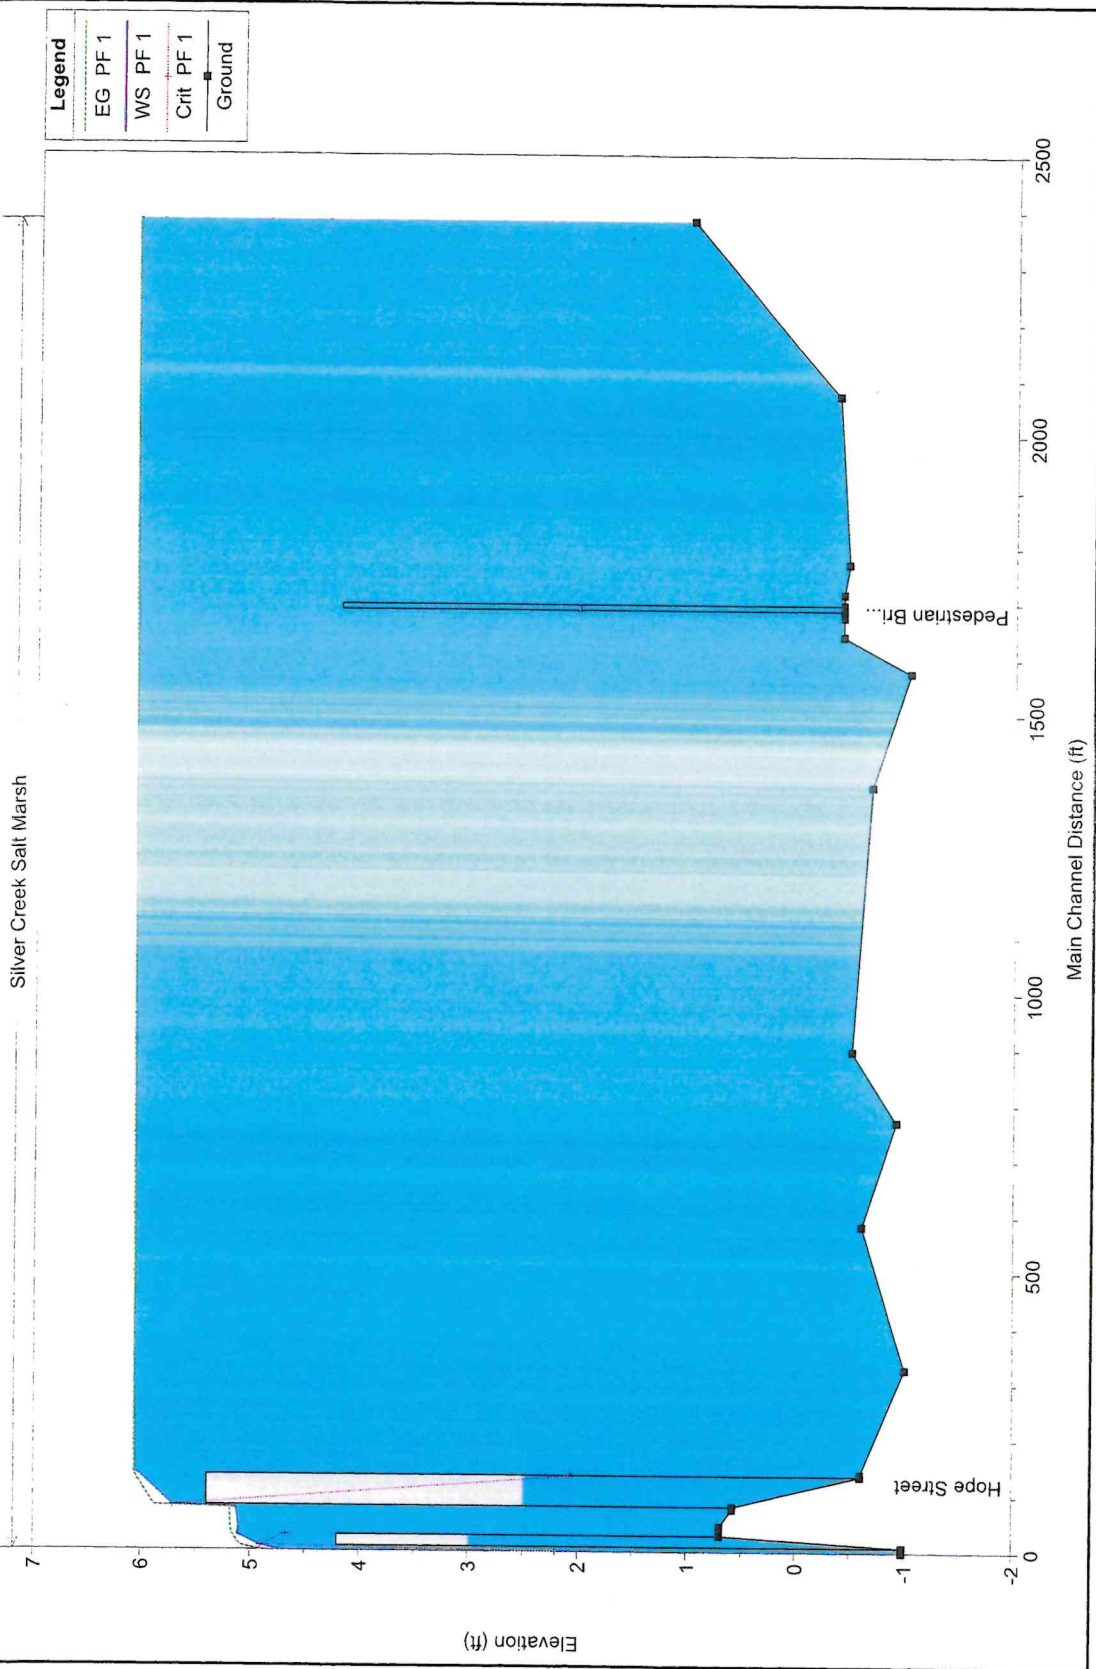
Silver Creek Plan: Sediment Removal 100 year  
Geom: Marsh Sediment Removal Figure 23

As shown in Figure 23, the flow from the one hundred-year design storm overtops the bike path and Hope Street. The water surface elevations are the same regardless of whether a tailwater condition was simulated. The elevation throughout the marsh is 6.07 feet which is 0.37 feet above the existing condition

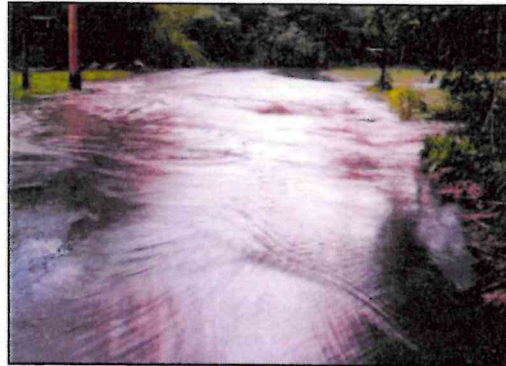
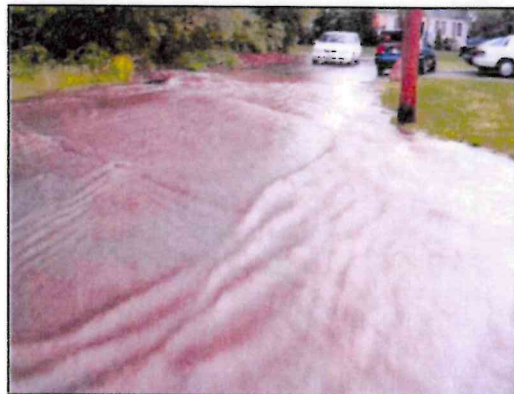
That issue aside, the runoff from the pond and other overland flow is directed to Elbow Street in a drainage channel, or as an intermittent stream, where it was designed to flow under Elbow Street to a wetland area north and west of the roadway. However, the existing 12" CMP under Elbow Street is crushed or collapsed, according to a report by Caputo and Wick, further reducing the capacity. The roadway is flat in this area, with a low point near the culvert. The stormwater runoff tops the roadway and flows across the pavement, as shown in the photographs.

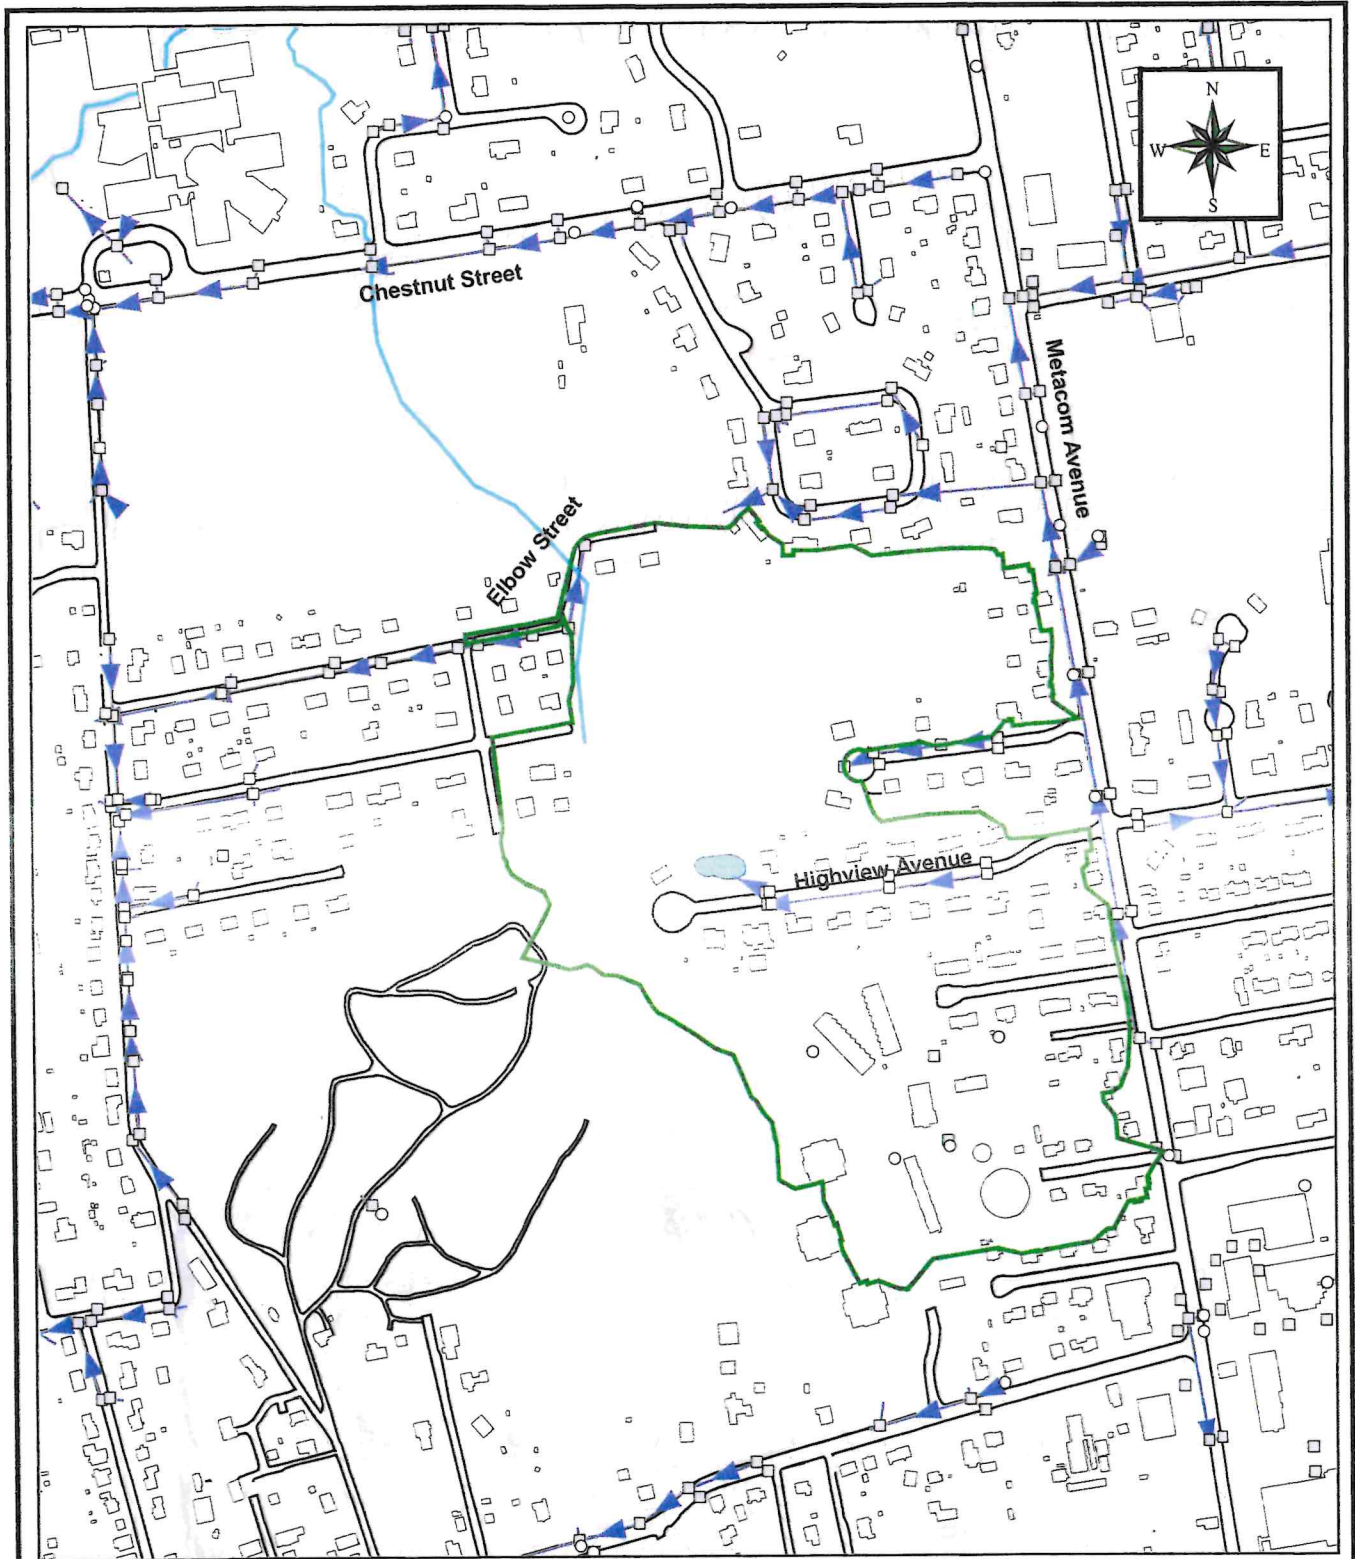
Elbow Street is an extension of Waterman Avenue, located east of Sherry Avenue. As shown in Figure 25, this 44-acre subwatershed area receives runoff from the south and east of Elbow Street, from Jane Lane, Highview Drive, Francesca Lane, Kennedy Court, Carr Lane and a portion of Hattie Brown Lane and King Street. A small detention pond was constructed at the end of Highview Drive. The pond was originally designed to retain the increase in runoff from the new subdivision only, and was not designed to detain the flows it is receiving from other areas upstream. This detention pond is discussed further in Area 4 – Highview Drive.

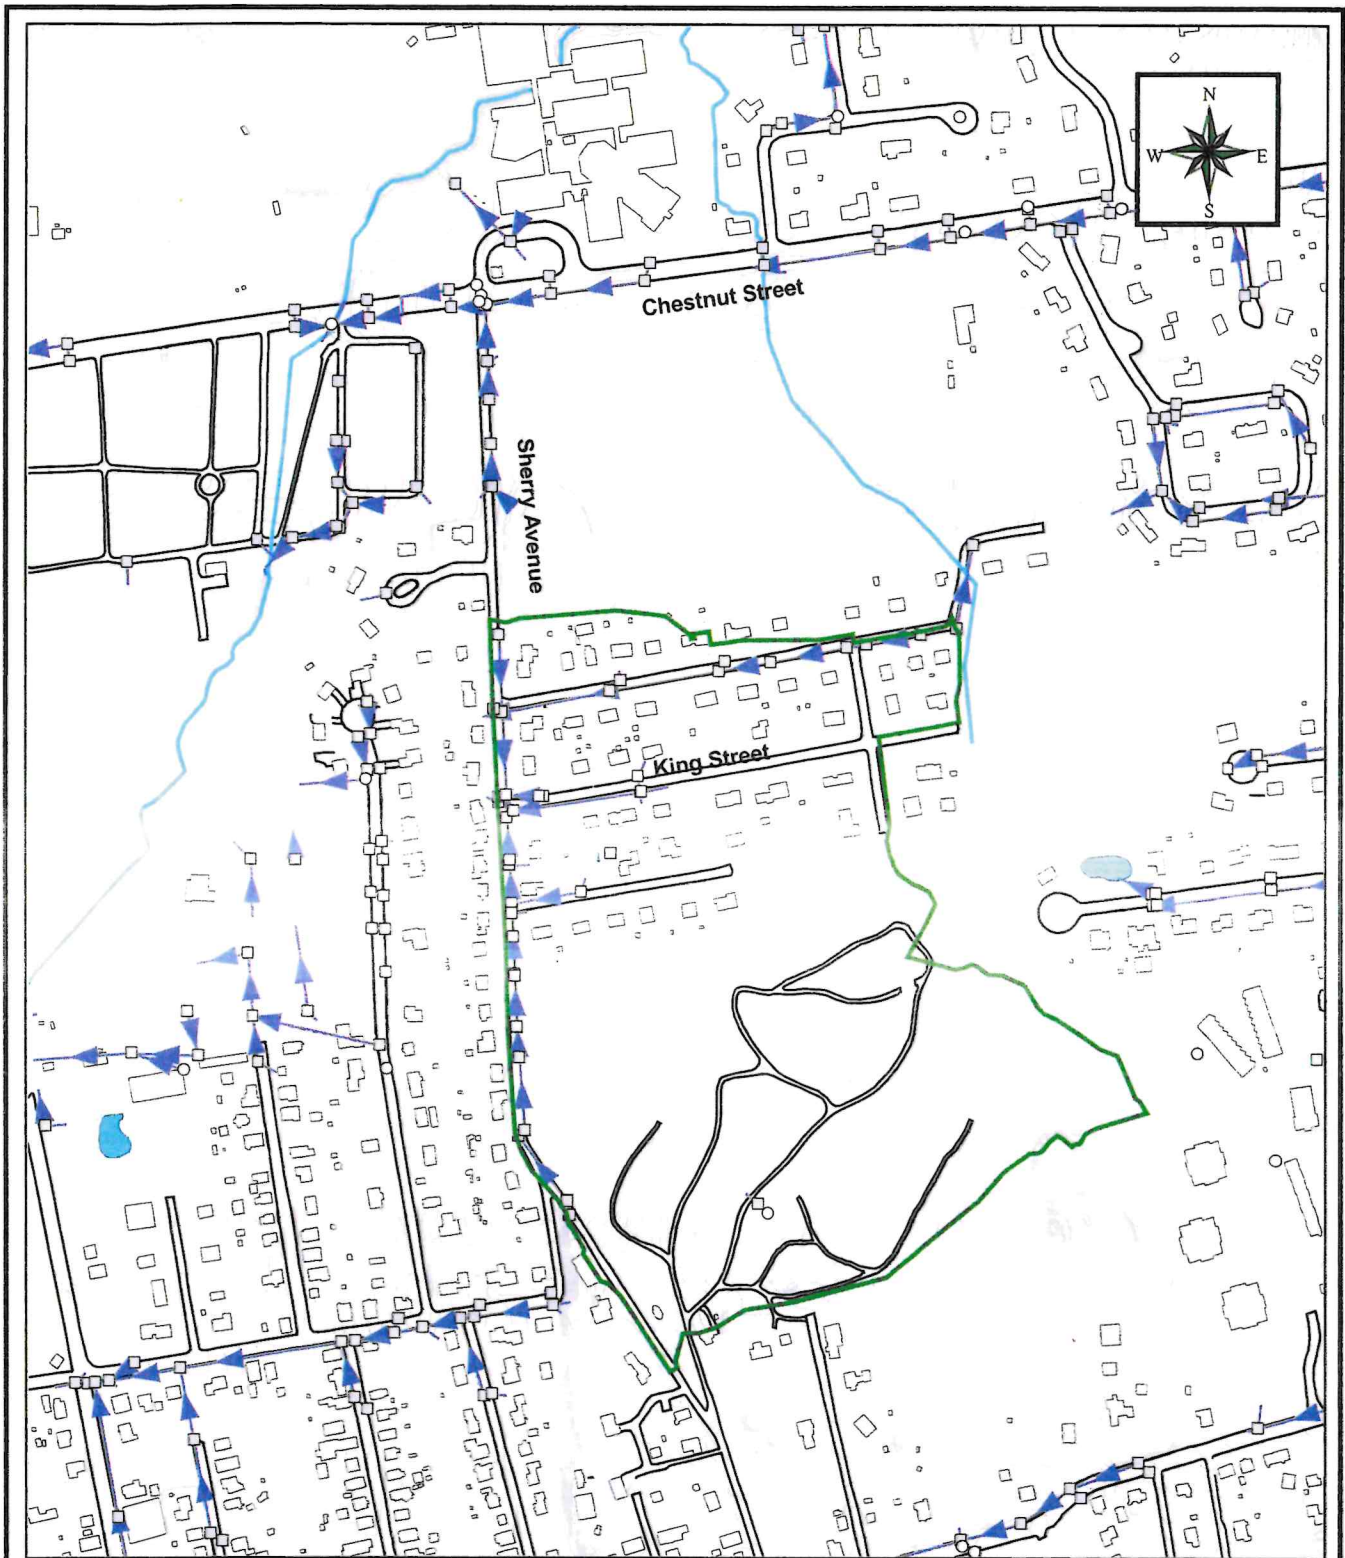
**Figure 26**

Sherry Avenue

Sherry Avenue is a north-south roadway which provides an alternate route to Wood Street and the downtown area from Chestnut Street (See Figure 26). Located opposite Mount Hope High School, it borders the Saint Mary Cemetery to the west, and town-owned land to the north. The remaining length of the roadway, from Silver Creek Court south is residential. There is a closed drainage system in Sherry

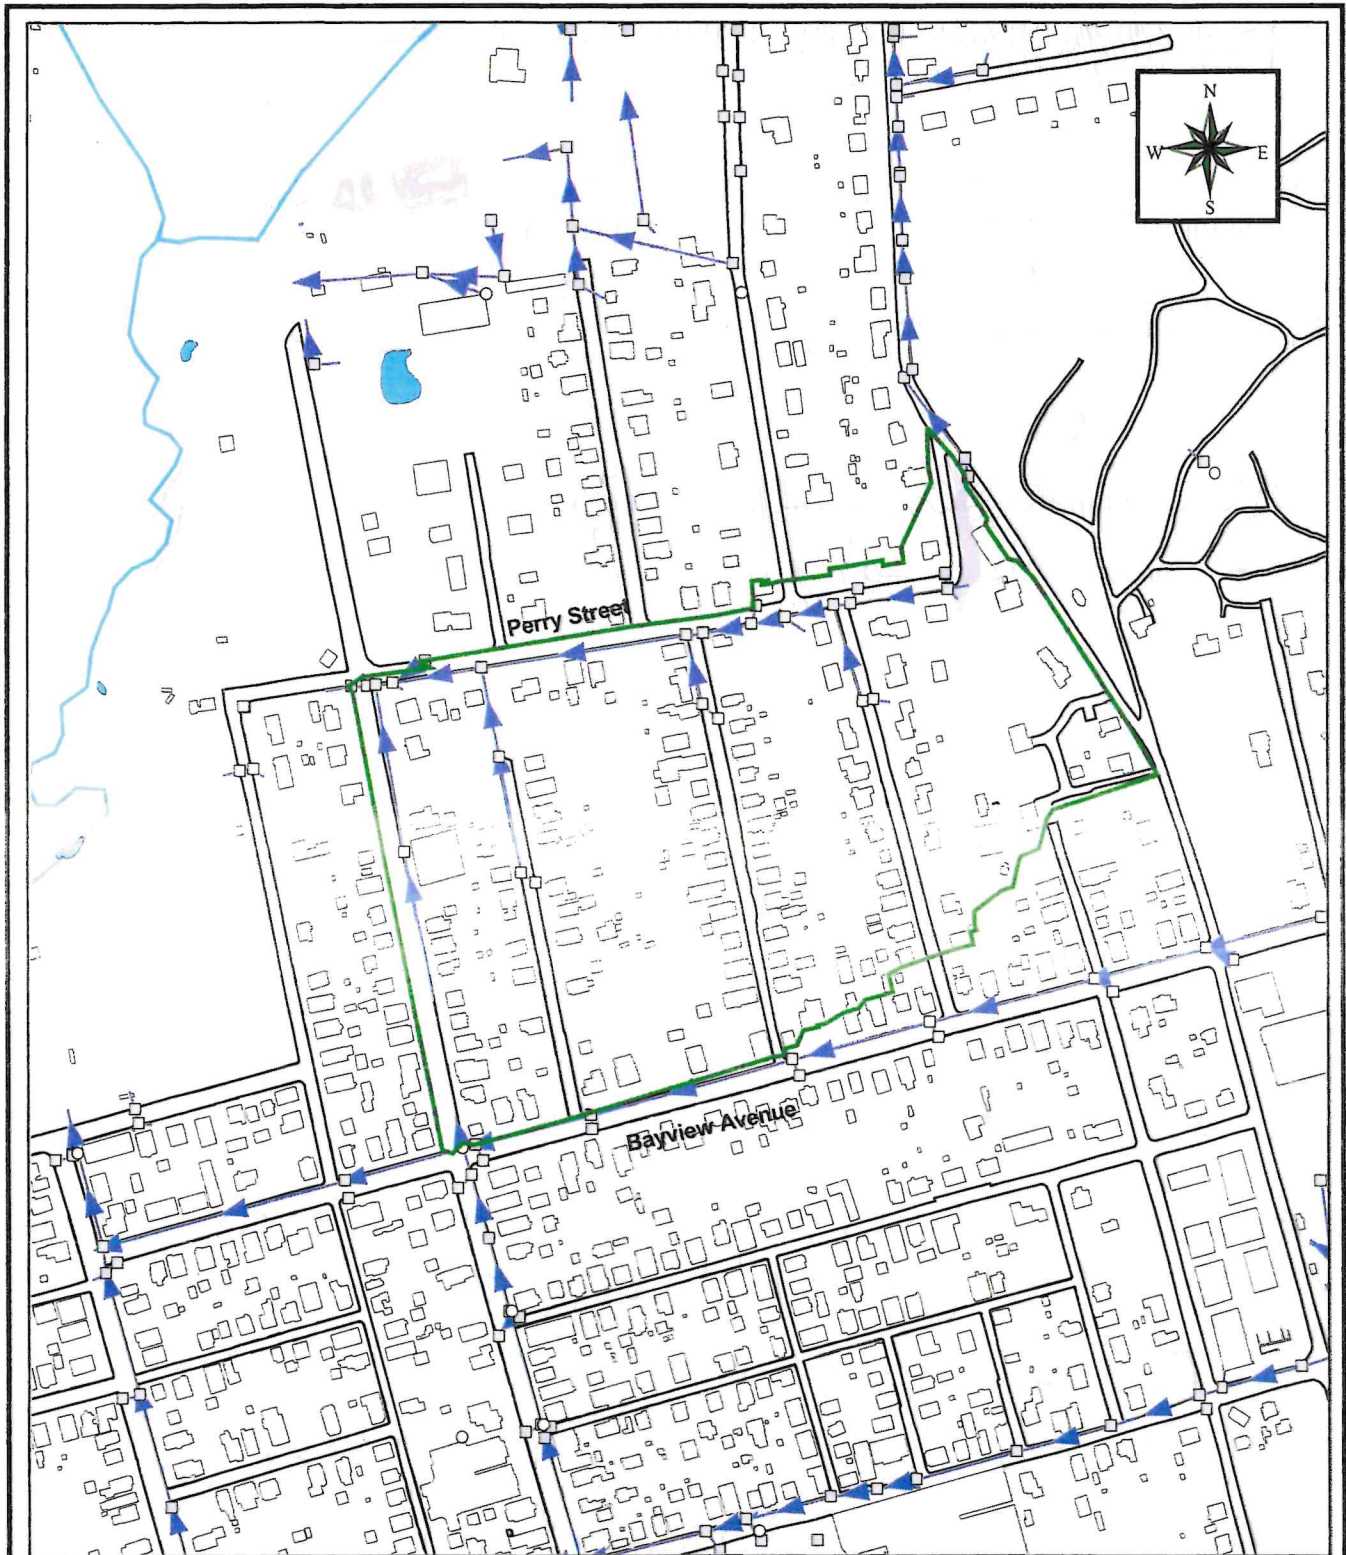
**Figure 27**  
 Perry Street

It is recommended that a new trunkline be installed on Perry Street, gradually increasing in size from an 18" pipe to the east, to a 30" RCP near the outfall at Monroe Avenue. The lateral pipes would be replaced, requiring 180 LF of 24" RCP, 770 LF of 18" RCP, and 300 LF of 12" RCP. New structures would be proposed incorporating high-capacity double grates where warranted on the steep grades and at low points. Bituminous berm or curbing is recommended along both sides of the roadway to channelize the flows and prevent flooding of adjacent properties. Catch basins would be located upstream of all intersections and crosswalks to minimize localized flooding. High capacity grates are needed to catch the flow, reducing the splash-over velocity due to the steepness of the roadway. As this is a residential area in close proximity to schools, an alternate grate to the RI standard high capacity grate could be selected which would not create a trip hazard.

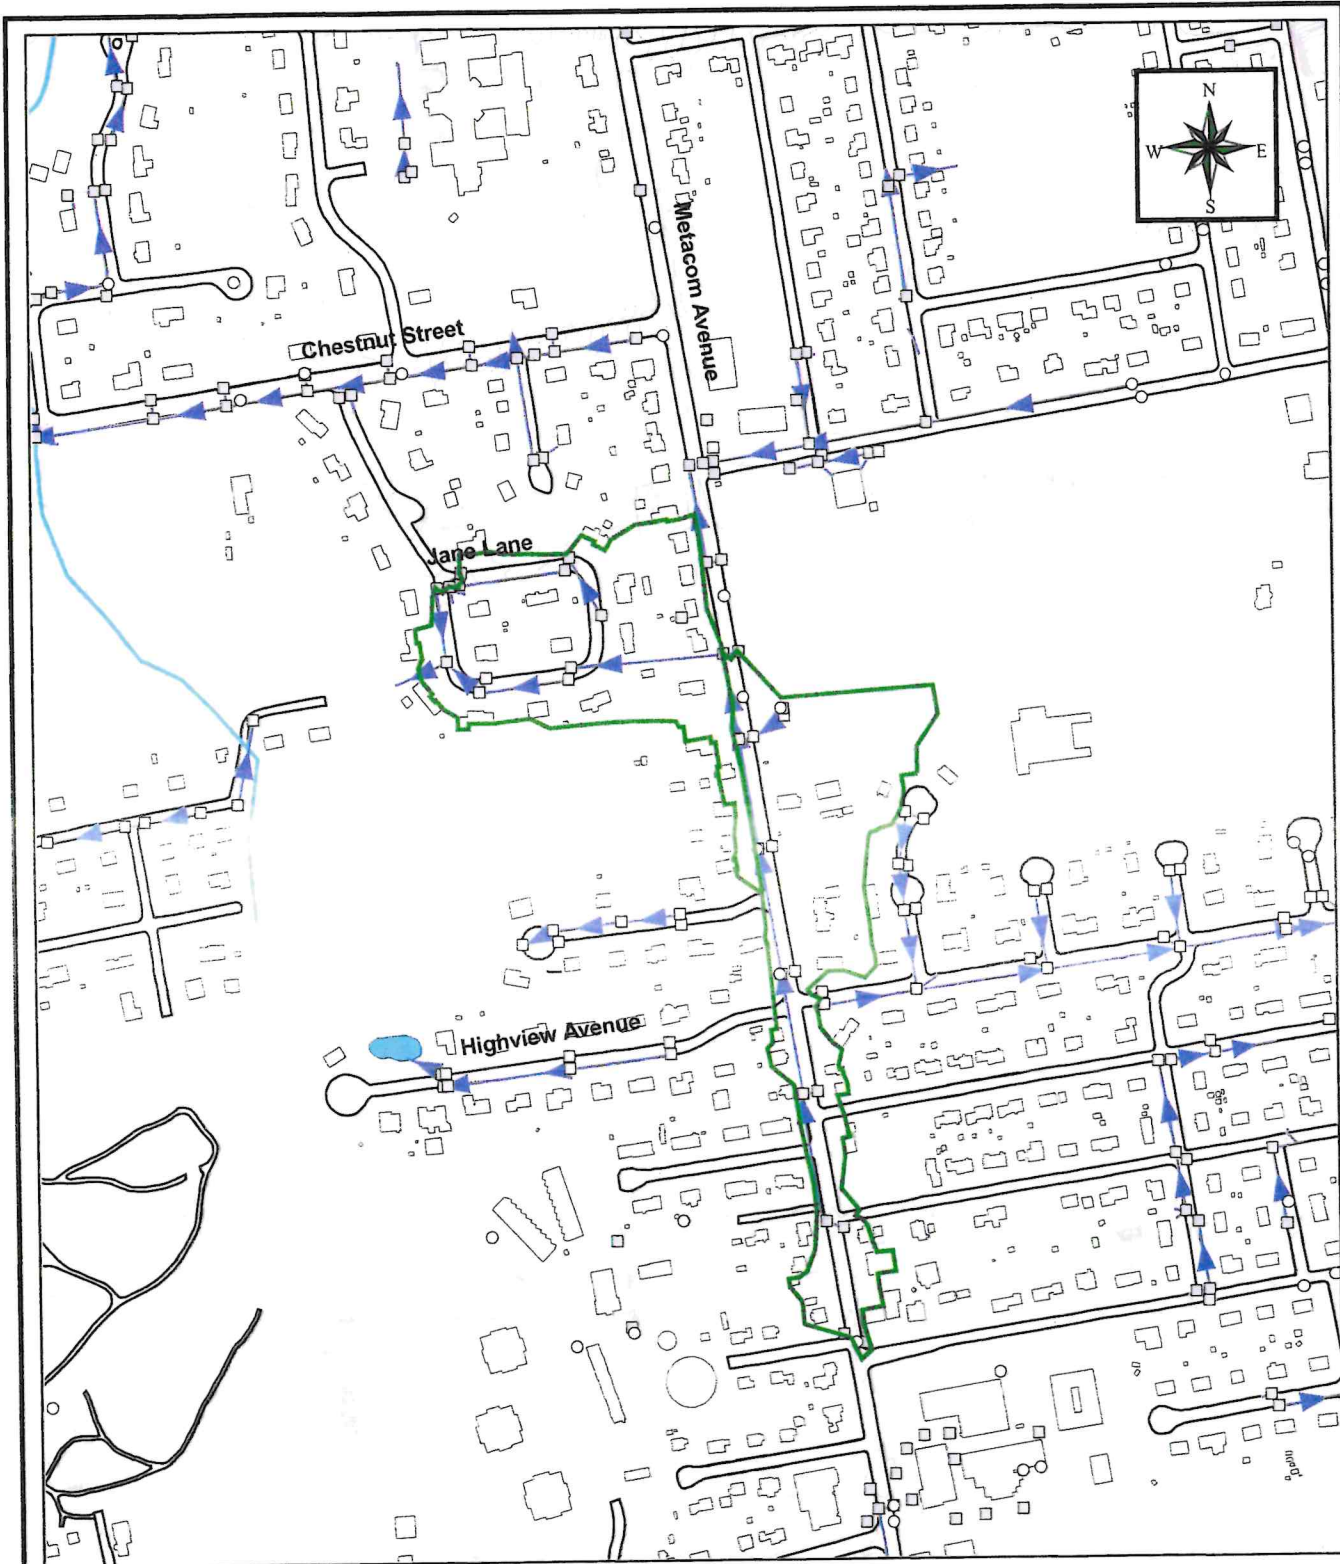
**Figure 29**  
 Jane Lane

As shown in Figure 29, Jane Lane is a looped roadway servicing approximately 20 homes off of Chestnut Street. The closed drainage system in Jane Lane is connected to the drainage system in Metacom Avenue (a State highway) via an 18" corrugated metal pipe. The flows from Metacom Avenue exceeds the pipe capacity for the 10 year storm by approximately 10%, yet the pipes in Jane Lane and connecting to Chestnut Street are insufficient to handle the 2 year storm, causing flooding within the subdivision. Also, our field inspections noted sump pumps connected to the catch basins with algae growth, indicating a chronic problem.

It is recommended that the pipes from Metacom Avenue be video-inspected to identify possible collapse of the CMP. It is recommended that the 18" CMP be replaced with an 18" RCP, which would provide increased capacity and structural soundness. Other pipes within the roadway should be upgraded to 18" RCP, and the outlet pipe discharging to the wetland east of Elbow Street should be a 24" RCP. These improvements should alleviate the flooding in this immediate area.
