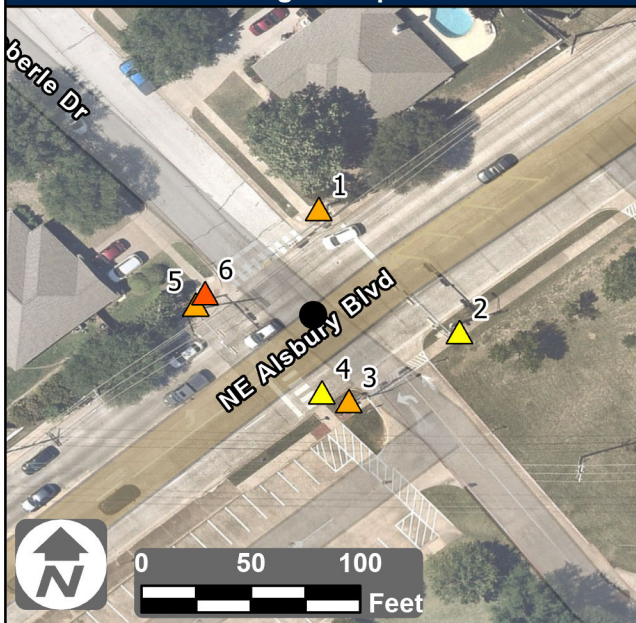
NE Alsbury Blvd & Heberle Dr

| | 1 | 2 | 3 | 4 | 5 | 6 | 7 | 8 | |
|---|---|---|---|---|---|---|---|---|---|
| Missing head symbol | | | X | | | X | | | Install countdown pedestrian signal head |
| Head does not show countdown | | X | | X | | | | | Install countdown pedestrian signal head |
| Missing adjacent button | X | | | X | | | | | Install adjacent pedestrian push button |
| Missing speech message | X | X | X | X | X | | | | Remove PBs and replace with APS push buttons |
| Push button height is greater than 48" | X | | X | | X | X | | | Relocate pedestrian push buttons |
| Running slope at push button is greater than 2.1% | X | | X | | X | X | | | Remove and replace clear floor space |
| Floor at push button is not firm or stable | | | | X | | | | | Remove and replace clear floor space |

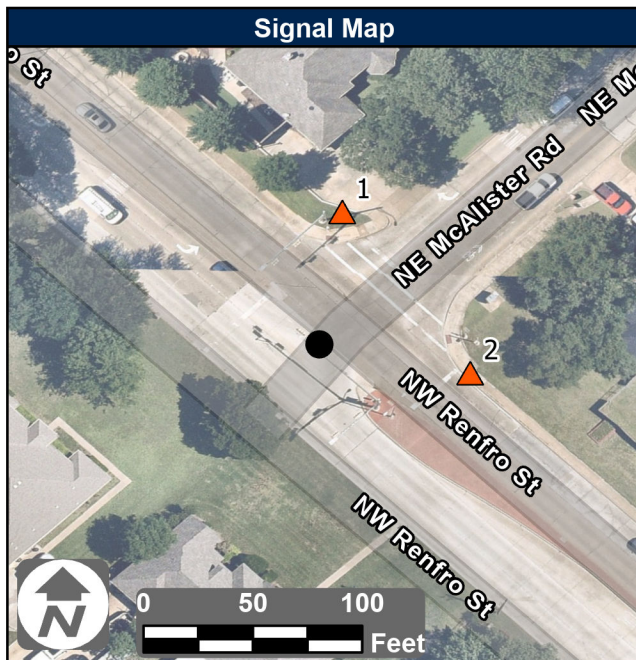
### NE McAlister Rd & NW Renfro St

| | 1 | 2 | 3 | 4 | 5 | 6 | 7 | 8 | |
|---|---|---|---|---|---|---|---|---|---|
| Missing adjacent button | X | X | | | | | | | Install adjacent pedestrian push button |
| Missing speech message | X | X | | | | | | | Remove PBs and replace with APS push buttons |
| Push button is missing band | X | X | | | | | | | Remove PBs and replace with APS push buttons |
| Cross slope at push button is greater than 2.1% | X | X | | | | | | | Remove and replace clear floor space |
| Floor at push button is not firm or stable | | X | | | | | | | Remove and replace clear floor space |

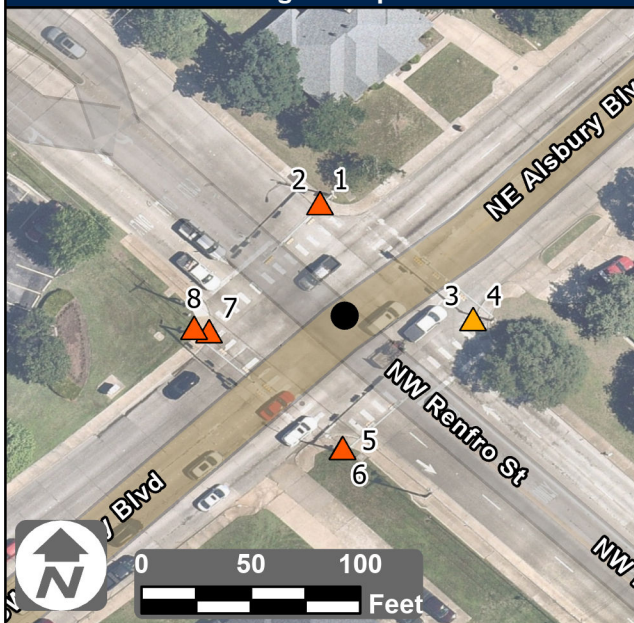
NW Renfro St & NE/SW Alsbury Blvd

| | 1 | 2 | 3 | 4 | 5 | 6 | 7 | 8 | |
|---|---|---|---|---|---|---|---|---|---|
| Missing speech message | X | | X | X | X | X | X | | Remove PBs and replace with APS push buttons |
| Push button is missing band | X | X | X | X | | X | X | X | Remove PBs and replace with APS push buttons |
| Push button is missing locator tone | X | X | X | X | X | X | X | X | Remove PBs and replace with APS push buttons |
| Running slope at push button is greater than 2.1% | X | X | X | X | X | | | X | Remove and replace clear floor space |
| Cross slope at push button is greater than 2.1% | | | | | | | X | X | Remove and replace clear floor space |

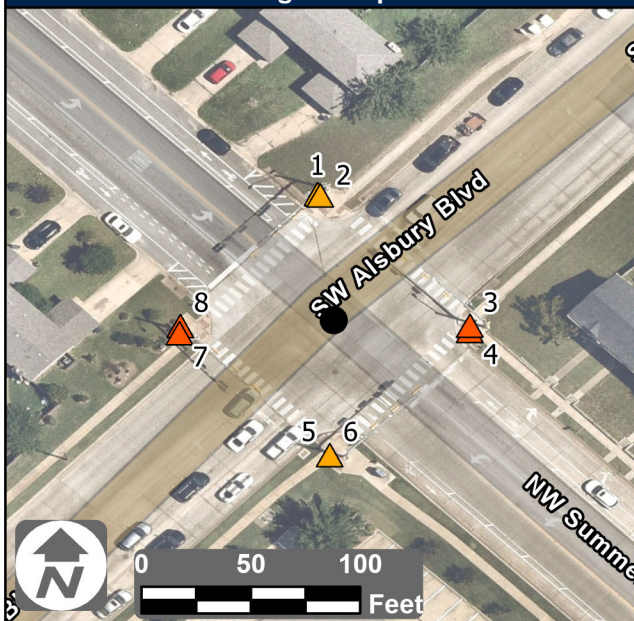
### SW Alsbury Blvd & NW Summercrest Blvd

| | 1 | 2 | 3 | 4 | 5 | 6 | 7 | 8 | |
|---|---|---|---|---|---|---|---|---|---|
| Missing adjacent button | | | | | | | X | | Install adjacent pedestrian push button |
| Missing speech message | X | X | | X | | X | X | X | Remove PBs and replace with APS push buttons |
| Push button is missing band | X | X | X | X | X | X | X | X | Remove PBs and replace with APS push buttons |
| Cross slope at push button is greater than 2.1% | | | X | X | | | | X | Remove and replace clear floor space |

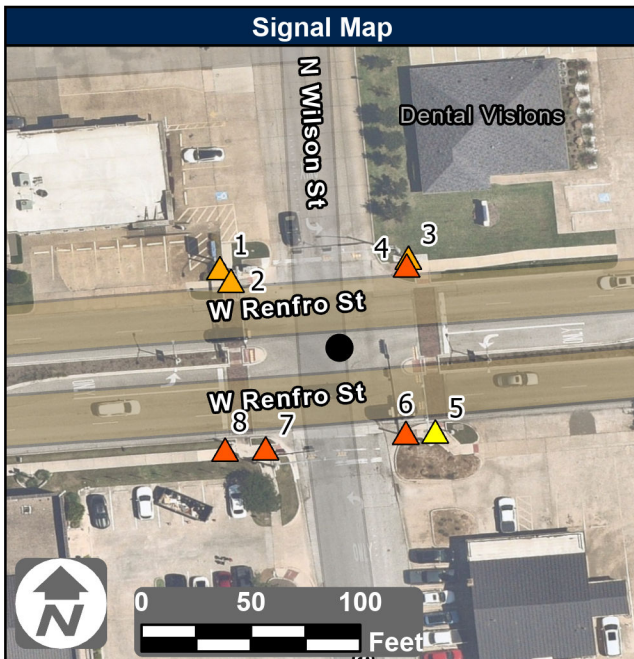
W Renfro St & S Wilson St

| | 1 | 2 | 3 | 4 | 5 | 6 | 7 | 8 | |
|---|---|---|---|---|---|---|---|---|---|
| Missing speech message | X | X | X | X | X | X | X | X | Remove PBs and replace with APS push buttons |
| Push button is missing band | X | X | X | X | X | X | X | X | Remove PBs and replace with APS push buttons |
| Running slope at push button is greater than 2.1% | X | | | X | X | | | | Remove and replace clear floor space |
| Cross slope at push button is greater than 2.1% | | | | | | X | X | | Remove and replace clear floor space |

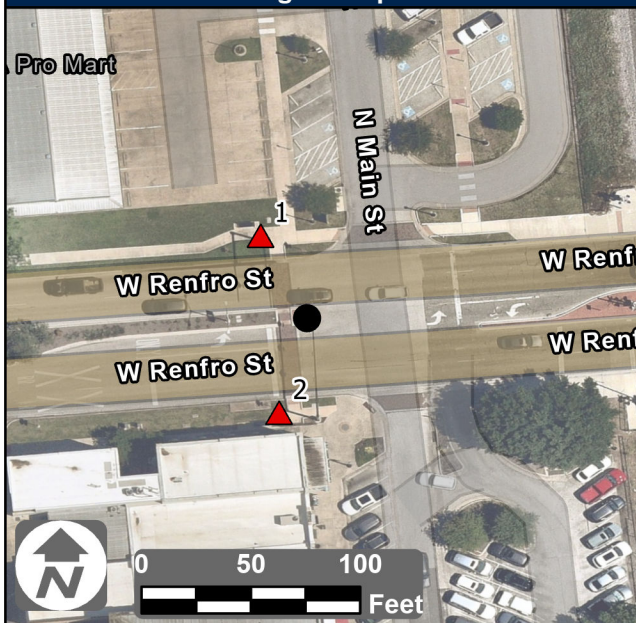
### N Main St & W Renfro St

| | 1 | 2 | 3 | 4 | 5 | 6 | 7 | 8 | |
|---|---|---|---|---|---|---|---|---|---|
| Missing signal head | X | X | | | | | | | Install countdown pedestrian signal head |
| Missing head symbol | X | X | | | | | | | Install countdown pedestrian signal head |
| Missing adjacent button | X | X | | | | | | | Install adjacent pedestrian push button |
| Missing speech message | X | X | | | | | | | Remove PBs and replace with APS push buttons |
| Cross slope at push button is greater than 2.1% | | X | | | | | | | Remove and replace clear floor space |

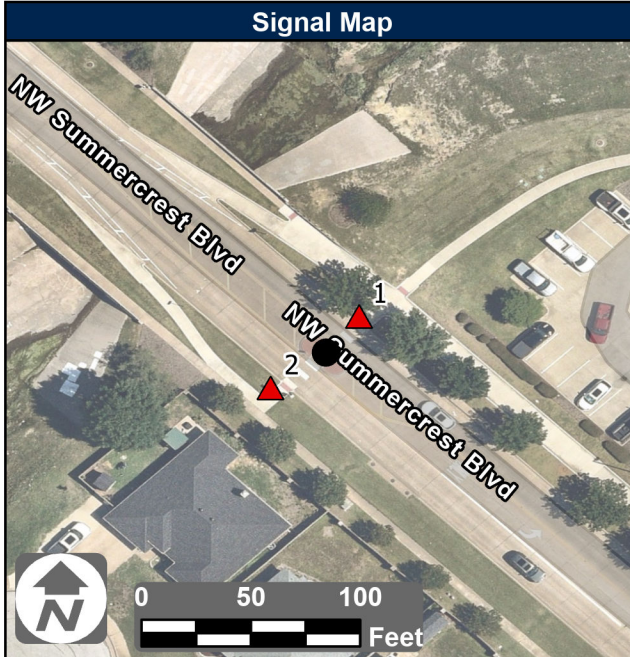
N Midblock of NW Summercrest Blvd

| | 1 | 2 | 3 | 4 | 5 | 6 | 7 | 8 | |
|---|---|---|---|---|---|---|---|---|---|
| Missing signal head | X | X | | | | | | | Install countdown pedestrian signal head |
| Missing head symbol | X | X | | | | | | | Install countdown pedestrian signal head |
| Missing adjacent button | X | X | | | | | | | Install adjacent pedestrian push button |
| Missing speech message | X | X | | | | | | | Remove PBs and replace with APS push buttons |
| Push button does not have sufficient clear floor length | | X | | | | | | | Remove and replace clear floor space |
| Running slope at push button is greater than 2.1% | | X | | | | | | | Remove and replace clear floor space |

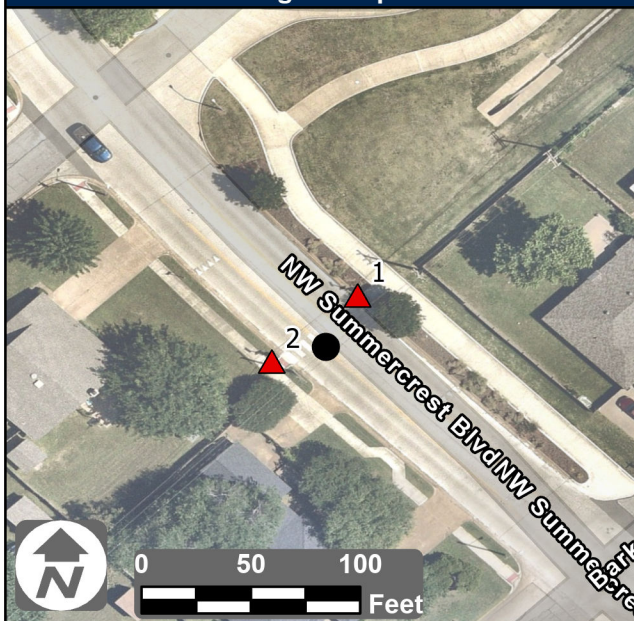
**S Midblock of NW Summercrest Blvd**

| | 1 | 2 | 3 | 4 | 5 | 6 | 7 | 8 | |
|---|---|---|---|---|---|---|---|---|---|
| Missing signal head | X | X | | | | | | | Install countdown pedestrian signal head |
| Missing head symbol | X | X | | | | | | | Install countdown pedestrian signal head |
| Missing adjacent button | X | X | | | | | | | Install adjacent pedestrian push button |
| Missing speech message | X | X | | | | | | | Remove PBs and replace with APS push buttons |
| Running slope at push button is greater than 2.1% | X | X | | | | | | | Remove and replace clear floor space |

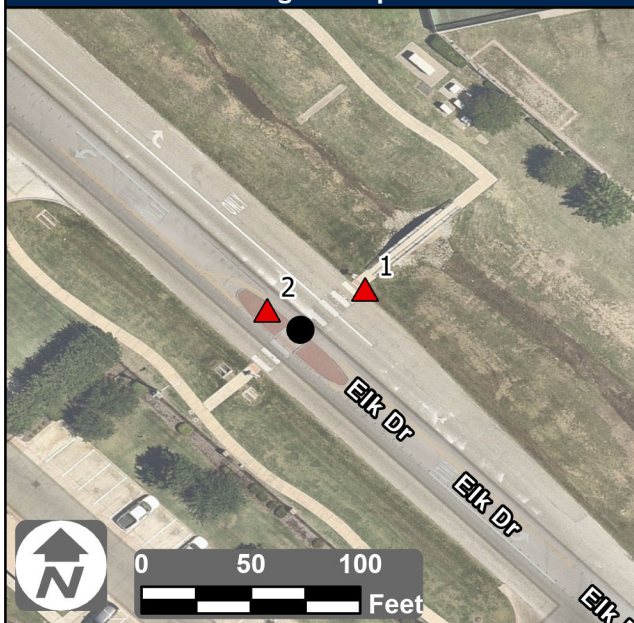
Midblock of Elk Dr

| | 1 | 2 | 3 | 4 | 5 | 6 | 7 | 8 | |
|---|---|---|---|---|---|---|---|---|---|
| Missing signal head | X | X | | | | | | | Install countdown pedestrian signal head |
| Missing adjacent button | X | X | | | | | | | Install adjacent pedestrian push button |
| Missing speech message | X | X | | | | | | | Remove PBs and replace with APS push buttons |
| Running slope at push button is greater than 2.1% | | X | | | | | | | Remove and replace clear floor space |

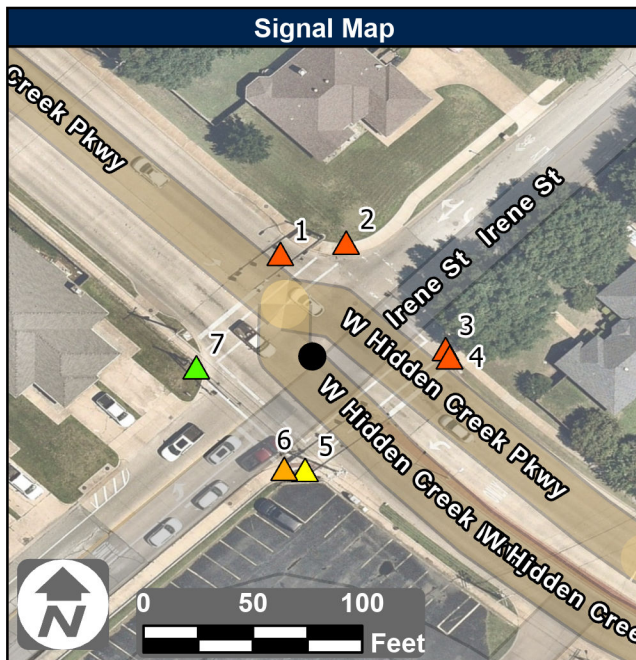
W Hidden Creek Pkwy & Irene St

| | 1 | 2 | 3 | 4 | 5 | 6 | 7 | 8 | |
|---|---|---|---|---|---|---|---|---|---|
| Push button is missing band | X | X | X | X | X | X | X | | Remove PBs and replace with APS push buttons |
| Push button arrow contrasting missing | | | | | X | | | | Remove PBs and replace with APS push buttons |
| Push button does not have sufficient clear floor length | | | X | | | | | | Remove and replace clear floor space |
| Running slope at push button is greater than 2.1% | | | | X | X | X | | | Remove and replace clear floor space |
| Cross slope at push button is greater than 2.1% | X | | | X | | | | | Remove and replace clear floor space |

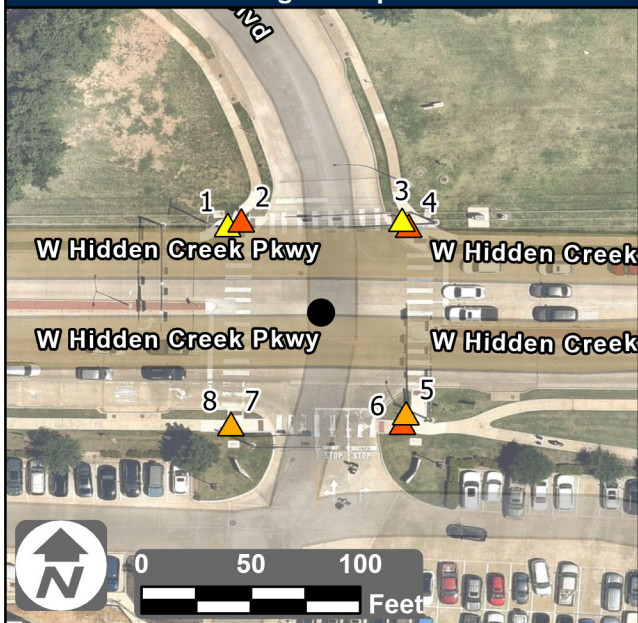
### W Hidden Creek Pkwy & SE Gardens Blvd

| | 1 | 2 | 3 | 4 | 5 | 6 | 7 | 8 | |
|---|---|---|---|---|---|---|---|---|---|
| Missing adjacent button | X | | | | | | | | Install adjacent pedestrian push button |
| Push button is missing band | X | X | X | X | X | X | X | X | Remove PBs and replace with APS push buttons |
| Running slope at push button is greater than 2.1% | | | | | X | | | | Remove and replace clear floor space |
| Cross slope at push button is greater than 2.1% | | X | | | | | | | Remove and replace clear floor space |

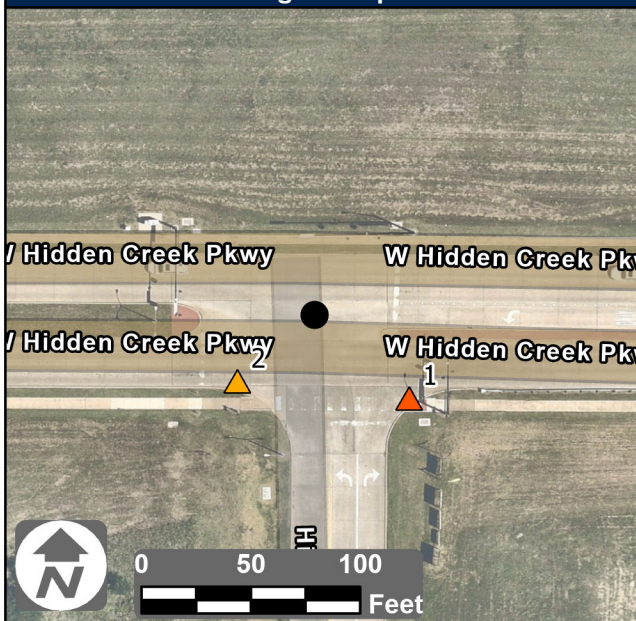
**W Hidden Creek Pkwy & Hidden Vistas Blvd**

| Issue | Map Feature Number | | | | | | | | Possible Solution |
|---|---|---|---|---|---|---|---|---|---|
| Missing adjacent button | X | X | | | | | | | Install adjacent pedestrian push button |
| Push button is missing band | X | X | | | | | | | Remove PBs and replace with APS push buttons |
| Cross slope at push button is greater than 2.1% | X | | | | | | | | Remove and replace clear floor space |
