INDOOR POOL SLIDE AND STAIR TOWER

CITY COUNCIL-APRIL 7, 2025

STRUCTURAL ENGINEER INITIAL DRAFT REPORT: FREESE AND NICHOLS OBSERVATIONS

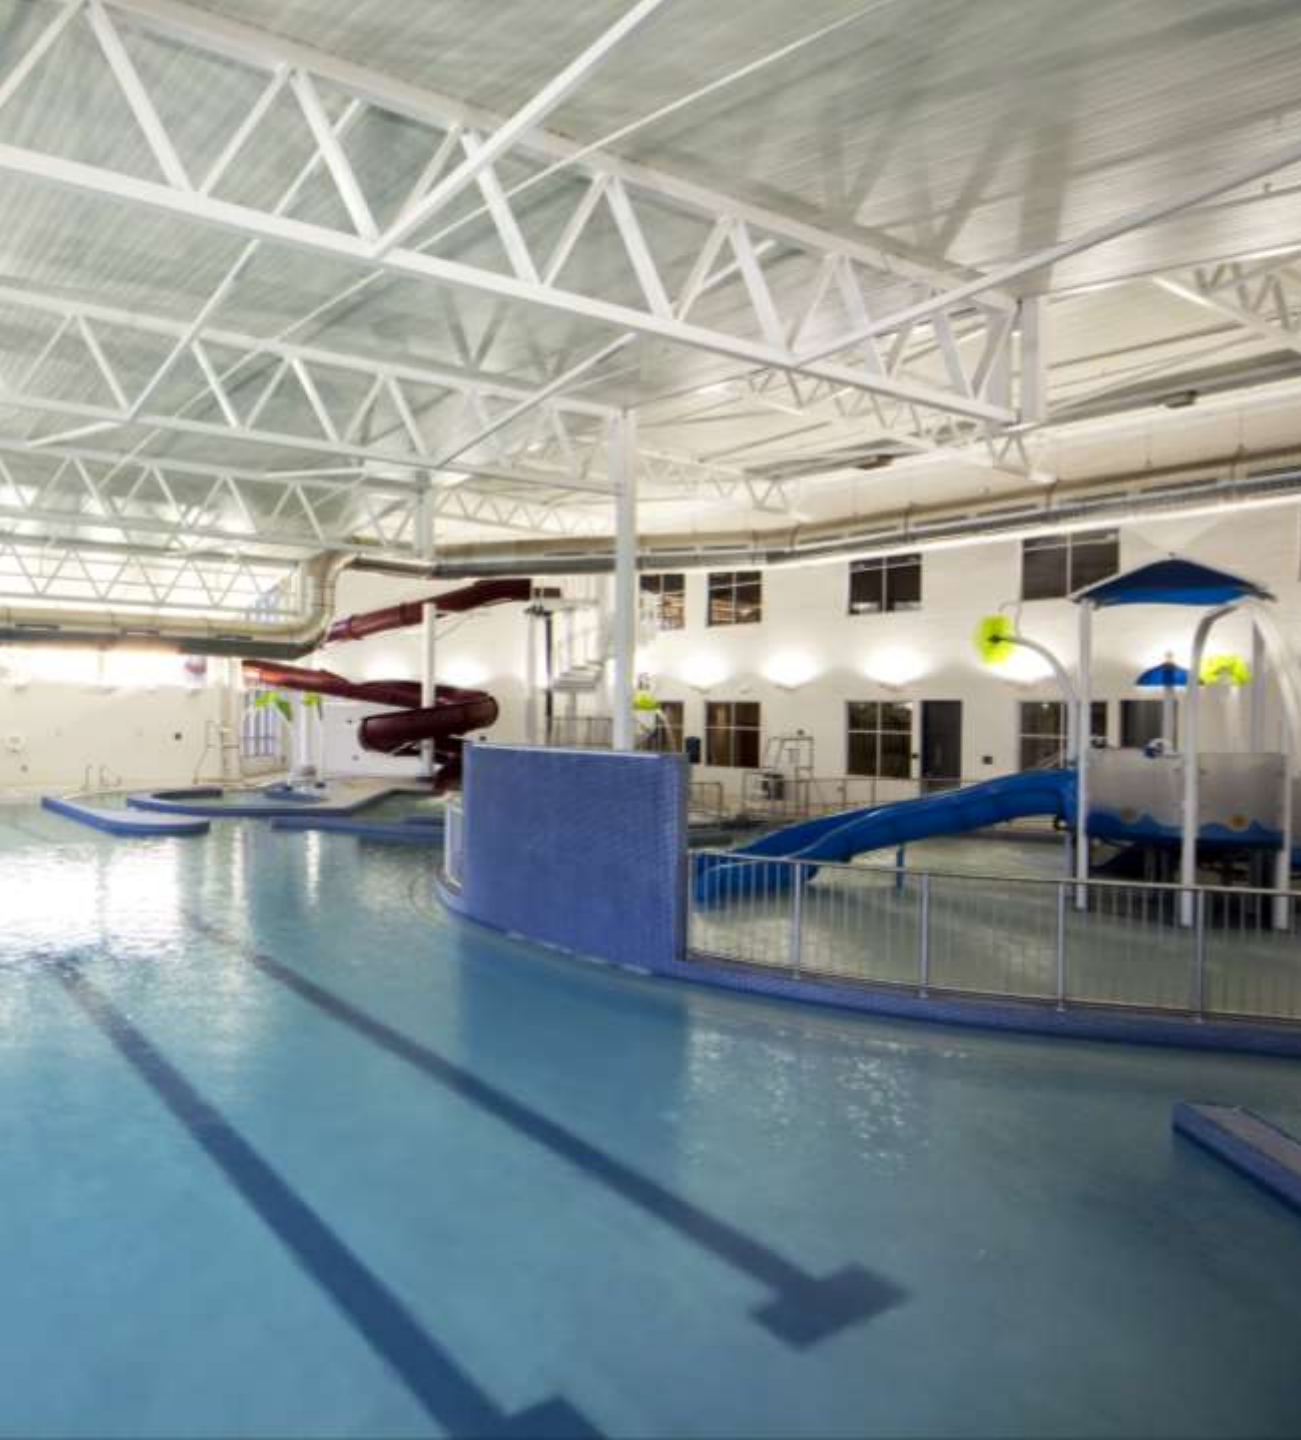
- Staff contacted the manufacturer to obtain their recommendations for **remediation**. The manufacturer provided a recommendation of refurbishment based on submitted photos. A subsequent in-person inspection occurred on March 25. The information presented to park board was based on the virtual inspection **utilizing** submitted photos.

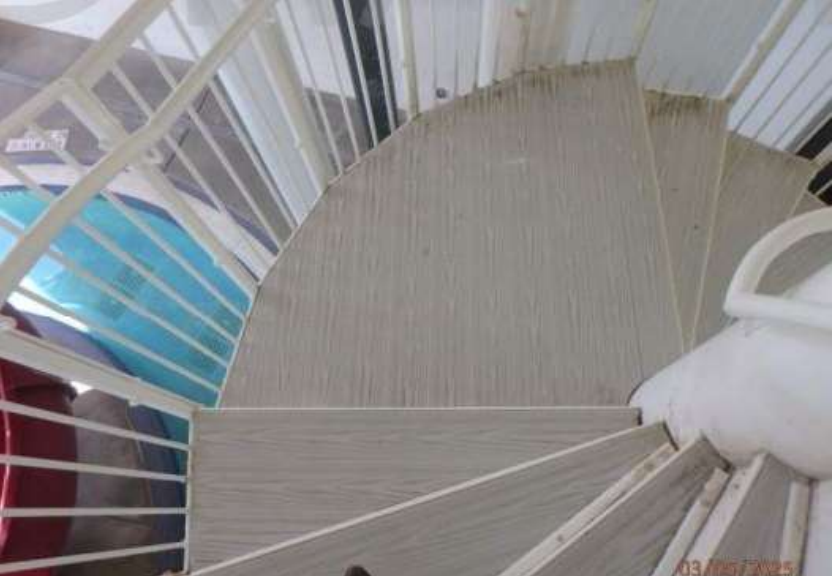
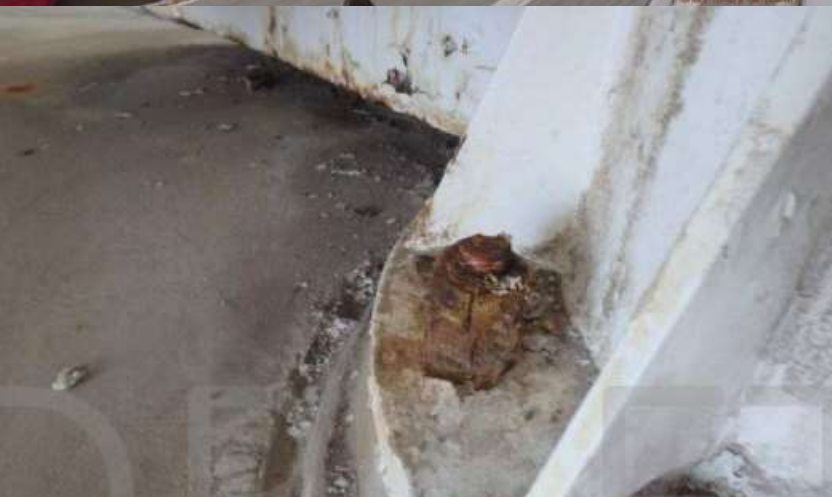
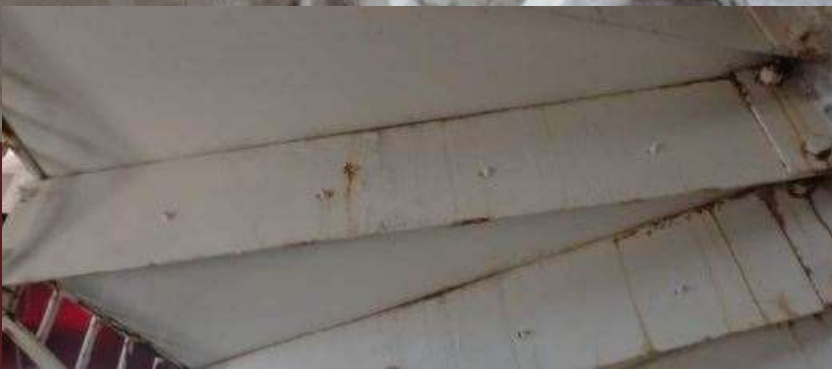
- The most visually obvious rust staining originated at the top of the rises at the contact point with the tread pans. While highly visible, the corrosion was not a significant structural concern.

- In general, the bolts appeared to be very corroded and a close second in terms of visual impact.
- Some localized heavy corrosion and scaling was observed on the face of a few risers.

- **Most of the corrosion on the staircase appeared to be due to pool water cascading down the structure from the upper platform.**
- Evidence for this conclusion area as follows:

- Surface mineral deposits not observed on other structures.
 - The general lack of corrosion below the landings in areas protected from cascading water.

- The general lack of similar corrosion for other steel structures in the vicinity which were exposed to the same atmosphere but no direct water exposure.

- The galvanized and non-galvanized pipe supports below the upper landing were heavily corroded.
 - *This supports staff's initial findings that the stairs degradation is due to design and not to maintenance protocols historically utilized.

None of the observed corrosion appeared to present an immediate concern for structural integrity or safety. The structure is in need of maintenance and a new coating.

Either recoat or replace the staircase.

- If possible, all of the circulated water at the upper landing should be made to enter a drain.
 - *This is a new recommendation that staff will be pursuing regardless of decision to repair or replace.

- In general, bolts should be replaced before the face of the bolts begins to scale off.
- Consider replacement with a more corrosion resistant material. Bolt head markings were not visible during my site visit but should be verified by removing the coating. If the bolts are not high-strength, consider replacement with Type 316 stainless steel. If high-strength bolts were used, the bolts should be replaced in kind but should be hot-dip galvanized.

- The bolts at the upper landing guardrail appeared to have significant exposure and significant corrosion inside the post. While the guardrails did not have signs of incipient bolt failure, we recommend bolt removal for inspection and replacement as appropriate.

- When recoating, the treads should be removed to improve the surface preparation and coating between the treads and risers.
- Replace the heavily corroded galvanized pipe supports below the upper landing.

- Replace the bolts between the risers and the central column with welds.
- Insert a neoprene or plastic strip between the risers and tread pans to reduce coating damage due to foot traffic.

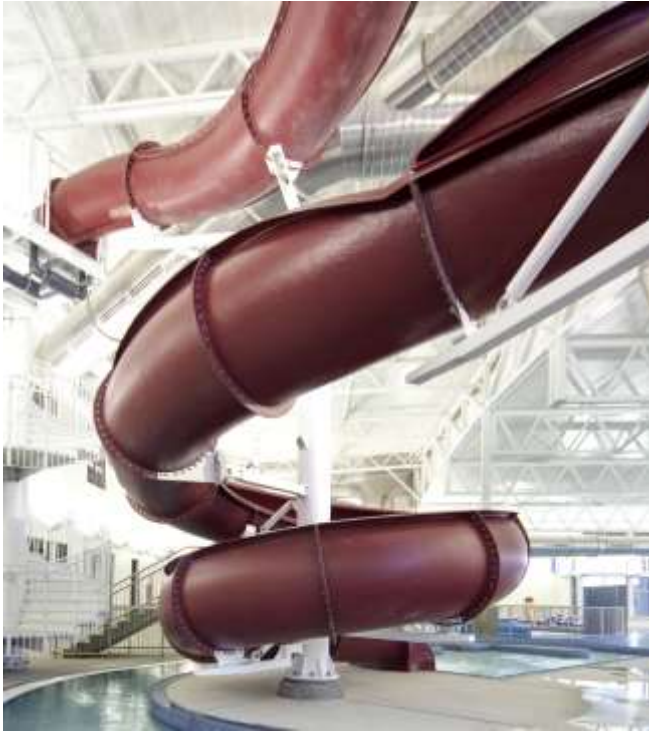
Daily:

Inspect before & after pumps are turned on (address deficiencies immediately)

NEW: Utilize preventative rust chemical (currently researching this option)

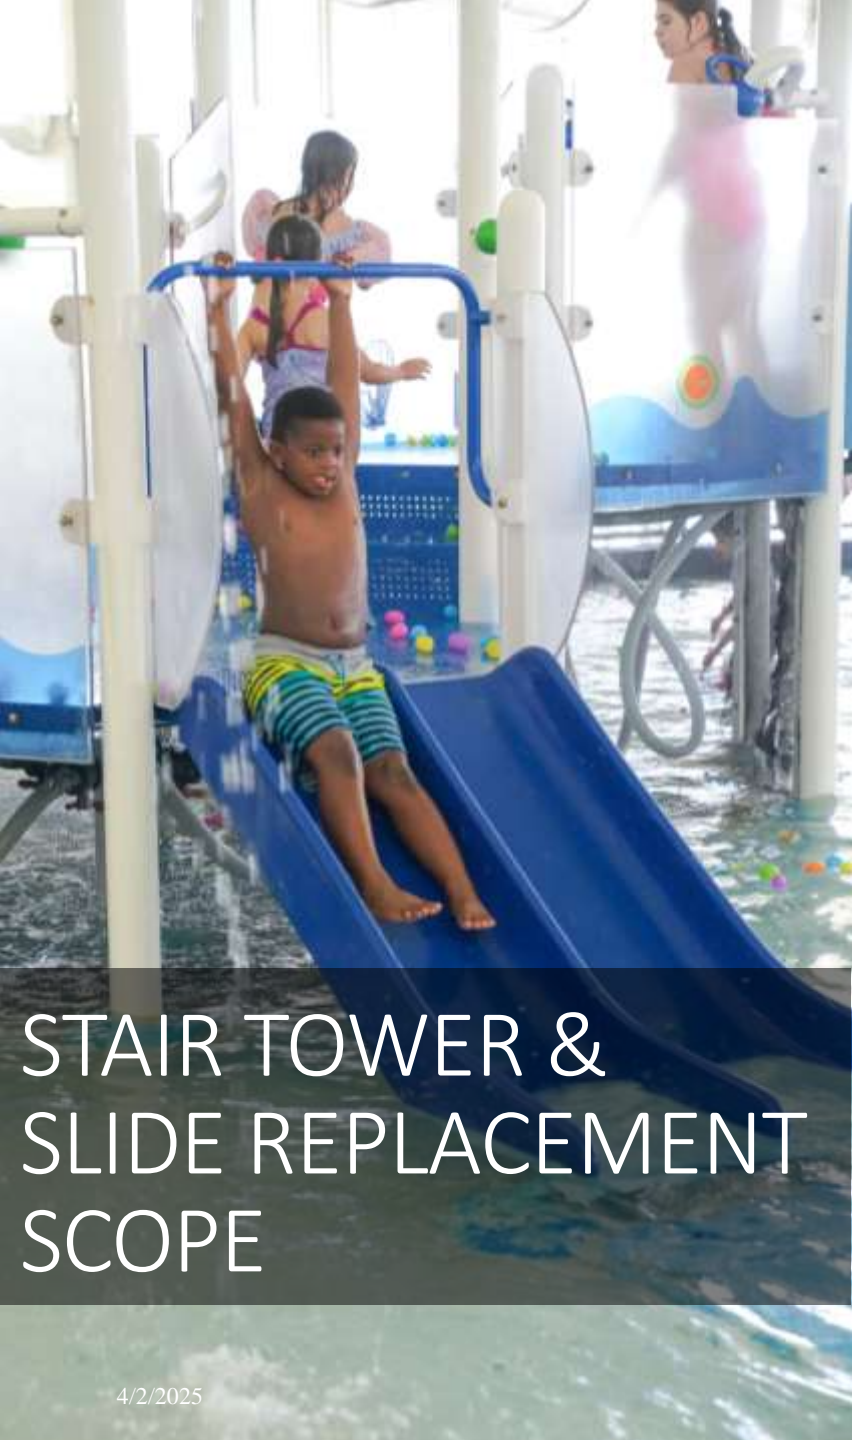
STAIR TOWER &
SLIDE REPLACEMENT
SCOPE

Scope	Splashtacular	SafeSlide
Demo entire steel support tower and fiberglass slide to include haul off	X	X
Install new steel support tower of same design, height, and ride path on existing foundations design/engineered by Splashtacular	X	X
Install new fiberglass slide of same design, height, length, and ride path on existing foundations design/engineered by Splashtacular	X	X
Includes lift equipment and freight	X	X

In all scopes, the new Smart Tread design will resolve the drainage issue raised by the structural engineer.
