Overview

Background

- Cemetery expansion opened May 23, 2023
- Irrigation system and fountain are fed by ground well pump that feeds into irrigation pond southeast of the cemetery
 - Over last few weeks, irrigation system has failed multiple times due to siltation from pond being pulled from pump causing pump to clog and trip.
 - Failure of irrigation system due to pump tripping including exceedingly high temperatures has led to newly planted landscaping dying
 - Recent concerns have been raised by staff and patrons over the odor and murkiness of water in the ornamental fountain due water being supplied by well

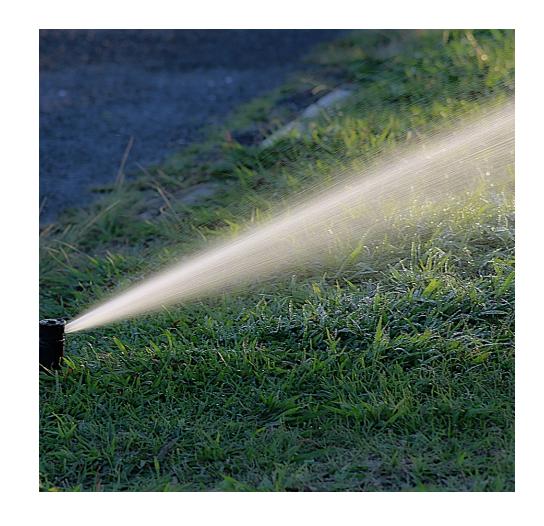
Cemetery Irrigation Challenges

- System was not completing irrigation cycles and was shutting down due to pump clogging with silt and fill sensor issues
- As rainfall decreased and temperatures began to sustain highs in the triple digits, it became apparent which irrigation zones were being missed due to system tripping during run cycles
- In late-July, staff adjusted irrigation to run during daytime hours to monitor for shutdowns and increase irrigation run times to keep plants alive

- To address pump clogging issues, staff ordered a pond liner using project contingency funds on 7/20/2023
- Liner installation will prevent issues of clogging and installation is projected to be completed by mid-August 2023
- Liner should provide consistency in run times to meet landscape needs
- Staff is also exploring the use of a ground reservoir tank to serve as additional filtration for pond

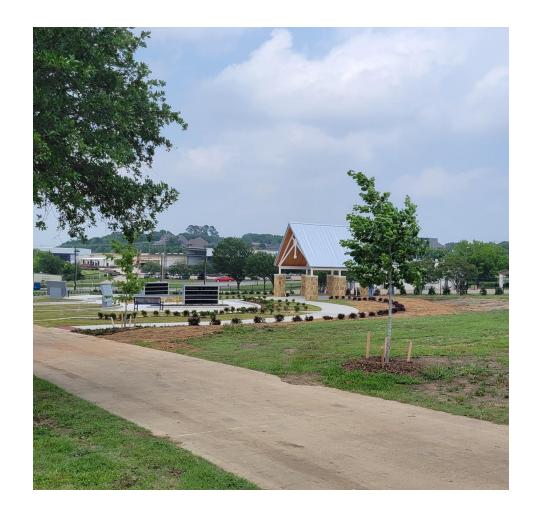
Cemetery Landscape Challenges

- Since irrigation system runs during evening hours, staff became aware of issues by seeing plants suffering heat stress
- Staff began to add supplemental water but the small root zones of some new plants reached permanent wilting points
- Staff recommends some plants will need to be replaced during fall planting window and others removed due to maintenance concerns
 - Staff recommends replacing dead plants in plaza area near committal shelter and along fence line during as soon as possible
 - Most plants lost were in the field grave areas. These plants would likely suffer damages during future interments and through damages from landscape equipment so staff recommends not to replace
 - Surviving plants in field areas can be transplanted to plaza area of cemetery to save on replacement costs

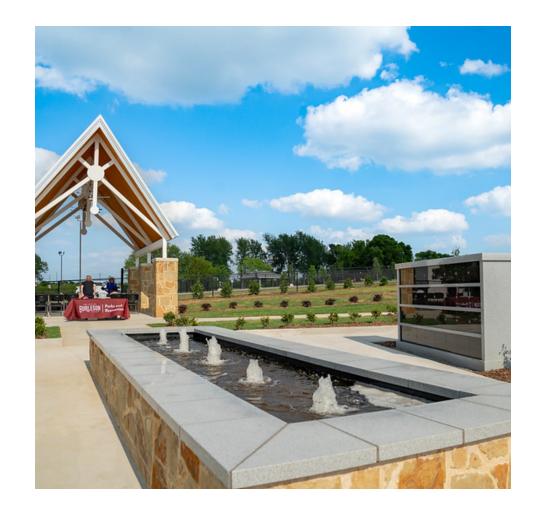
Cemetery Ornamental Fountain Updates

- Fountain is also supplied by well water and pumped from pond
- Clogging has also caused issues in fountain and well water tends to be murky and have odor
- The fountain will be disconnected from well water supply and connected to potable water line to prevent issues from occuring
- Water connection is being installed by Public Works beginning week of 7/31/23
- A double-check installed for backflow prevention
- Estimated completion mid-August 2023

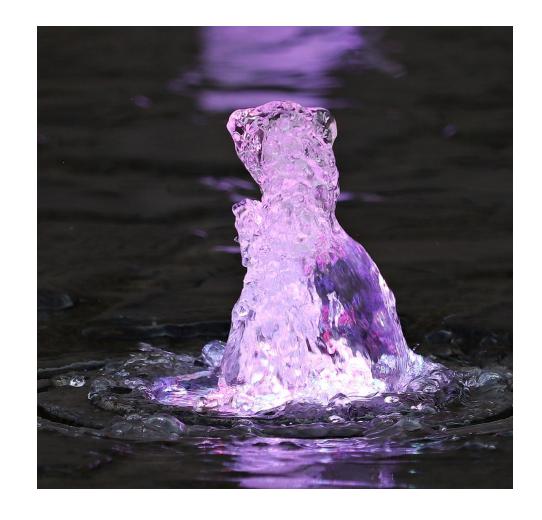
Cemetery Fountain Vault Updates

- Silt and dirt discovered at the bottom of fountain vault
- Caused by muddy filter in filtering out silt from pond and surrounding landscape bed dirt falling in
- Submersible pump and screen to be utilized to help prevent issue from reoccurring
- Tying fountain directly into clean, potable water will also help mitigate this
