# INDOOR POOL SLIDE AND STAIR TOWER

PARK BOARD: MARCH 20, 2025

# STRUCTURAL ENGINEER INITIAL DRAFT REPORT: FREESE AND NICHOLS OBSERVATIONS

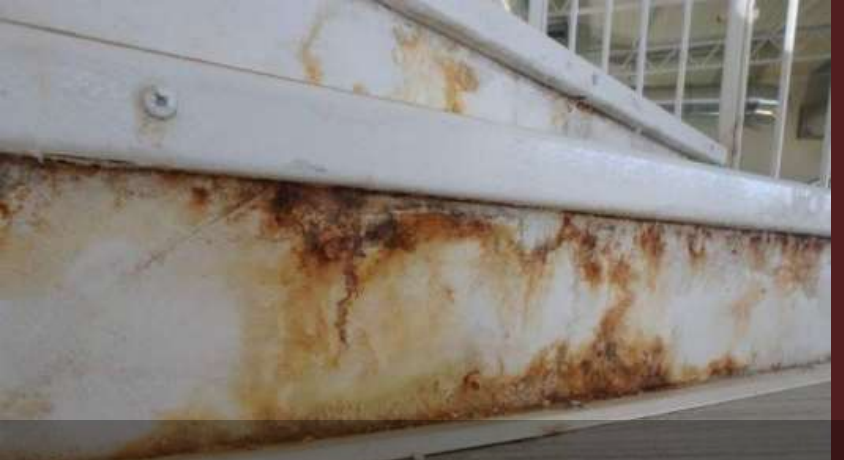
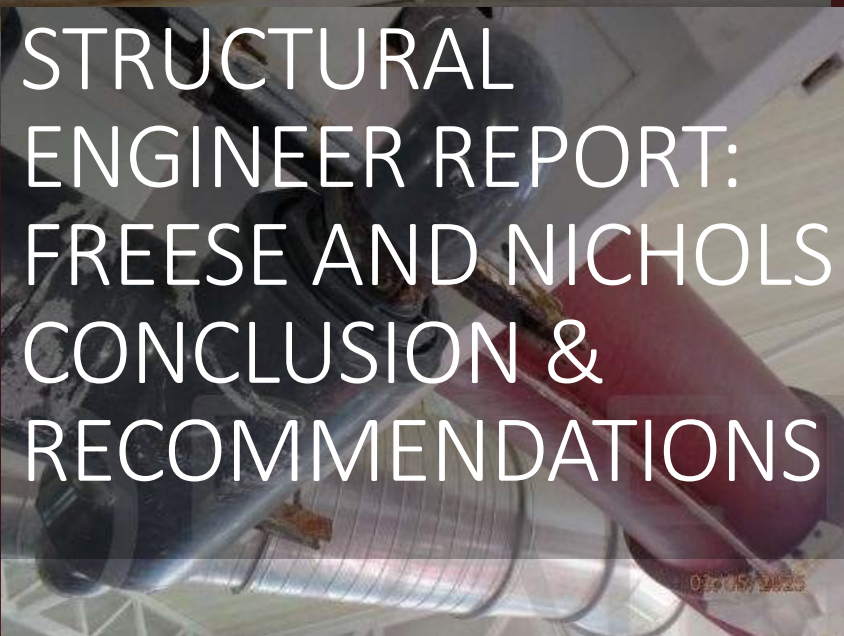
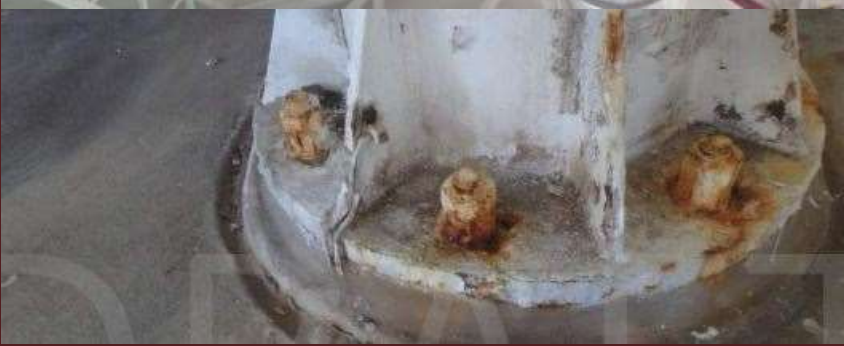
- The most visually obvious rust staining originated at the top of the risers at the contact point with the tread pans. While highly visible, the corrosion was not a significant structural concern.

- In general, the bolts appeared to be very corroded and a close second in terms of visual impact.
- Some localized heavy corrosion and scaling was observed on the face of a few risers.

- **Most of the corrosion on the staircase appeared to be due to pool water cascading down the structure from the upper platform.**
- Evidence for this conclusion area as follows:

- The galvanized and non-galvanized pipe supports below the upper landing were heavily corroded.
  - \*This supports staff's initial findings that the stairs degradation is due to design and not to maintenance protocols historically utilized.

None of the observed corrosion appeared to present an immediate concern for structural integrity or safety. The structure is in need of maintenance and a new coating.

- In general, bolts should be replaced before the face of the bolts begins to scale off.
- Consider replacement with a more corrosion resistant material. Bolt head markings were not visible during my site visit but should be verified by removing the coating. If the bolts are not high-strength, consider replacement with Type 316 stainless steel. If high-strength bolts were used, the bolts should be replaced in kind but should be hot-dip galvanized.

- The bolts at the upper landing guardrail appeared to have significant exposure and significant corrosion inside the post. While the guardrails did not have signs of incipient bolt failure, we recommend bolt removal for inspection and replacement as appropriate.

- When recoating, the treads should be removed to improve the surface preparation and coating between the treads and risers.
- Replace the heavily corroded galvanized pipe supports below the upper landing.

- Replace the bolts between the risers and the central column with welds.
- Insert a neoprene or plastic strip between the risers and tread pans to reduce coating damage due to foot traffic.
