Preliminary Storm Drainage Report

Camas Business Center
4723 NW Lake Road
Camas, WA 98607
2200867.10

October 2021

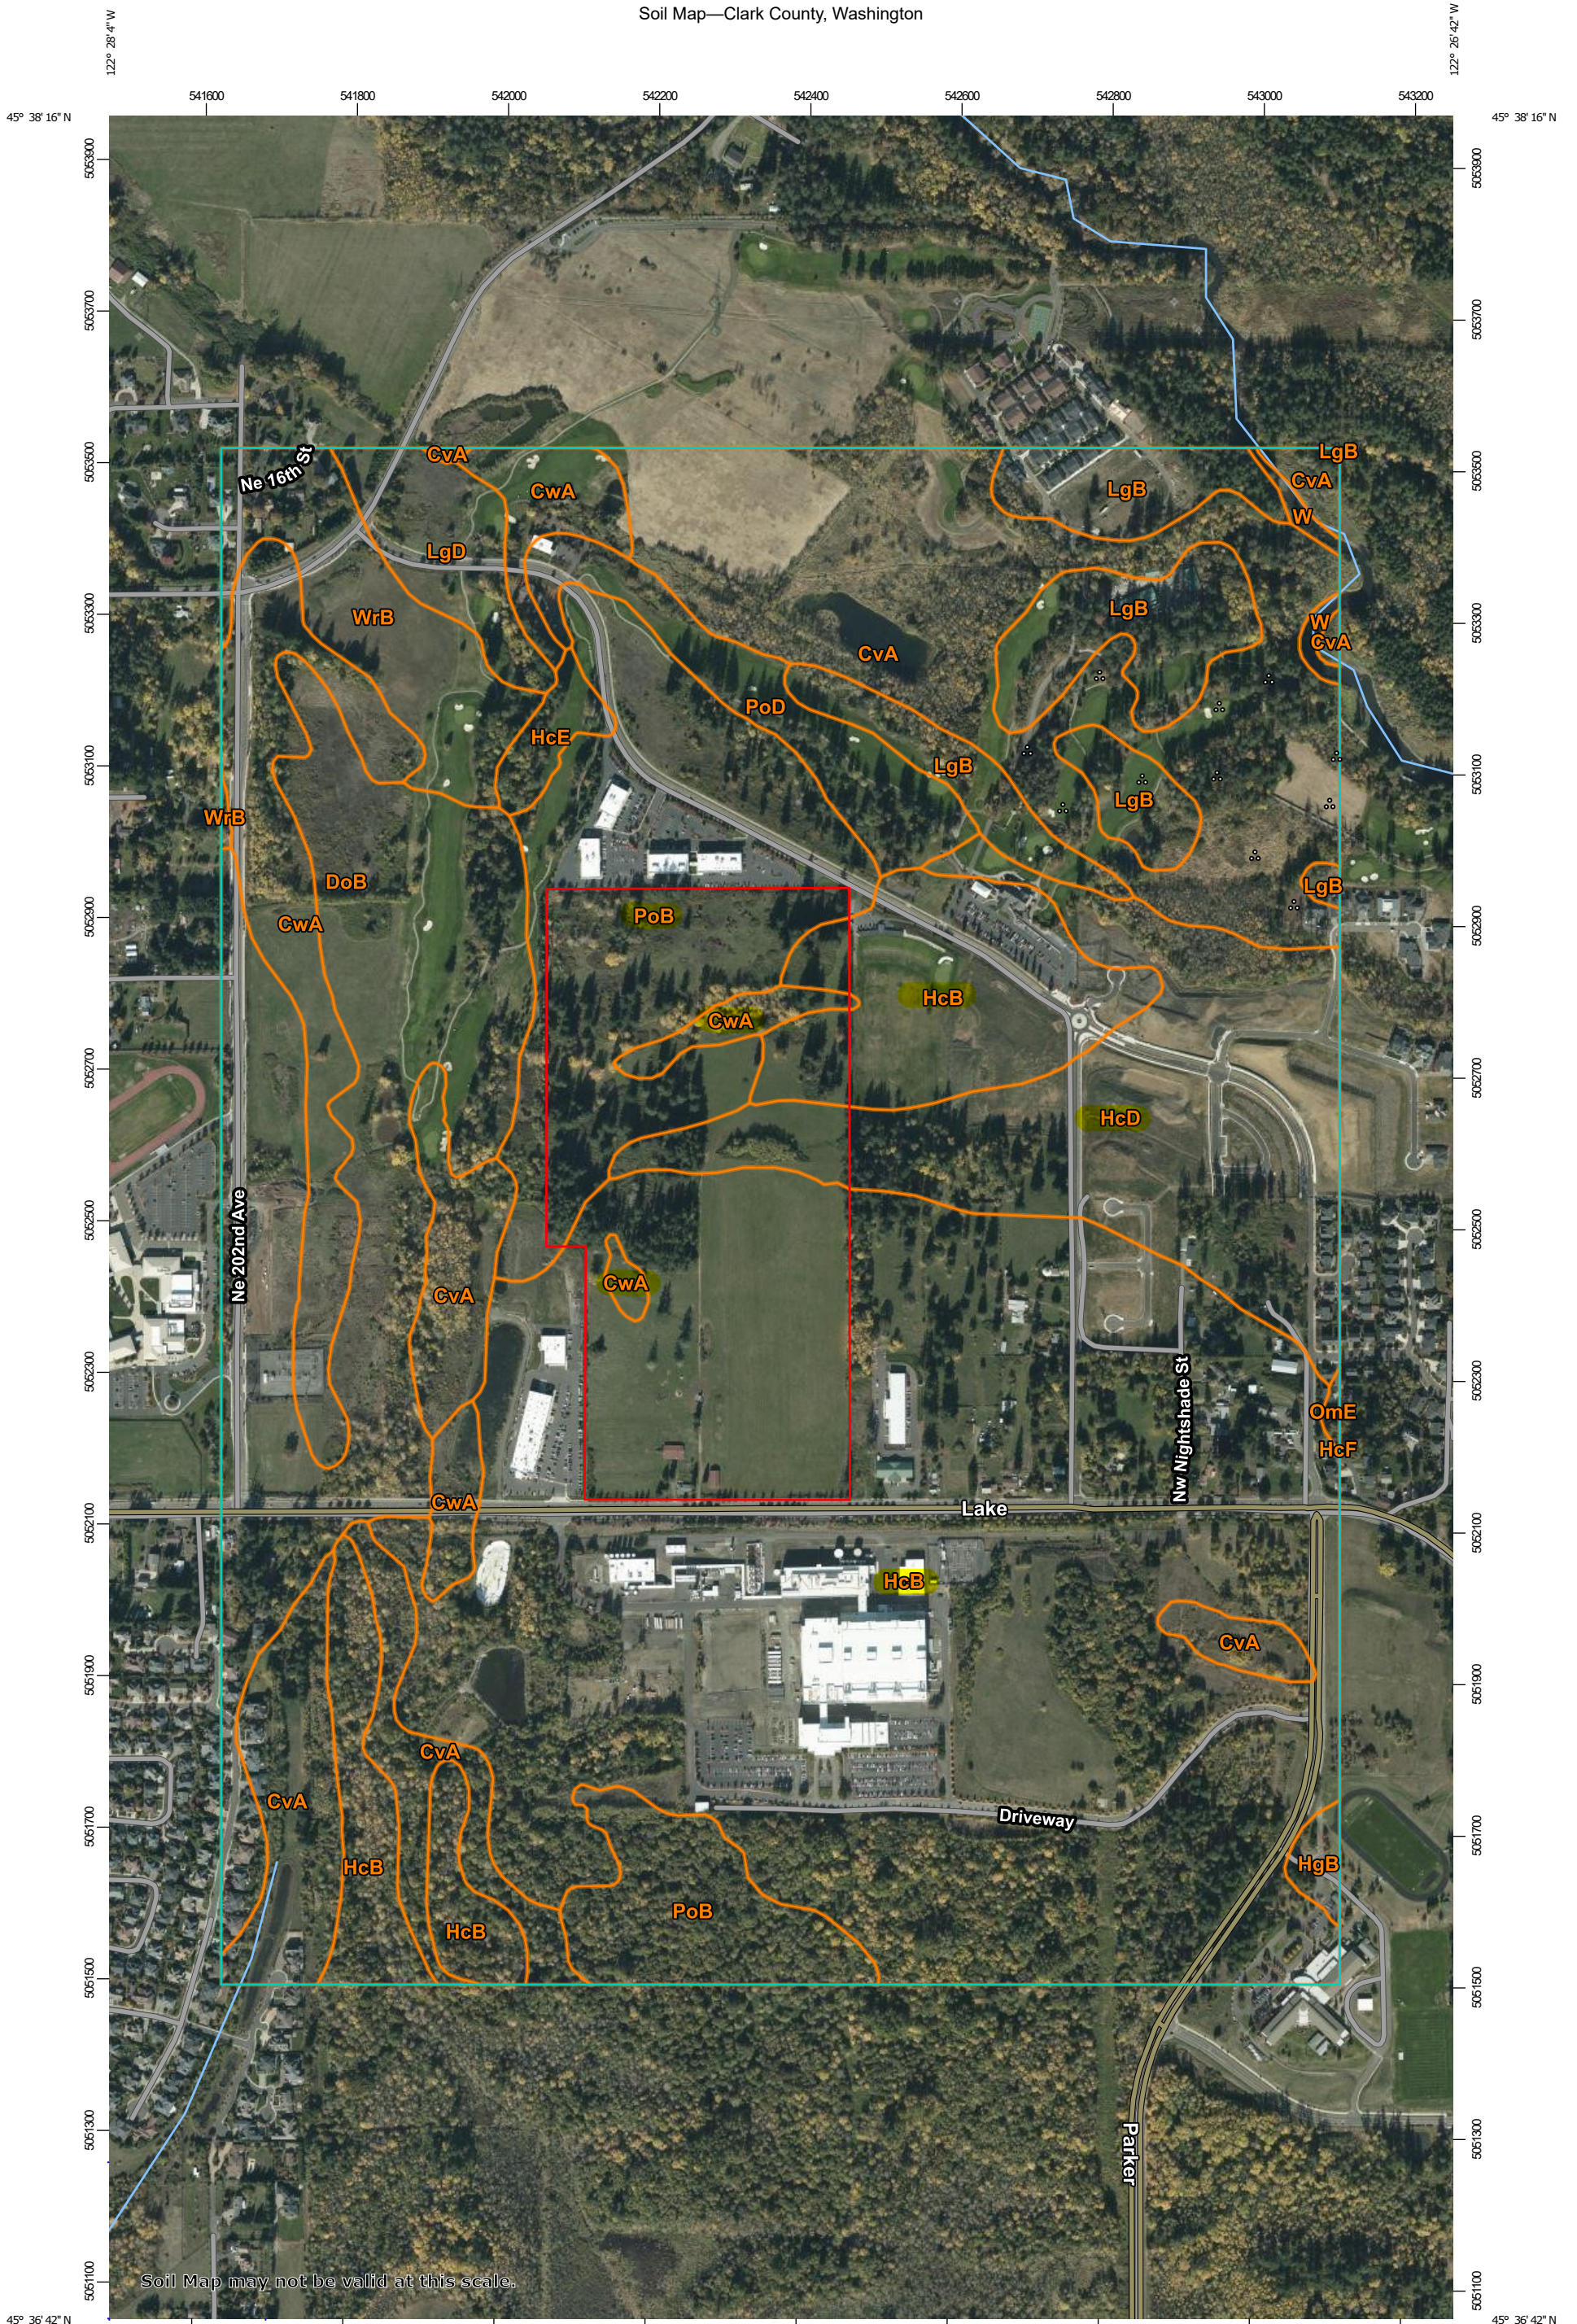
Soil Map—Clark County, Washington

Soil Map may not be valid at this scale.

Map Scale: 1:8,130 if printed on B portrait (11" x 17") sheet.

A field investigation performed by Terra Associates, Inc. revealed the site soils generally consist of 3 to 12 feet of medium stiff to very stiff silt, with varying amounts of sand and gravel. In some test pits in the north and north-central portions of the site, Columbia River Basalt (bedrock) was observed within the upper 3 to 9 feet. Groundwater was observed in 8 of 80 test pits between 2.5 and 12 feet below grade. Refer to Appendix C for the Draft Geotechnical Report.

For stormwater modeling, Clark County classifies soils into Soil Groups (SG) 1 through 5. Per the *CSDSM*, it is appropriate to use the Clark County Soil Group definitions within the Western Washington Hydrology Model (WWHM) for storm facility sizing. The onsite soils are defined by the *Clark County Stormwater Manual* as SG3 and SG4. However, the project geotechnical report indicates that infiltration is not feasible in the onsite soils due to soil gradation, high groundwater concerns, and shallow depth to bedrock. Therefore, the onsite soils most closely match SG4, which is defined as “poorly drained soils (slowly infiltrating C soils, as well as D soils).” For stormwater facility sizing, the onsite soils have been modeled as SG4 in the WWHM program. This is consistent with the development of the project immediately to the west, Dwyer Creek Business Center, which contains similar soil conditions.

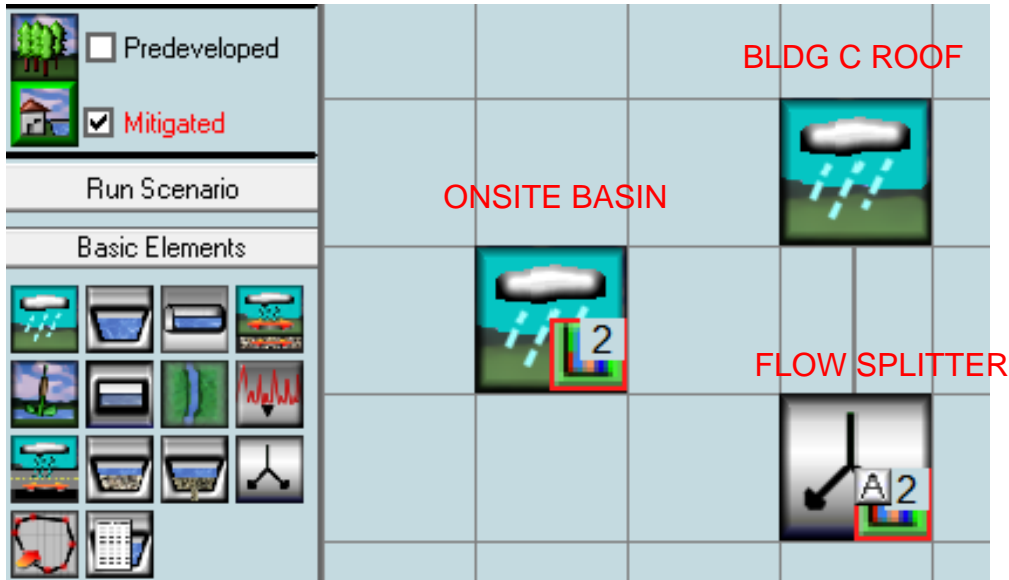
EXHIBIT
B-3

THE FLOW SPLITTER SENDS FLOWS ABOVE 0.4 CFS FROM THE BUILDING C ROOF AREA TO THE POND (TREATMENT REQUIRED).

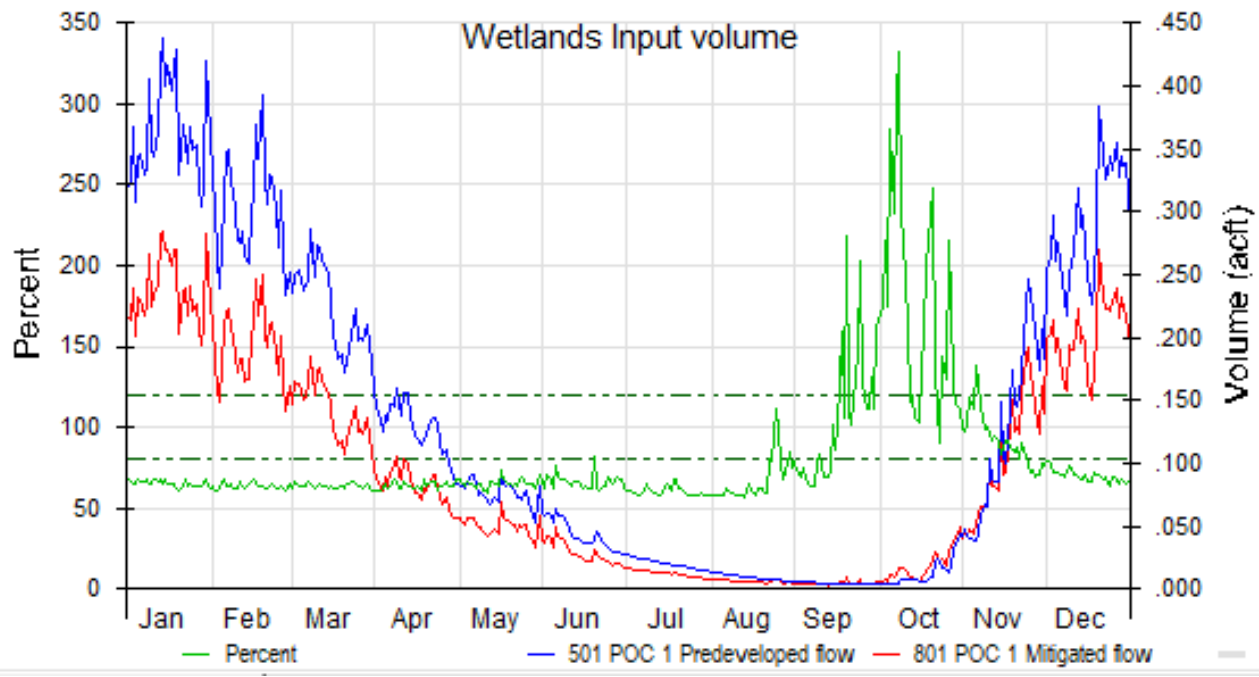
Wetlands Input Volume
Average Annual Volume (acft)
Series 1: 501 POC 1 Predeveloped flow
Series 2: 801 POC 1 Mitigated flow

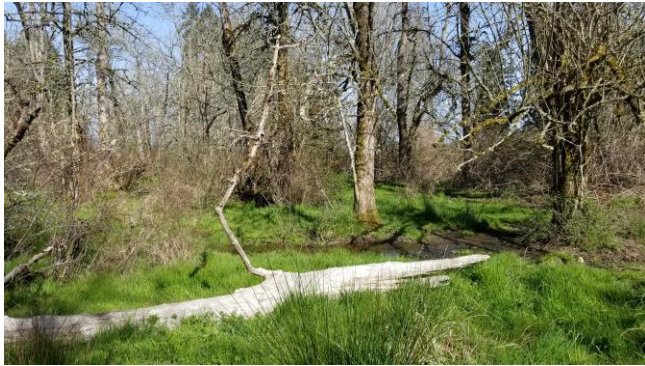
| WETLAND A – INFORMATION SUMMARY | | |

| WETLAND A – INFORMATION SUMMARY | | |
|---|---|---|
| Location: | Located on the northern portion of the subject property, centrally located. | |
| | WSDOE Rating (Hruby, 2014) | III |

The criteria will be met for Wetland D because its tributary basin consists only of its buffer area, which will remain undisturbed in the developed condition. The criteria will be met to the maximum extent feasible for Wetland A. The offsite portion of Wetland A's tributary basin will be conveyed to the wetland by a ditch or culvert in the developed condition. To match the existing hydroperiod as closely as possible, runoff from the Building C roof will be conveyed directly to the wetland. A flow splitter will send low flows to the wetland, while any flows exceeding the bypass allowance of the flow control facility will be conveyed to the detention pond. Preliminary wetland hydroperiod calculations are included in Appendix B.

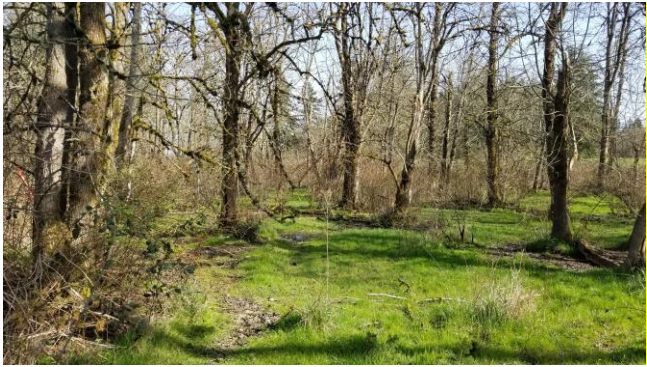
| WETLAND B – INFORMATION SUMMARY | | |

| WETLAND B – INFORMATION SUMMARY | | |
|---|---|---|
| Location: | Located on the western portion of the subject property, extending offsite to the west. | |
| | WSDOE Rating (Hruby, 2014) | III |

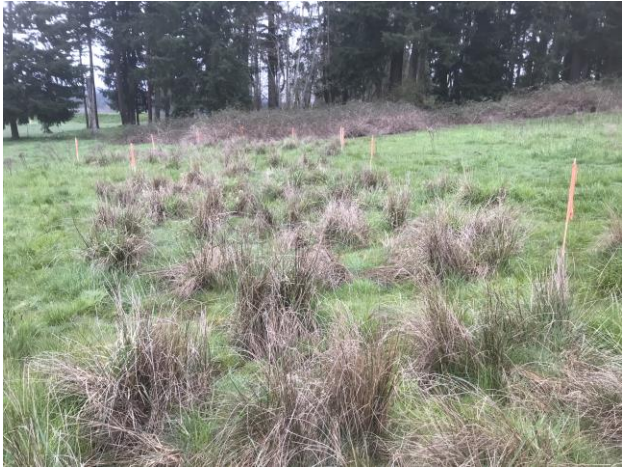
| WETLAND C – INFORMATION SUMMARY | | |

| WETLAND C – INFORMATION SUMMARY | | |
|---|---|---|
| Location: | Located on the eastern boundary of the subject property. | |
| | WSDOE Rating (Hruby, 2014) | IV |

Four wetlands are identified onsite. Wetland C will be filled and Wetlands A, B, and D will remain. Refer to Appendix C for the Critical Areas Report, which contains a detailed breakdown of the existing wetlands and relevant project conditions.

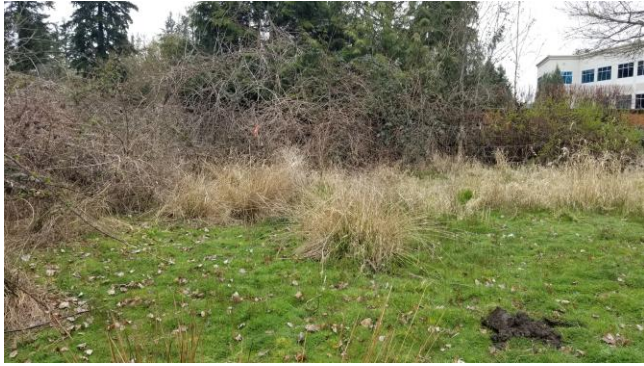
| WETLAND D – INFORMATION SUMMARY | | |

| WETLAND D – INFORMATION SUMMARY | | |
|---|---|---|
| Location: | Located on the northwest corner of the subject property. | |
| | WSDOE Rating (Hruby, 2014) | III |
