CRITICAL AREAS REPORT & OREGON WHITE OAK MITIGATION PLAN

Monte Verde Subdivision

August 5, 2022

Updated October 12, 2022

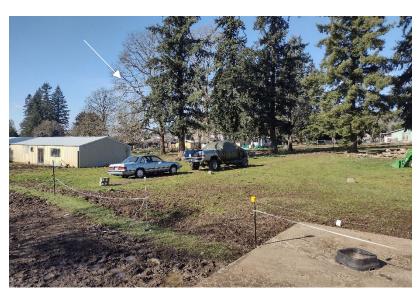
Photo 1.

February 22, 2022 – View of the northwest corner of the subject site and the proposed site access from NE 28th Street. The three oaks (#s 14, 15, and 16) which will be removed are located just north of the white shed visible in this photo.

The removal of three jurisdictional Oregon white oaks (Oak #s 14, 15, and 16, over 20-inch dbh) is unavoidable by the proposed project to meet the City development code requirements. The original mitigation plan quantified the oak tree removal impact and mitigation following CMC Section 16.51.120.C.5.b.iii and proposed a replacement ratio of two, two-inch caliper trees for each tree removed. However, upon further coordination with WDFW staff the oak habitat impacts were calculated by quantifying the total oak canopy habitat and functions to be removed from the site. See Appendix D for the Oregon White Oak Habitat Assessment documented for the three trees proposed for removal. The Oregon White Oak Habitat Assessment included quantifying the existing condition of the crown, size of the oak canopy, diameter at breast height (dbh), presence of galls, acorns, dead branches, cavities and condition of the understory.

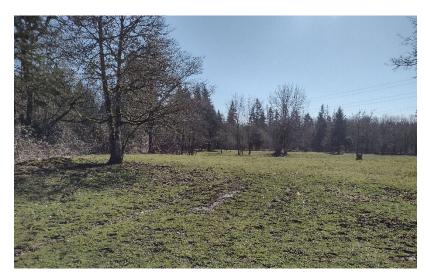
Photo 2.

February 22, 2022 – View south across the subject site. The site is highly impacted from years of animal grazing. Few native trees are present within the central portion of the property and it is dominated by grazed herbaceous cover.

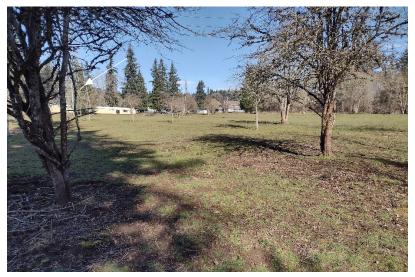
Photo 3.

February 22, 2022 – View north across the central area of the subject site. Few native trees are present within the central portion of the property and there is no understory due to grazing. An overhead powerline tower located within the powerline easement onsite is visible at far right in this photo.

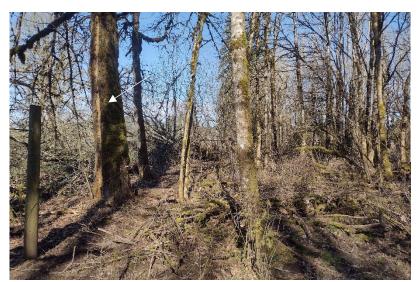
Photo 4.

February 22, 2022 – View north from the southwest corner of the property. The area is forested, but with little native understory or herbaceous layer due to grazing. Oak #76 is visible in this photo along the western parcel boundary. This tree will be retained and protected.

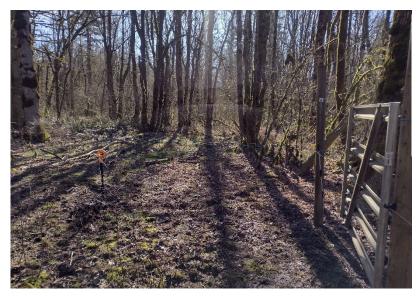
Photo 5.

February 22, 2022 – View east from the southwest corner of the property. The area is highly disturbed due to animal grazing. Test plot #1 was within this location. The area was determined to be an upland with non-hydric soils and no hydrology indicators.

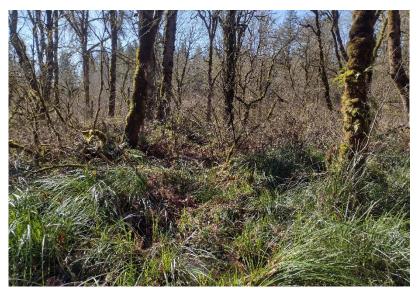
Photo 6.

February 22, 2022 – Photo of the offsite wetland over 300-feet south of the subject parcel. The county owned property located south of the subject property is more biologically diverse and dominated in native vegetation.

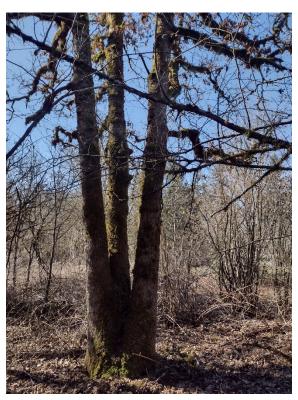
Photo 7.
February 22, 2022 – View of Oak #127 along the eastern parcel boundary. The 3-trunk Oregon white oak is just offsite and will be retained.

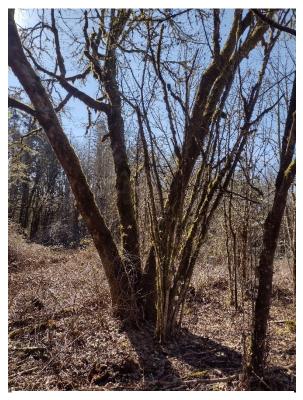
Photo 8.
February 22, 2022 – View of Oak #126 along the eastern parcel boundary. The 3-trunk Oregon white oak will be retained and protected.

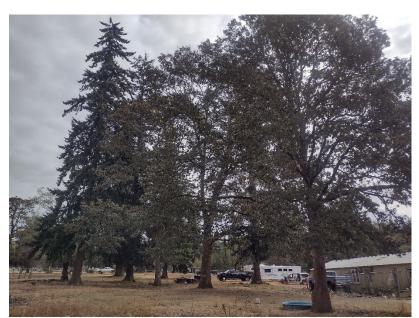
Eleven individual Oregon white oak trees were identified onsite or immediately offsite and numbered by the tree survey, Appendix C. Three oaks with over 20-inch dbhs were documented onsite north of the existing barn (Oak #s 14, 15, and 16). One non-jurisdictional oak is located centrally onsite (Oak #s 32). One oak is a hazard snag (Oak #27). Three oaks are located along parcel boundaries with partial canopies encroaching into the subject parcel (Oak #s 76, 79, and 126). The remaining three oaks identified were determined to be entirely offsite (Oak #s 31, 38, and 127). See Figure 4 and Appendix C. Six of the oak trees inventoried by the tree survey are jurisdictional and meet the WDFW criteria for "individual oak" Priority Habitats as they have dbh measurements of 20-inches or larger. Oregon white oak Priority Habitat is protected by WDFW and also jurisdictional under the local CMC habitat code. The understory and herbaceous layer associated with the onsite oak habitat is highly disturbed due to grazing or dominated by Himalayan blackberry.

Photo 1.
September 14, 2022 – View of Oak #s 14, 15, and 16 within the northern section of the subject parcel. All three are proposed for removal.
