CRITICAL AREAS REPORT & OREGON WHITE OAK MITIGATION PLAN

Monte Verde Subdivision

August 5, 2022

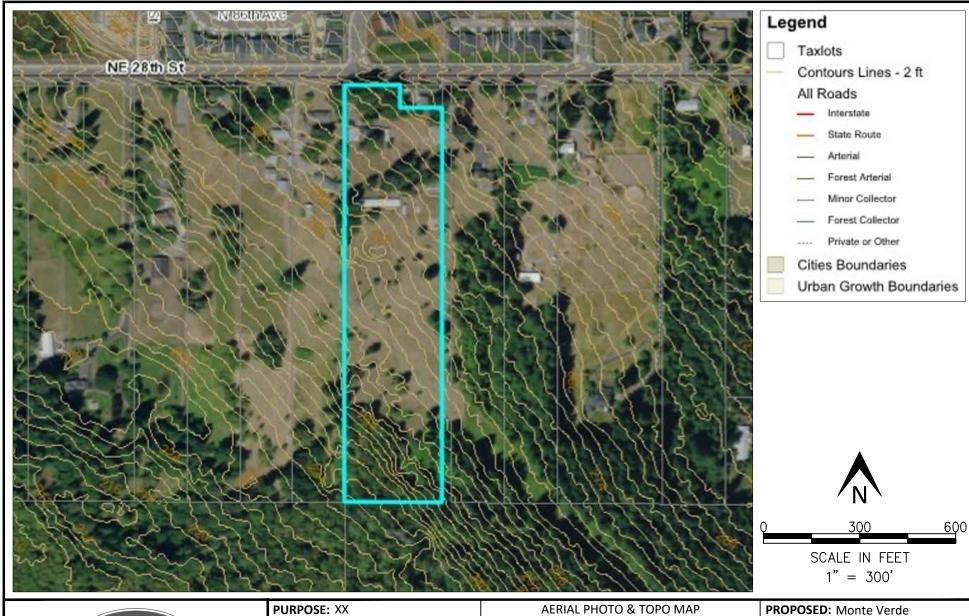
FIGURE: 2 **DATE:** 3-1-22

The site generally consists of a southwest facing slope. Topography maps show that the site drops approximately forty-eight feet in elevation from NE 28th Street to the southwest corner of the parcel, Figure 2.

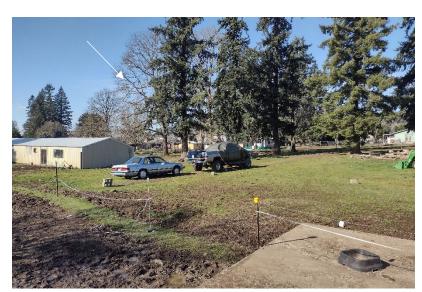
Photo 1.

February 22, 2022 – View of the northwest corner of the subject site and the proposed site access from NE 28th Street. The three oaks (#s 14, 15, and 16) which will be removed are located just north of the white shed visible in this photo.

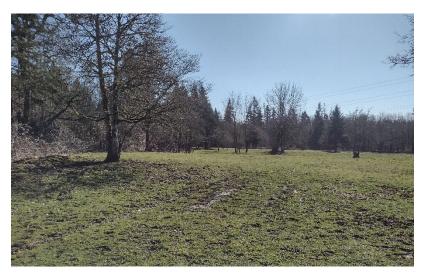
Photo 2.

February 22, 2022 – View south across the subject site. The site is highly impacted from years of animal grazing. Few native trees are present within the central portion of the property and it is dominated by grazed herbaceous cover.

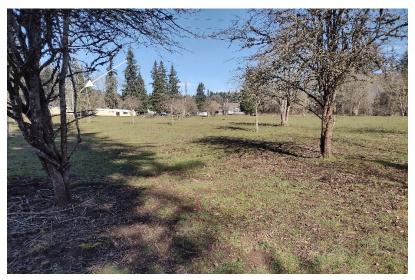
Photo 3.

February 22, 2022 – View north across the central area of the subject site. Few native trees are present within the central portion of the property and there is no understory due to grazing. An overhead powerline tower located within the powerline easement onsite is visible at far right in this photo.

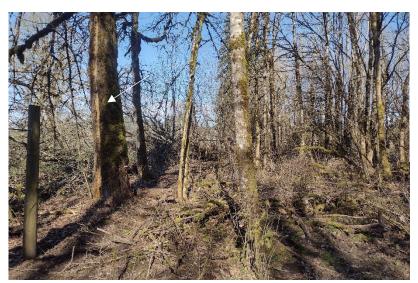
Photo 4.

February 22, 2022 – View north from the southwest corner of the property. The area is forested, but with little native understory or herbaceous layer due to grazing. Oak #76 is visible in this photo along the western parcel boundary. This tree will be retained and protected.

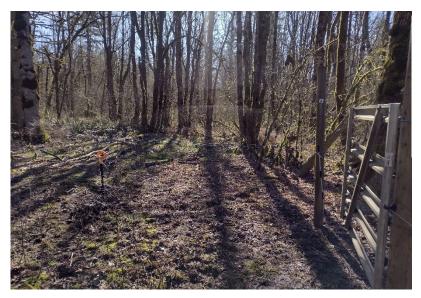
Photo 5.

February 22, 2022 – View east from the southwest corner of the property. The area is highly disturbed due to animal grazing. Test plot #1 was within this location. The area was determined to be an upland with non-hydric soils and no hydrology indicators.

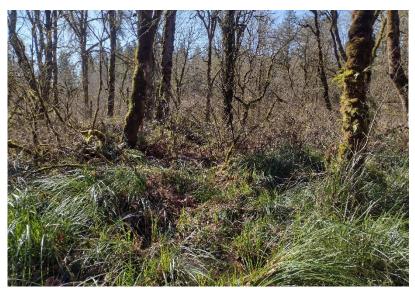
Photo 6.

February 22, 2022 – Photo of the offsite wetland over 300-feet south of the subject parcel. The county owned property located south of the subject property is more biologically diverse and dominated in native vegetation.

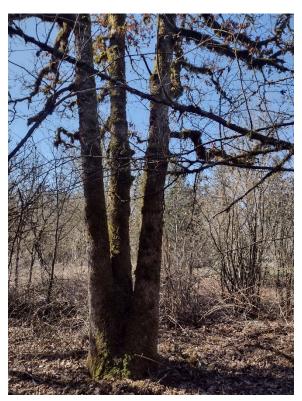
Photo 7.
February 22, 2022 – View of Oak #127 along the eastern parcel boundary. The 3-trunk Oregon white oak is just offsite and will be retained.

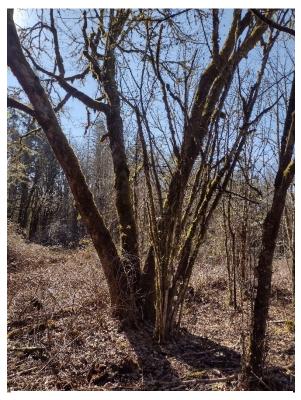
Photo 8.
February 22, 2022 – View of Oak #126 along the eastern parcel boundary. The 3-trunk Oregon white oak will be retained and protected.

Oak #s 126, 76 and 79 within the south section of the property will be retained. The project will not impact the root system or damage these trees. The dripline of all three oaks will be located, staked, and fenced prior to site grading and construction activities. Compensatory measures will need to be implemented if during construction the critical root mass of the trees are impacted.
