**Pacific Lifestyle Homes, Inc.
Geotechnical Engineering Evaluation**

**Monte Verde Subdivision
22205 NE 28th St, Camas WA 98607
Camas, Washington 98607**

**True North Project No. 22-0111-1
July 2022**

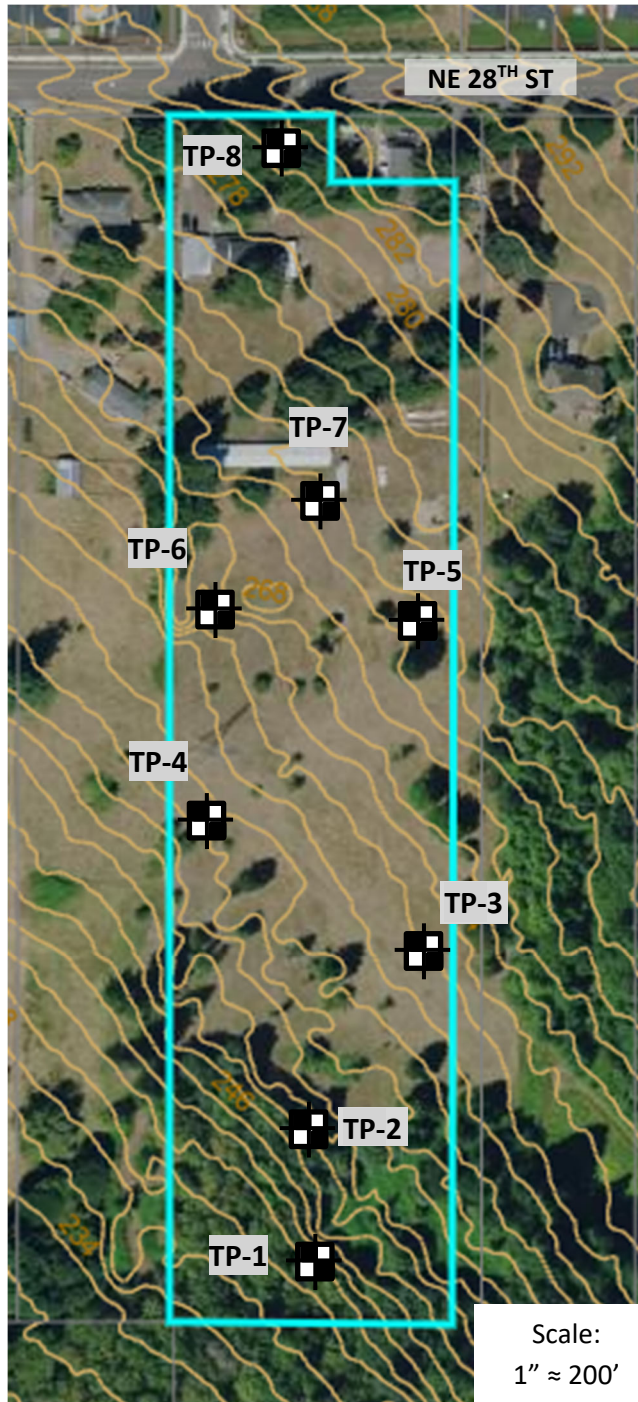
<p>TRUE NORTH ◆ GEOTECHNICAL ◆</p>	<p>Pacific Lifestyle Homes Monte Verde Subdivision Camas WA</p>	<p>Project # 22-0111-1</p>
<p>202 E. Evergreen Blvd Suite B Vancouver, WA 98660 360-984-6584</p>	<p>July 2022</p>	<p>Figure 2 –Site Plan</p>

Approximate Exploratory Test Pit Locations, May 6, 2022.

On May 6th, 2022, we visited the site to excavate eight test pits and to perform two infiltration tests (see attached Site Plan, Figure 2). The test pit explorations, designated TP-1 through TP-8, were excavated to maximum depths between about 6 and 12 feet bgs. The approximate test pit locations are shown on Figure 2. Descriptions of field and laboratory procedures and the interpreted exploration logs are included in Attachment A. The following is a generalized description of the subsurface units encountered in our explorations:

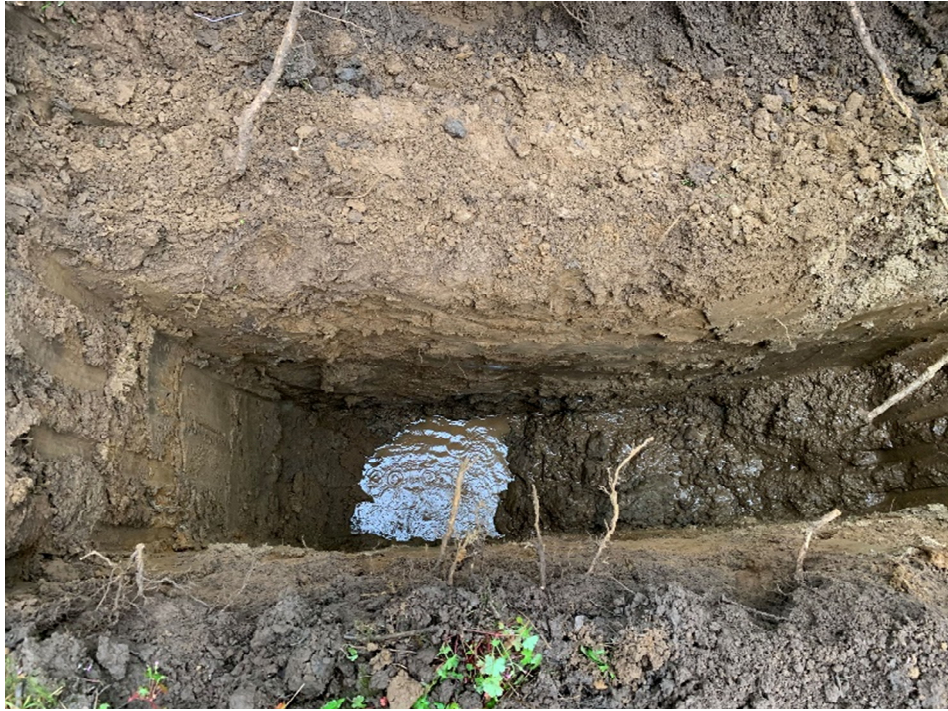
Photo 1. Seepage observed at TP-1.

Groundwater was encountered at three of the eight test pit explorations, TP-1, TP-2, and TP-4. At each of these locations, moderate seepage was observed at about 4 feet bgs and heavy seepage was encountered at approximately 5 to 7 feet bgs. These three test pits were all located within the lower, southern portion of the site. Based on a review of nearby well logs as well as Clark County data, the static groundwater level at the property is mapped at about 10 to 20 feet bgs, although zones of isolated restrictive layers may occur, resulting in seasonally higher perched water levels at times.

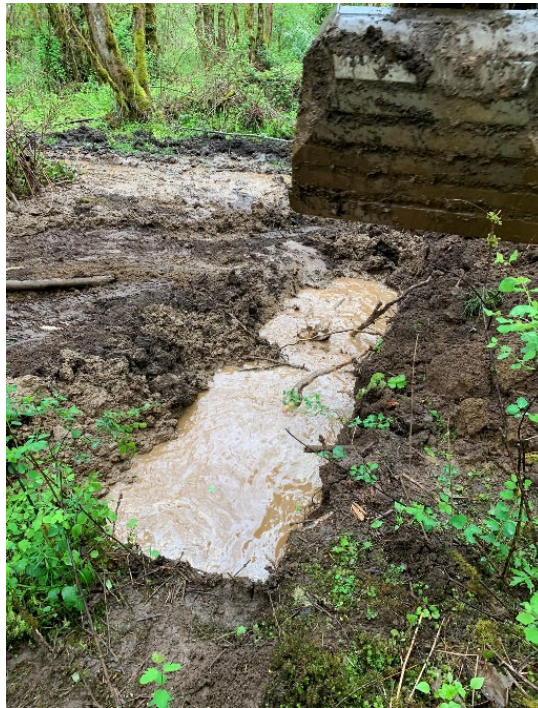
Photo 2. Seepage ponding at TP-2 during backfill operations.

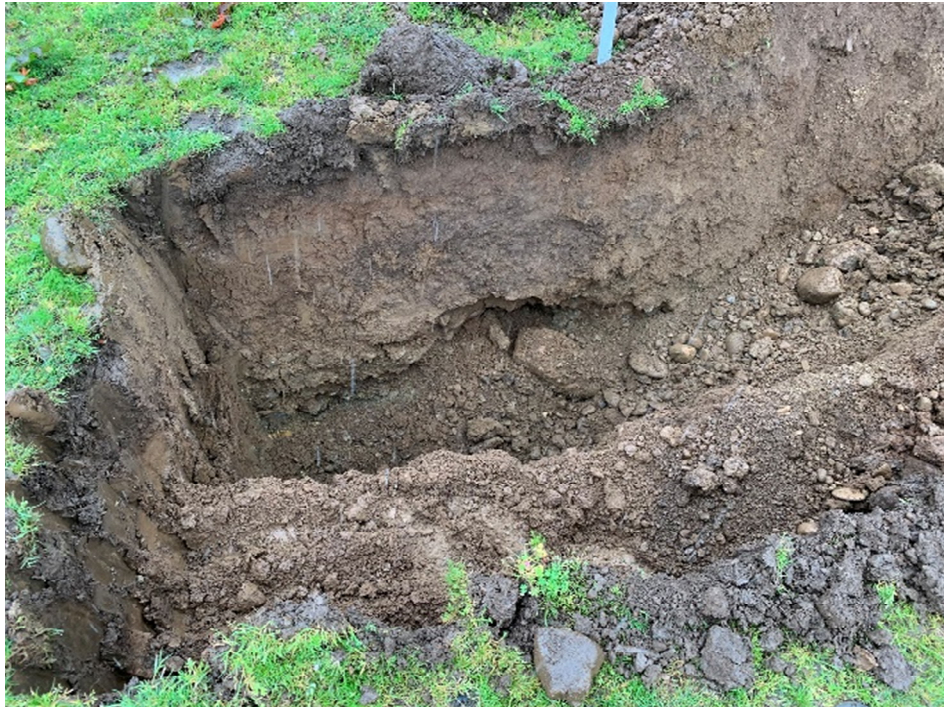
Photo 3. Cobbles and gravel evident at TP-3.

Sandy GRAVEL: Gray-brown to brown Sandy Gravel (GP) with silt and cobbles was encountered below the sand layer in all test pits extending to the termination depth in all, at about 6 to 12 feet bgs. In general, the relative density of this layer was dense to very dense, and soil particles were observed to consistently increase in size with depth. The moisture content of samples tested from this layer ranged from about 18 to 58 percent. The fines content of one sample from this layer in TP-3 was about 4 percent.

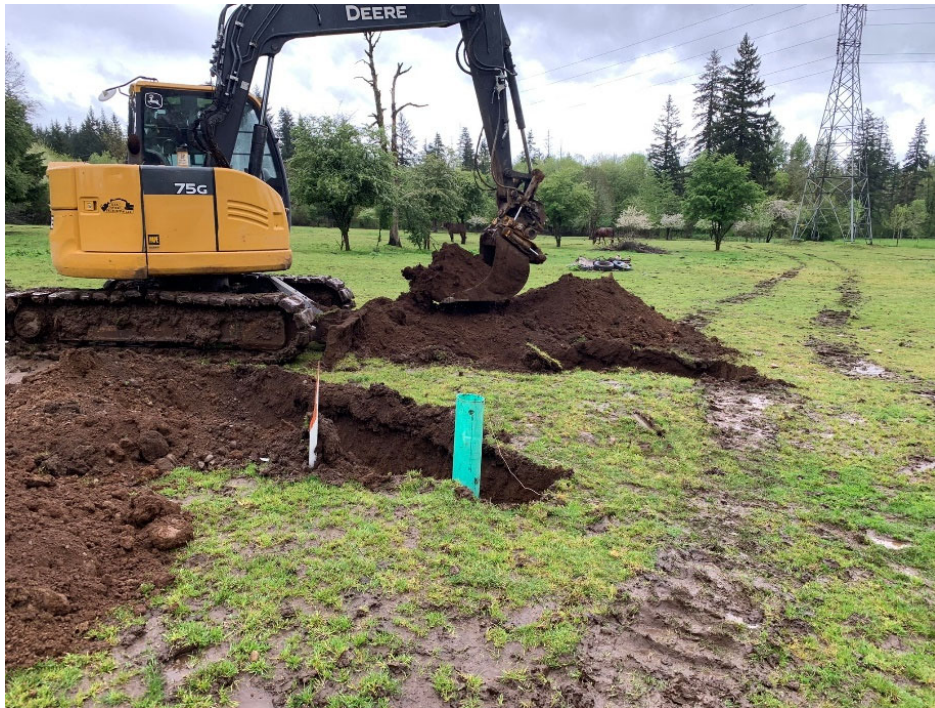
Photo 4. Infiltration testing at TP-7.

Infiltration testing was completed in TP-3 and TP-7 at depths of about 5 and 2 feet bgs, respectively. The infiltration tests were conducted within 6-inch outside diameter PVC pipes embedded into the underlying soils using the single-ring falling head method, in general accordance with the 2015 Clark County Stormwater Manual. Water was placed into each pipe to achieve a minimum 6-inch-high column of water (head). After a period of saturation, the height of the water column in each pipe was measured initially and at regular timed intervals to determine the rate of water infiltration into the soil. Results of the field infiltration testing are presented in Table 1.

Table 1. Infiltration Testing Results				
Location	Depth of Test (feet bgs)	Coefficient of Permeability, k (inches/hour)	Fines Content (percent)	Soil Classification ²
TP-3	5	42.2	14.4	Brown Silty GRAVEL with Sand and Cobbles, moist
TP-7	2	4.7	32.3	Brown Silty SAND with Gravel, damp
