11. Wetland and Habitat

CRITICAL AREAS REPORT

Camas Parcel 178140000

Camas, Washington

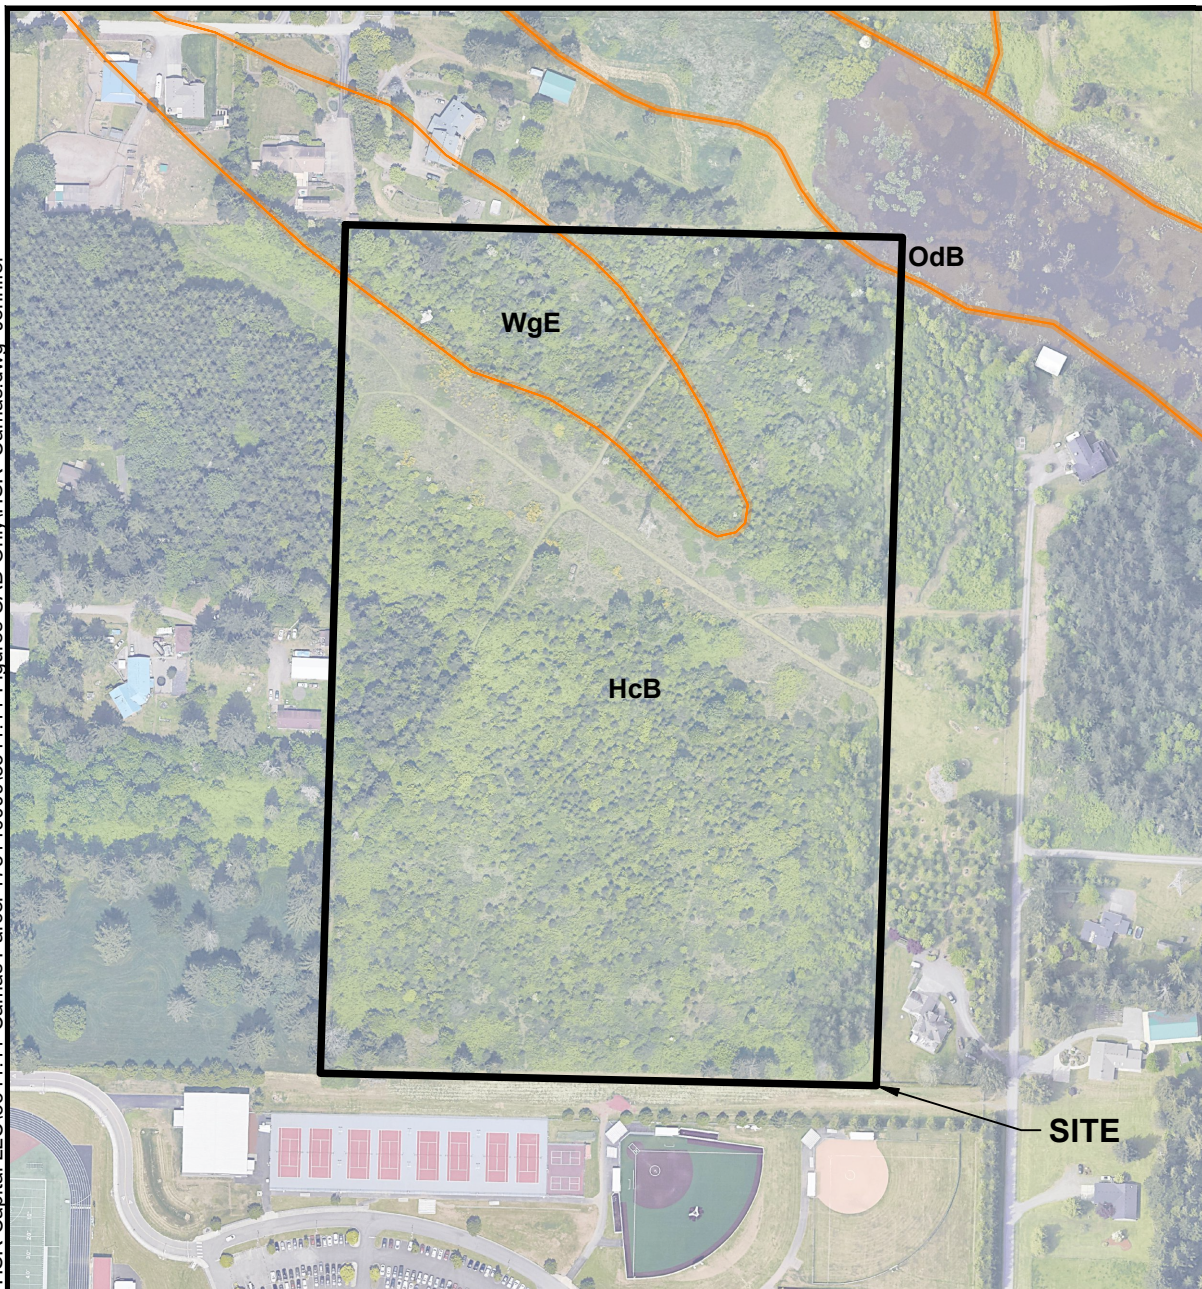
Figure 3
NRCS SOIL SURVEY
Parcel 178140-000
HSR Capital
City of Camas, Clark County, Washington
Section 35, Township 2N, Range 3E, W.M.

- Site Boundary
- NRCS Soil Boundary
- HcB** Hesson clay loam, 0 to 8 percent slopes. Not hydric.
- OdB** Odne silt loam, 0 to 5 percent slopes. **Hydric.**
- WgE** Washougal gravelly loam, 8 to 30 percent slopes. Not hydric.

OdB is characterized as a poorly drained soil with a moderately high capacity for the most limiting layer to transmit water, and an average depth to water table of 0 to 18 inches BGS. This soil is generally found on terraces and drainageways and is formed from alluvium. A typical profile includes ashy silt loam from 0 to 5 inches, silt loam from 5 to 33 inches, and loam from 33 to 60 inches BGS. OdB is in Hydrologic Group D². Soils in Group D have high runoff potential when thoroughly wet and subsurface water movement ranges from restricted to very restricted. OdB is included on the National Hydric Soils List (NRCS 2024b).

WgE is characterized as a somewhat excessively drained soil with a moderately high to high capacity for the most limiting layer to transmit water, and an average depth to water table of more than 80 inches BGS. This soil is generally found on terraces and is formed from gravelly alluvium. A typical profile includes gravelly medial loam from 0 to 20 inches, very gravelly medial loam from 20 to 28 inches, and very cobbly coarse sand from 20 to 60 inches BGS. WgE is in Hydrologic Soil Group B³. Soils in Group B have a moderate infiltration rate when thoroughly wet and consist chiefly of moderately deep or deep, moderately well-drained or well-drained soils that have moderately fine texture to moderately coarse texture. WgE is not included on the National Hydric Soils List (NRCS 2024b).

biologists' soil observations were consistent with NRCS mapped soil series, as wetlands were delineated in areas where hydric soils are mapped, and uplands were observed in areas where non-hydric soils are mapped. Soils present onsite are summarized in Table 1.

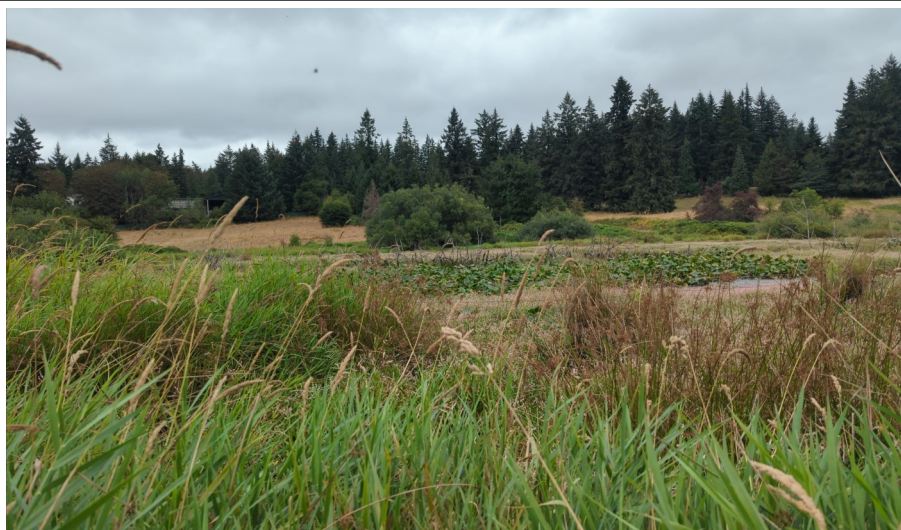
Photo 1 was taken facing north and shows Wetland A, which extends offsite.

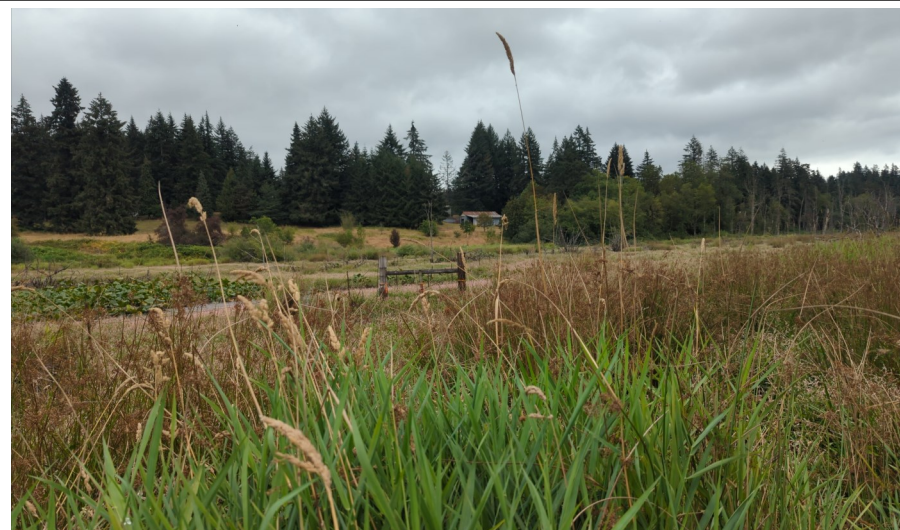
Photo 2 was taken facing northeast and shows Wetland A, which extends offsite.

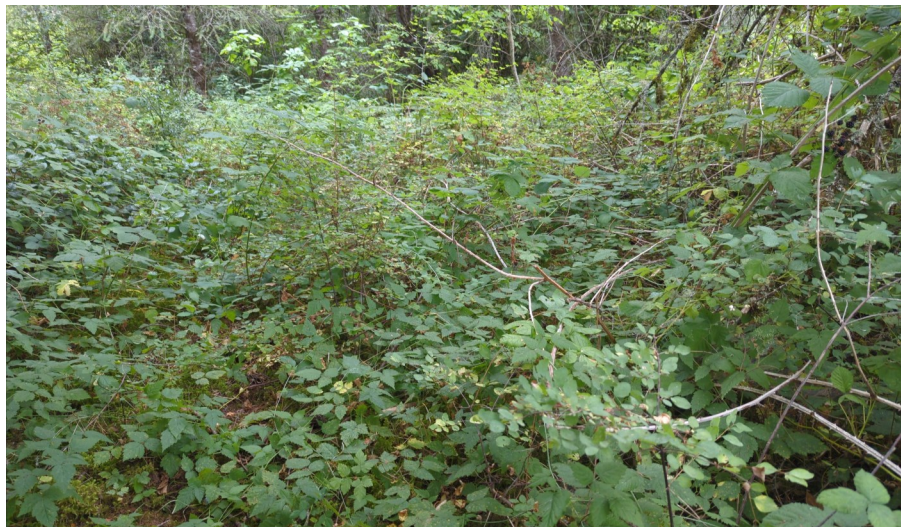
Photo 3 was taken facing southwest and shows upland Test Plot 4.

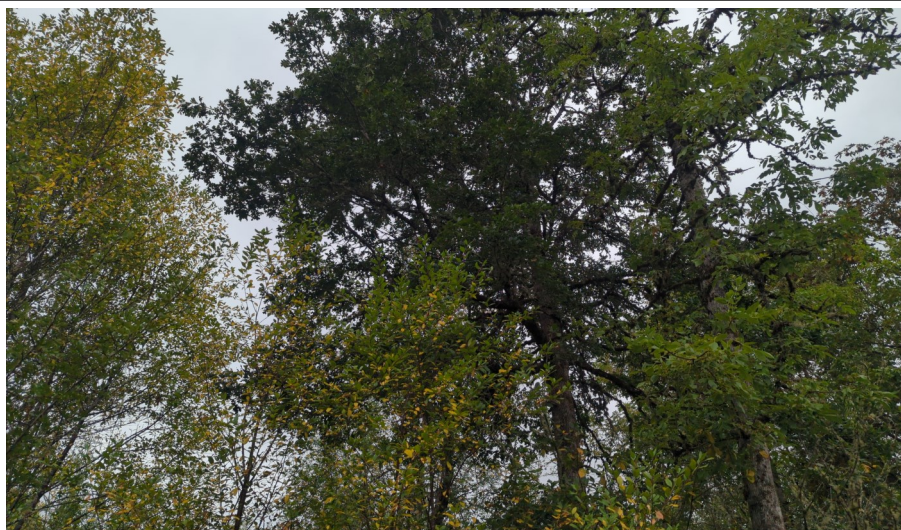
Photo 5 was taken facing west and shows one of the oaks onsite.

Three Oregon white oak trees (Oaks 1, 2, 3) and a priority snag were observed onsite. Oak 1 was mapped in the northeastern portion of the site and is approximately 40 to 50 feet tall with a DBH of approximately 14.5 inches. Oak 2 was mapped in the central portion of the site and is approximately 15 to 20 feet tall with a DBH of approximately 5 inches. Oak 3 was mapped in the northeastern portion of the site, near Oak 1, and is approximately 40 to 50 feet tall with a DBH of approximately 17 inches. Oak 1 and Oak 2 appear to be in good health while Oak 3 appears to be in poor health. The snag was mapped in the western central portion of the site, southwest of Oak 2. The snag was approximately 40 to 50 feet tall with a DBH of approximately 42 inches.

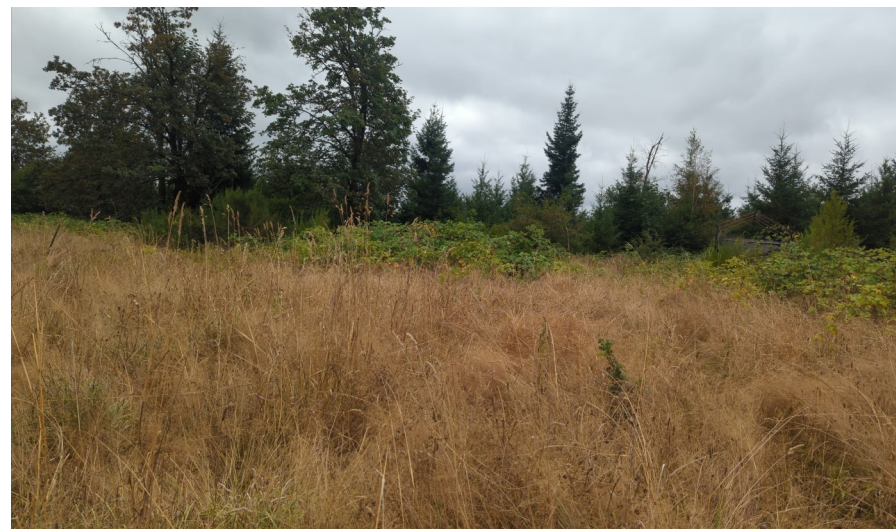
Photo 8 was taken facing south and shows general conditions within the powerline easement.

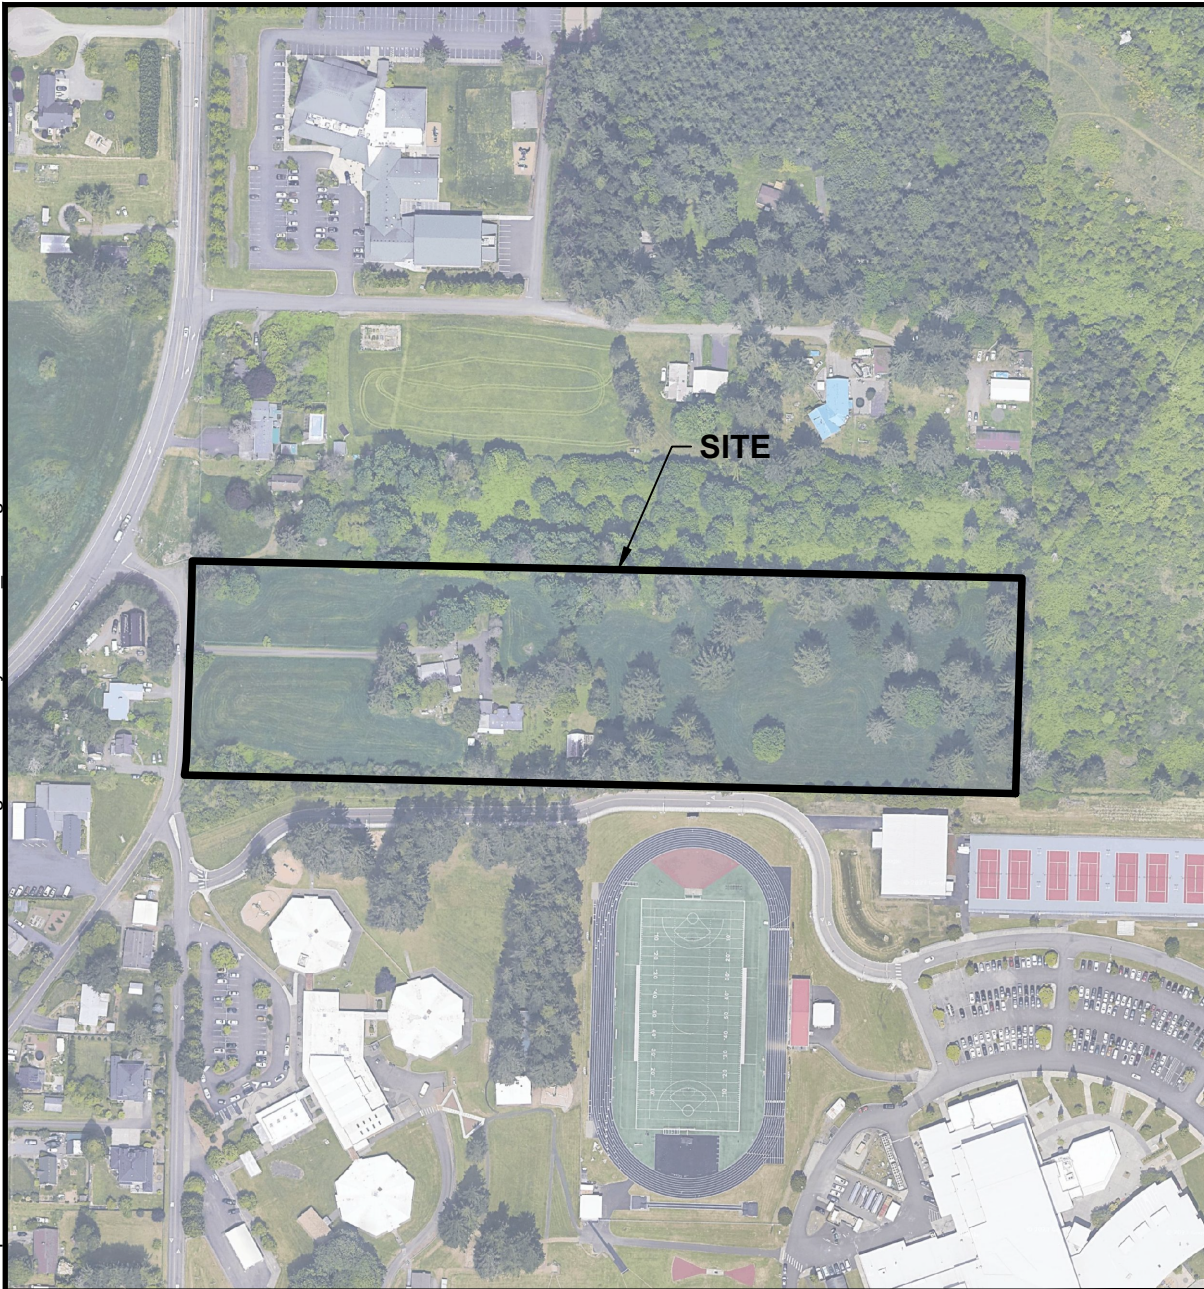
USFWS NATIONAL WETLANDS INVENTORY
Rek Dahl Determination
HSR Capital, LLC.
Camas, Clark County, Washington
Section 35, Township 02N, Range 03E, W.M.

No mapped wetlands indicated onsite by US Fish & Wildlife Service.

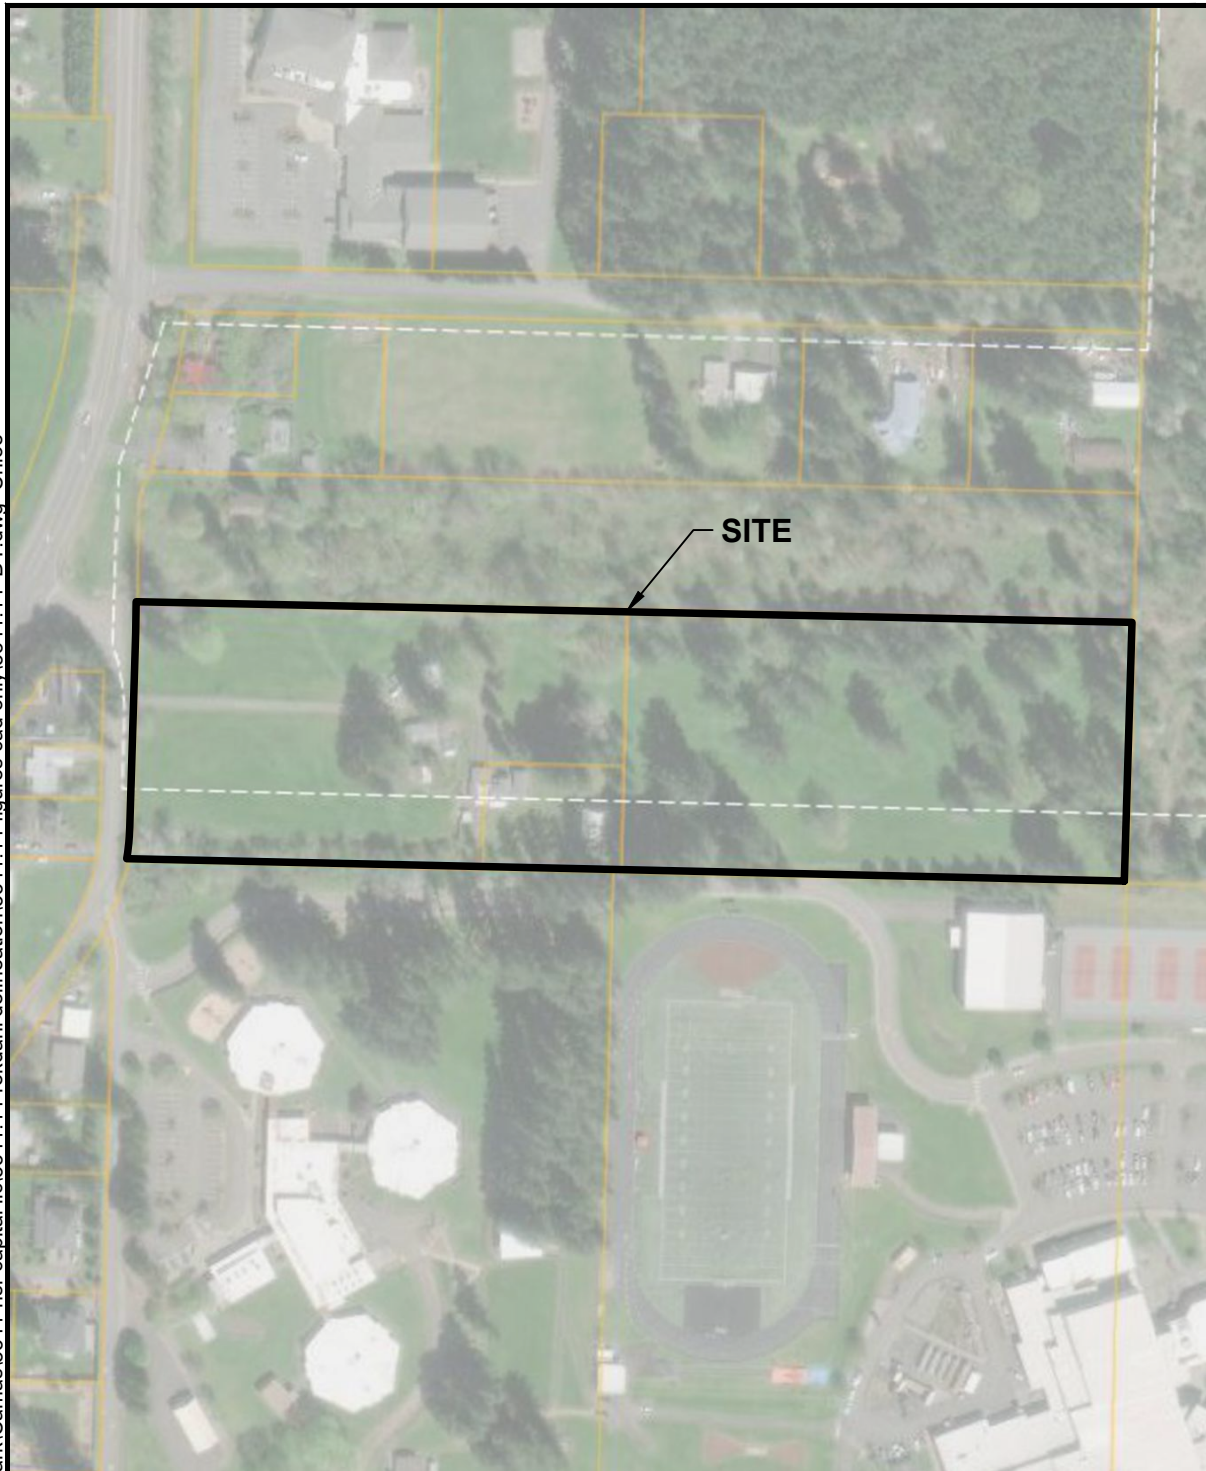
Figure 6
WDFW PRIORITY HABITATS AND SPECIES
 Rekdahl Determination
 HSR Capital, LLC.
 Camas, Clark County, Washington
 Section 35, Township 02N, Range 03E, W.M.

No mapped priority habitats or species indicated onsite by Washington State Department of Fish & Wildlife.
