**GEOTECHNICAL ENGINEERING STUDY  
W/INFILTRATION**

**Proposed Oliver's Terrace Subdivision  
1004 SE Everett Road  
Camas, WA 98607  
(Parcel No. 178221000)**

**Project No. G2352400r  
{July 2025}**

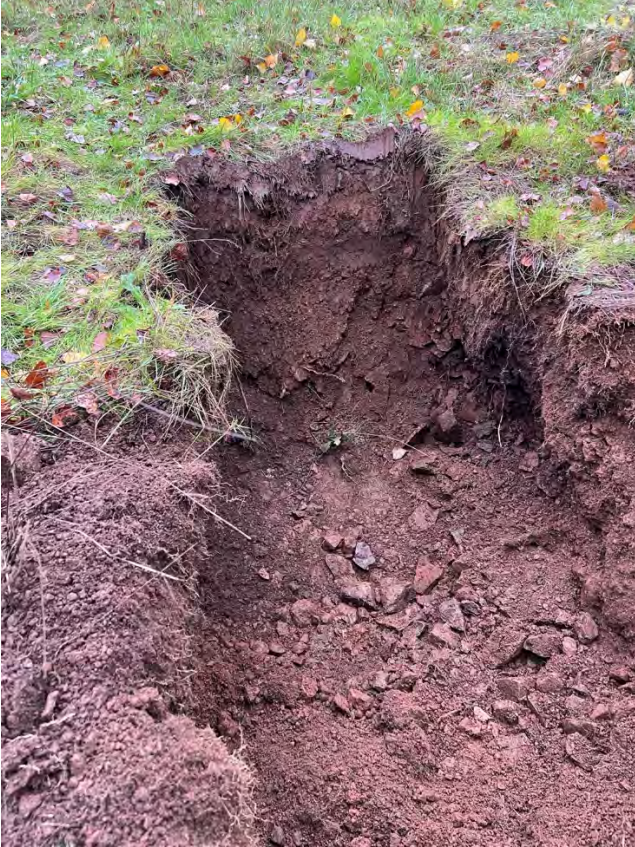
I-1. Bedrock @ 2.5 ft. bgs

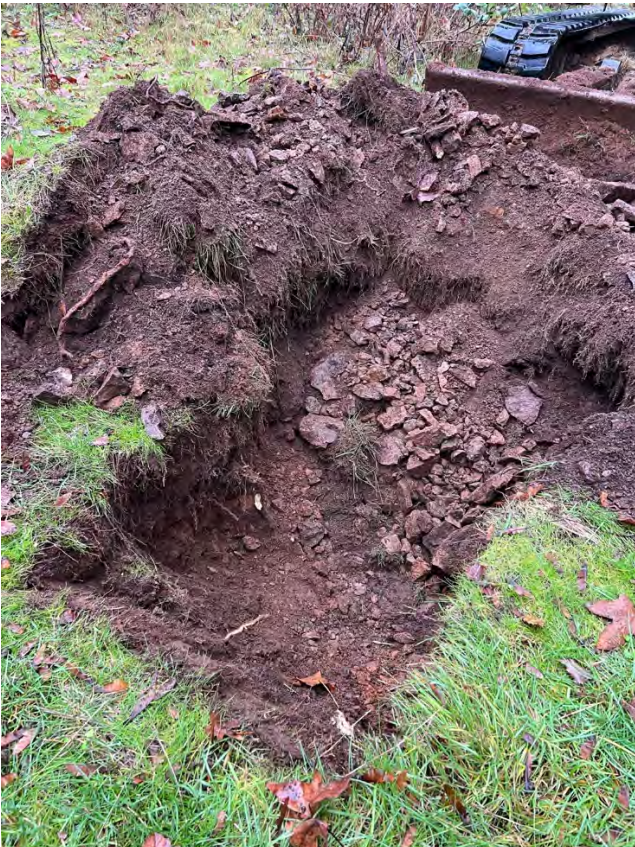
TP-2. Bedrock @ 2.0 ft. bgs

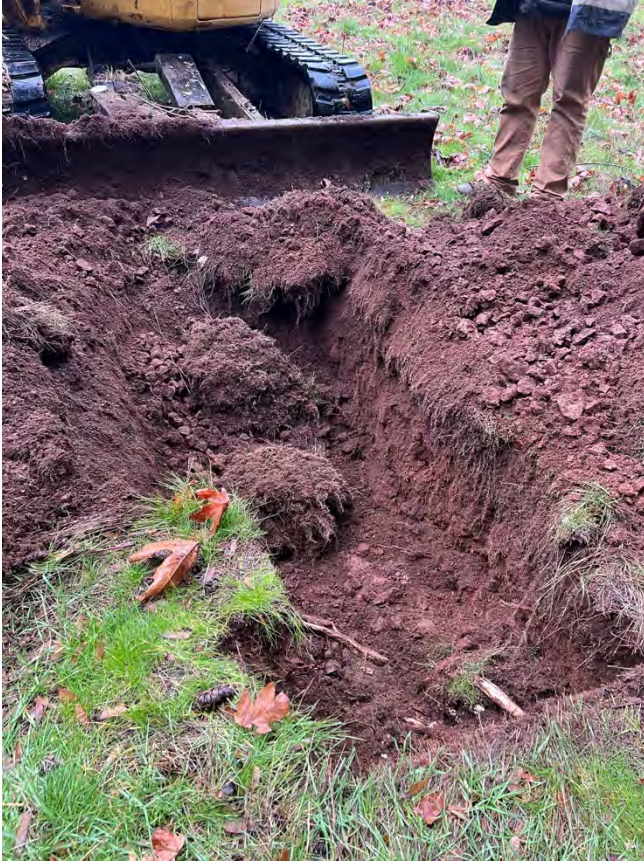
TP-3. Bedrock @ 2.0 ft. bgs

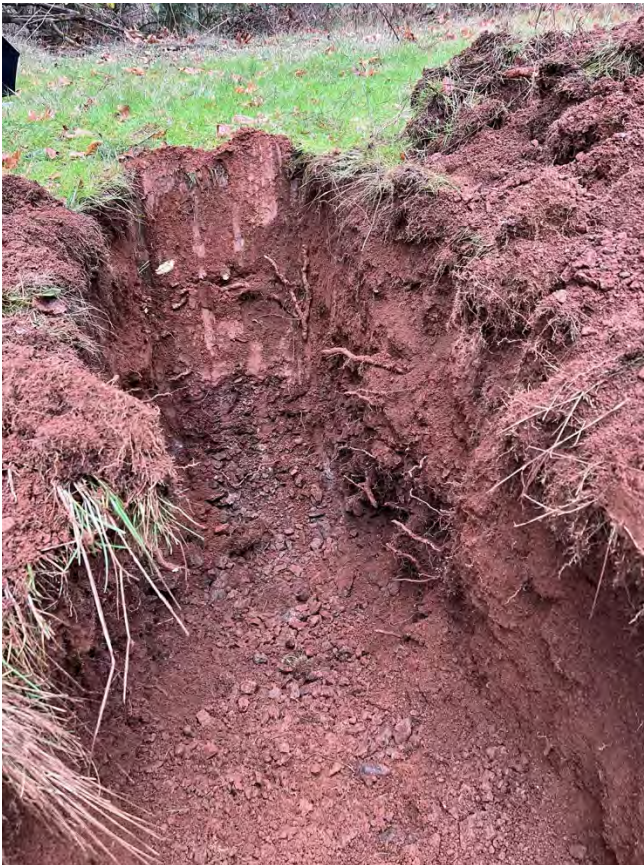
TP-4. Bedrock @ 4.5 ft. bgs

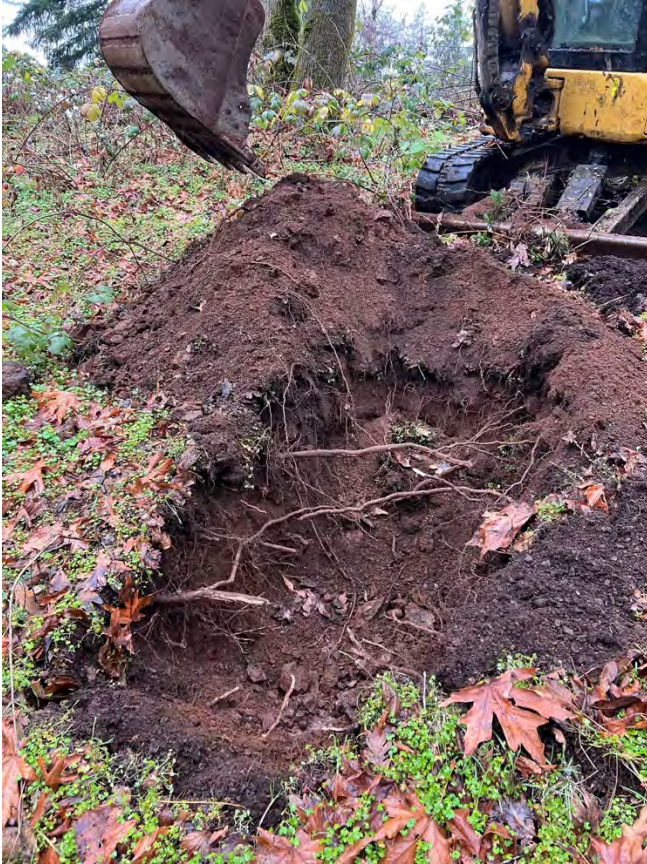
TP-5. Bedrock @ 2.0 ft. bgs

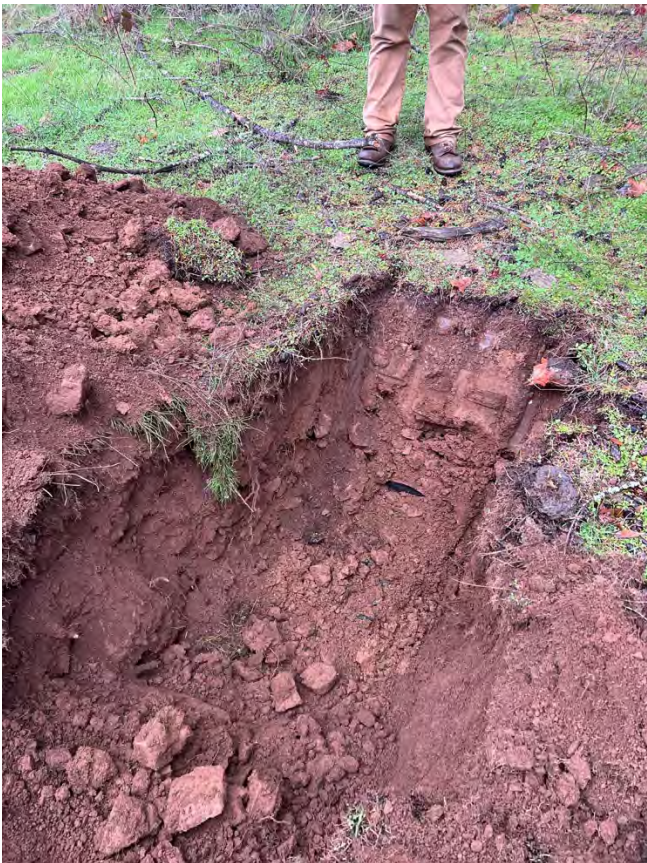
TP-6. Bedrock @ 2.5 ft. bgs

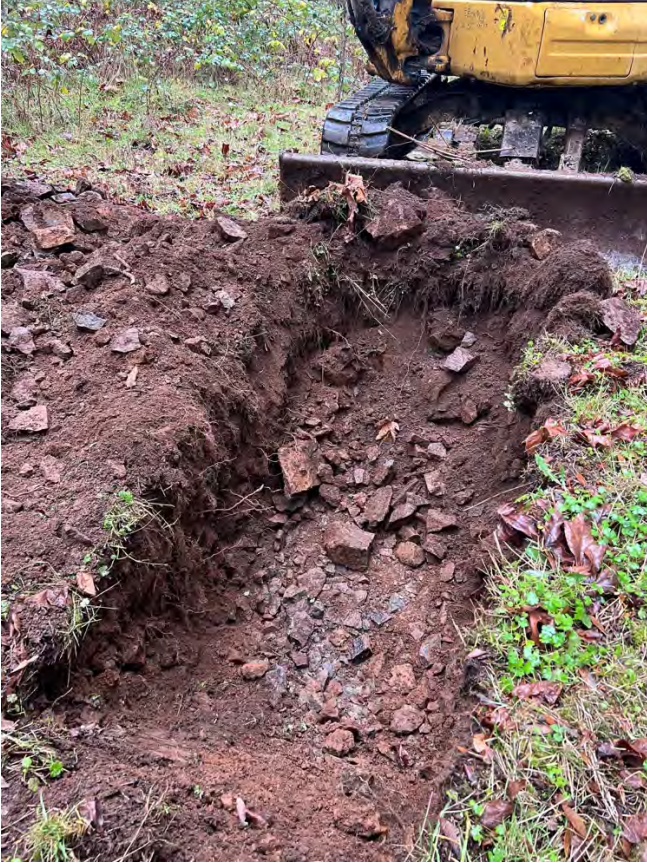
I-7. Bedrock @ 2.5 ft. bgs
