Camas High School District Tennis Courts

Technical Information Report

September 27, 2024

MacKay Sposito
Prepared By: Michael Rogers
Project Number: 18551

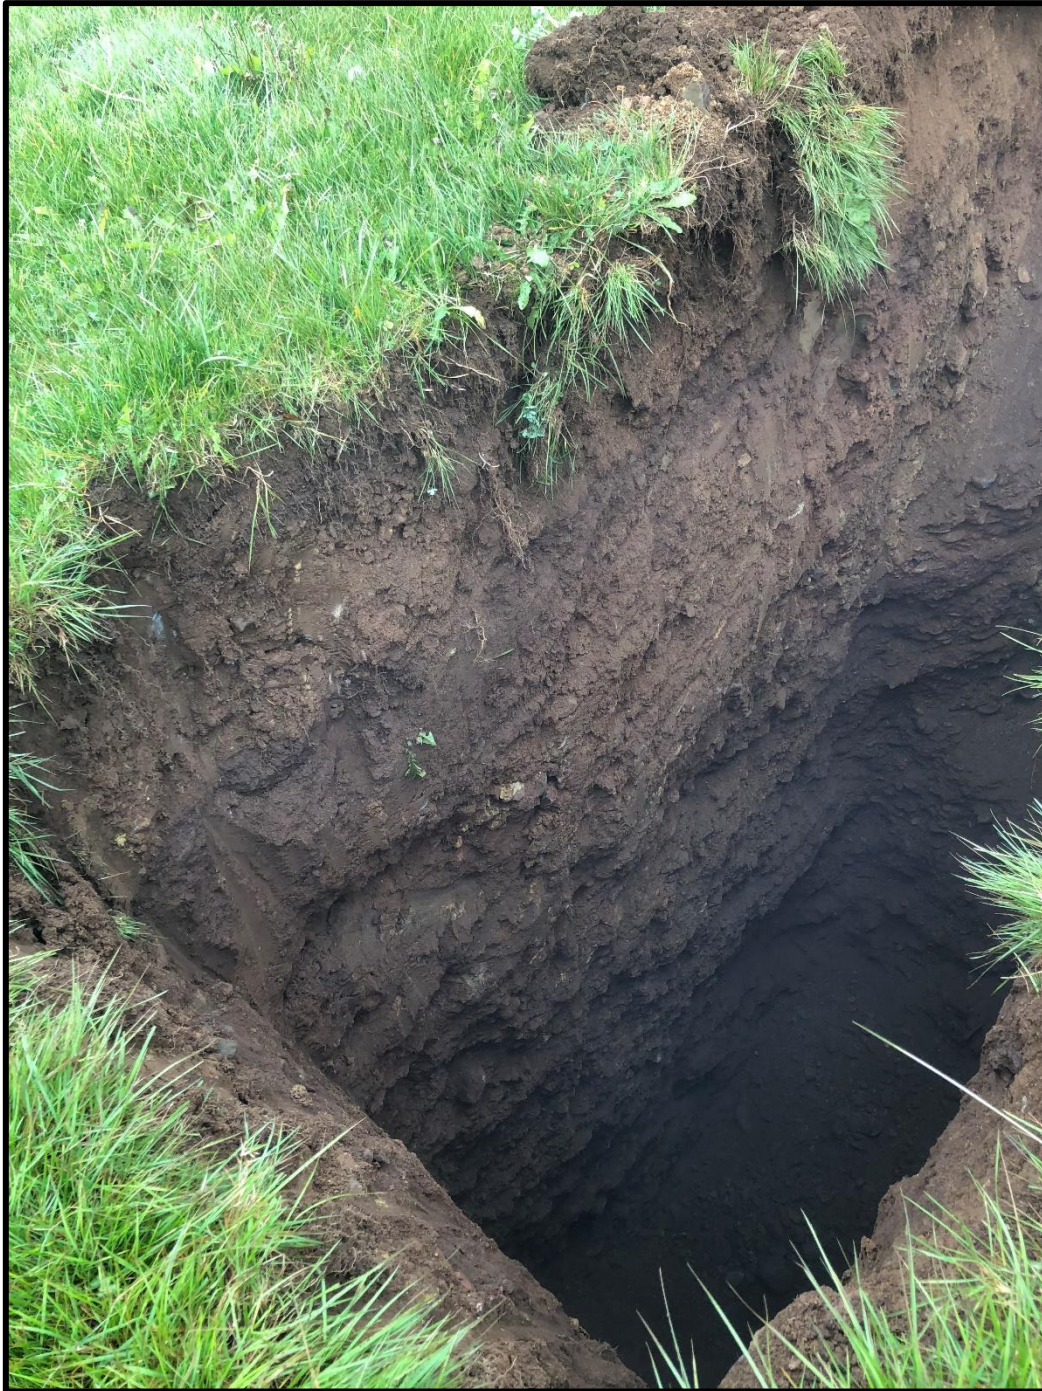
Test Pit Profile, TP-1

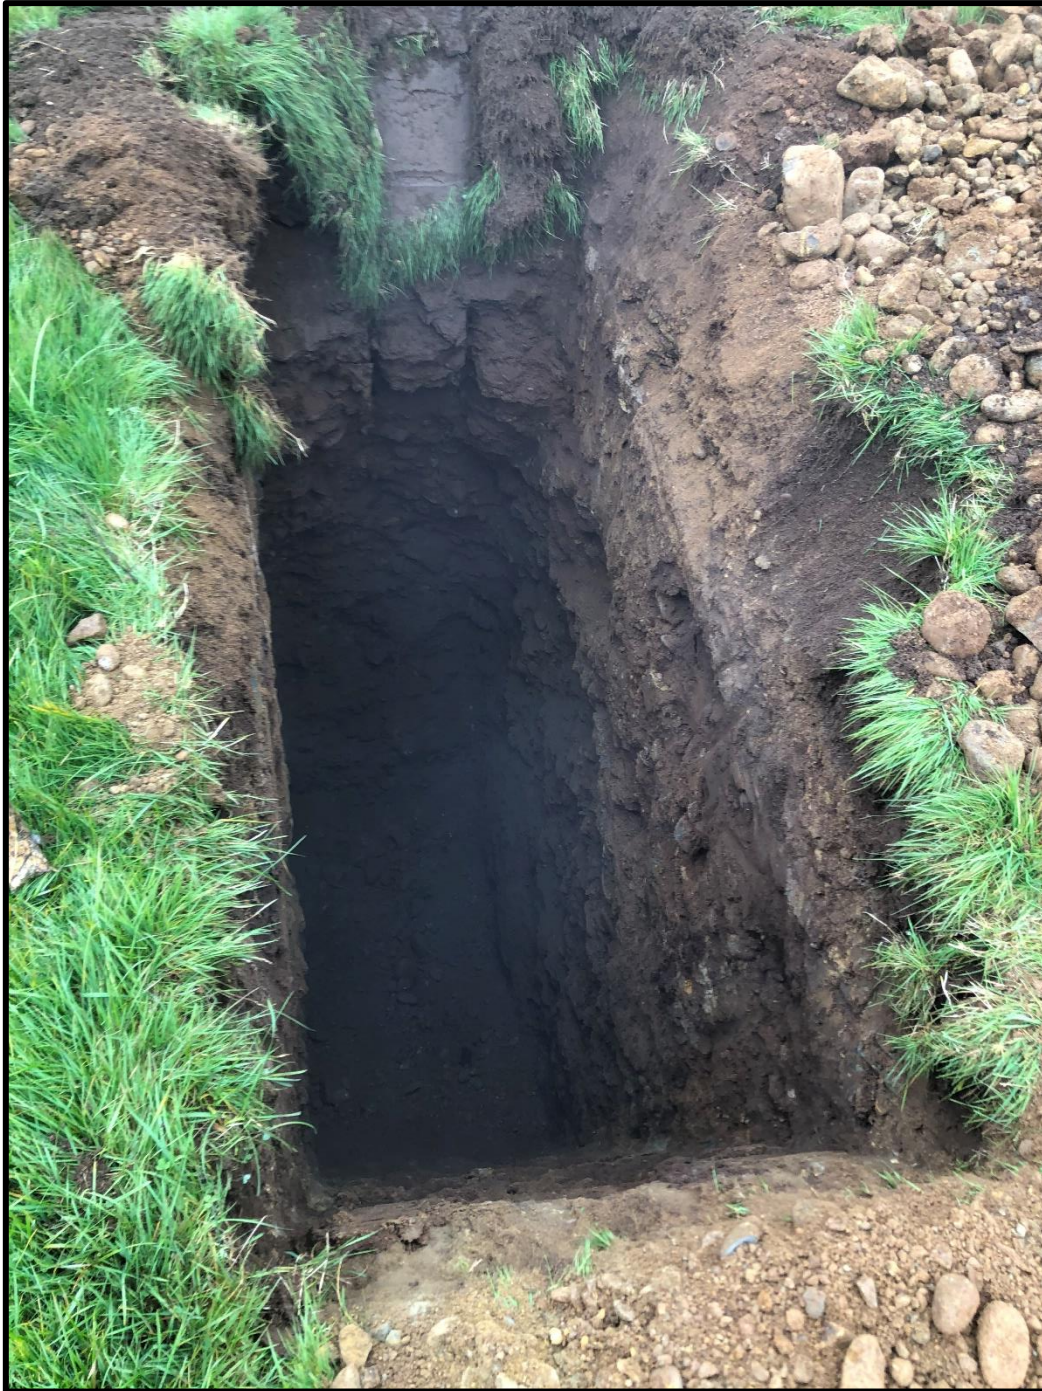
Test Pit Profile, TP-2

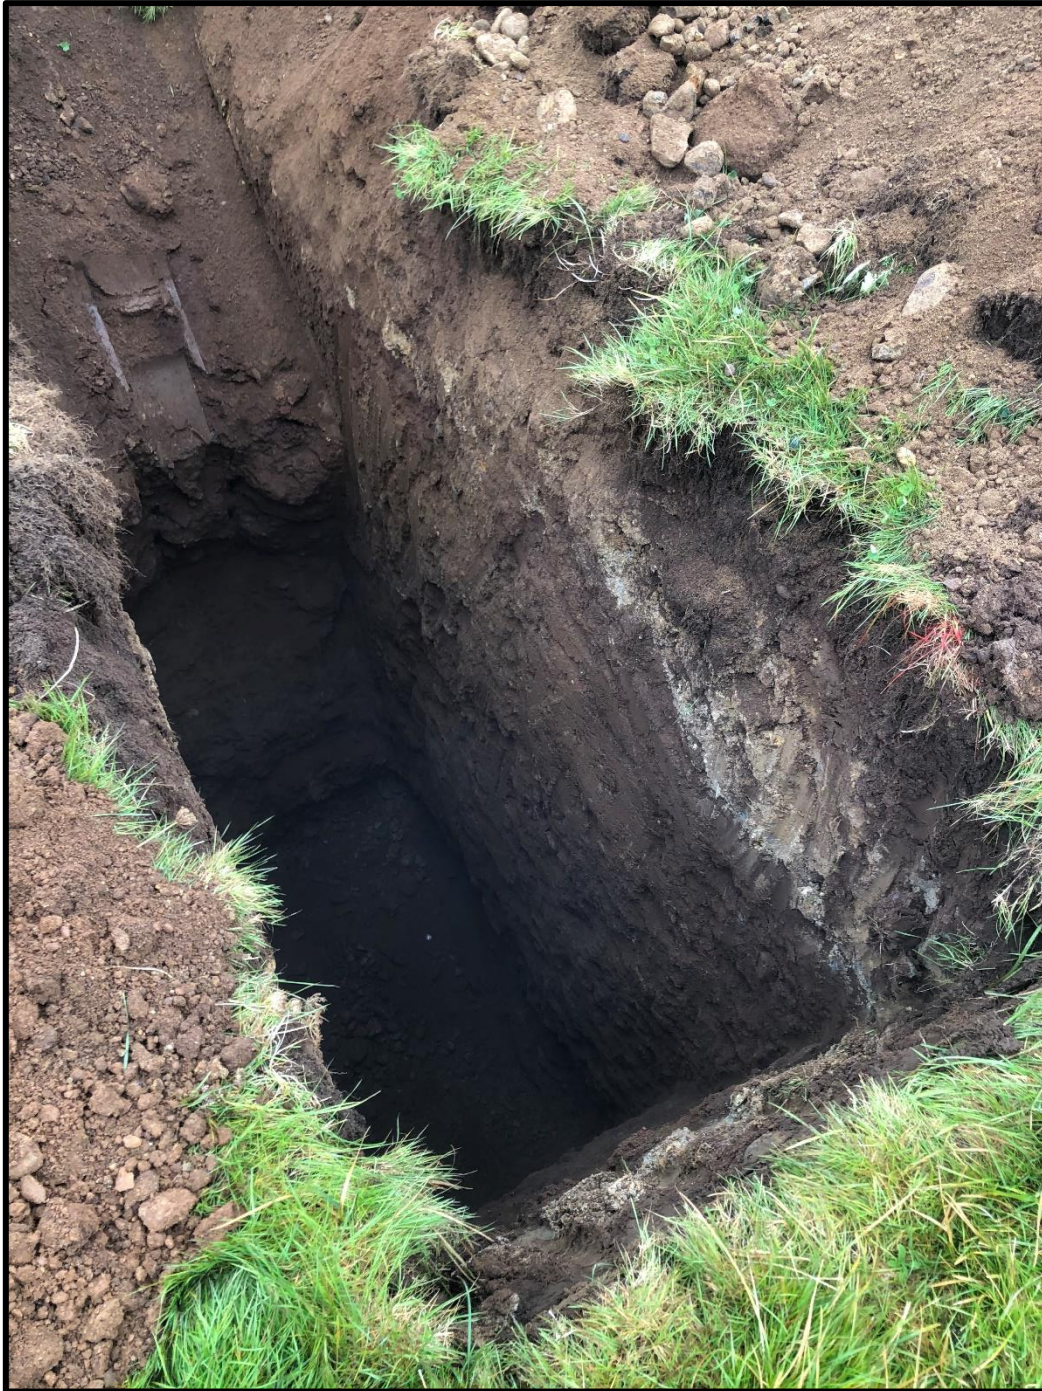
Test Pit Profile, TP-3

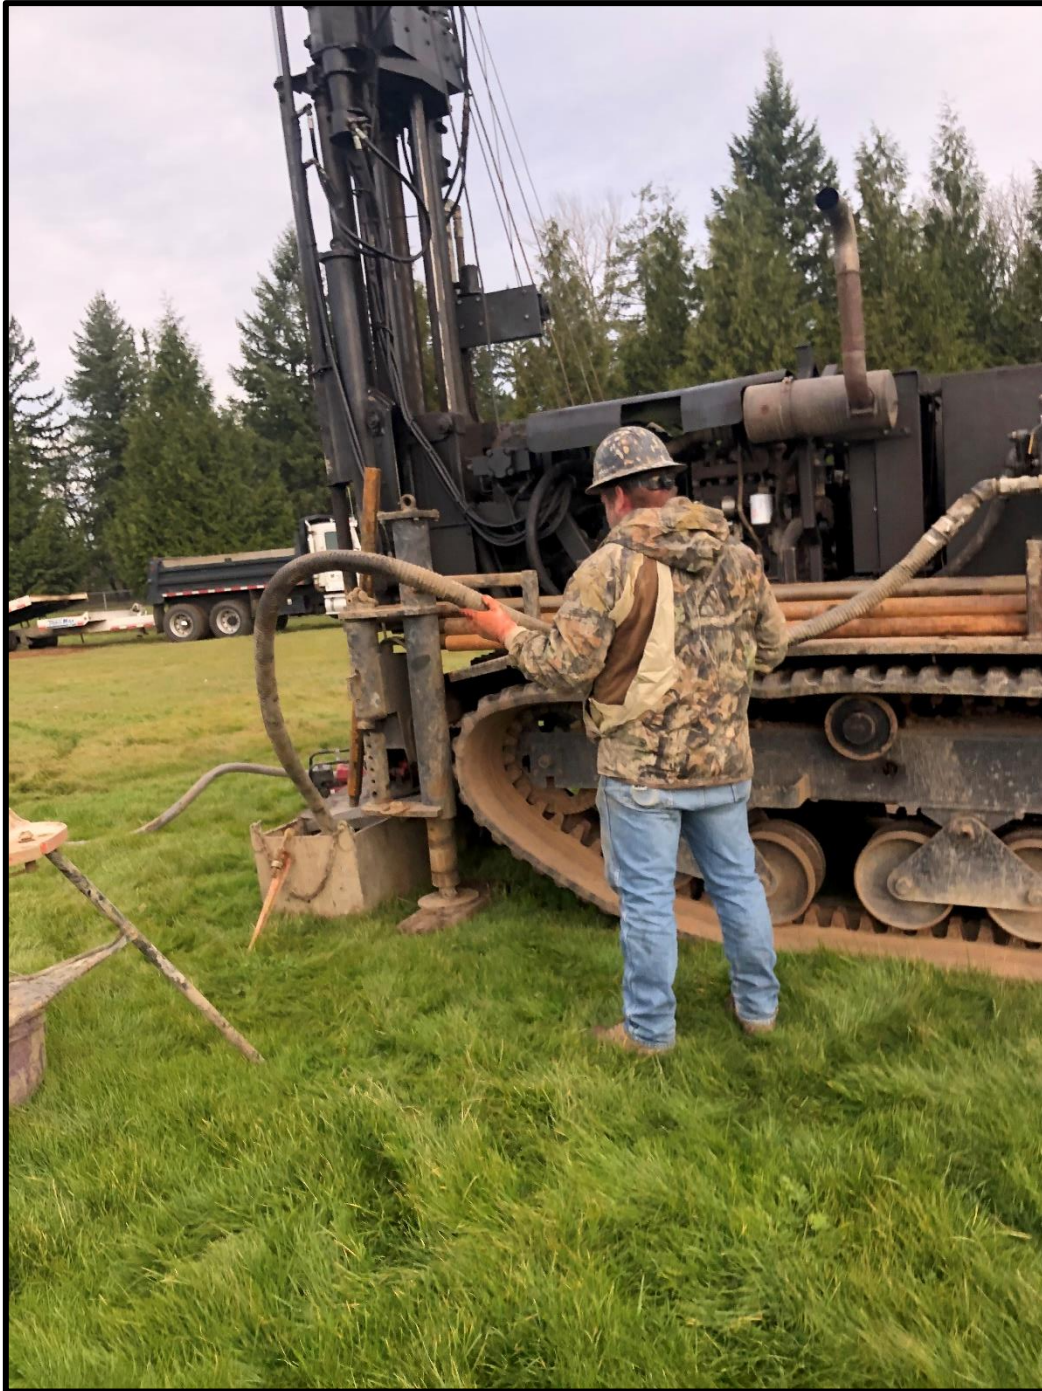
Soil Boring, SB-1

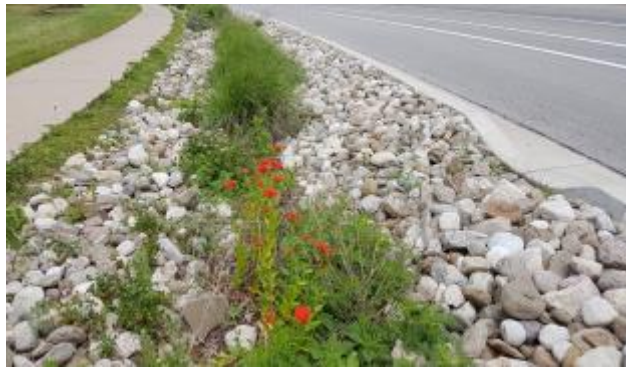
Wet Biofiltration Swale

A wet biofiltration swale is a variation of basic biofiltration swale for use where the centerline slope is slight, groundwater table are high, or a continuous low base flow is likely to result in wet soil conditions for long periods of time. Where continuously wet soil exceeds about 2 weeks, typically grasses will die. Thus, vegetation specifically adapted to wet soil conditions is needed. Different vegetation requires modification of several of the design and maintenance requirements from the basic biofiltration swale.

See SWMMWW [Appendix V-A](#), Table V-A.9 for wet biofiltration swale maintenance standards. If available, reference record drawings for seed mix and groundcover replacements, or see SWMMWW [BMP T9.20, Table V-7.5](#). Removal of cattail is required when vegetation is crowded out by very dense clumps of cattails, prevents water flow, or alters the designed functionality.

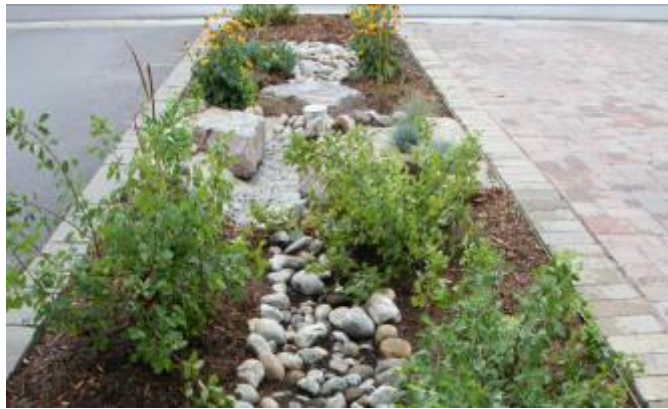
Conveyance Ditch

Ditches are often manmade open-channels that convey stormwater runoff. These ditches are maintained to prevent localized flooding.

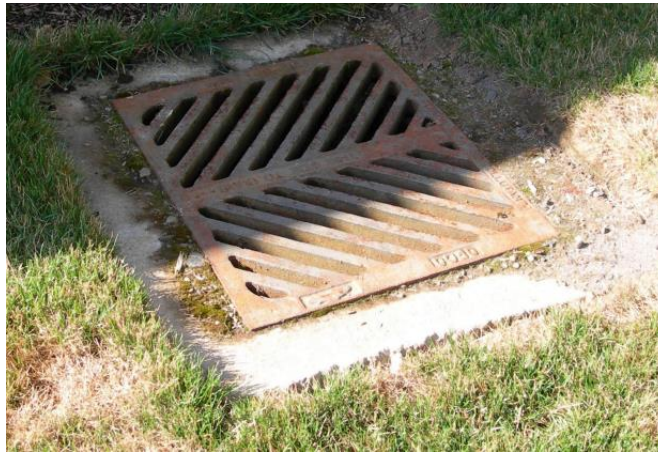
Field Inlet

An inlet is a concrete, plastic or steel structure fitted with a slotted grate to collect stormwater runoff and route through underground pipes. A field inlet has a flat grate, and a ditch inlet has an angled grate. These inlets typically provide a sump below the outlet pipe to allow sediment and debris to settle out of the stormwater runoff. Some of these inlets are fitted with a spill control device such as an inverted elbow on the outlet pipe to control grease or oils. The most common tool for cleaning out the inlet is a vactor truck which is used to remove sediment and debris from the sump. The sediment and oils if not removed from the inlet has the potential to pollute downstream water bodies. Unless you have OSHA approved confined space training and equipment, never enter an inlet. There is a considerable risk of poisonous gas and injury.

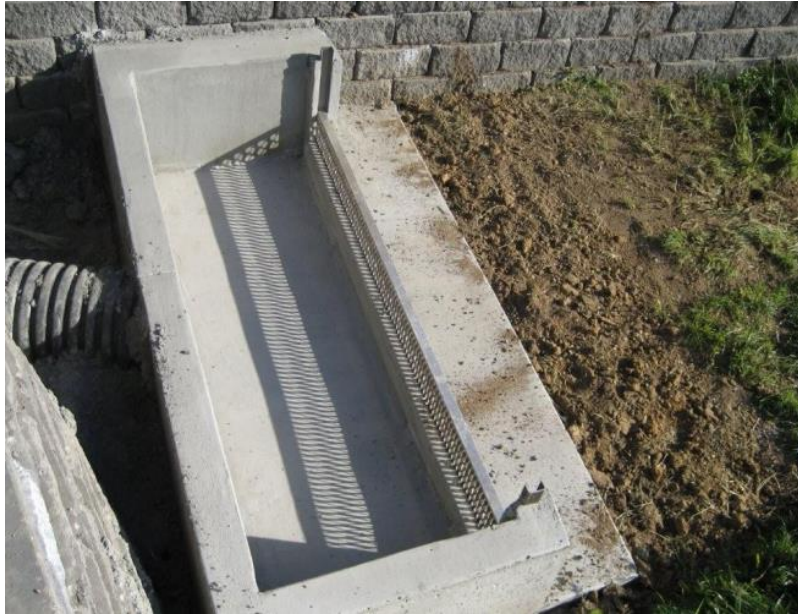
A sediment trap is a concrete structure typically fitted with slotted grate or multiple slotted grates. The concrete structure provides a storage volume (sump) below the outlet pipe to allow sediment and debris to settle out of the stormwater runoff. A sediment trap can be a fully enclosed concrete structure (above or below ground) with a sump, inlet pipe(s) and outlet pipe.

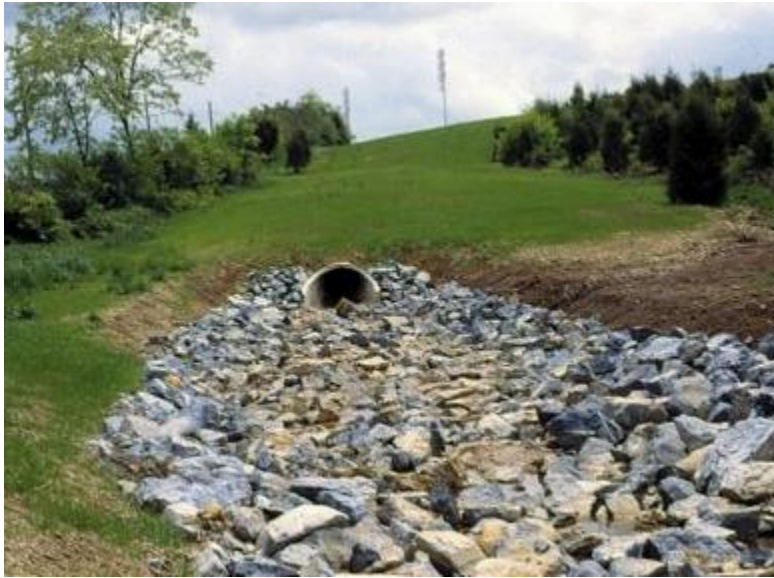
Discharge Point

Stormwater facility discharge points may convey drainage from the stormwater facility into open channels, ditches, ponds, wetlands, streams, or lakes. Stormwater facility discharge points need to be assessed to make sure stormwater is not causing any negative impacts to these drainage areas.

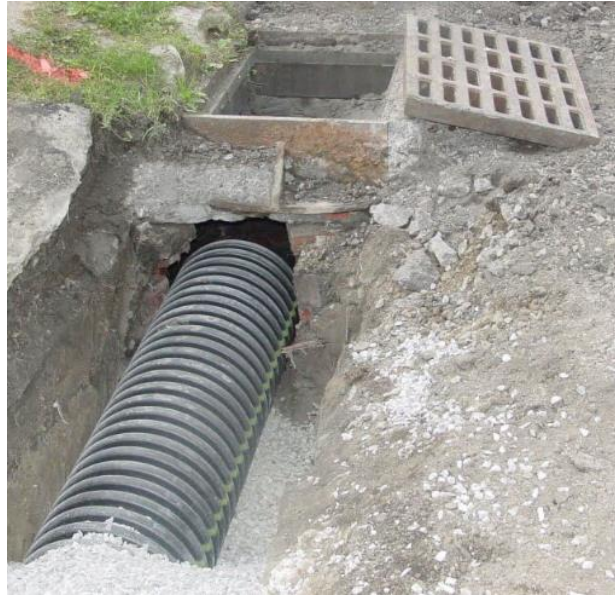
Storm Sewer Pipe

Storm sewer pipes convey stormwater. Storm pipes are constructed of many different types of materials and are sometimes perforated to allow groundwater to be collected by the storm system. Storm pipes are cleaned to remove sediment or blockages when problems are identified. Storm pipes must be clear of obstructions and breaks to prevent localized flooding.

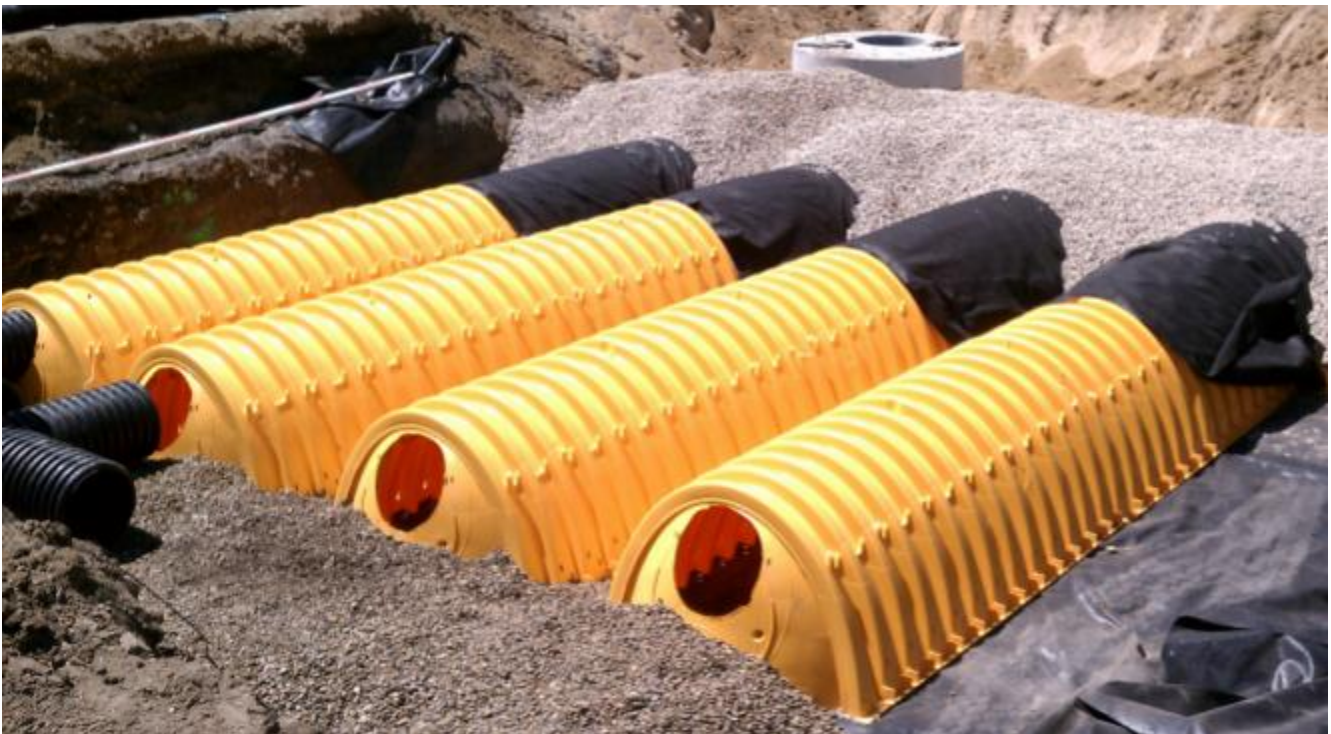
Drywell

Drywells are perforated, open-bottomed manholes used to infiltrate stormwater into the ground. While not the intended use, drywells trap sediment and some of the oil pollutants in stormwater runoff. Drywells are more likely to fill with oily sediment in areas that lack swales or other treatment facilities. Fine oil sediment can clog drywells and lead to localized street flooding. Also, pollutants discharged into drywells can migrate into groundwater. Drywells were often installed in closed topographic depressions, areas with will-drained soils, or areas having inadequate storm sewers. Often, drywells contain groundwater.

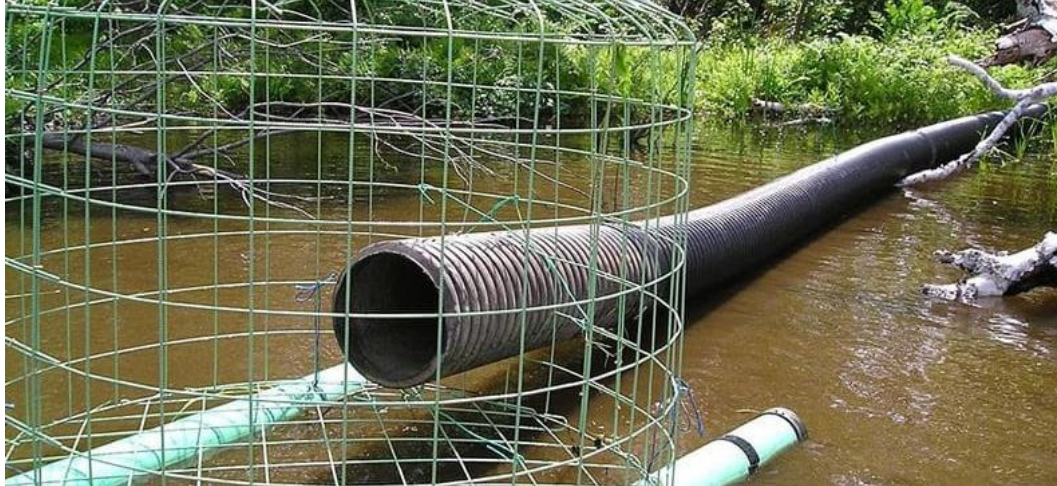
Pond Leveler System

The pond leveler system consists of an intake cage and outlet pipe. This system is used to bypass beaver dams. The pond leveler system creates a permanent leak through the beaver dam that the beavers cannot stop.

Pond Leveler			
Maintenance Component	Defect or Problem	Conditions When Maintenance Is Needed	Minimum Maintenance Required
Intake Cage	Debris and sediment	Debris and sediment build up around cage	Remove debris and sediment build up around cage. Recommended tools: potato rake and a narrow, stiff shop broom.
	Structure	Broken cage, resulting in holes larger than 6" diameter.	Repair hole with similar cage material, attach with hog rings.
	Obstruction to inflow pipe	Debris obstructing pipe flow inside intake cage	Remove obstruction
Outflow Pipe	Obstruction	Debris obstructing outflow	Remove obstruction

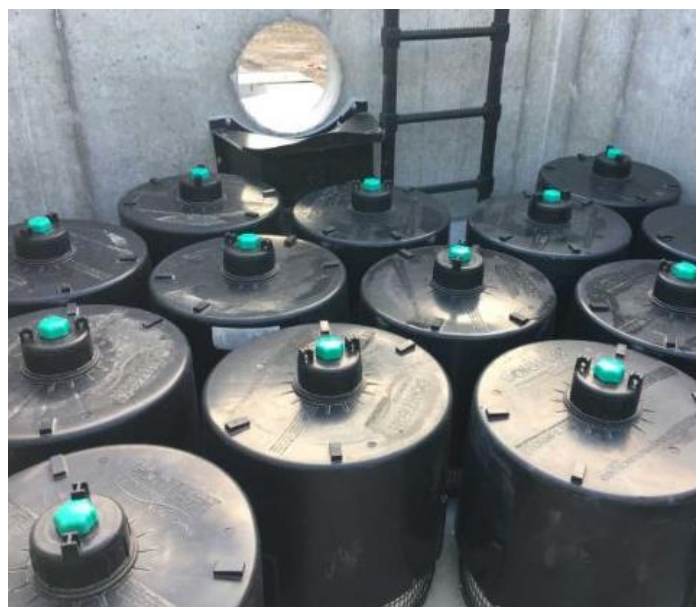
The filter media can be housed in cartridge filters enclosed in concrete vaults or catch basins. Structures will have vault doors or manhole lids for maintenance access. Various types of filter media are available from different manufactures. Determine the type of filter media used and consult manufacturer for maintenance recommendations.

Manufactured Media Filter – Additional Maintenance Standards			
Maintenance Component	Defect or Problem	Conditions When Maintenance Is Needed	Minimum Maintenance Required
Below Ground Vault or Manhole	Sediment Accumulation in Vault (no first chamber)	Sediment depth exceeds 4-inches on vault floor.	Remove sediment from vault floor. May require replacing media cartridges, consult manufacturer.

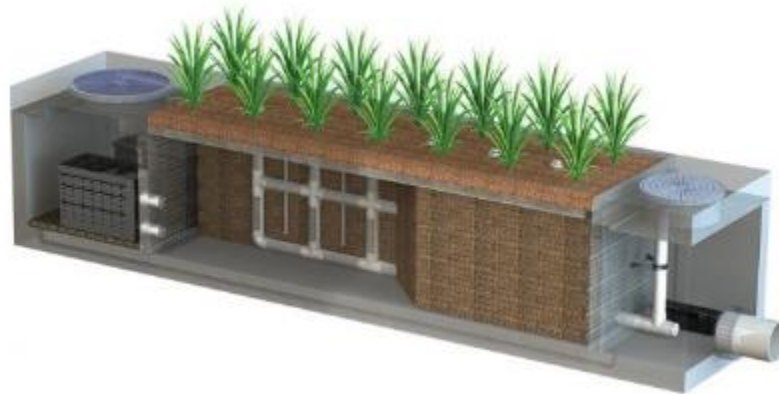
Modular wetlands linear is a biofiltration system that utilizes horizontal flow which allows for a smaller footprint, higher treatment capacity and design versatility. This system can be utilized downstream of storage for additional volume control and treatment. The modular wetland is contained in an underground vault that has different chambers containing media. Some modular wetlands can have plants growing out of it, but it is not required for the system to function. Once filtered through the media, the treated stormwater is directed to a collection pipe or discharge to a pond or open channel drainage way.

Modular Wetland			
Maintenance Component	Defect or Problem	Conditions When Maintenance Is Needed	Minimum Maintenance Required
General	Missing or damaged components	Missing or damaged internal components or cartridges	Replace missing or repair damaged internal components or cartridges
Inlet or Outlet	Obstruction	Obstruction to inlet or outlet that impedes flow	Remove obstruction
Pretreatment Chamber	Floatingables	Excessive accumulation of floatables, in which the length and width of the chamber is fully impacted more than 18"	Remove floatables
	Sediment	Excessive accumulation of sediment, more than 6" in depth	Remove sediment
Filter Cartridges	Sediment	Excessive accumulation of sediment on media, more than 85% clogged (blackish color)	Replace media
Vegetation (if applicable)	Overgrown	Overgrown vegetation	Trim/prune vegetation in accordance with landscaping and safety needs
Structure	Cracks in structure	Cracks wider than 1/2 inch or evidence of soil particles entering the structure through cracks	Repair cracks in vault

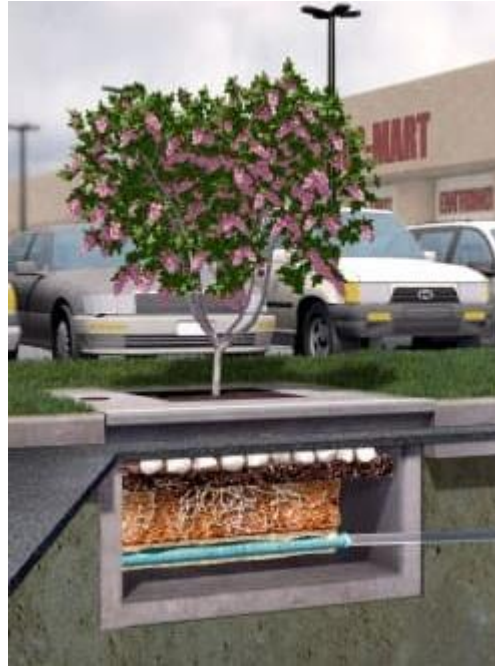
Tree box filter is a stormwater treatment system incorporating high performance biofiltration media to remove pollutants from stormwater runoff.

Tree Box Filter			
Maintenance Component	Defect or Problem	Conditions When Maintenance Is Needed	Minimum Maintenance Required
Inlet	Excessive sediment or trash accumulation	Accumulated sediments or trash impair free flow of water into system	Remove sediment and/or trash
Mulch cover	Trash and debris	Excessive trash and/or debris accumulation	Remove trash and/or debris.
	Standing water	Ponding of water over mulch due to excessive fine sediment accumulation or spill of petroleum oils	Remove mulch and replace, contact manufacturer for advice
Vegetation	Plant not growing or in poor condition	Soil/mulch too wet, evidence of spill, incorrect plant selection, pest infestation, vandalism to plants	Plants should be healthy and pest free, contact manufacturer for advice
	Plant growth excessive	Plants should be appropriate to the species and location	Trim/prune plants in accordance with landscaping and safety needs

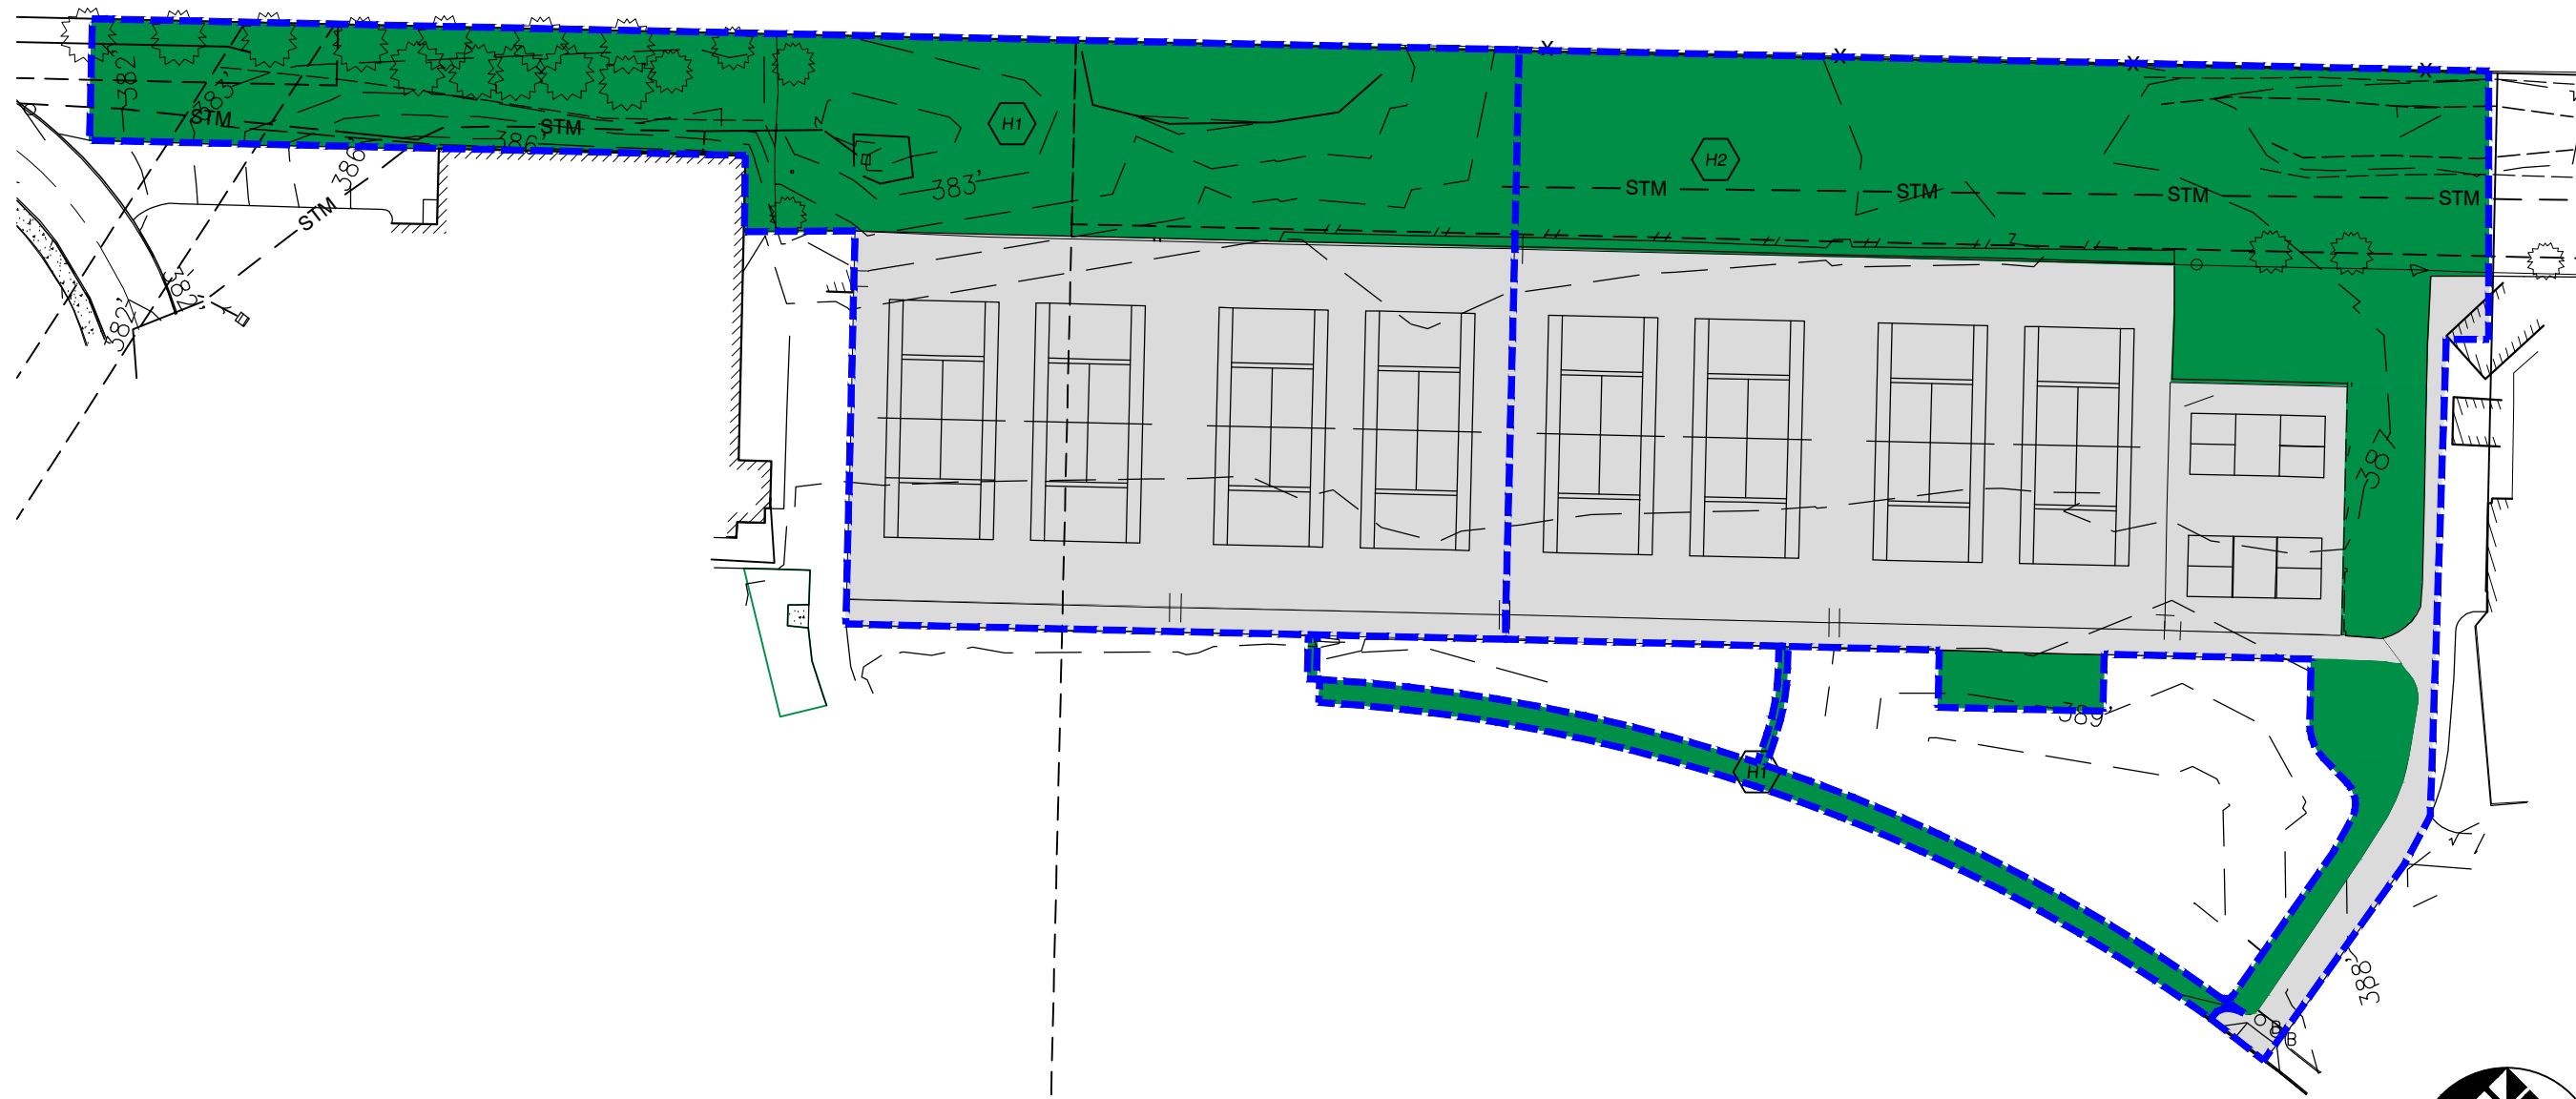
BASIN	IMPERVIOUS AREA (AC)	PERVIOUS AREA (AC)	TOTAL
H1	0.64	0.63	1.27
H2	0.82	0.68	1.5
TOTAL	1.46	1.31	2.77

The first step in our design was to determine the existing flow to the west facility and the existing flow to the east facility. Our proposed site area was divided into two catchments based on the existing condition named H1 which flows to the western facility and H2 which flows to the eastern facility. These catchments are shown on sheet CP-1 in Appendix G. The flows for these two catchments were determined using WWHM. The redevelopment of the site as stated above includes the installation of an air dome, a drive isle and additional parking. This results in an increase in stormwater which will need to be mitigated. The two existing facilities were not designed to accept the additional runoff which will be generated by the proposed redevelopment. An additional infiltration facility is proposed to mitigate for the excess runoff.
