MITIGATION PLAN

Leadbetter Road Subdivision Stream Crossing *Camas, Washington*

Prepared for
Toll Bros., Inc.
8815 122nd Ave. NE
Kirkland, WA 98033
425.825.1955

Prepared by
Ecological Land Services

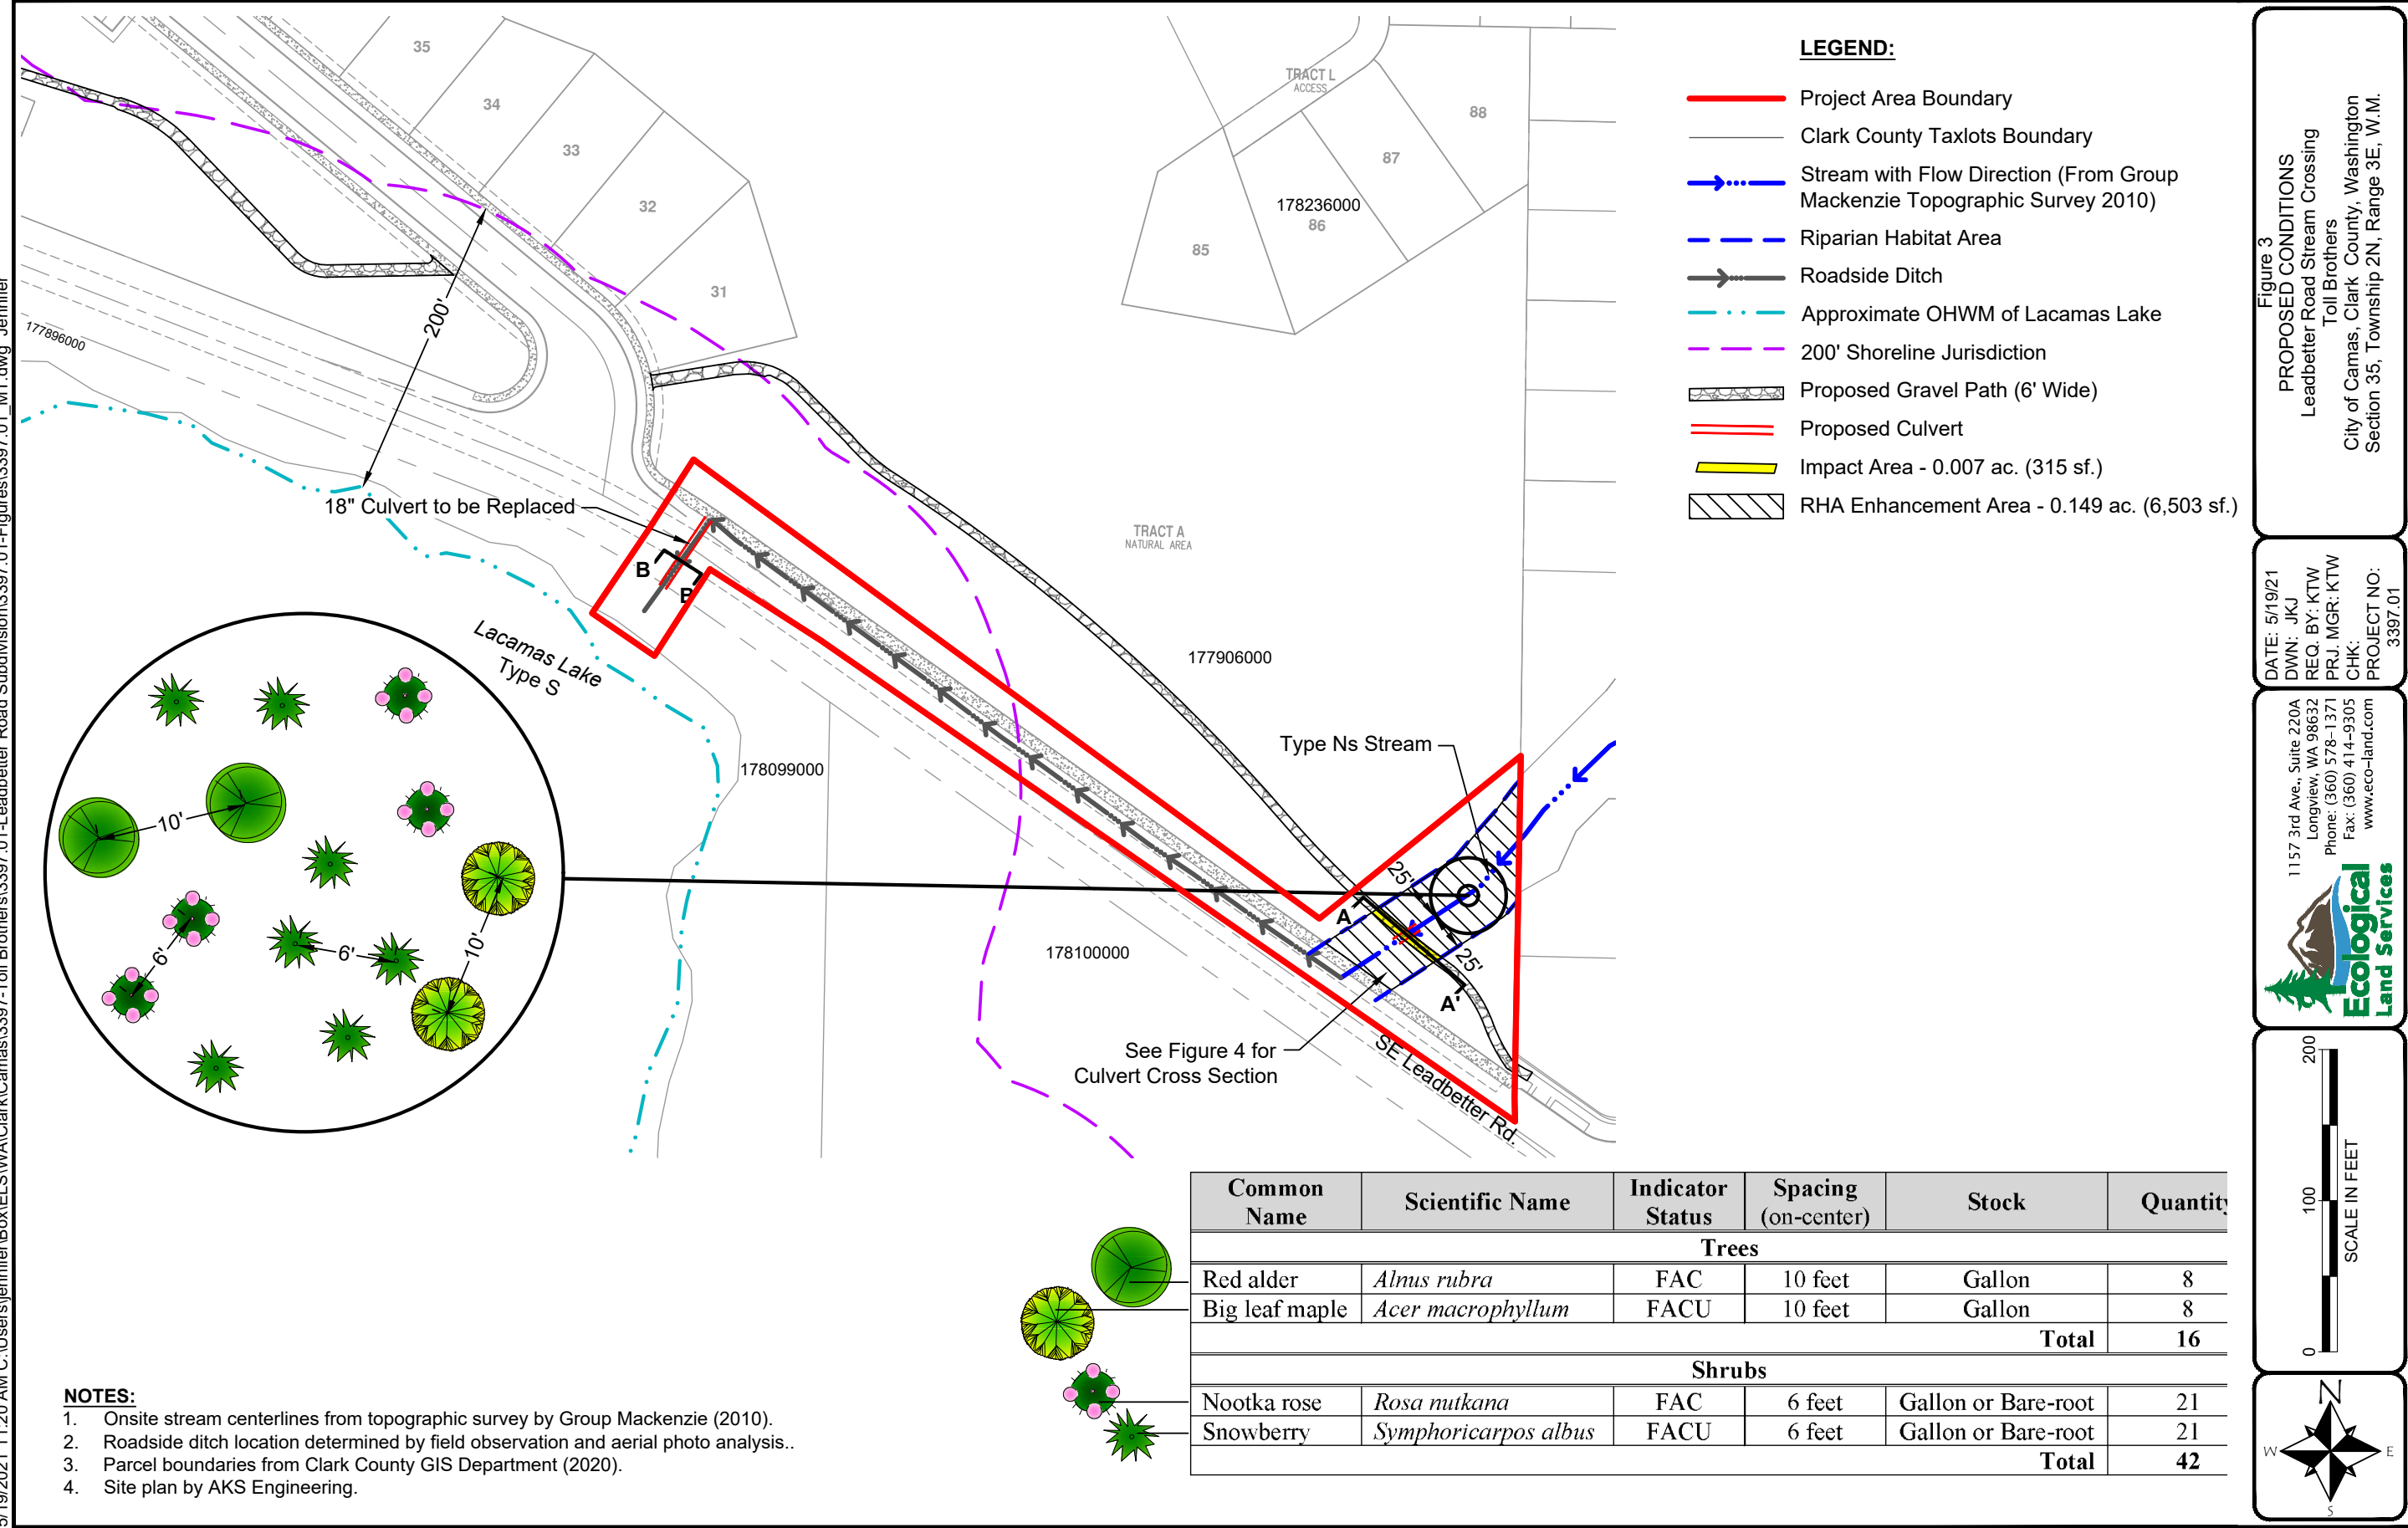
The applicant is proposing to construct a six-foot wide gravel walking path that will connect from the future Leadbetter Subdivision to the existing Deerhaven subdivision to the east. The walking path will cross the small unnamed Type Ns stream in the southeastern portion of the project area (Figure 3). The stream crossing will consist of the installation of a 30-inch diameter plastic culvert that is approximately 25 feet long. The culvert will be bedded and backfilled with typical stream grave. Fill slope armoring of quarry spalls or rip rap will be placed at the inlet and outlet. The trail surface will consist of 5/8-inch minus crushed rock (Figure 4). Additionally, the existing 18-inch diameter cement culvert that conveys the stream under SE Leadbetter Road from the roadside ditch
