From: Kimbal Logan <kimbal@kl-re.com>
Sent: Monday, August 10, 2020 11:29 PM
To: Sarah Fox
Cc: Barry McDonnell; Phil Bourquin; Shawn MacPherson (macphersonlaw@comcast.net); Jerry Acheson; Fox, Jamal; Steve Hogan; Don Chaney; 'LeAnne Bremer'; mpmills18@gmail.com; pakjam@gmail.com; karenmartel@comcast.net
Subject: Mills Family LLC - Application for Comp Plan Amendment - 57 acres in Lacamas North Shore

Earth Engineers, Inc. (EEI) is pleased to provide our attached Preliminary Geotechnical Investigation Report for the above referenced project. This report includes the results of our field investigation, an evaluation of geotechnical factors that may influence the proposed construction, and preliminary geotechnical recommendations for the future buildings and general site development.

57-Acres of the Mills Family Property
Parcels 5 and 6
North Shore of Lacamas Lake
Camas, Clark County, Washington

LEGACY LANDS MASTER PLAN: ADVISORY COMMITTEE MEETING #3

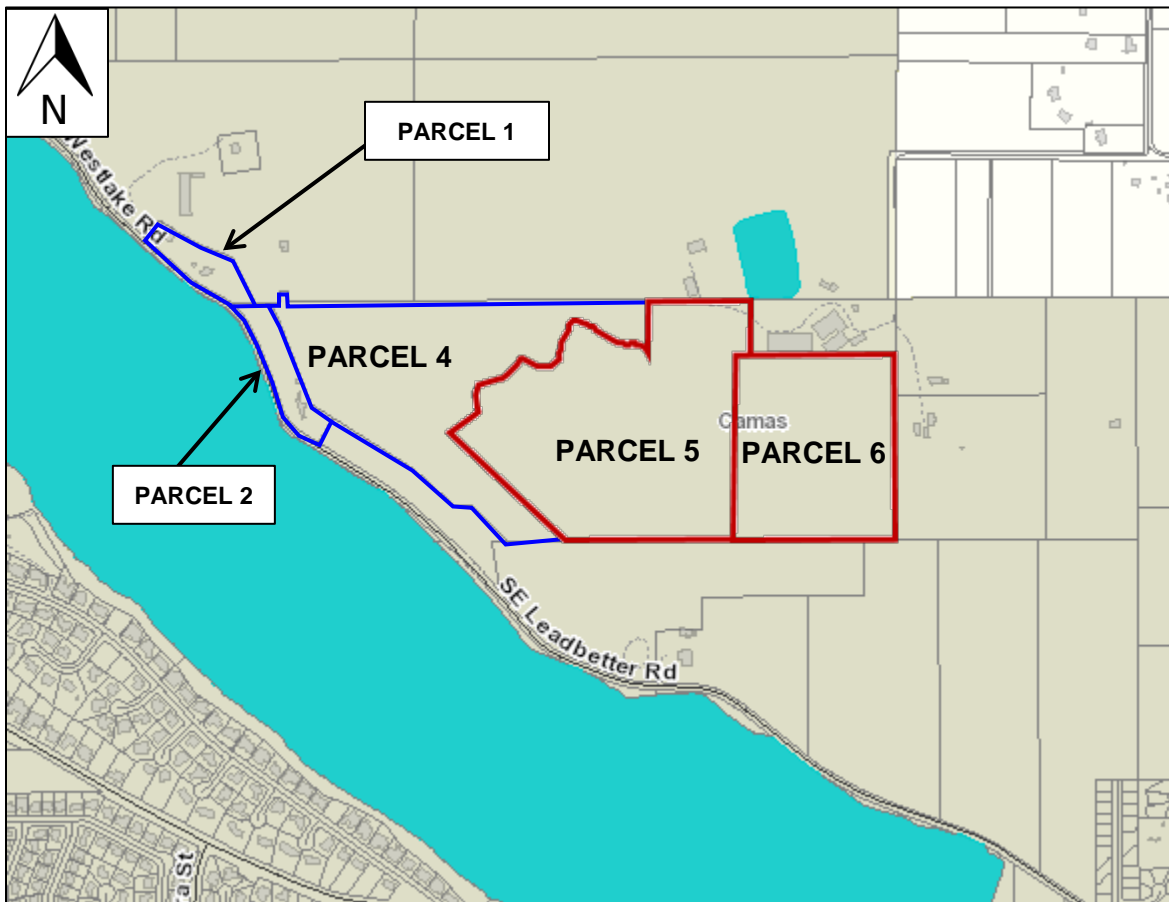
Figure 2: Vicinity map showing the subject property for this project (Parcels 5 and 6 – outlined in red), as well as the Mills Family LLC property that has been sold to the City of Camas (Parcels 1, 2 and 4 – outlined in blue). Base map source: <https://gis.clark.wa.gov/mapsonline/>.

As shown in Figure 2 above, Parcel 5 is irregularly shaped and Parcel 6 is rectangular. Cumulatively, the subject property (i.e. both parcels) is roughly 57 acres in size and is currently vacant. With respect to site topography, the subject parcels have variable slopes (i.e. there is not a general slope trend). The steepest slopes on the subject property are located on the northwestern property line of Parcel 5, with slopes of up to 70 percent (i.e. 1.4H:1V - Horizontal:Vertical). See Figure 3 below for the slopes on the subject property.

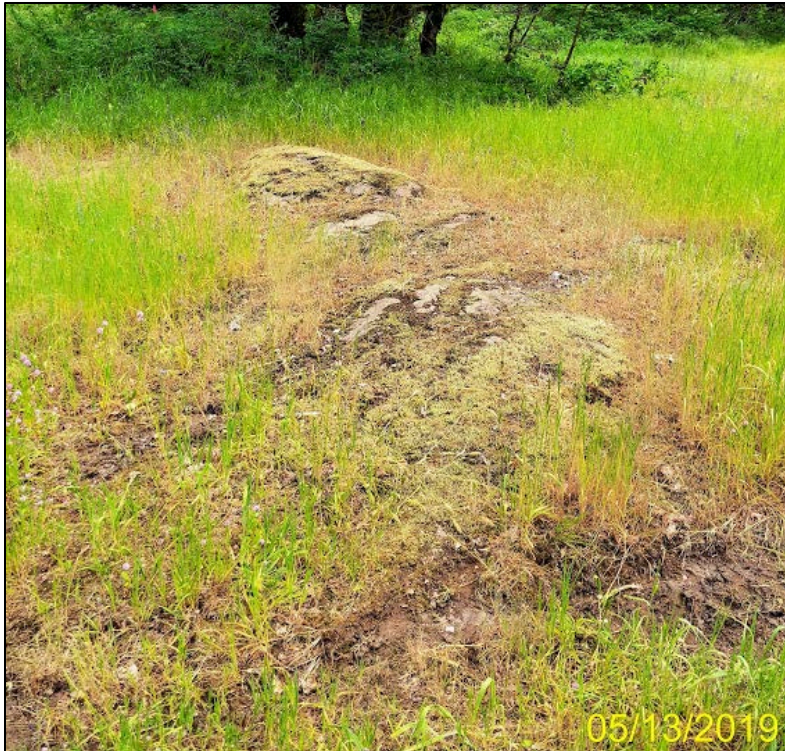
Photo 1: Example of a basalt outcrop encountered during our explorations.

The property is currently heavily vegetated with both young and mature trees, brush, shrubs and grass. While conducting our subsurface investigation, we encountered outcrops (i.e. visible exposures) of basalt rock. An example is shown in Photo 1 below. We also encountered a large ridge along the northern perimeter of Parcel 5 where bedrock is exposed at the surface, shown in Photo 2. In addition, we encountered a marshy wetland in the northeast corner of Parcel 6. See Photo 3 below.

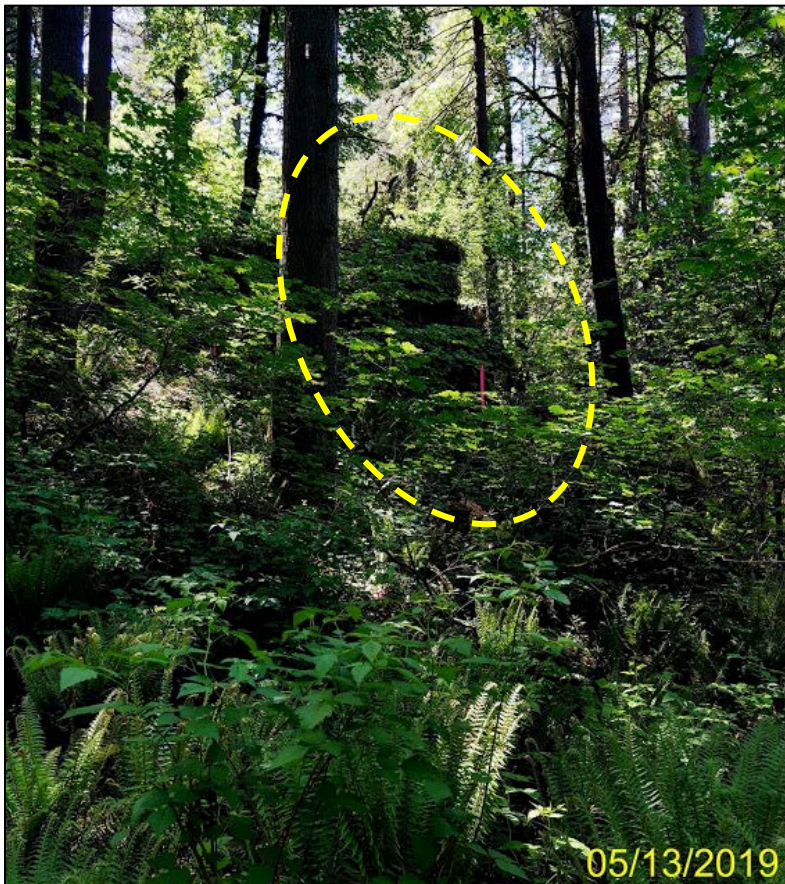
Photo 2: Steep ridge encountered during our explorations, exposing a basalt rock face.

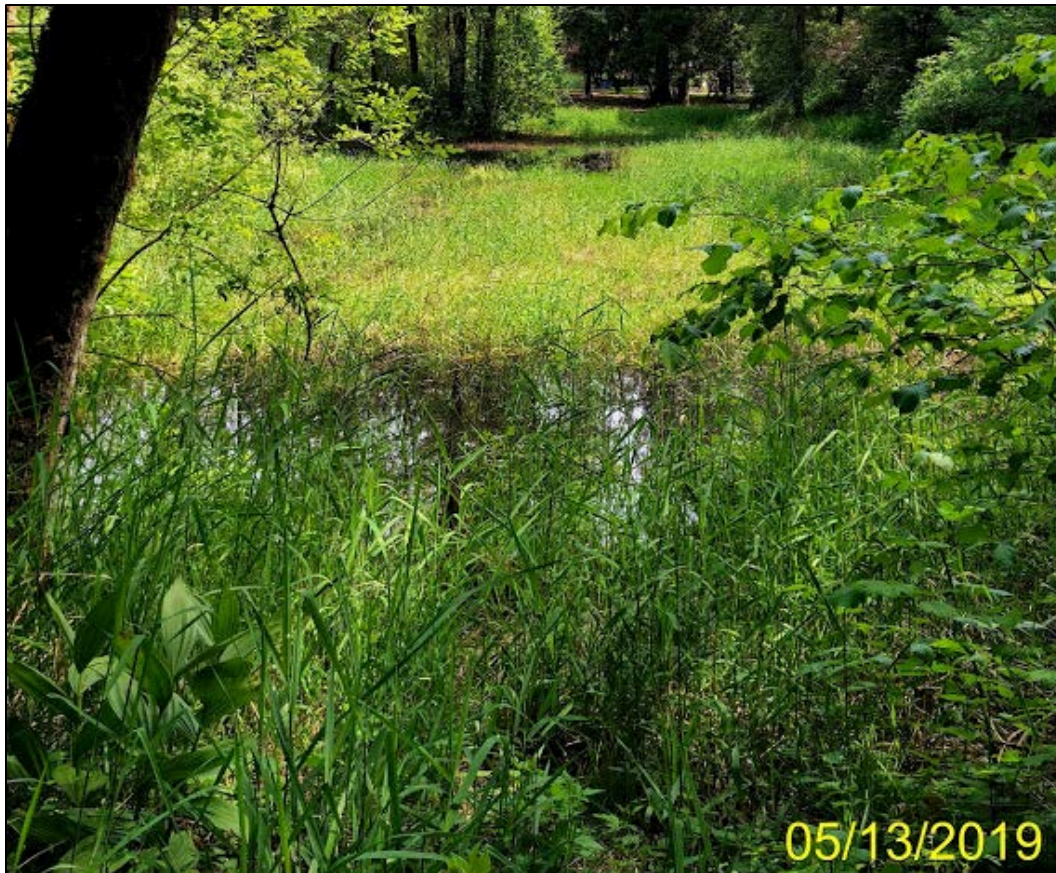
Photo 3: Marshy area encountered during our explorations.

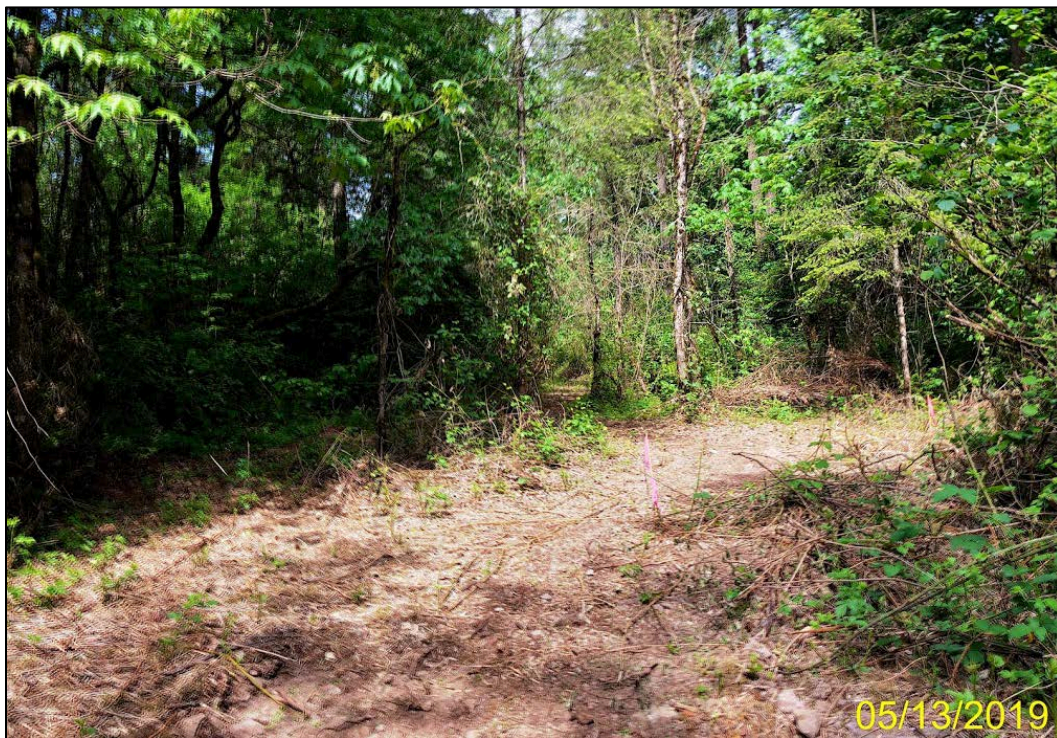
Photo 4: Access to the western property line from the newly cleared trail.

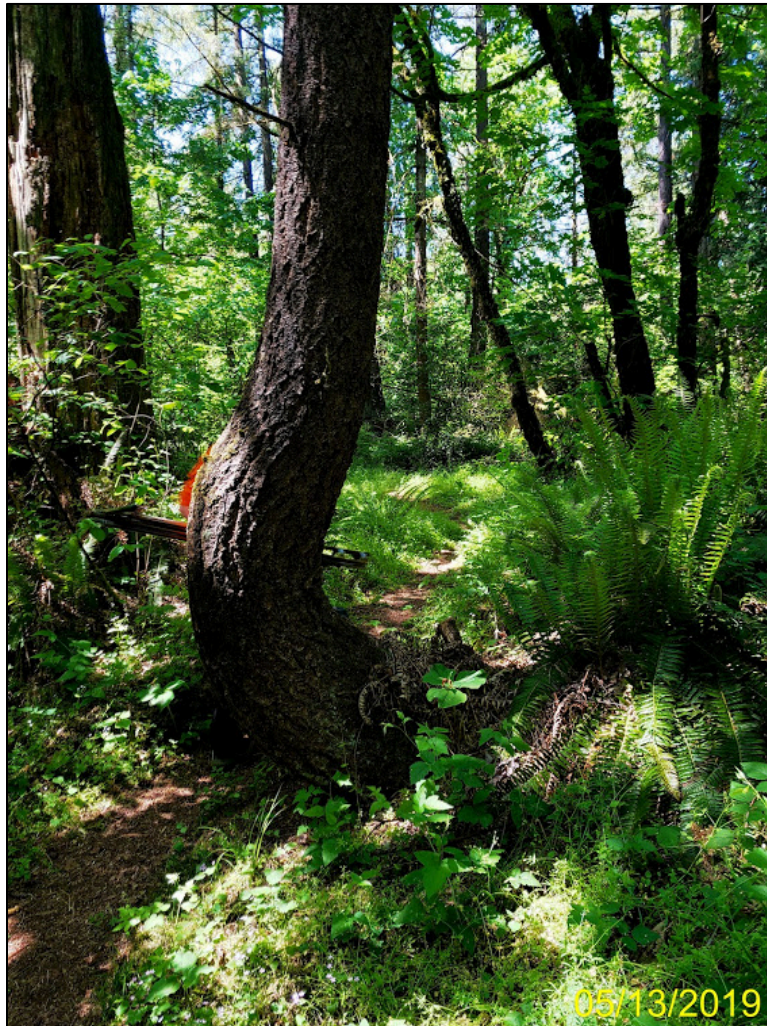
Photo 5: Pistol butting observed on the subject property, possibly indicative of soil movement.

During our site visits and investigation, we did not observe signs of previous or current soil movement, such as clearly identifiable landslide head scarps, bowl-shaped depressions, or surface cracking in the soils. We did, however, observe leaning tree trunks and pistol-butting, shown in Photo 4 below, which can be an indicator of shallow soil creep.

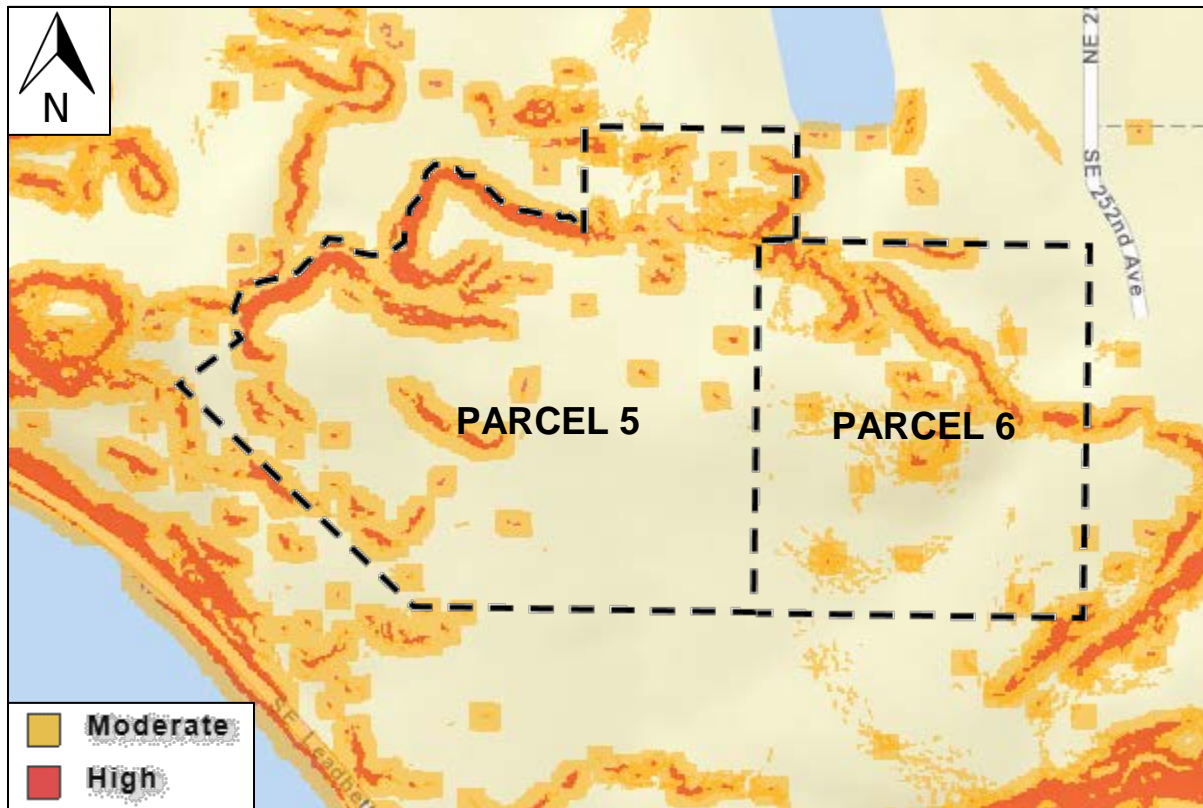
Figure 7: Map produced by the Washington State DNR showing the landslide hazard for the subject parcels (base map source: <https://geologyportal.dnr.wa.gov/>).

As a part of our due diligence we also reviewed the Washington State Department of Natural Resources (DNR) Geologic Information Portal (<https://geologyportal.dnr.wa.gov/>). According to the DNR portal, the property is mapped within an area of moderate to high susceptibility to landslide failure, shown in Figure 7 below. However, the portal does not map the subject parcels to be within any mapped historic landslides. The portal also maps the property to be 600 feet east of the Lacamas Lake fault, lining the North Shore of Lacamas Lake. It should be noted that the DNR portal also indicates that the subject property is not mapped within an area of liquefaction susceptibility, again due to the presence of relatively shallow bedrock.

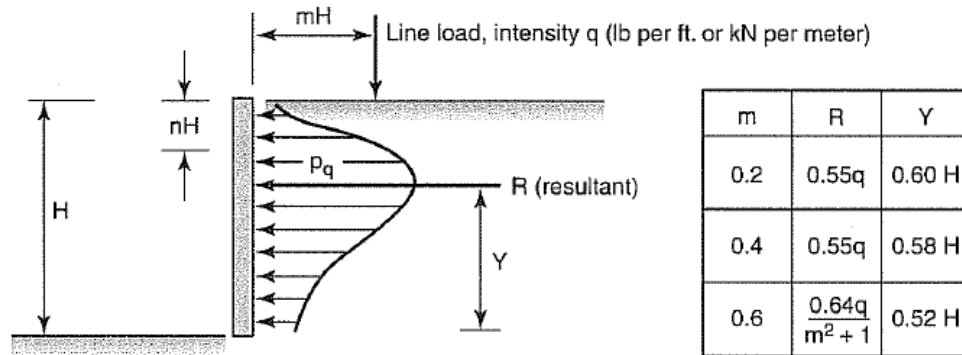
LINE LOAD (applicable for retaining walls not exceeding 20 feet in height):

Figure 16-28 Pressure distribution against vertical wall resulting from line load of intensity q.

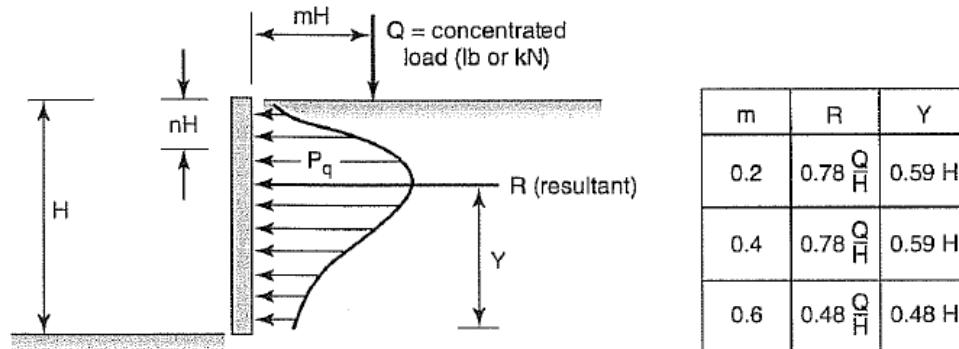
CONCENTRATED POINT LOAD (applicable for retaining walls not exceeding 20 feet in height):

Figure 16-27 Pressure distribution against vertical wall resulting from point load, Q.
