PRELIMINARY TECHNICAL INFORMATION REPORT

NE 13th Street Site Plan City of Camas, Washington

***NE 13th Street Gas Station Site Plan
Technical Information Report***

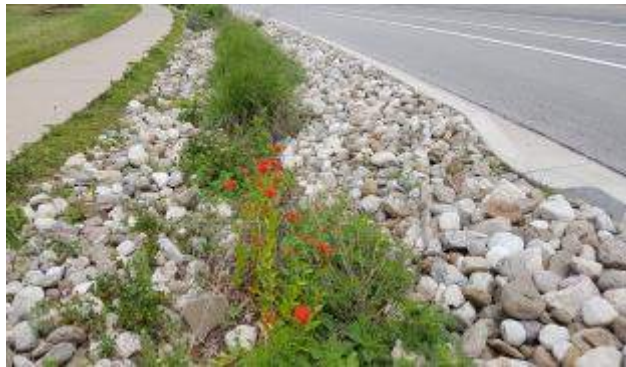
Biofiltration swales use grass or other dense vegetation to filter sediment and oily materials out of stormwater. Usually, they look like flat-bottomed channels with grass growing in them. As water passes through the vegetation, pollutants are removed through the effects of filtration, infiltration and settling.

See SWMMWW [Appendix V-A](#), Table V-A.8 for biofiltration swale maintenance standards. If available, reference record drawings for seed mix and groundcover replacements, or see SWMMWW [BMP T9.10, Tables V-7.3 and V-7.4](#). Presence of cattails is a sign that that there is water ponding and the facility is not functioning as design. Cattails will need to be removed and further investigation may be required.

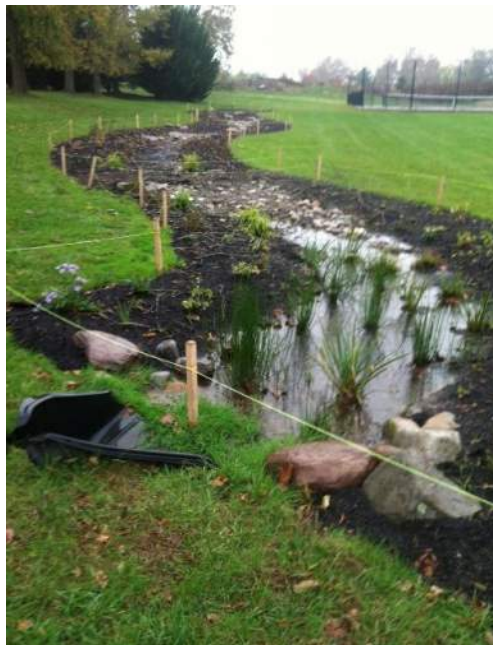
Wet Biofiltration Swale

A wet biofiltration swale is a variation of basic biofiltration swale for use where the centerline slope is slight, groundwater table are high, or a continuous low base flow is likely to result in wet soil conditions for long periods of time. Where continuously wet soil exceeds about 2 weeks, typically grasses will die. Thus, vegetation specifically adapted to wet soil conditions is needed. Different vegetation requires modification of several of the design and maintenance requirements from the basic biofiltration swale.

See SWMMWW [Appendix V-A](#), Table V-A.9 for wet biofiltration swale maintenance standards. If available, reference record drawings for seed mix and groundcover replacements, or see SWMMWW [BMP T9.20, Table V-7.5](#). Removal of cattail is required when vegetation is crowded out by very dense clumps of cattails, prevents water flow, or alters the designed functionality.

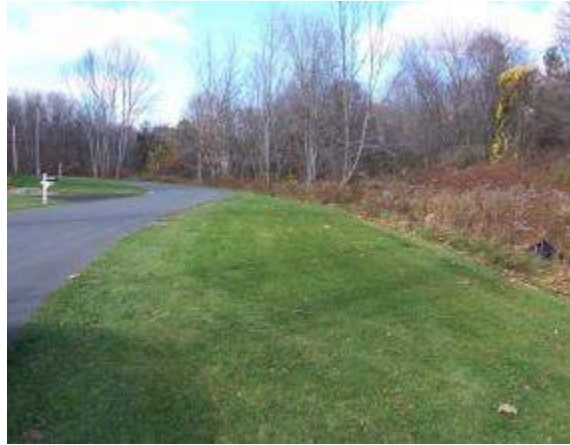
Filter Strip

Filter strips are linear strips of grass that remove sediment and oils from stormwater by filtering it. Stormwater is treated as it sheet flows across the filter strip. Usually, filter strips are placed along the edge of linear paved areas, such as parking lots and roads. Where designed filter strips are installed; road shoulders should only be graded to maintain level flow off the road.

See SWMMWW [Appendix V-A](#), Table V-A.10 for filter strip maintenance standards. If available, reference record drawings for seed mix replacement, or see SWMMWW [BMP T9.10, Table V-7.3](#).

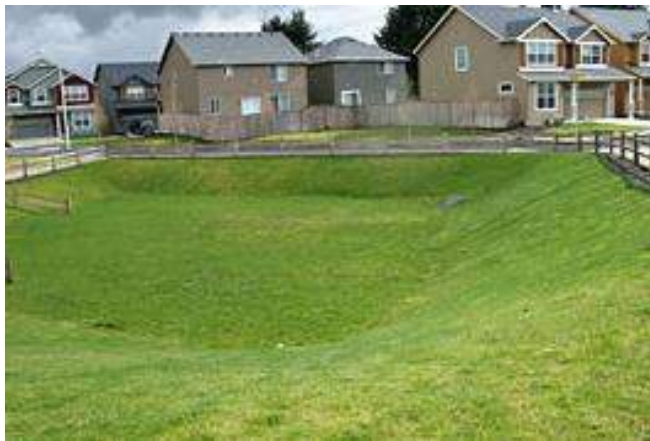
Detention Pond

Detention pond facilities are designed to hold and slowly release stormwater by use of a pond with a specially designed control structure. Styles vary greatly from well-manicured to natural appearing. Generally, native vegetation is preferred for reduced maintenance and enhance wildlife habitat. Some facilities are designed to appear as natural water bodies or are in a park-like setting.

See SWMMWW [Appendix V-A](#), Table V-A.1 for detention pond maintenance standards. If available, reference record drawings for seed mix replacement, or see SWMMWW [BMP D.1, Table V-12.3](#). Removal of cattail is required when vegetation is crowded out by very dense clumps of cattails, prevents water flow, or alters the designed functionality.

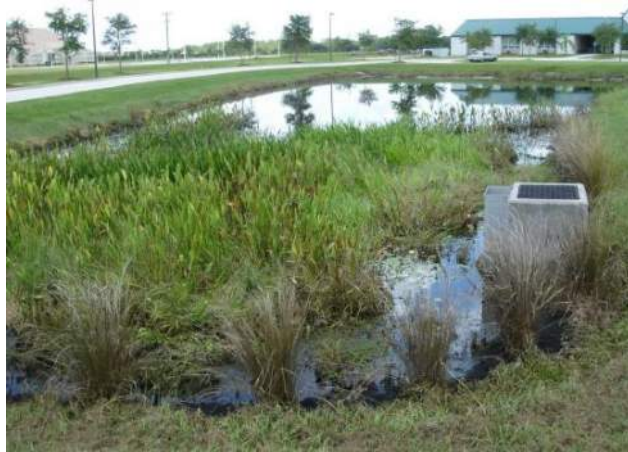
Wet Pond

A wet pond is an open basin that retains a permanent pool of water year-round or only during the wet season. The volume of the wet pond allows sediment and other pollutants to settle out of the runoff. Wetland vegetation is typically planted within the wet pond to provide additional treatment through nutrient removal. Detention quantity control can be provided with additional temporary storage volume above the permanent pool elevation.

See SWMMWW [Appendix V-A](#), Table V-A.11 for wet pond maintenance standards. If available, reference record drawings for seed mix and plants replacement, or see SWMMWW [BMP D.1, Table V-12.3](#) for seed mix and [BMP T10.10, Table V-8.1](#) for plants. Removal of cattails is required when vegetation is crowded out by very dense clumps of cattails, prevents water flow, or alters the designed functionality.

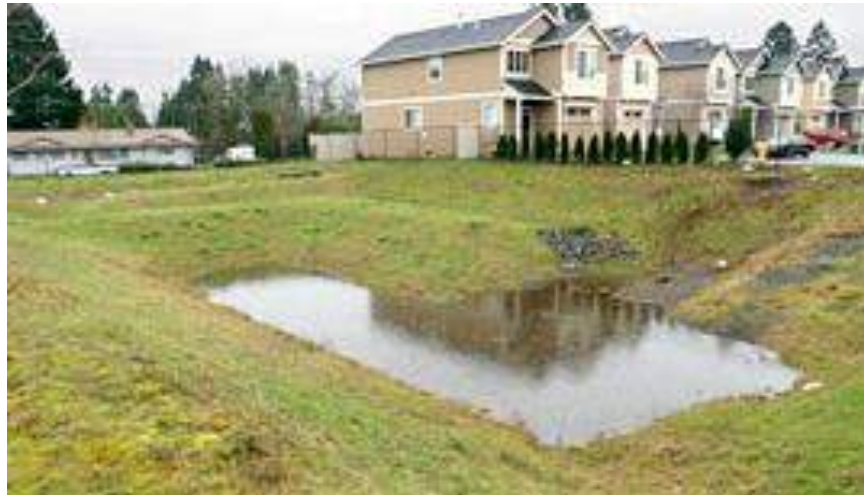
Infiltration Facility

Infiltration facilities dispose of water by holding it in an area where it can soak into the ground. These are open facilities that may either drain rapidly and have grass bases or have perpetual ponds where water levels rise and fall with stormwater flows. Infiltration facilities may be designed to handle all of the runoff from an area or they may overflow and bypass larger storms.

Since the facility is designed to pass water into the ground, generally after passing through a sediment trap/manhole, anything that can cause the base to clog will reduce the performance and is a large concern. Generally, infiltration basins are managed like detention ponds, but with greater emphasis on maintaining the capacity to infiltrate stormwater.

See SWMMWW [Appendix V-A](#), Table V-A.2 for infiltration facility maintenance standards. If available, reference record drawings for seed mix replacement, or see SWMMWW [BMP D.1, Table V-12.3](#). Removal of cattail is required when vegetation is crowded out by very dense clumps of cattails, prevents water flow, or alters the designed functionality.

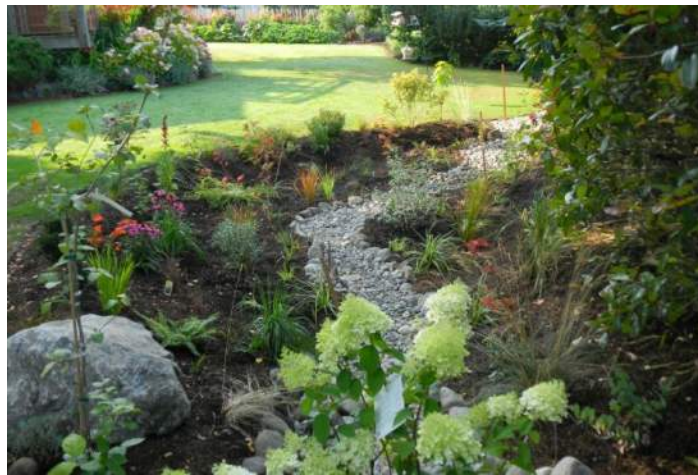
Rain Garden

Rain gardens are non-engineered, shallow, landscaped depressions with compost-amended soils and adapted plants. The depression temporarily stores stormwater runoff from adjacent areas. Some or all the influent stormwater passes through the amended soil profile and into the underlying native soil. Stormwater that exceeds the storage capacity is designed to overflow to an adjacent drainage system.

If available, reference record drawings for plant replacements, or see [Rain Garden Handbook for Western Washington, Appendix A](#) for recommendation on rain garden plants. Presence of cattails is a sign that there is water ponding and the facility is not functioning as design. Cattails will need to be removed and further investigation may be required.

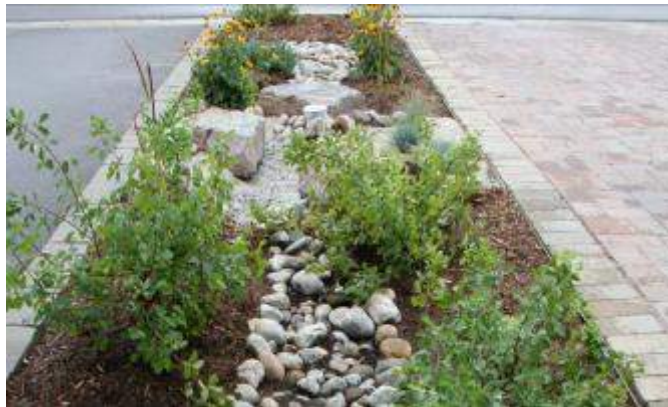
Bioretention facilities are engineered facilities that store and treat stormwater by filtering it through a specified soil profile. Water that enters the facility ponds in an earthen depression or other basin (e.g., concrete planter) before it infiltrates into the underlying bioretention soil. Stormwater that exceeds the surface storage capacity overflow to an adjacent drainage system. Treated water is either infiltrated into the underlying native soil or collected by an underdrain and discharged. An underdrain system can be comprised of perforated or slotted pipe, wrapped in an aggregate blanket.

See SWMMWW [Appendix V-A](#), Table V-A.21 for bioretention maintenance standards. If available, reference record drawings for plant replacements, or see [LID Technical Guidance Manual for Puget Sound](#), Appendix 1 for plant recommendations. Presence of cattails is a sign that there is water ponding and the facility is not functioning as design. Cattails will need to be removed and further investigation may be required.

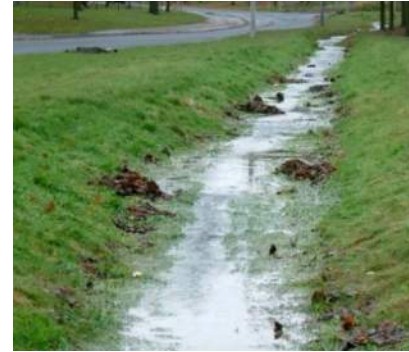
Ditches are often manmade open-channels that convey stormwater runoff. These ditches are maintained to prevent localized flooding.

Conveyance Ditch			
Maintenance Component	Defect or Problem	Conditions When Maintenance Is Needed	Minimum Maintenance Required
General	Sediment	Sediment exceeds 20% of ditch depth or affects the historic or designed hydraulic capacity.	Remove sediment deposits. When finished, ditch should be level from side to side and drain freely in intended direction.
	Standing Water	Excessive standing water in ditch between storms due to ditch not draining freely	If possible, repair cause of poor drainage. This may include but is not limited to the following activities: remove sediment or trash blockages, improve grade of ditch.
	Eroded or Unstable Side Slopes	When grass is sparse, bare or eroded, patches occur in more than 20% of the ditch	Determine why grass growth is poor and correct that condition. Replant with plugs of grass at eight-inch intervals or reseed. If cause is excessive moisture replace grass with wetland plantings.

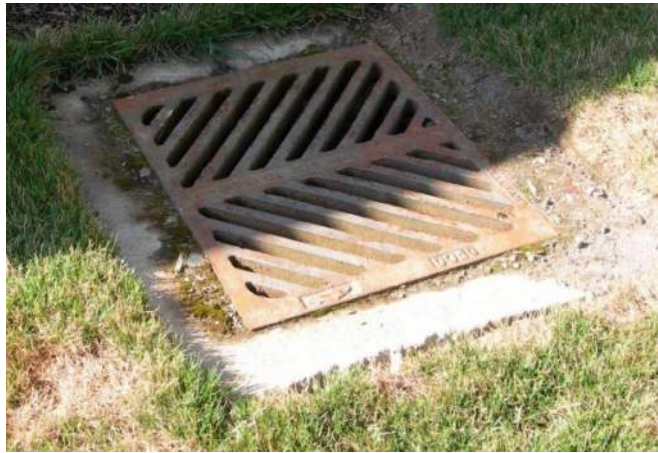
Field Inlet

An inlet is a concrete, plastic or steel structure fitted with a slotted grate to collect stormwater runoff and route through underground pipes. A field inlet has a flat grate, and a ditch inlet has an angled grate. These inlets typically provide a sump below the outlet pipe to allow sediment and debris to settle out of the stormwater runoff. Some of these inlets are fitted with a spill control device such as an inverted elbow on the outlet pipe to control grease or oils. The most common tool for cleaning out the inlet is a vactor truck which is used to remove sediment and debris from the sump. The sediment and oils if not removed from the inlet has the potential to pollute downstream water bodies. Unless you have OSHA approved confined space training and equipment, never enter an inlet. There is a considerable risk of poisonous gas and injury.

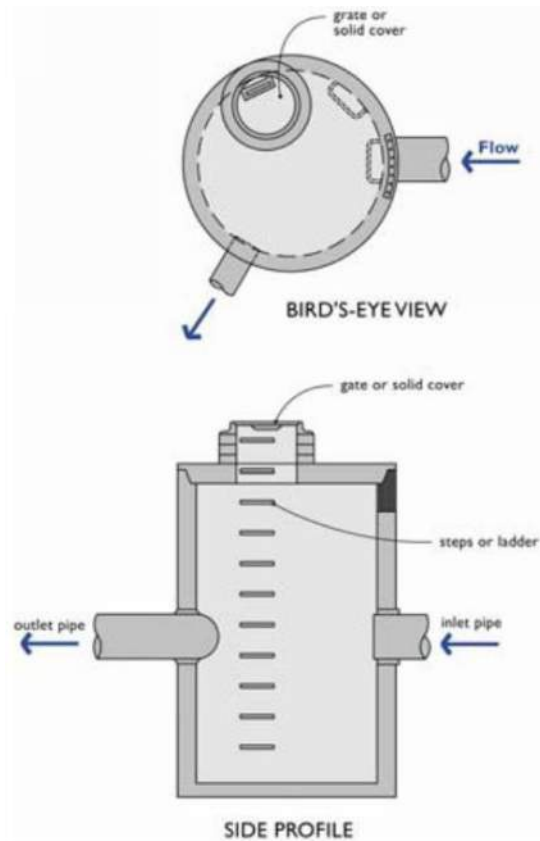
Manholes are large cylindrical underground structures usually set at storm sewer pipe connections. Manholes are used in storm sewer system at any change in direction, slope, pipe material or pipe size. Some manholes have sumps and fitted with stormwater flow control structures such as orifices or weirs. Unless you have OSHA approved confined space training and equipment, never enter a manhole. There is a considerable risk of poisonous gas and injury.

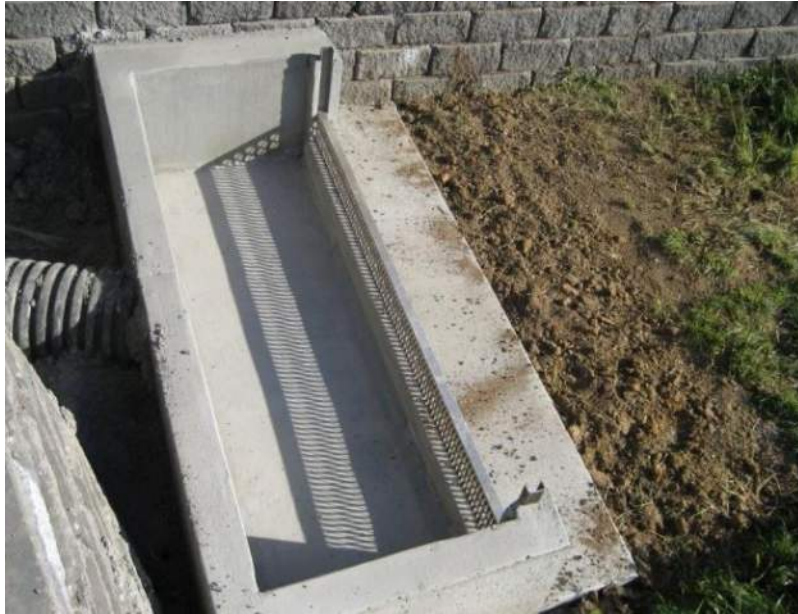
A sediment trap is a concrete structure typically fitted with slotted grate or multiple slotted grates. The concrete structure provides a storage volume (sump) below the outlet pipe to allow sediment and debris to settle out of the stormwater runoff. A sediment trap can be a fully enclosed concrete structure (above or below ground) with a sump, inlet pipe(s) and outlet pipe.

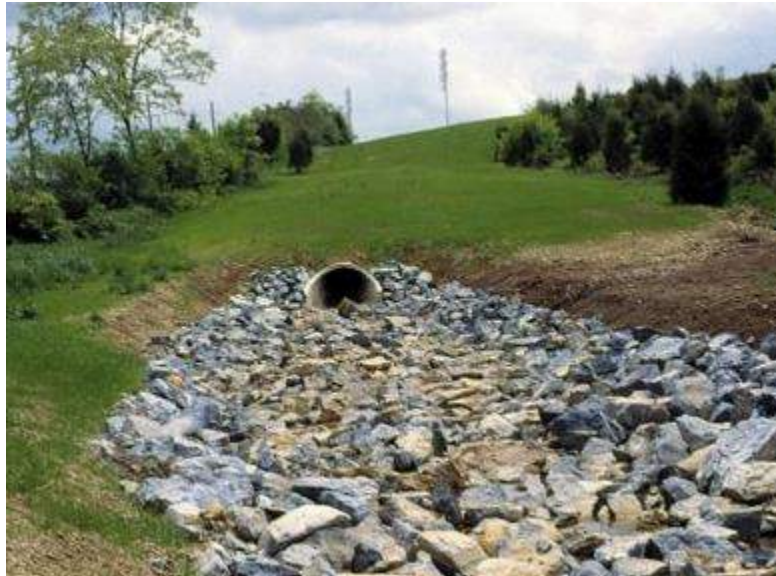
Energy dissipaters are critical for preventing erosion at storm drain outfalls. There are a variety of designs, including wire gabion baskets, rock splash pads, trenches, and specially designed pools or manholes. They are installed on or near the inlet or outlet to a closed pipe system to prevent erosion at these locations.

See SWMMWW [Appendix V-A](#), Table V-A.7 for energy dissipater maintenance standards.

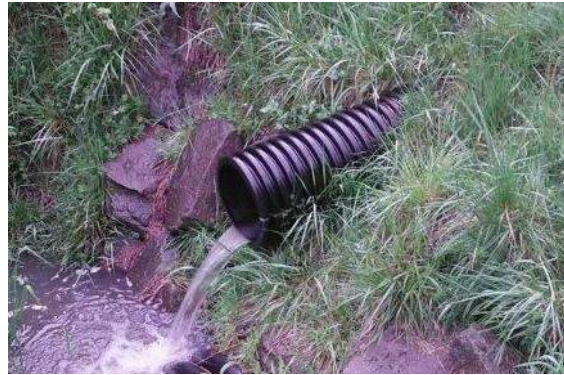
Stormwater facility discharge points may convey drainage from the stormwater facility into open channels, ditches, ponds, wetlands, streams, or lakes. Stormwater facility discharge points need to be assessed to make sure stormwater is not causing any negative impacts to these drainage areas.

Discharge Point			
Maintenance Component	Defect or Problem	Conditions When Maintenance Is Needed	Minimum Maintenance Required
Monitoring	Contaminants and Pollution	Any evidence of oil, gasoline, sewage, contaminants, or other pollutants	Identify and remove source. The effluent discharge should be clear and free of odor. Notify City at (360) 817-1567.
	Ditch or Stream Banks Eroding	Erosion, scouring, or head cuts in ditch or stream banks downstream of facility discharge point due to flow channelization or higher flows.	Stabilize ditch or stream banks. Report to City for engineer evaluation.
General	Missing or Moved Rock	Only one layer of rock exists above native soil in an area five square feet or larger, or any exposure of native soil	Replace or repair rock pad to design standards
	Erosion	Soil erosion in or adjacent to rock pad	Replace or repair rock pad to design standards
	Sediment	Sediment blocking 20% of the pipe diameter	Remove sediment

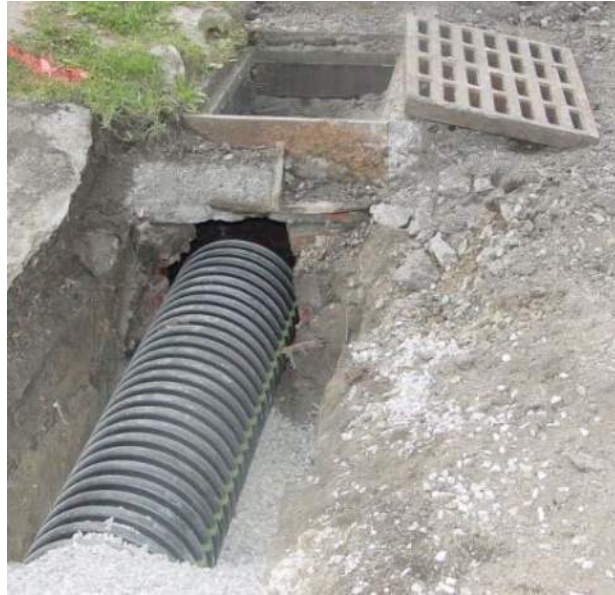
Storm sewer pipes convey stormwater. Storm pipes are constructed of many different types of materials and are sometimes perforated to allow groundwater to be collected by the storm system. Storm pipes are cleaned to remove sediment or blockages when problems are identified. Storm pipes must be clear of obstructions and breaks to prevent localized flooding.

Storm Sewer Pipe			
Maintenance Component	Defect or Problem	Conditions When Maintenance Is Needed	Minimum Maintenance Required
General	Obstructions, Including Roots	Obstruction exists in pipe, reducing flow capacity	Remove obstruction. Use mechanical methods. Do not put root-dissolving chemicals in storm sewer pipes. If necessary, remove the vegetation over the line.
	Pipe Dented or Broken	Inlet/outlet pipe damaged or broken	Repair or replace pipe
	Pipe rusted or deteriorated	Any part of the piping that is crushed or deformed excessively or any other failure to the piping	Repair or replace pipe
	Sediment and Debris	Sediment or debris depth is greater than 15% of the pipe diameter	Clean pipe. Evaluate source of sediment upstream of the pipe and stabilize if possible.
	Broken Trash Screen	Trash screen is broken or missing parts	Repair or replace trash screen
	Contaminants and Pollution	Any evidence of oil, gasoline, contaminants, or other pollutants	Identify and remove source. Notify City at (360) 817-1567.

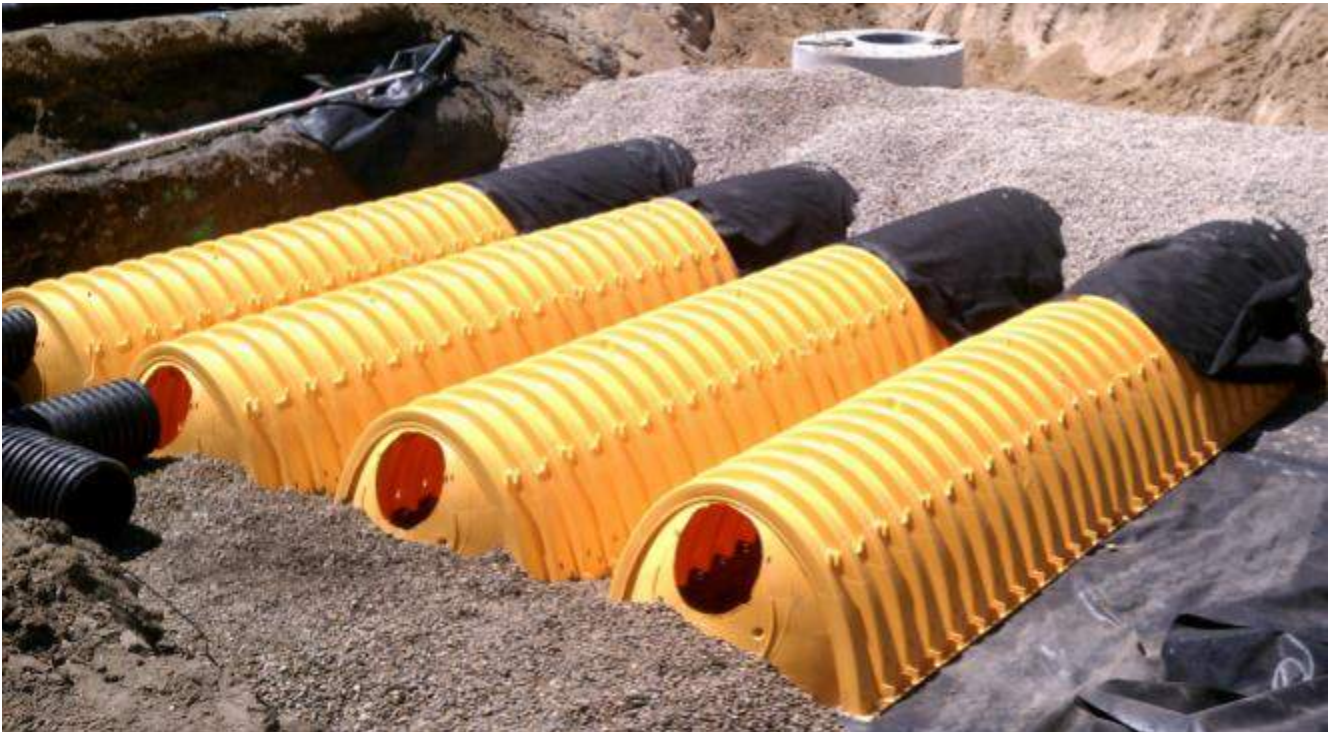
Underground detention systems are enclosed spaces where harmful chemicals and vapors can accumulate. Therefore, the maintenance of these facilities should be conducted by an individual trained and certified to work in hazardous confined spaces.

See SWMMWW [Appendix V-A](#), Table V-A.3 for closed detention maintenance standards.

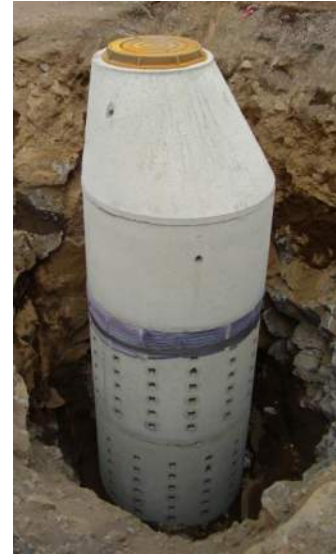
Drywells are perforated, open-bottomed manholes used to infiltrate stormwater into the ground. While not the intended use, drywells trap sediment and some of the oil pollutants in stormwater runoff. Drywells are more likely to fill with oily sediment in areas that lack swales or other treatment facilities. Fine oil sediment can clog drywells and lead to localized street flooding. Also, pollutants discharged into drywells can migrate into groundwater. Drywells were often installed in closed topographic depressions, areas with will-drained soils, or areas having inadequate storm sewers. Often, drywells contain groundwater.

Drywell			
Maintenance Component	Defect or Problem	Conditions When Maintenance Is Needed	Minimum Maintenance Required
General	Does not Dissipate Stormwater	Does not dissipate stormwater	Replace or repair
	Opening Clogged	Openings are clogged, reducing capacity	Clear openings or convert existing drywell to a sediment trap and install a new drywell or drainage trench. To convert to a sediment trap: grout holes, cover base with concrete, and add piping. Alterations to any storm facility cannot be done without approval from the City of Camas.
	Standing Water	Standing water indicates the drywell is into the groundwater table	Rebuild drywell to prevent stormwater from going directly into groundwater
	Trash and Debris	Trash or debris blocking any inlet or outlet pipe	Remove trash and debris
	Sediment	Sediment in drywell exceeds 60 percent of the depth below the lowest pipe	Remove sediment
	Structure Damage	Structure unsound	Replace or repair drywell to design standards.

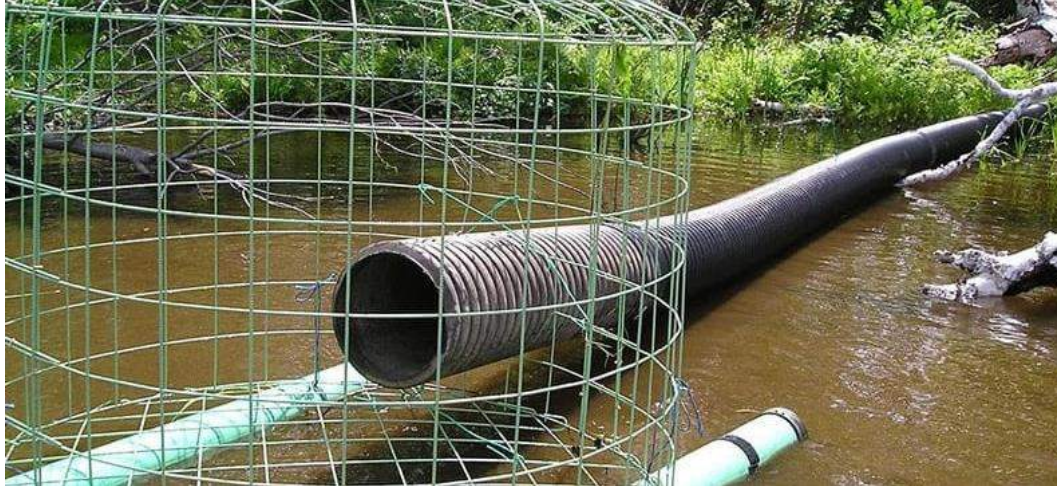
The pond leveler system consists of an intake cage and outlet pipe. This system is used to bypass beaver dams. The pond leveler system creates a permanent leak through the beaver dam that the beavers cannot stop.

Pond Leveler			
Maintenance Component	Defect or Problem	Conditions When Maintenance Is Needed	Minimum Maintenance Required
Intake Cage	Debris and sediment	Debris and sediment build up around cage	Remove debris and sediment build up around cage. Recommended tools: potato rake and a narrow, stiff shop broom.
	Structure	Broken cage, resulting in holes larger than 6" diameter.	Repair hole with similar cage material, attach with hog rings.
	Obstruction to inflow pipe	Debris obstructing pipe flow inside intake cage	Remove obstruction
Outflow Pipe	Obstruction	Debris obstructing outflow	Remove obstruction

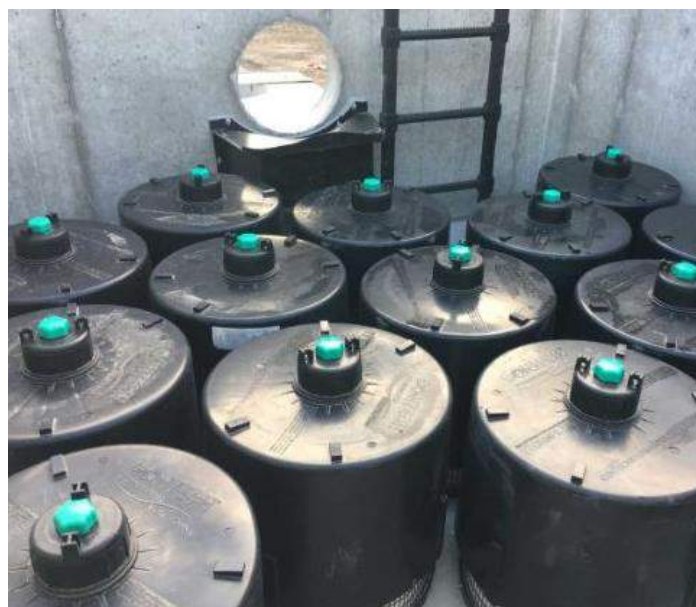
See SWMMWW [Appendix V-A](#), Table V-A.15 for manufactured media filters maintenance standards.

Manufactured Media Filter – Additional Maintenance Standards			
Maintenance Component	Defect or Problem	Conditions When Maintenance Is Needed	Minimum Maintenance Required
Below Ground Vault or Manhole	Sediment Accumulation in Vault (no first chamber)	Sediment depth exceeds 4-inches on vault floor.	Remove sediment from vault floor. May require replacing media cartridges, consult manufacturer.

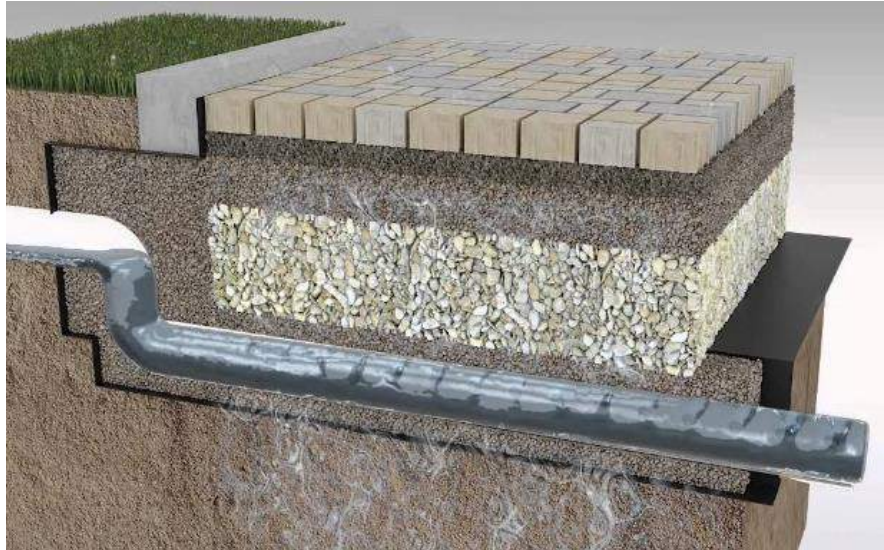
Permeable Pavement

Permeable pavement is a paving system which allows rainfall to percolate through the surface into the underlying soil or an aggregate bed, where stormwater is stored and infiltrated to underlying subgrade, or removed by an overflow drainage system.

See SWMMWW [Appendix V-A](#), Table V-A.22 for permeable pavement maintenance standards.

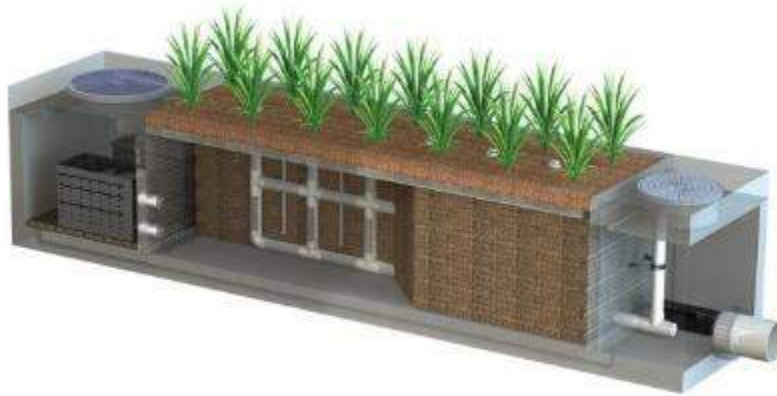
Modular wetlands linear is a biofiltration system that utilizes horizontal flow which allows for a smaller footprint, higher treatment capacity and design versatility. This system can be utilized downstream of storage for additional volume control and treatment. The modular wetland is contained in an underground vault that has different chambers containing media. Some modular wetlands can have plants growing out of it, but it is not required for the system to function. Once filtered through the media, the treated stormwater is directed to a collection pipe or discharge to a pond or open channel drainage way.

Modular Wetland			
Maintenance Component	Defect or Problem	Conditions When Maintenance Is Needed	Minimum Maintenance Required
General	Missing or damaged components	Missing or damaged internal components or cartridges	Replace missing or repair damaged internal components or cartridges
Inlet or Outlet	Obstruction	Obstruction to inlet or outlet that impedes flow	Remove obstruction
Pretreatment Chamber	Floatingables	Excessive accumulation of floatables, in which the length and width of the chamber is fully impacted more than 18"	Remove floatables
	Sediment	Excessive accumulation of sediment, more than 6" in depth	Remove sediment
Filter Cartridges	Sediment	Excessive accumulation of sediment on media, more than 85% clogged (blackish color)	Replace media
Vegetation (if applicable)	Overgrown	Overgrown vegetation	Trim/prune vegetation in accordance with landscaping and safety needs
Structure	Cracks in structure	Cracks wider than 1/2 inch or evidence of soil particles entering the structure through cracks	Repair cracks in vault

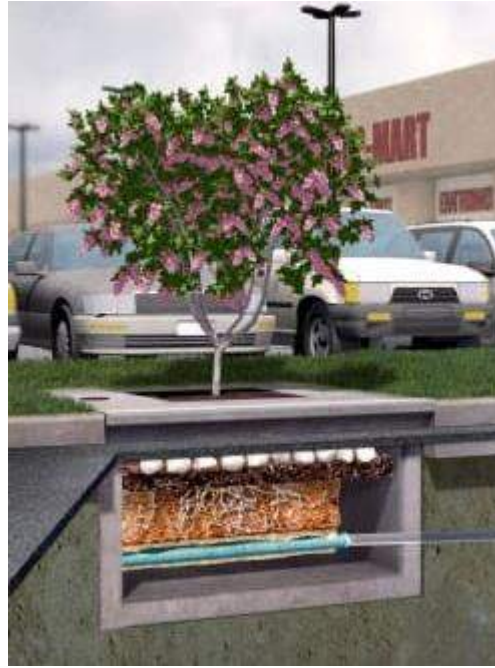
Tree box filter is a stormwater treatment system incorporating high performance biofiltration media to remove pollutants from stormwater runoff.

Tree Box Filter			
Maintenance Component	Defect or Problem	Conditions When Maintenance Is Needed	Minimum Maintenance Required
Inlet	Excessive sediment or trash accumulation	Accumulated sediments or trash impair free flow of water into system	Remove sediment and/or trash
Mulch cover	Trash and debris	Excessive trash and/or debris accumulation	Remove trash and/or debris.
	Standing water	Ponding of water over mulch due to excessive fine sediment accumulation or spill of petroleum oils	Remove mulch and replace, contact manufacturer for advice
Vegetation	Plant not growing or in poor condition	Soil/mulch too wet, evidence of spill, incorrect plant selection, pest infestation, vandalism to plants	Plants should be healthy and pest free, contact manufacturer for advice
	Plant growth excessive	Plants should be appropriate to the species and location	Trim/prune plants in accordance with landscaping and safety needs

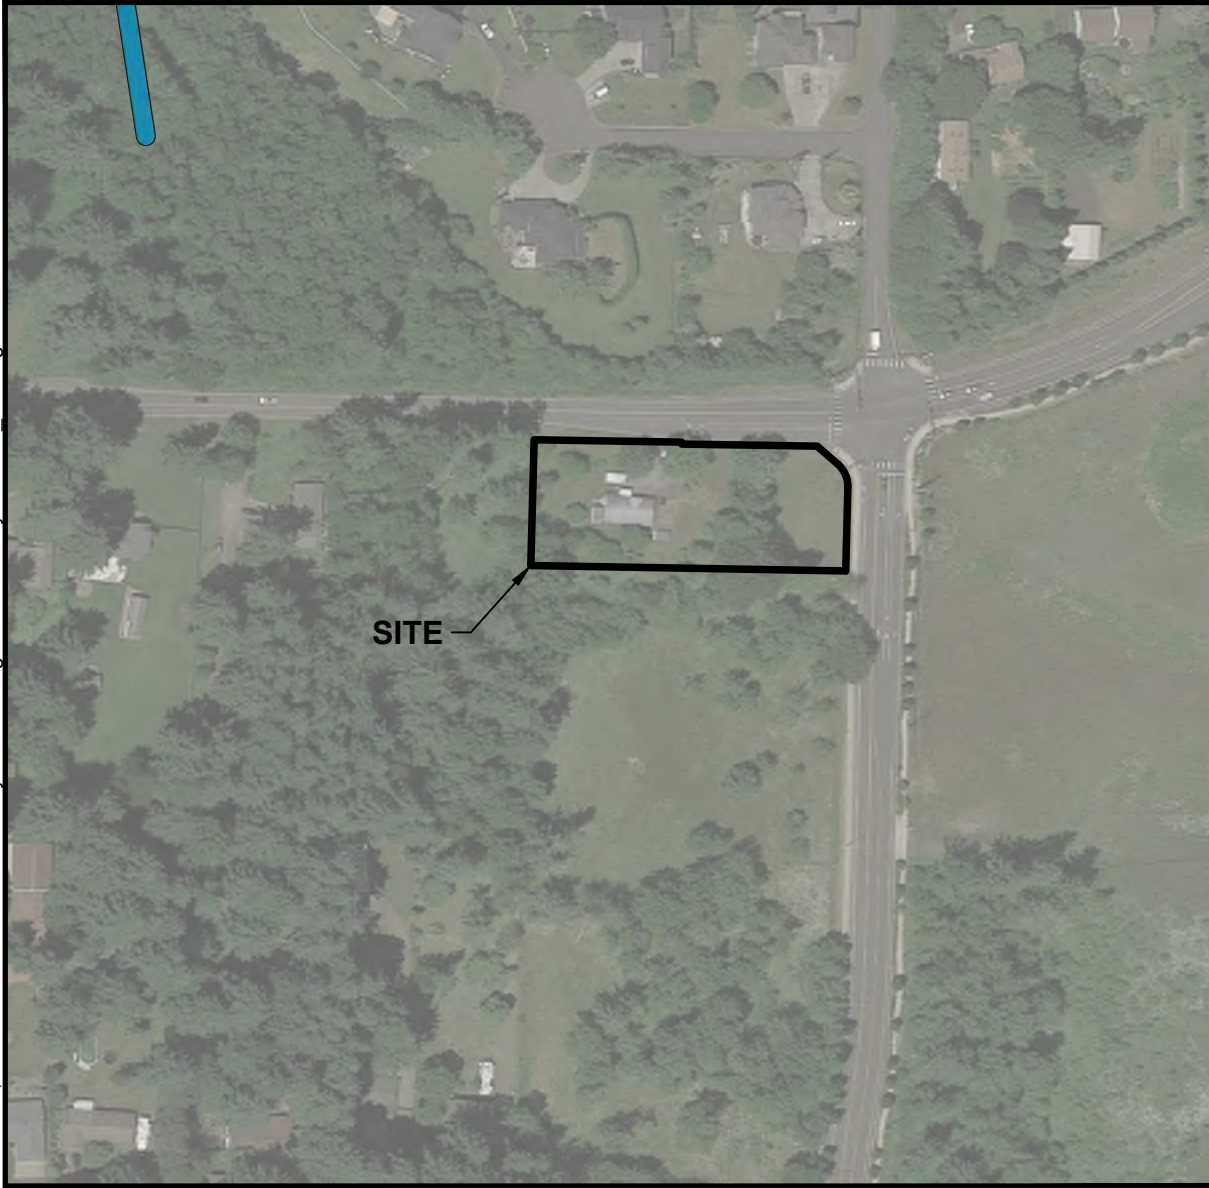
No mapped wetlands indicated onsite by US Fish & Wildlife Service.

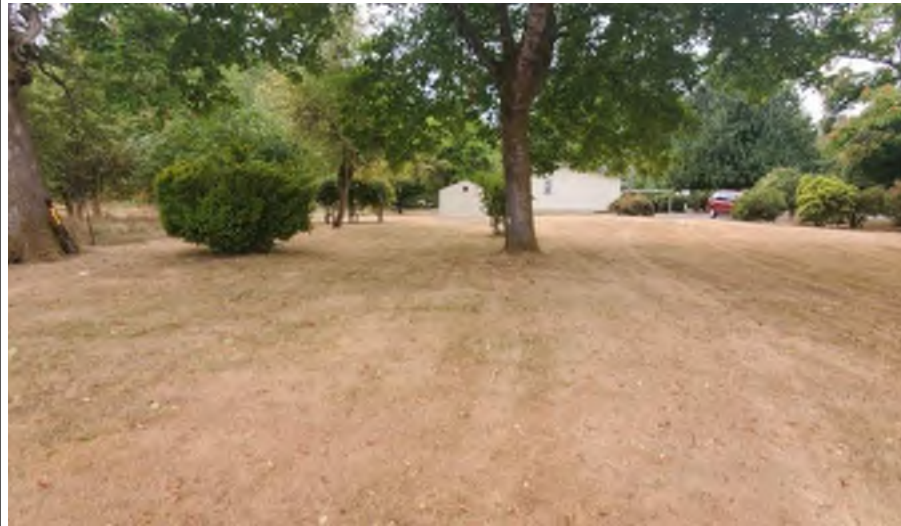
Photo 2 was taken facing west and shows general conditions onsite. The oak is visible on the left.

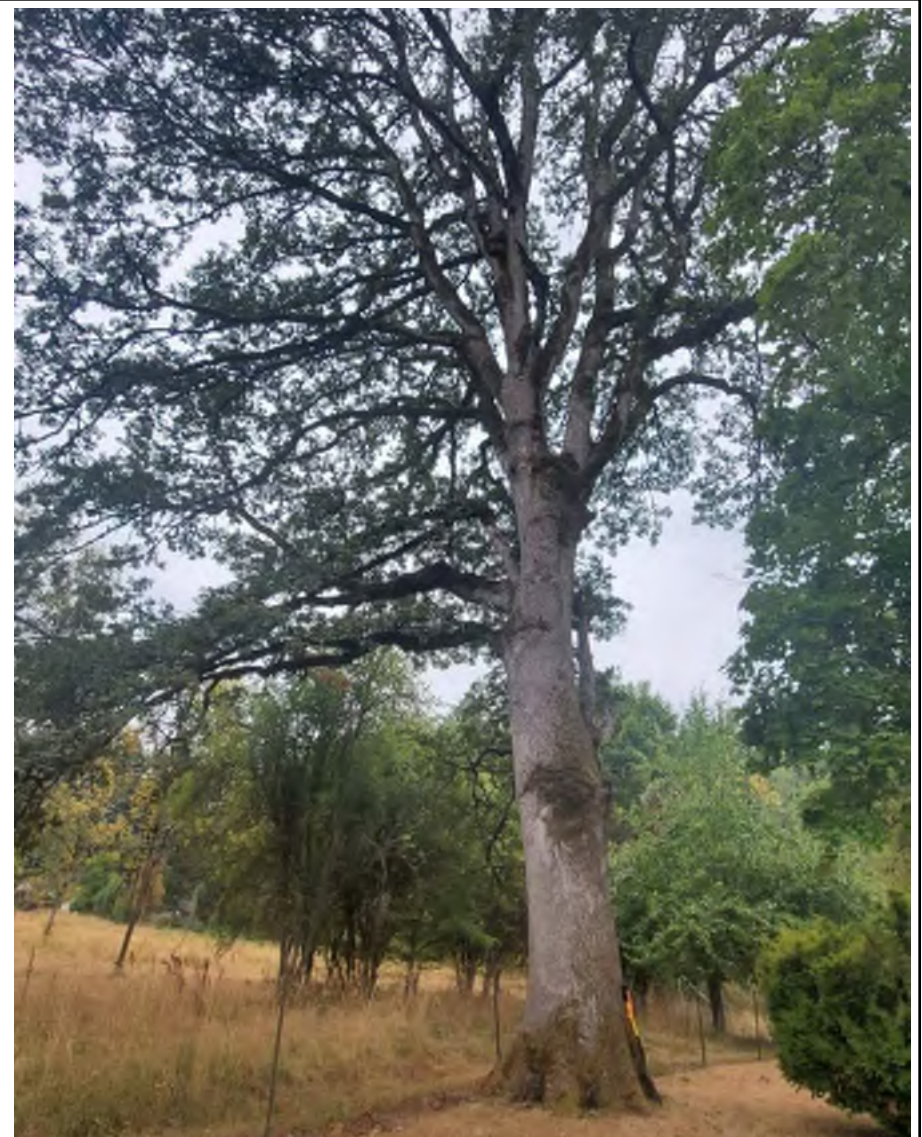
Photo 3 shows the onsite Oregon white oak.

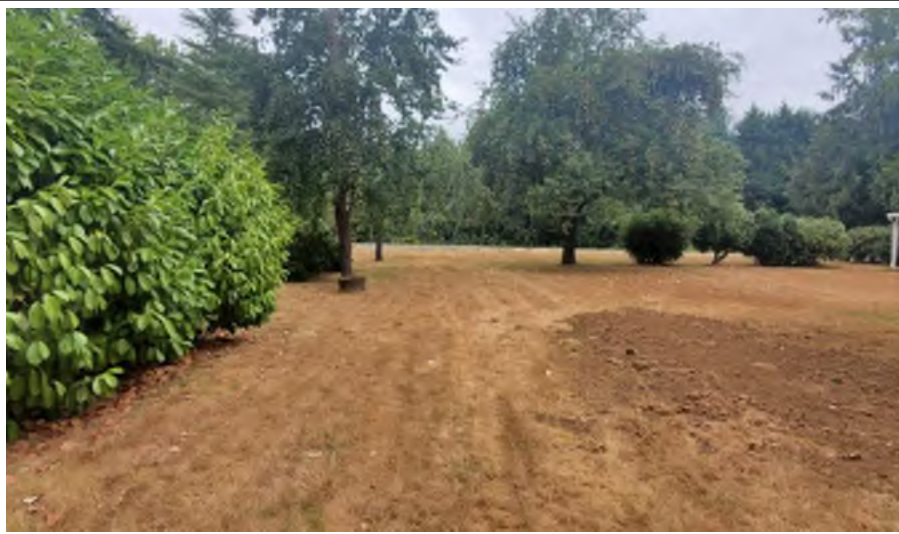
Photo 4 was taken facing north at TP-1 and shows general conditions onsite.

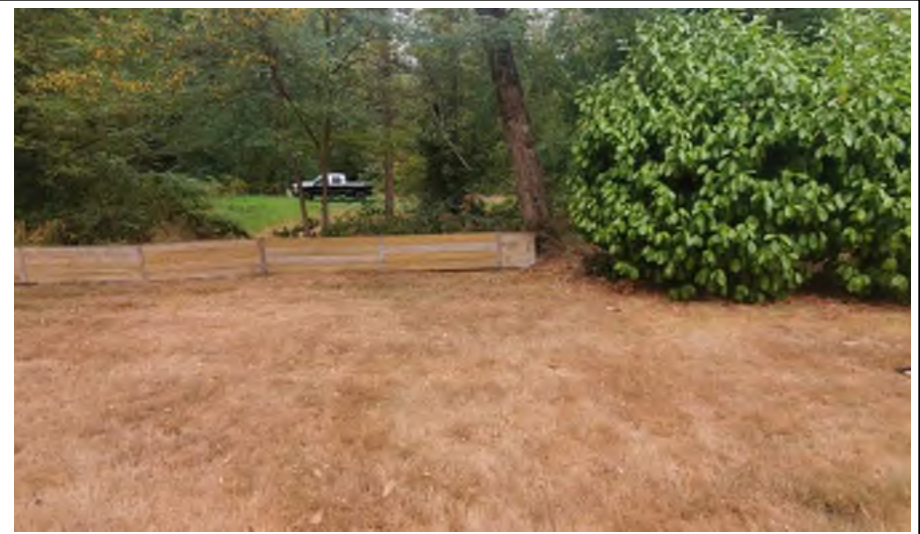
Photo 5 was taken facing west.

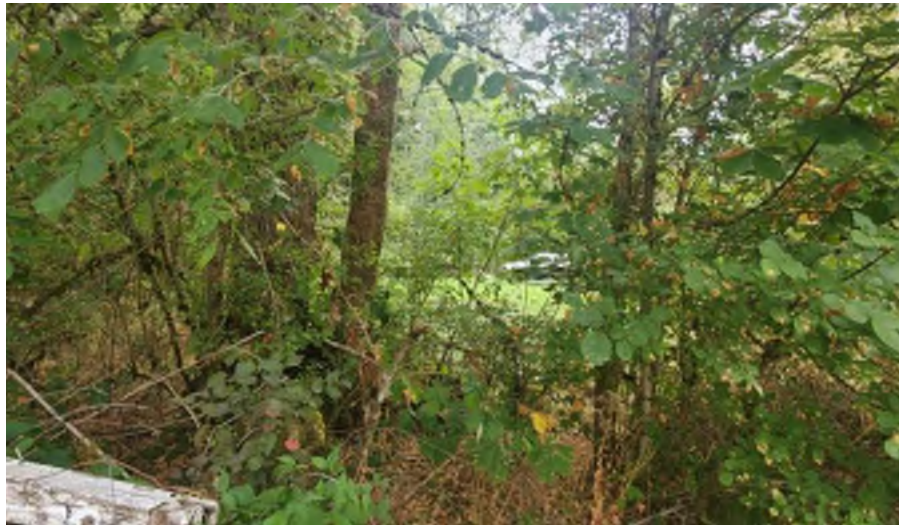
Photo 6 was taken facing west at TP-1.

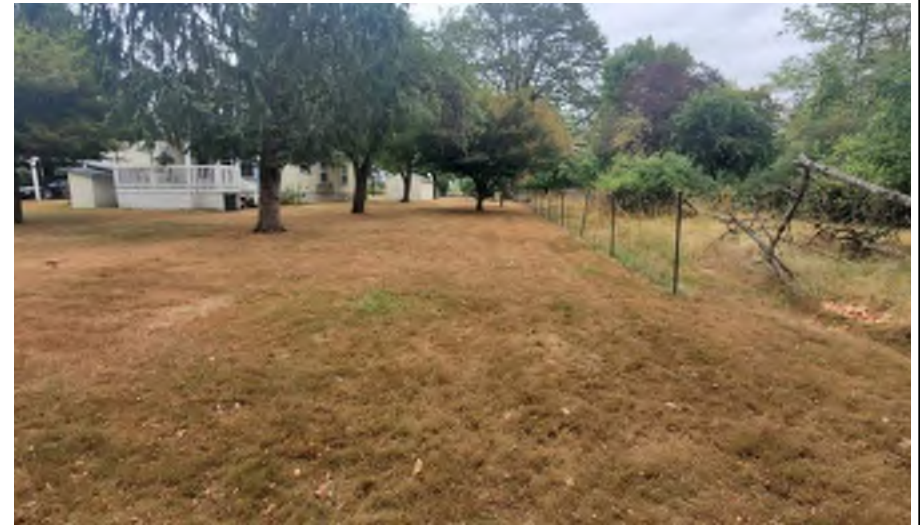
Photo 7 was taken facing east at TP-1 and shows general conditions onsite.
