CRITICAL AREAS REPORT

13th Street Gas Station
Camas, WA

Ecological Land Services

1157 3rd Avenue, Suite 220A • Longview, WA 98632
(360) 578-1371 • Project Number 3934.01

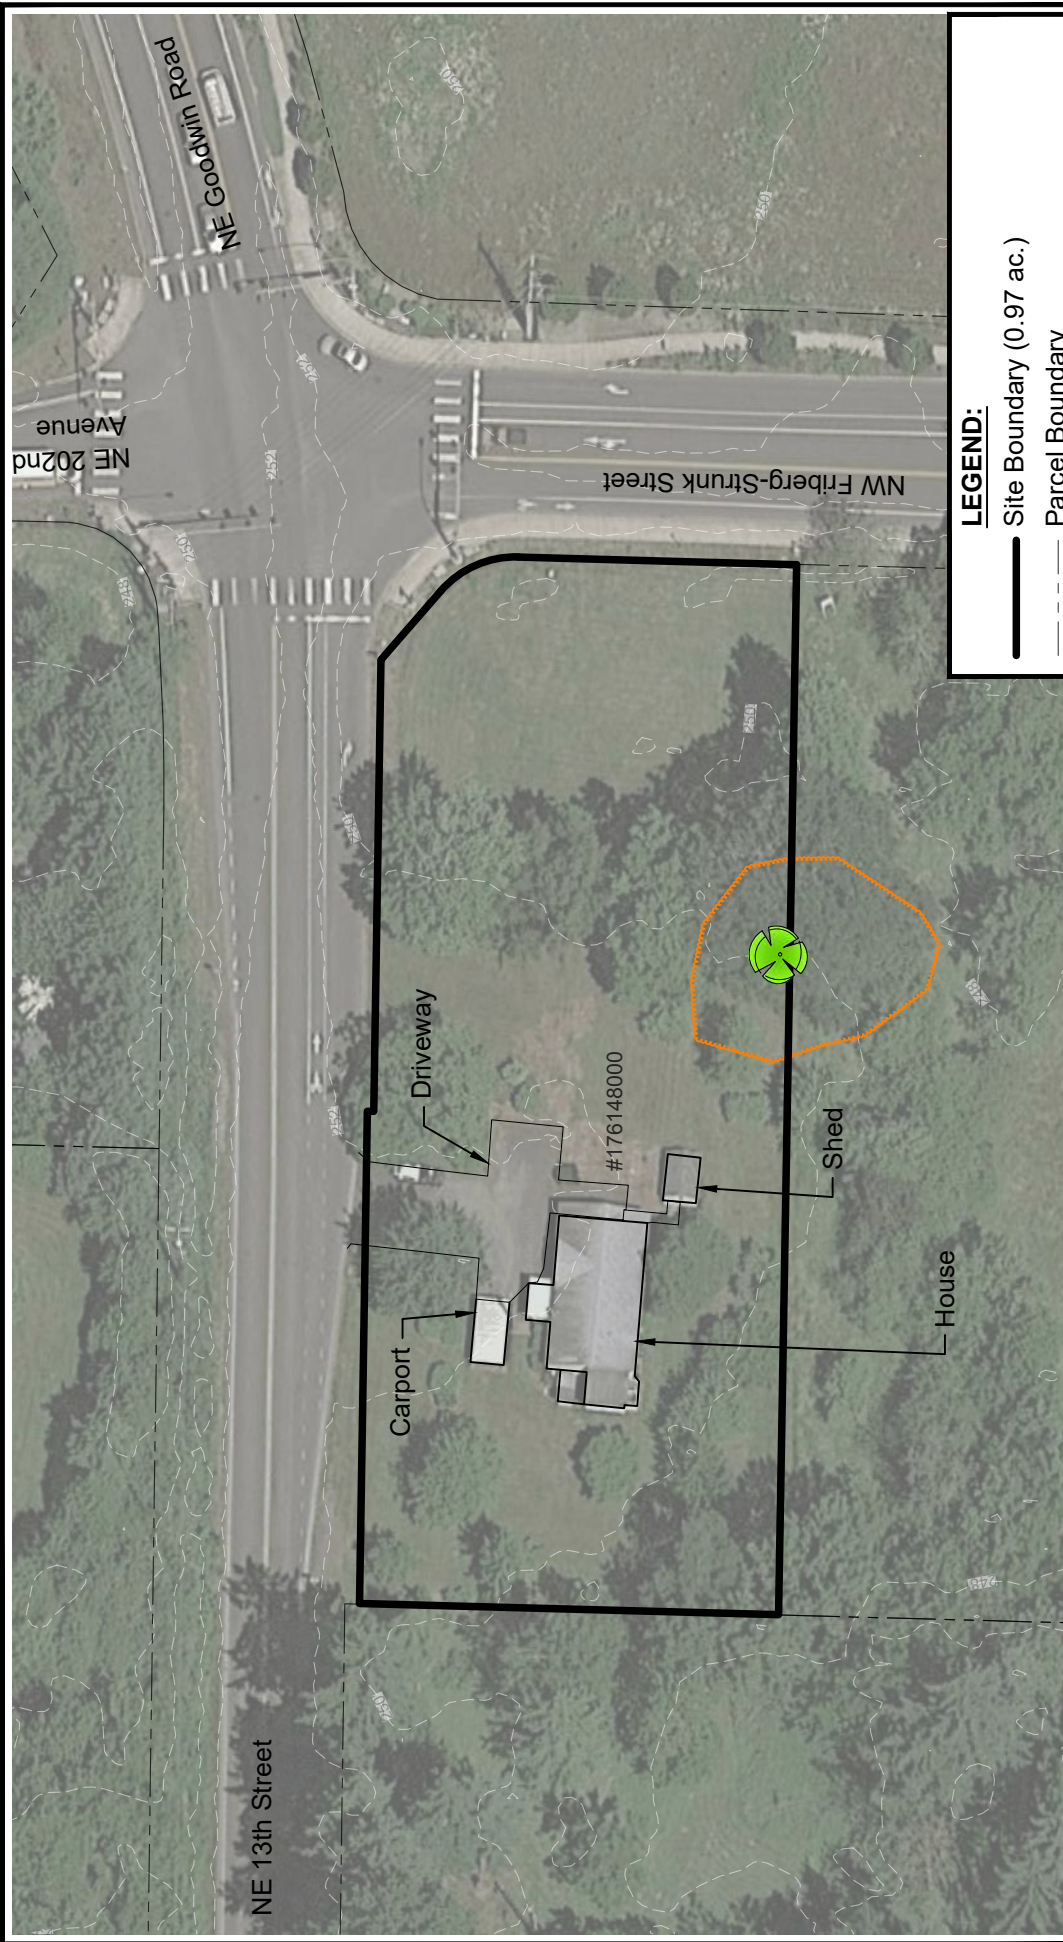
Figure 2
EXISTING CONDITIONS
 13th Street Gas Station
 PAK USA Camas, LLC
 City of Camas, Clark County, Washington
 Section 29, Township 2N, Range 3E, W.M.

The 0.97-acre site consists of Clark County Tax Parcel 176148000 and is accessed by a paved driveway off NE 13th Street. The site is zoned as Business Park (BP) and currently contains a single-family mobile home, shed, carport, and paved driveway. The site is bordered to the north by NE 13th Street, to the east by NW Friberg-Strunk Street, to the south by undeveloped land and commercial development in progress, and to the west by undeveloped land and a single-family residence (Figure 2).

The WDFW Priority Habitats and Species online mapping tool depicts oak woodlands within the vicinity of the observed oak along the southern site boundary. One oak tree measuring approximately 52 inches DBH was mapped along the southern site boundary during site reconnaissance (Figure 2). The oak has several live and dead branches, cavities, and has canopy connectivity with other trees in the vicinity but is not connected with other oaks. The oak location was mapped using a GPS system capable of submeter accuracy in ideal conditions. According to *CMC 16.61.010(3)(a)*, individual Oregon white oak trees with a twenty-inch DBH are considered a priority habitat.

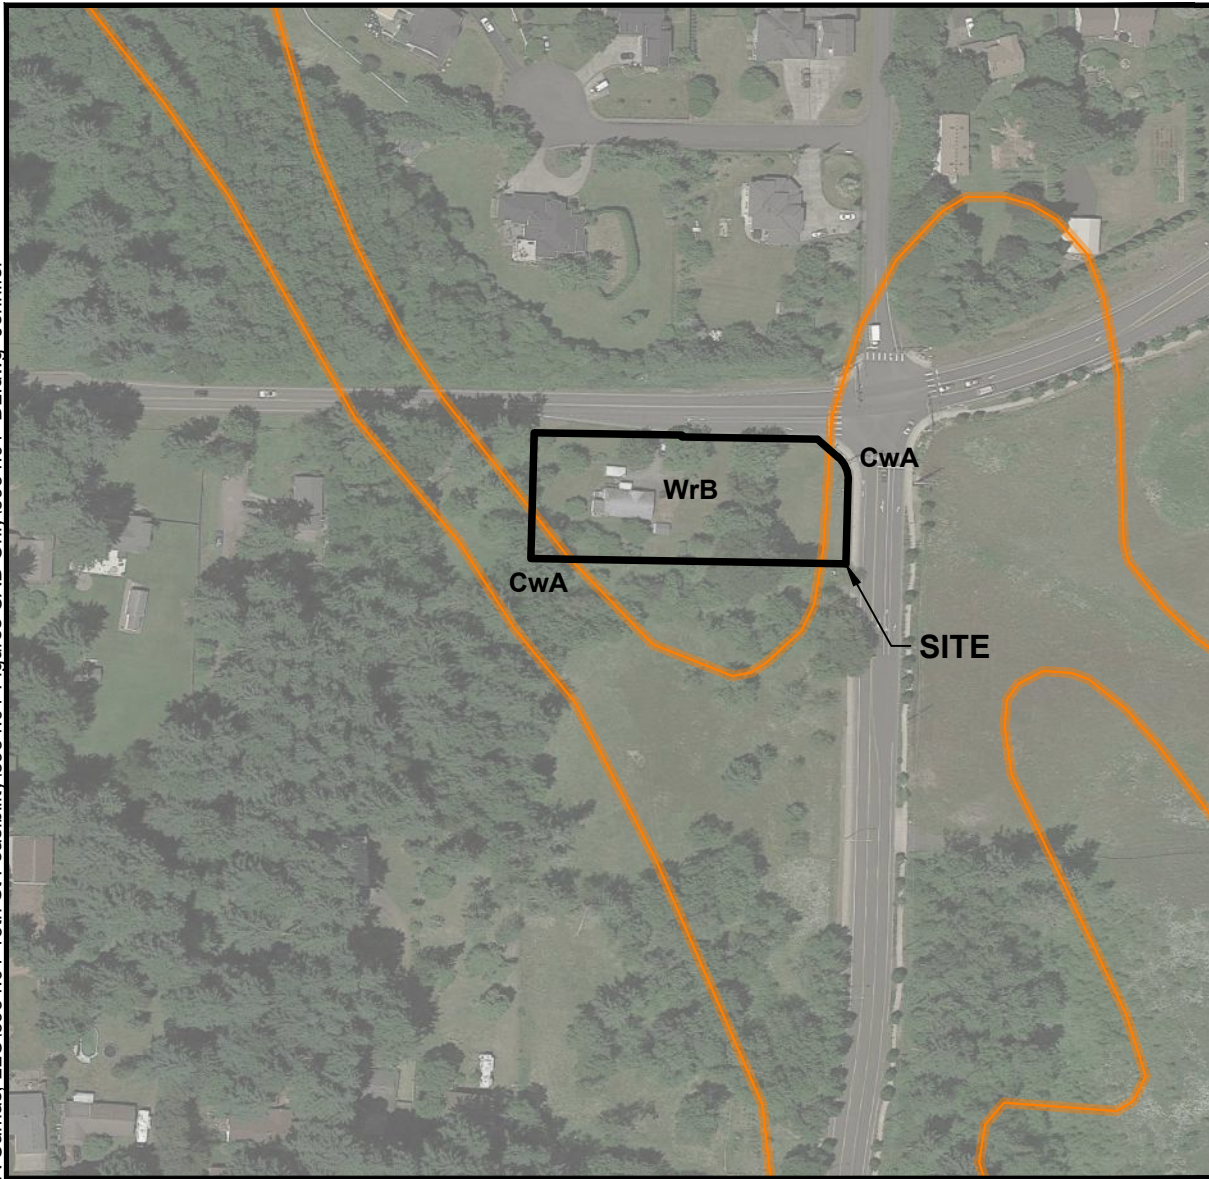
Figure 3
NRCS SOIL SURVEY
 13th Street Gas Station
 PAK USA Camas, LLC
 City of Camas, Clark County, Washington
 Section 29, Township 2N, Range 3E, W.M.

The Natural Resources Conservation Service (NRCS) designates soils onsite as cove silty clay loam, thin solum, 0 to 3 percent slopes (CwA), and Wind River gravelly loam, 0 to 8 percent slopes (WrB) (Figure 3, NRCS 2023B). Of the two soil types found onsite, cove silty clay loam, thin solum, 0 to 3 percent slopes is designated as hydric.

According to soil profile descriptions developed by NRCS, cove silty clay loam, thin solum, is characterized as a poorly drained soil, forming on floodplains, with a depth to water table of 0 to 12 inches below ground surface (BGS). A typical soil profile includes silty clay loam from 0 to 14 inches, clay from 14-21 inches, and silt loam from 21 to 60 inches BGS. Wind River gravelly loam is categorized as a somewhat excessively drained soil with a typical soil profile of gravelly loam from 0 to 4 inches, coarse sandy loam from 4 to 24 inches, and loamy coarse sand from 24 to 60 inches BGS. Wind River gravelly loam forms on floodplains from alluvium parent material and has an average depth to water table of more than 80 inches.

- Site Boundary
- NRCS Soil Boundary
- CwA** Cove silty clay loam, thin solum, 0 to 3 percent slopes. Hydric.
- WrB** Wind River gravelly loam, 0 to 8 percent slopes. Not hydric.

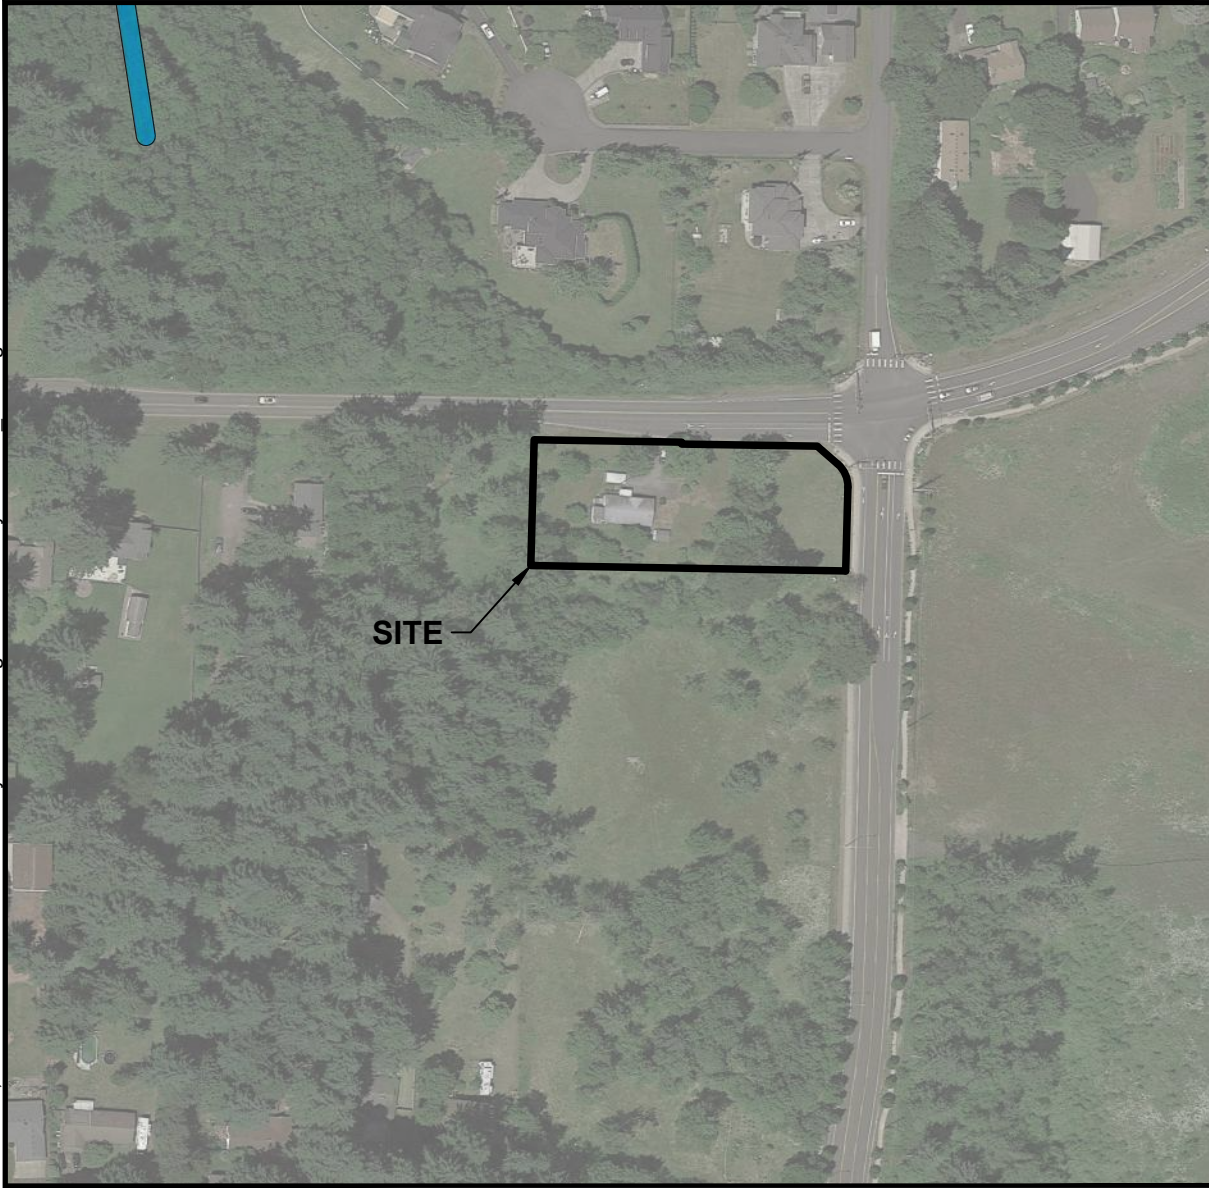
Figure 4
USFWS NATIONAL WETLANDS INVENTORY
 13th Street Gas Station
 PAK USA Camas, LLC
 City of Camas, Clark County, Washington
 Section 29, Township 2N, Range 3E, W.M.

The National Wetlands Inventory (NWI) map does not indicate any wetlands onsite (Figure 4, USFWS 1988). ELS agrees with the NWI mapping, as no wetlands were identified onsite.

No mapped wetlands indicated onsite by US Fish & Wildlife Service.

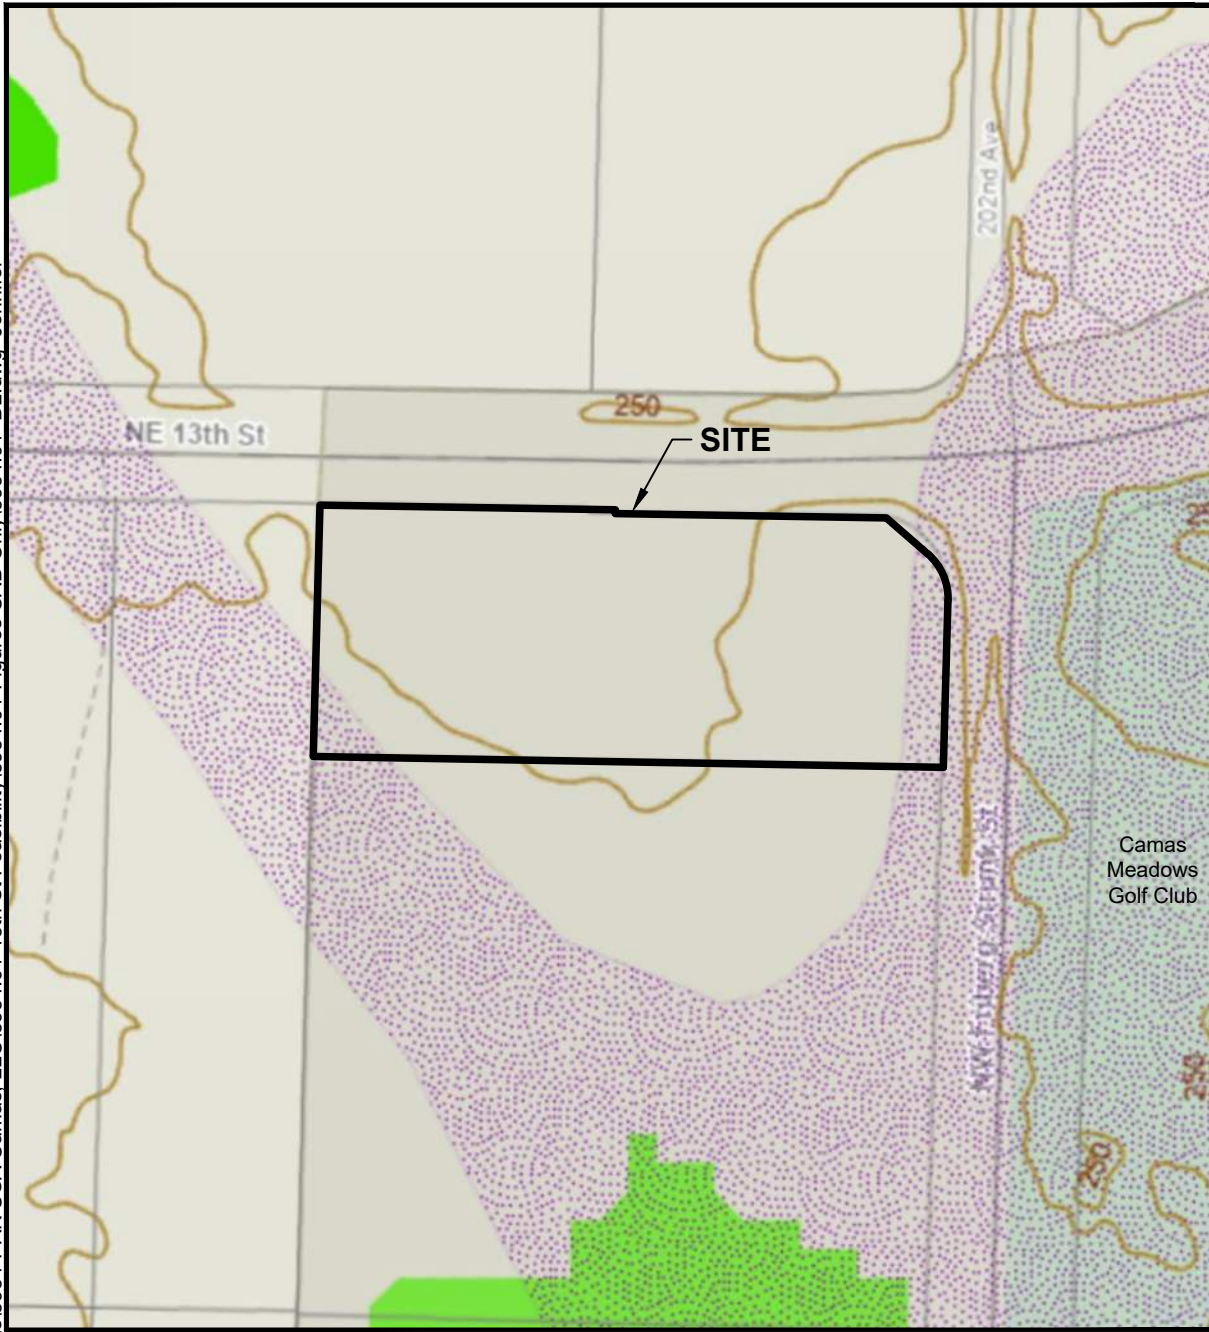
Figure 5
CLARK COUNTY CRITICAL AREAS
 13th Street Gas Station
 PAK USA Camas, LLC
 City of Camas, Clark County, Washington
 Section 29, Township 2N, Range 3E, W.M.

The Clark County Critical Area Inventory (CCCAI) map does not indicate any wetlands onsite but does indicate potential wetlands presence on the property to the south. Hydric soils are mapped along the eastern site boundary and the southwestern corner, and a habitat area is mapped over the majority of the eastern portion of the site (Figure 5). ELS partially agrees with the CCAI as no wetlands were identified onsite and one oak was observed in the vicinity of the mapped habitat area. The potential wetlands mapped to the south of the site are located in the footprint of a commercial development that has received permit approval. However, ELS does not agree with the extent of the mapped habitat area as only one oak was identified onsite and no other critical habitats were identified.

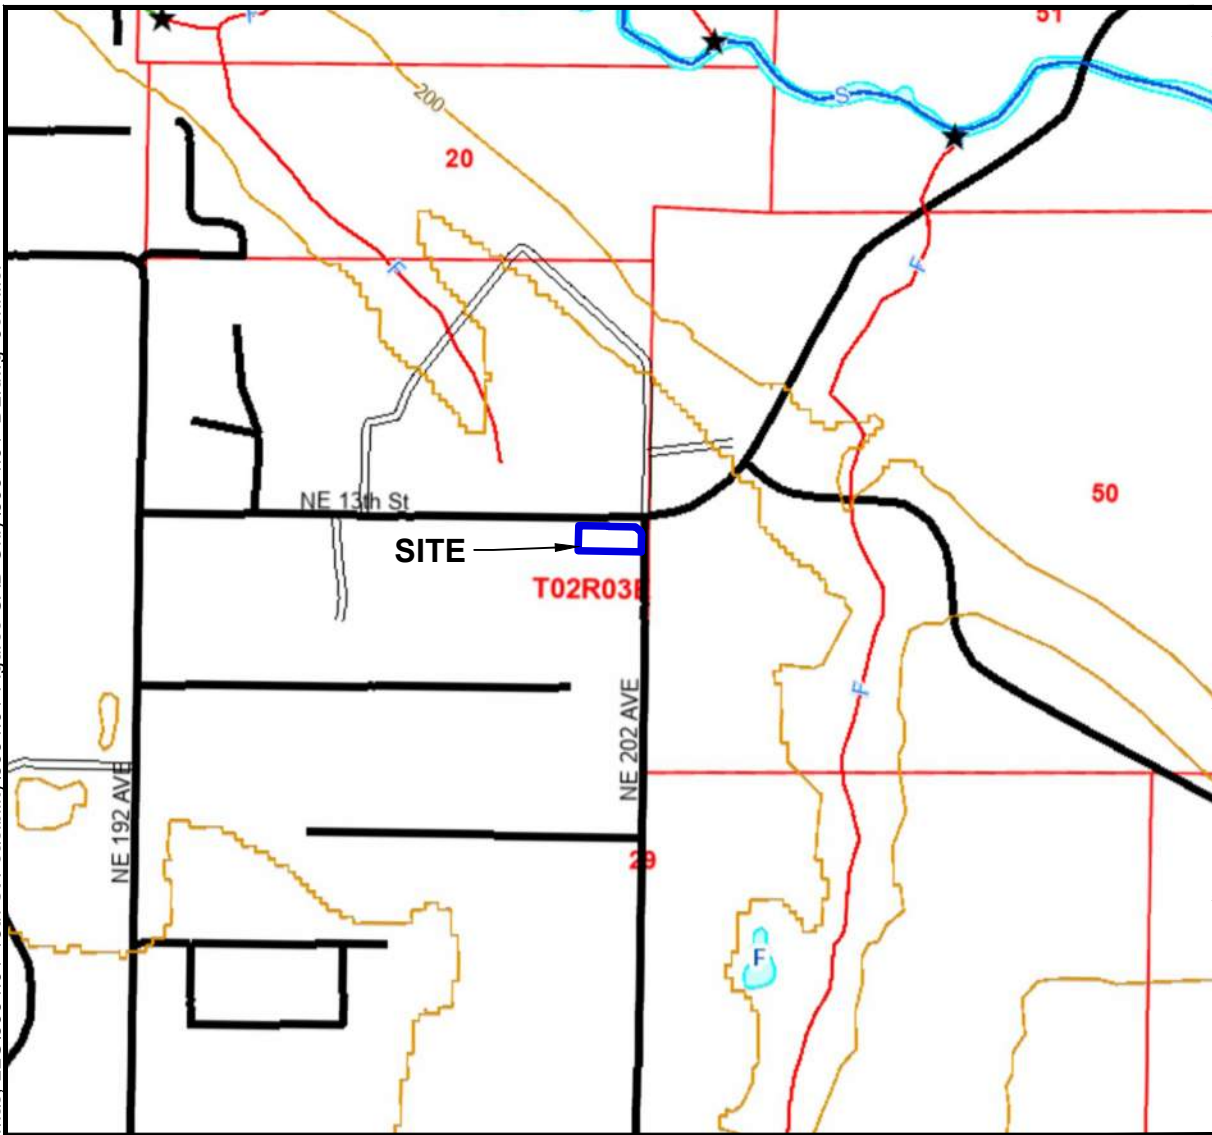
Figure 6
 WDNR STREAM TYPE MAP
 13th Street Gas Station
 PAK USA Camas, LLC
 City of Camas, Clark County, Washington
 Section 29, Township 2N, Range 3E, W.M.

The Washington Department of Natural Resources (WDNR) Stream Type Map does not depict any streams onsite (Figure 6, WDNR 2023). ELS agrees with the WDNR mapping as no streams were observed onsite.

No mapped streams indicated onsite by the Washington State Department of Natural Resources (DNR).

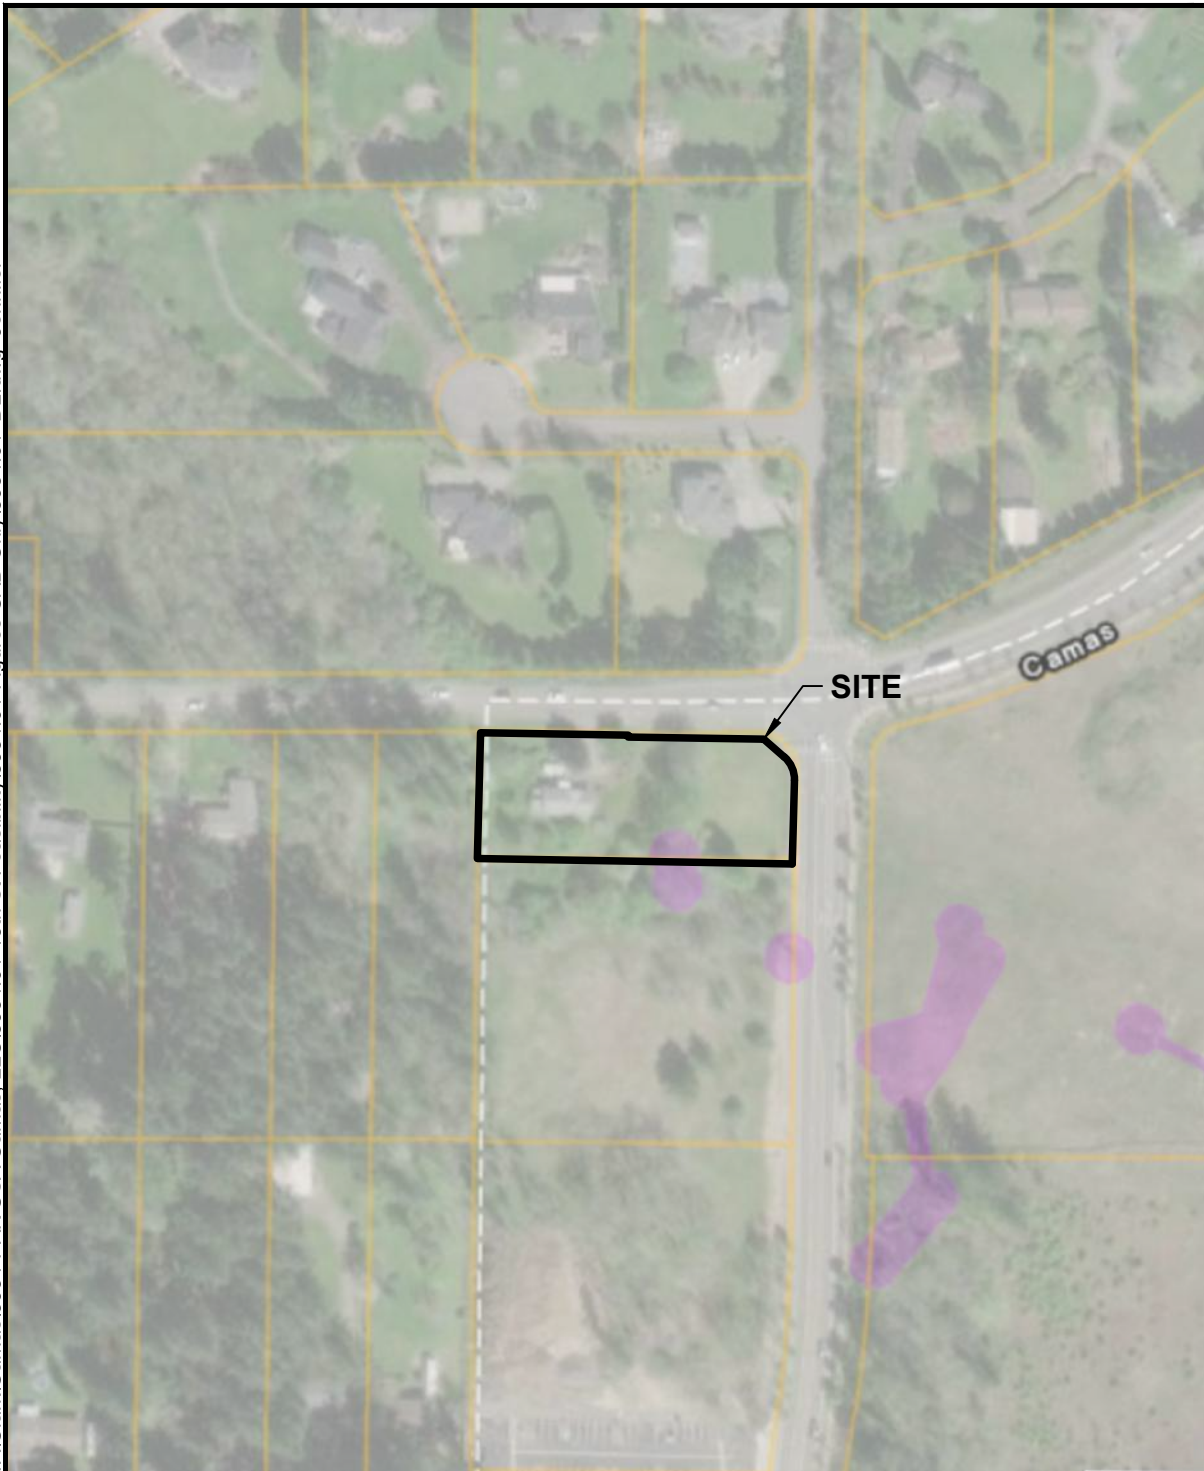
Figure 7
WDFW PRIORITY HABITAT AND SPECIES
13th Street Gas Station
PAK USA Camas, LLC
City of Camas, Clark County, Washington
Section 29, Township 2N, Range 3E, W.M.

The Washington Department of Fish and Wildlife (WDFW) Priority Habitats and Species (PHS) maps indicate oak woodland and caves or cave-rich areas on the southern boundary of the site

and within 300 feet of the site to the southwest (Figure 7, WDFW 2023). ELS confirmed the presence of a single oak along the southern site boundary, but no oak woodlands or caves were observed onsite.

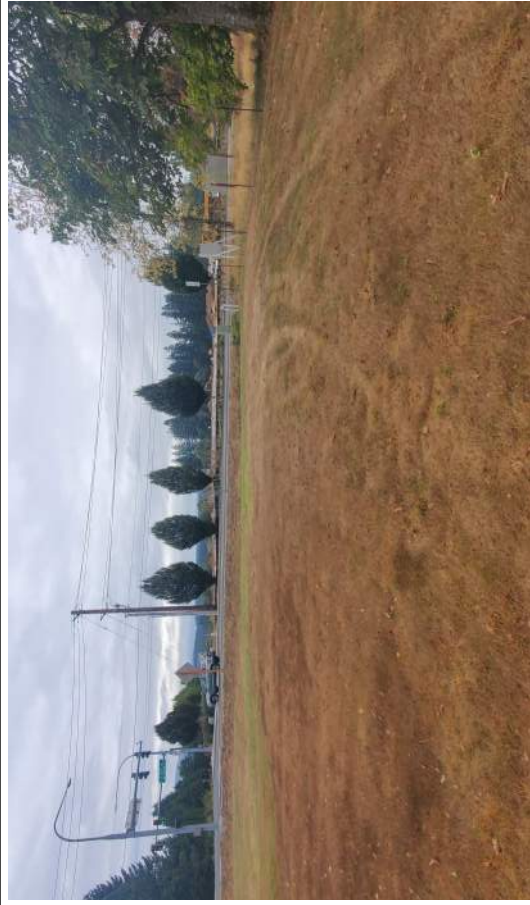
Photo 1 was taken facing east and shows general conditions onsite.

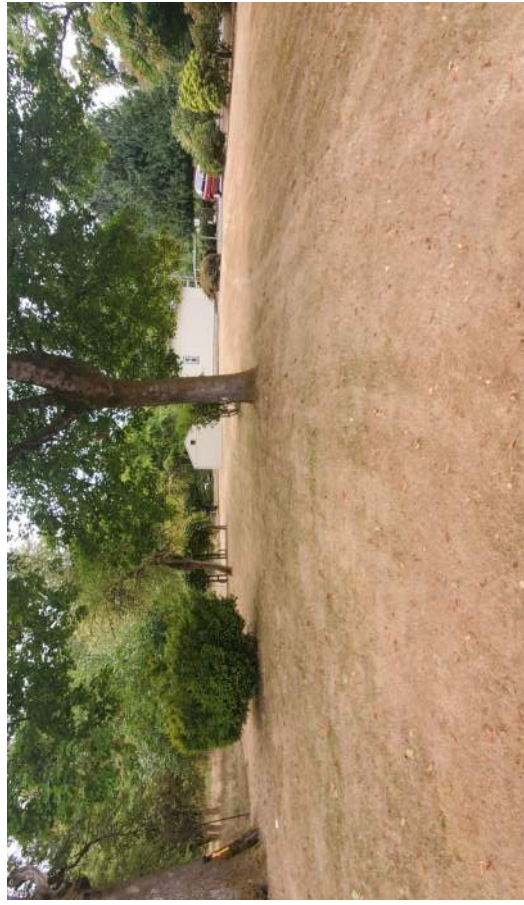
Photo 2 was taken facing west and shows general conditions onsite. The oak is visible on the left.

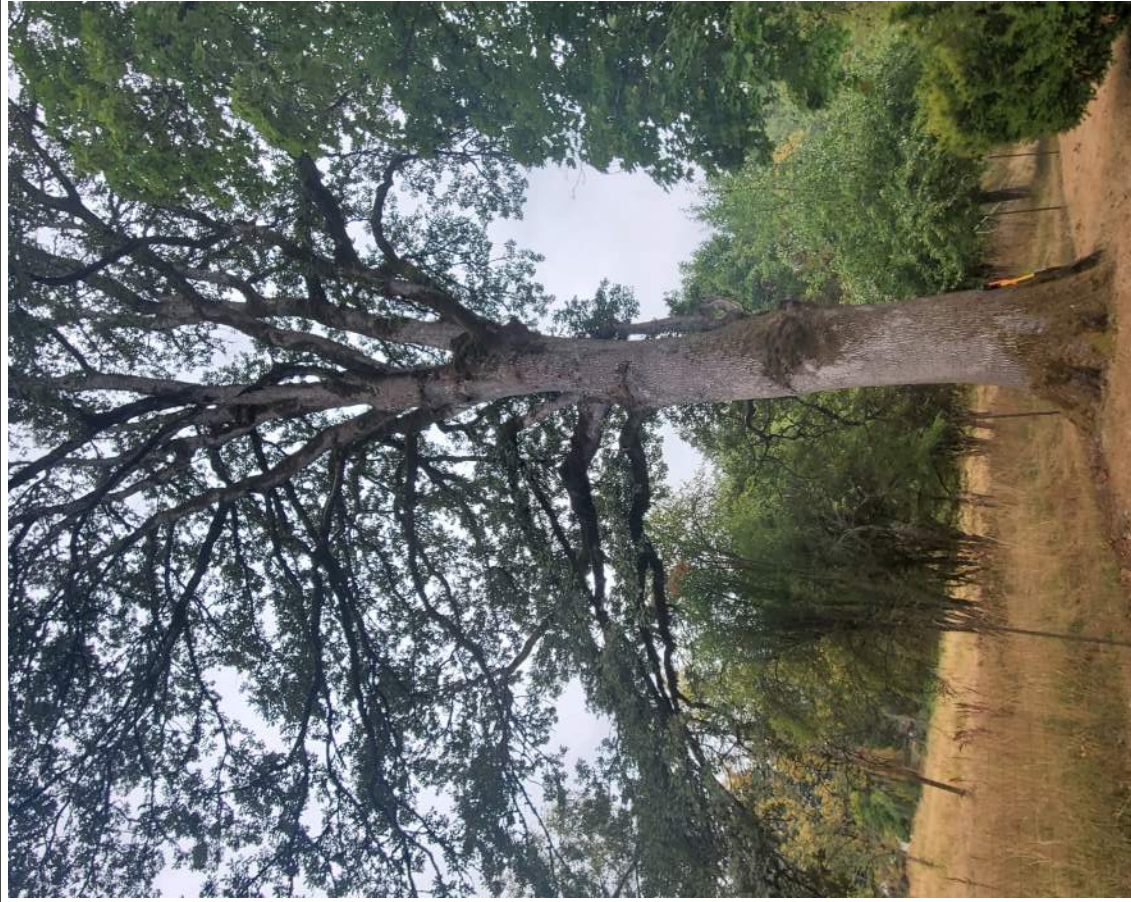
Photo 3 shows the onsite Oregon white oak.

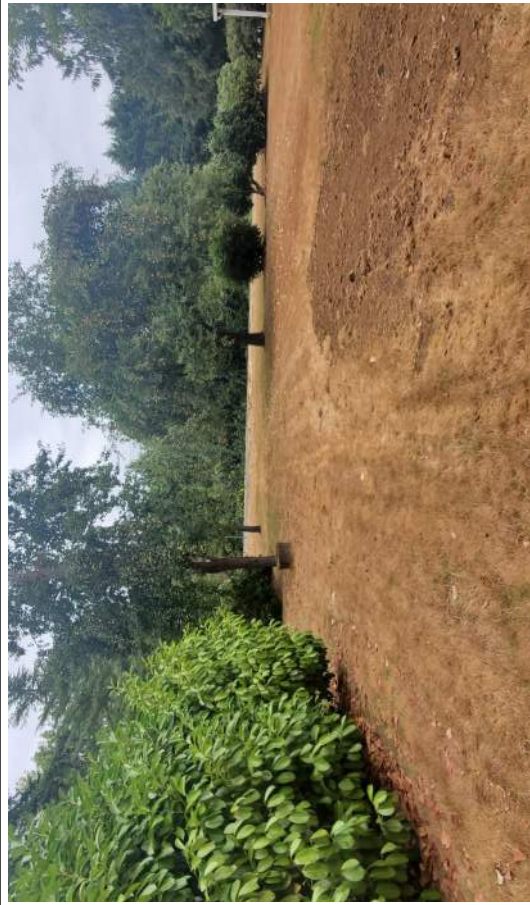
Photo 4 was taken facing north at TP-1 and shows general conditions onsite.

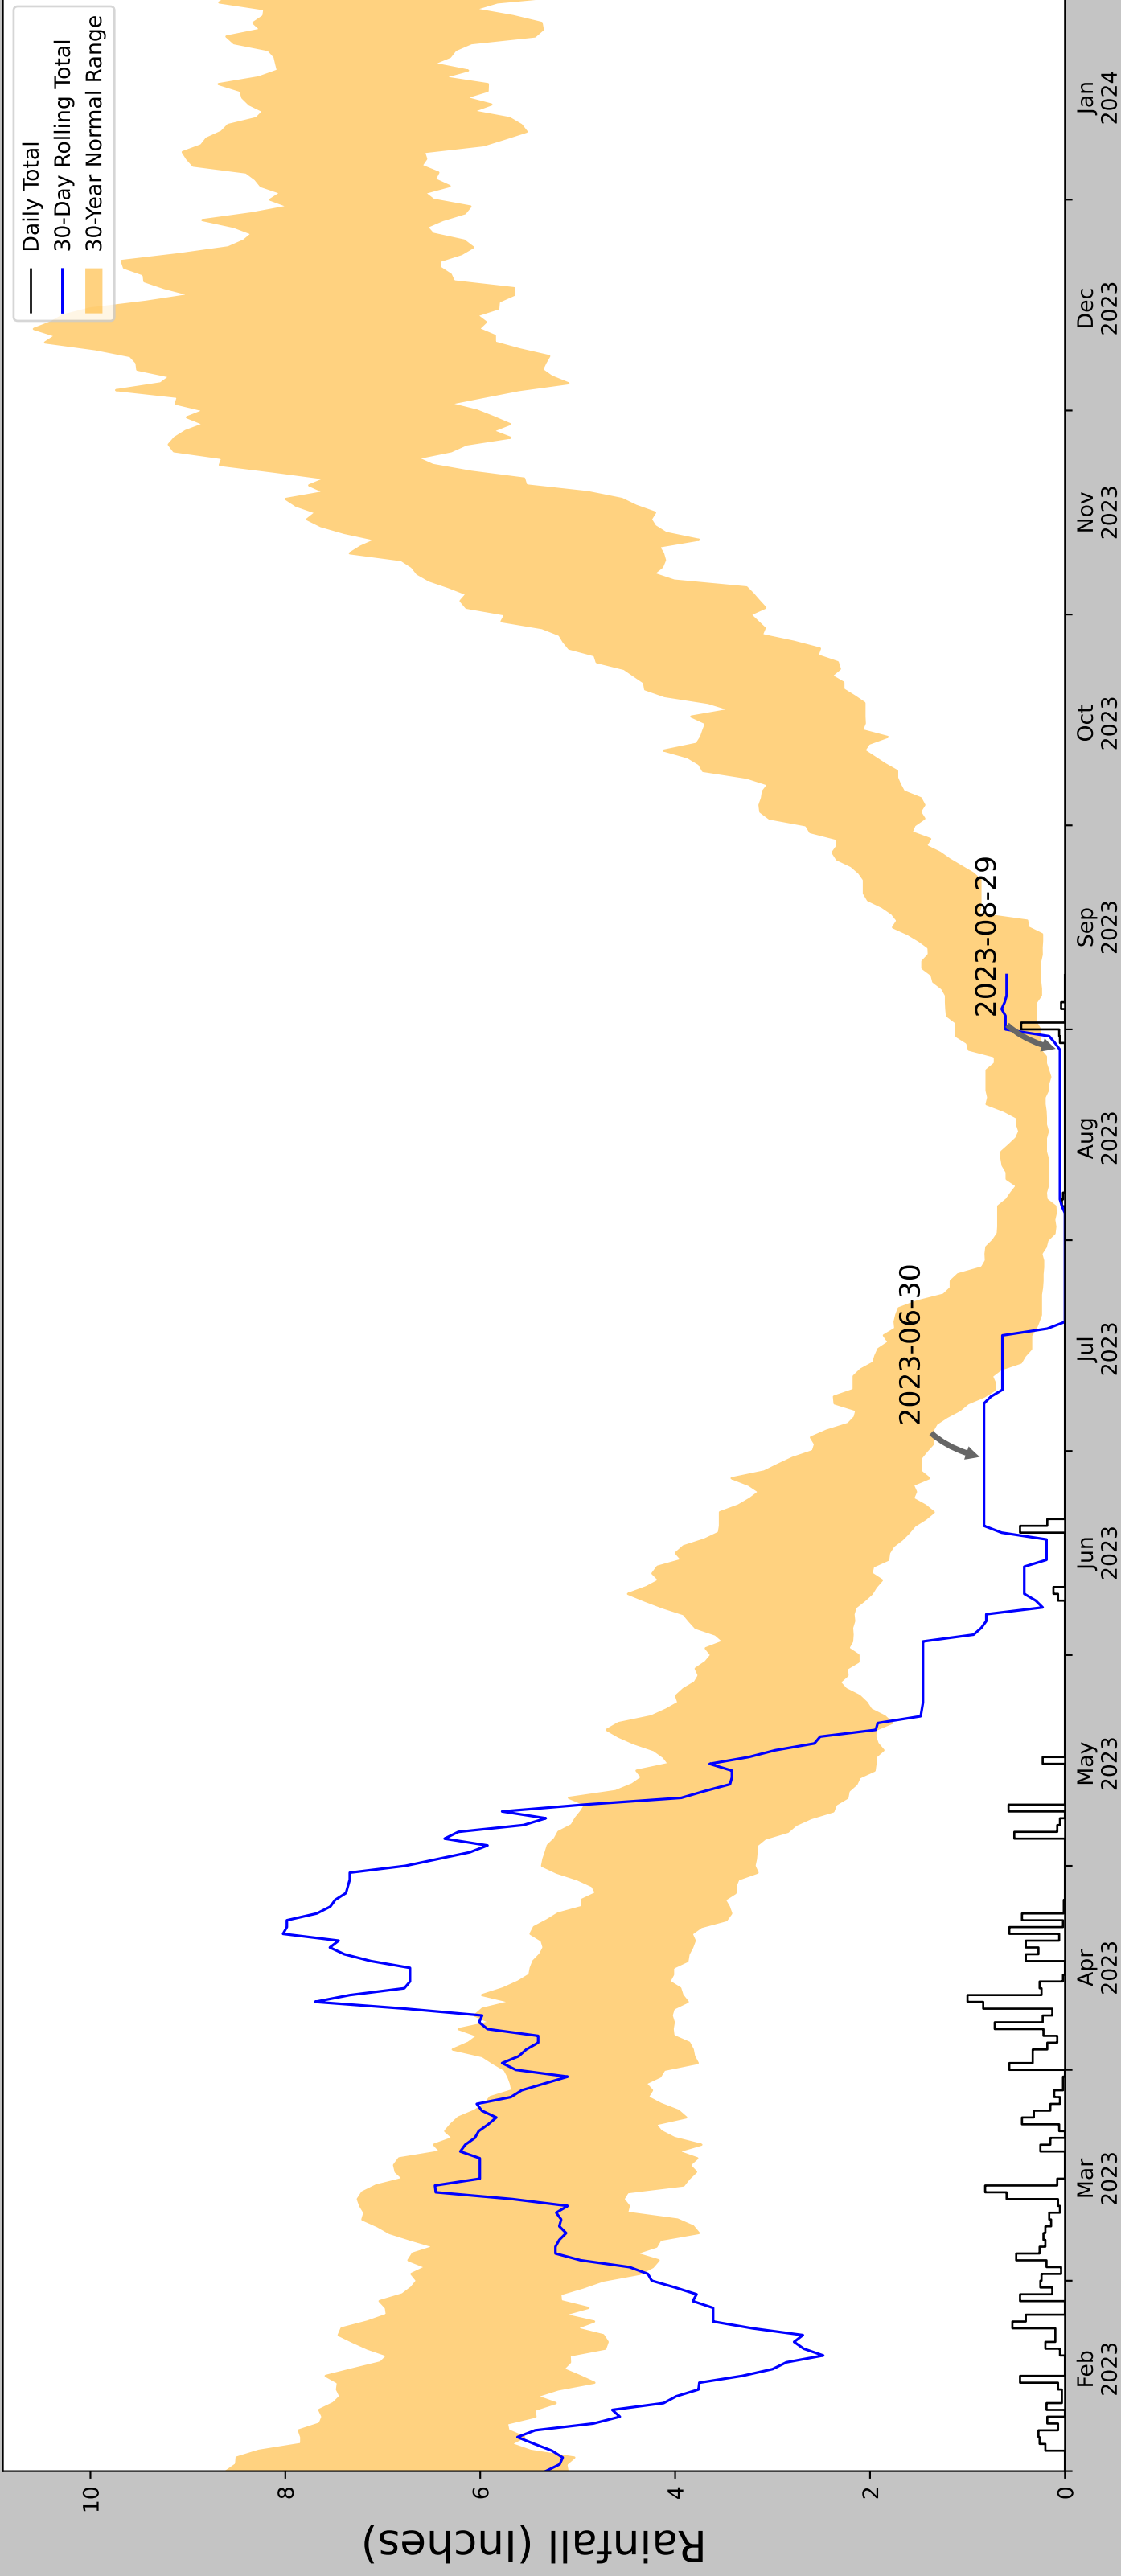
Antecedent Precipitation vs Normal Range based on NOAA's Daily Global Historical Climatology Network

Coordinates	45.632018, -122.467297
Observation Date	2023-08-29
Elevation (ft)	253.44
Drought Index (PDSI)	Severe drought
WebWIMP H ₂ O Balance	Dry Season

30 Days Ending	30 th %ile (in)	70 th %ile (in)	Observed (in)	Wetness Condition	Condition Value	Month Weight	Product
2023-08-29	0.253543	0.986221	0.051181	Dry	1	3	3
2023-07-30	0.24252	0.814961	0.0	Dry	1	2	2
2023-06-30	1.475197	2.795276	0.830709	Dry	1	1	1
Result							Drier than Normal - 6

Precipitation data was gathered from the NOAA Regional Climate Centers *Clark County, Washington, WETS Station: Battle Ground*, which is located closest to the site. No rainfall occurred the day of the site visit or in the two weeks prior. Rainfall in June, July, and August was below exceedance levels and approximately 94 percent of August rainfall occurred prior to the site visit. Furthermore, review of the USACE Antecedent Precipitation Tool (APT) indicates rainfall

in the two months preceding the August 29th site visit was drier than normal with a score of 6. A copy of the APT data is provided in Appendix C. Table 1 summarizes the precipitation data.
