RE: Hood Street Subdivision (SUB22-01) application review comments

HOOD STREET PROJECT

PRELIMINARY WETLAND MITIGATION PLAN

Camas, Washington

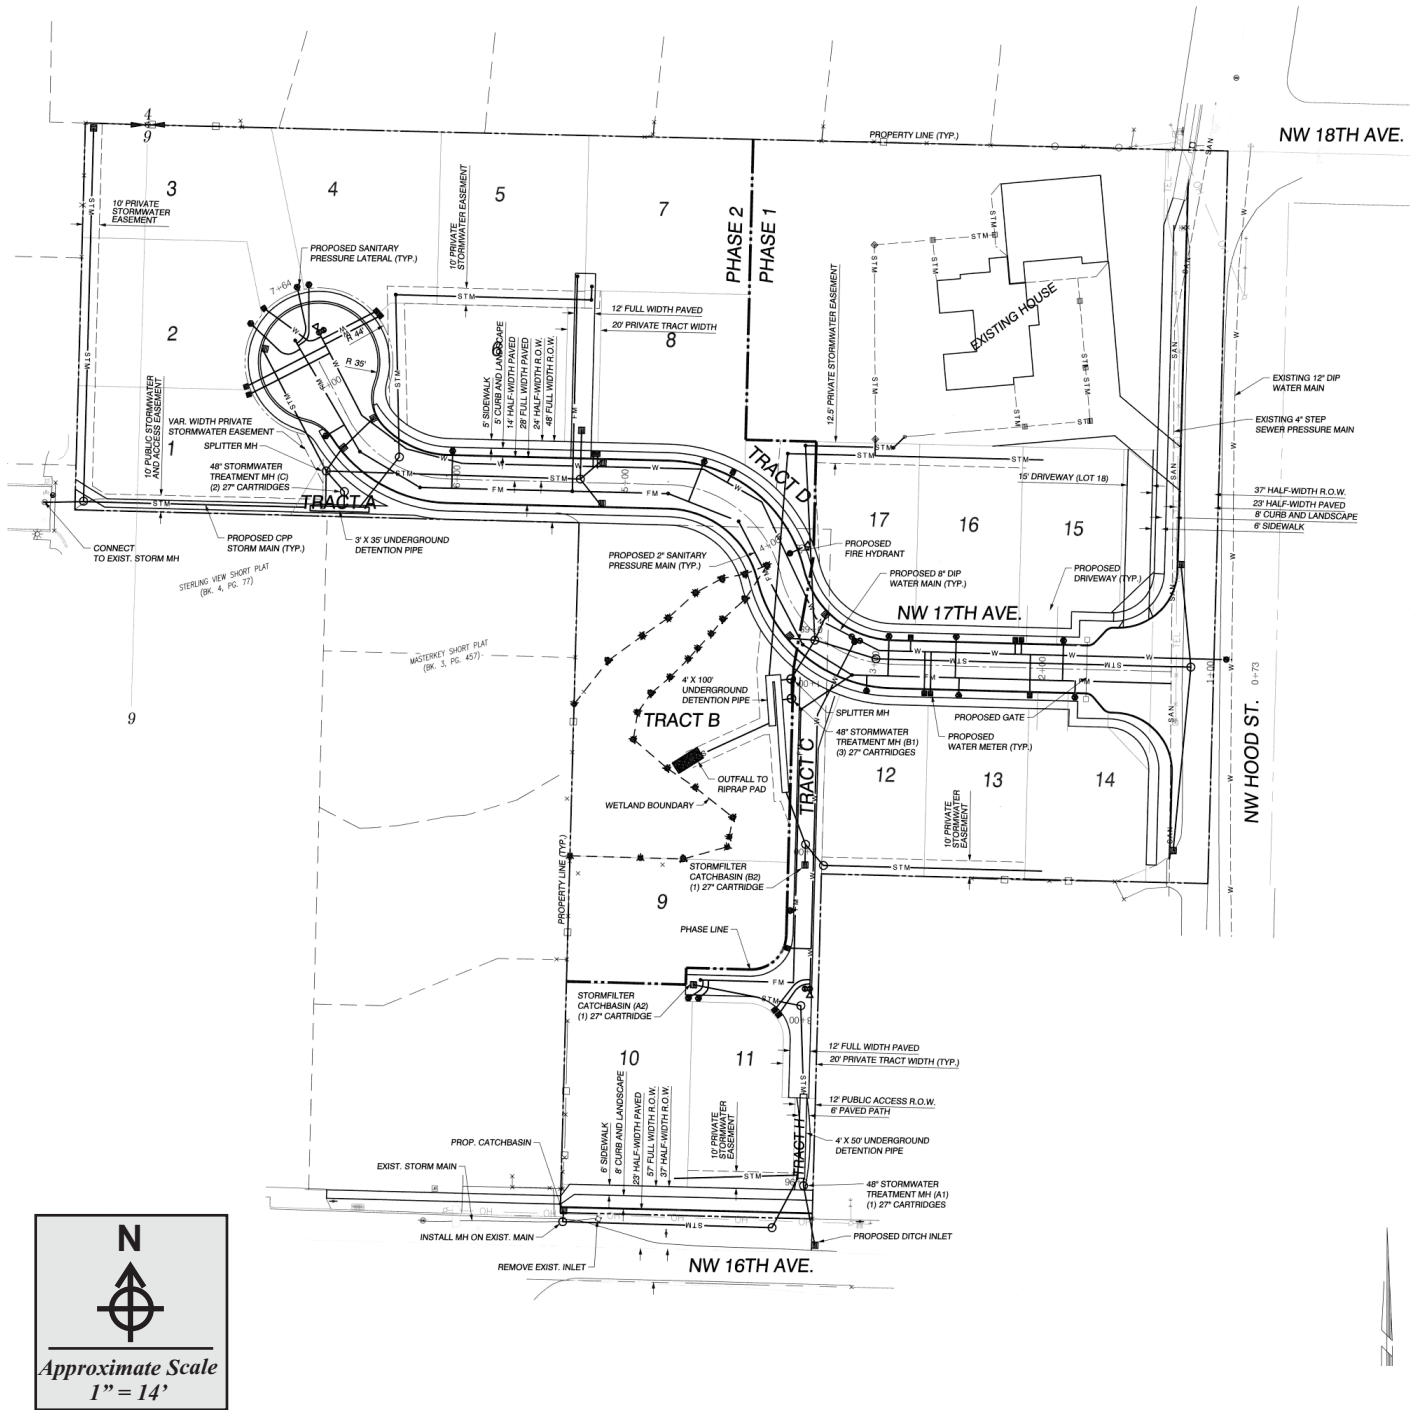
Figure 2

Most of direct impacts to Wetland A were minimized by site design (Fig. 2) but a small amount of direct and indirect wetland impacts were unavoidable within the northeast and southwest portion of the wetland (Fig 5). In order to minimize impacts further, lot lines were also shifted south from the original plat design to avoid an additional 1,307 square feet (.03 ac) within Lot#9 and 50 square feet (.001 ac) within the roadway in the northeast corner of the wetland.

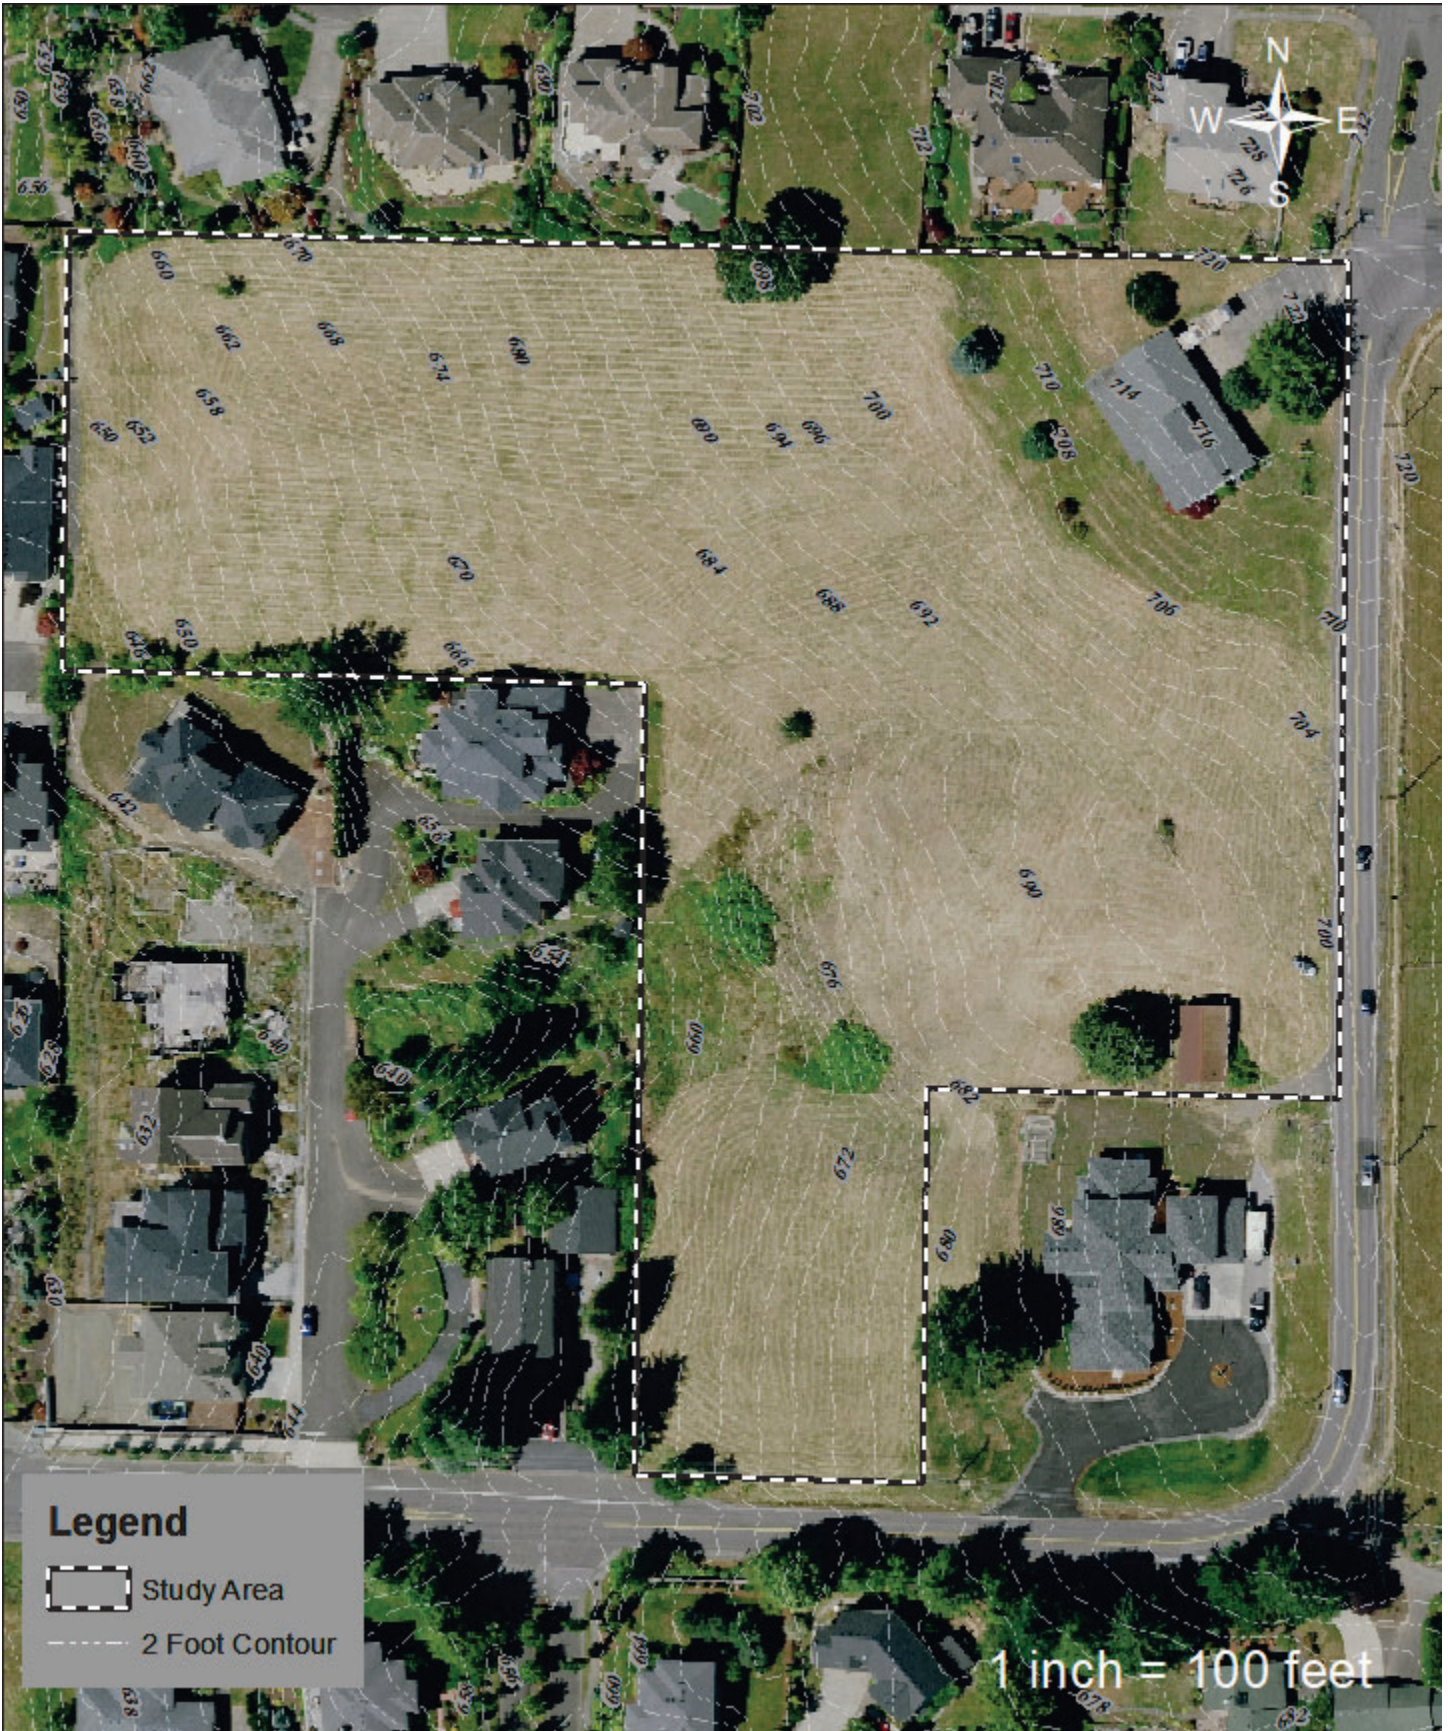
Figure 3

The majority of the study area is open grassland, it slopes moderately from the northeast to the southwest (Fig. 3). One existing house is located in the northeast corner of the property. The eastern property line is immediately parallel to Northwest Hood Street and NW Columbia Summit Drive and NW Klickitat Street are to the north and west, respectively. The property is located within the Dwyer Creek sub-watershed of the Lacamas Creek watershed (WRIA 28). Photographs of the study area are provided in Photo-Sheet 1.

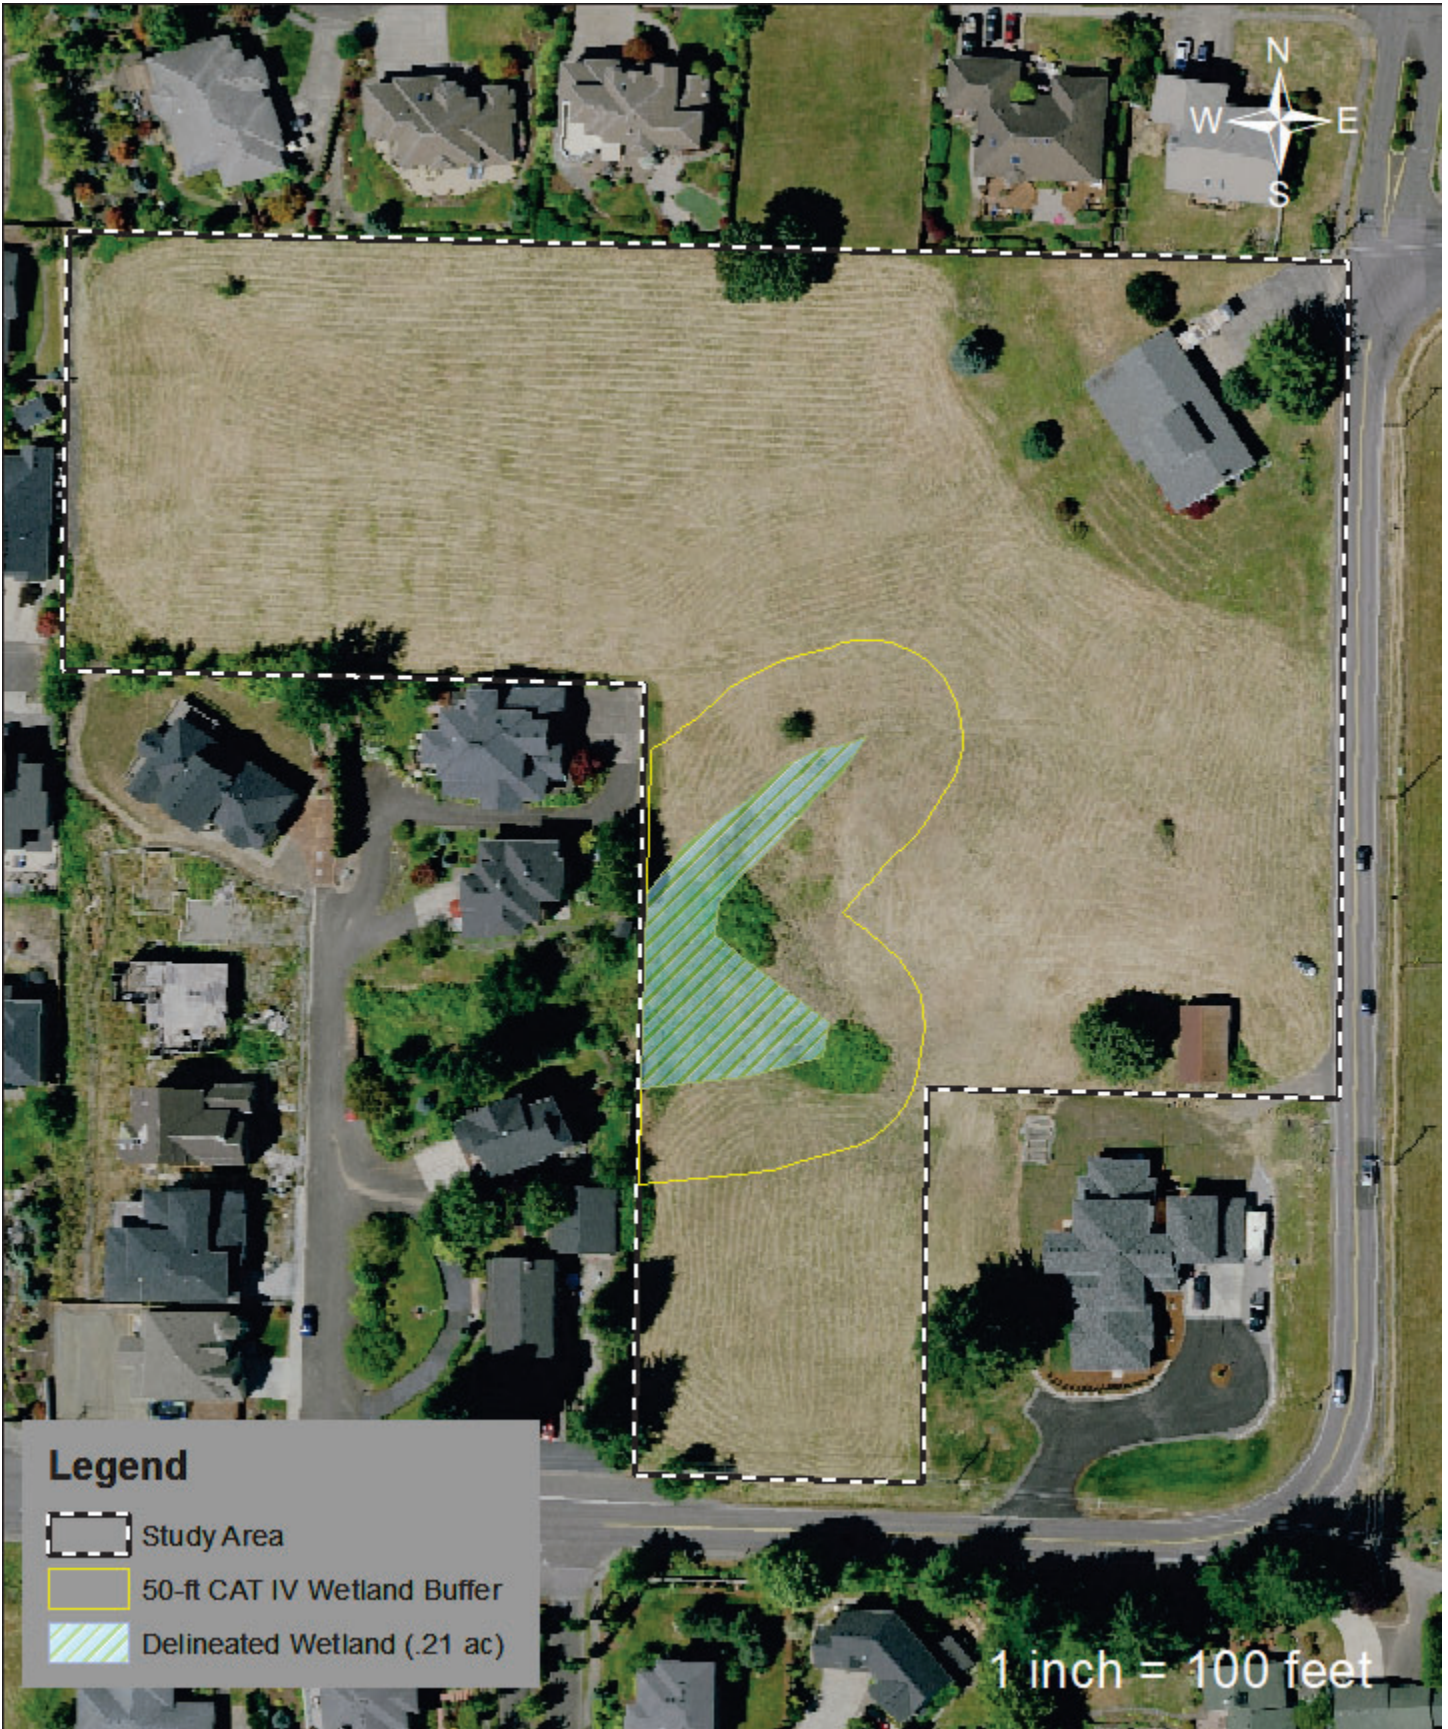
-   Study Area
-   50-ft CAT IV Wetland Buffer
-   Delineated Wetland (.21 ac)

CMC requires that Category IV wetlands with habitat function scores of 3 to be protected with a 50-foot high-intensity land use buffer (CMC Table 16.53.040-1). The buffer width for the identified wetland is depicted in Figure 4 and summarized in Table 3, below. In addition to CMC 16.53, jurisdictional wetlands are also regulated at the federal and state levels by the US Army Corps of Engineers (USACE) and the Washington State Department of Ecology (Ecology) under Sections 404 and 401 of the Clean Water Act, respectively. Any impacts to the wetlands may require notification and approval from the USACE and Ecology.

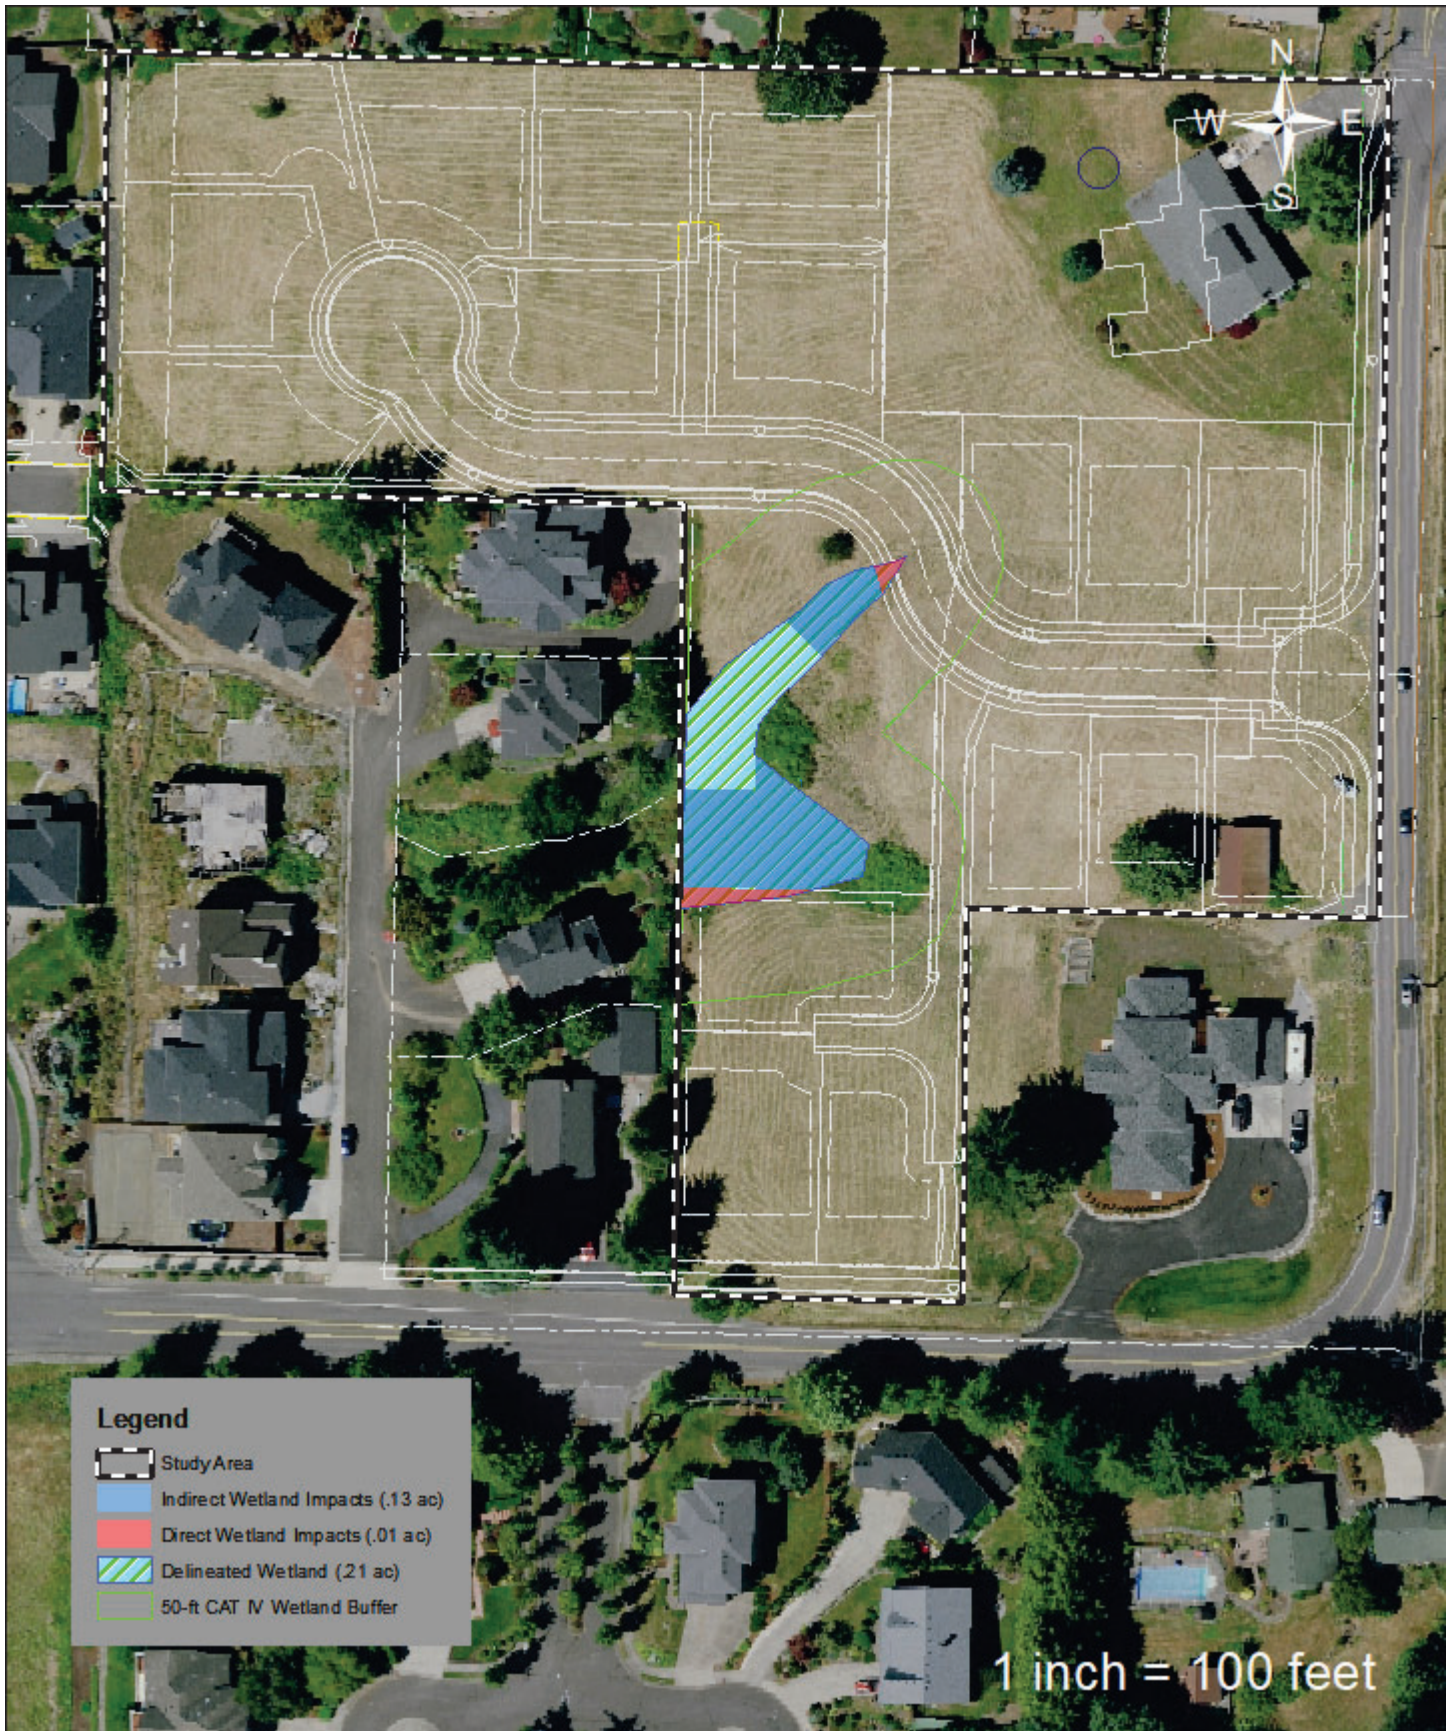
Figure 5

Based on the proposed site plan, unavoidable impacts are proposed to Wetland A in the form of grading, excavation and filling (Fig 5). Proposed impacts include 0.01 acres of direct wetland impact and .13 acres of indirect wetland impact. In addition, construction impacts from the installation of an underground detention pipe, outfall, and riprap pad for the stormwater facility will cause an additional .01 acres of temporary wetland impact (Fig. 6). The proposed impact areas are summarized in Table 4.

- Study Area
- Indirect Wetland Impacts (.13 ac)
- Direct Wetland Impacts (.01 ac)
- Delineated Wetland (.21 ac)
- 50-ft CAT IV Wetland Buffer

The goal of this compensation plan is the is to re-establish native vegetative cover within the wetland buffer in areas temporarily impacted by construction activities (Fig 5).

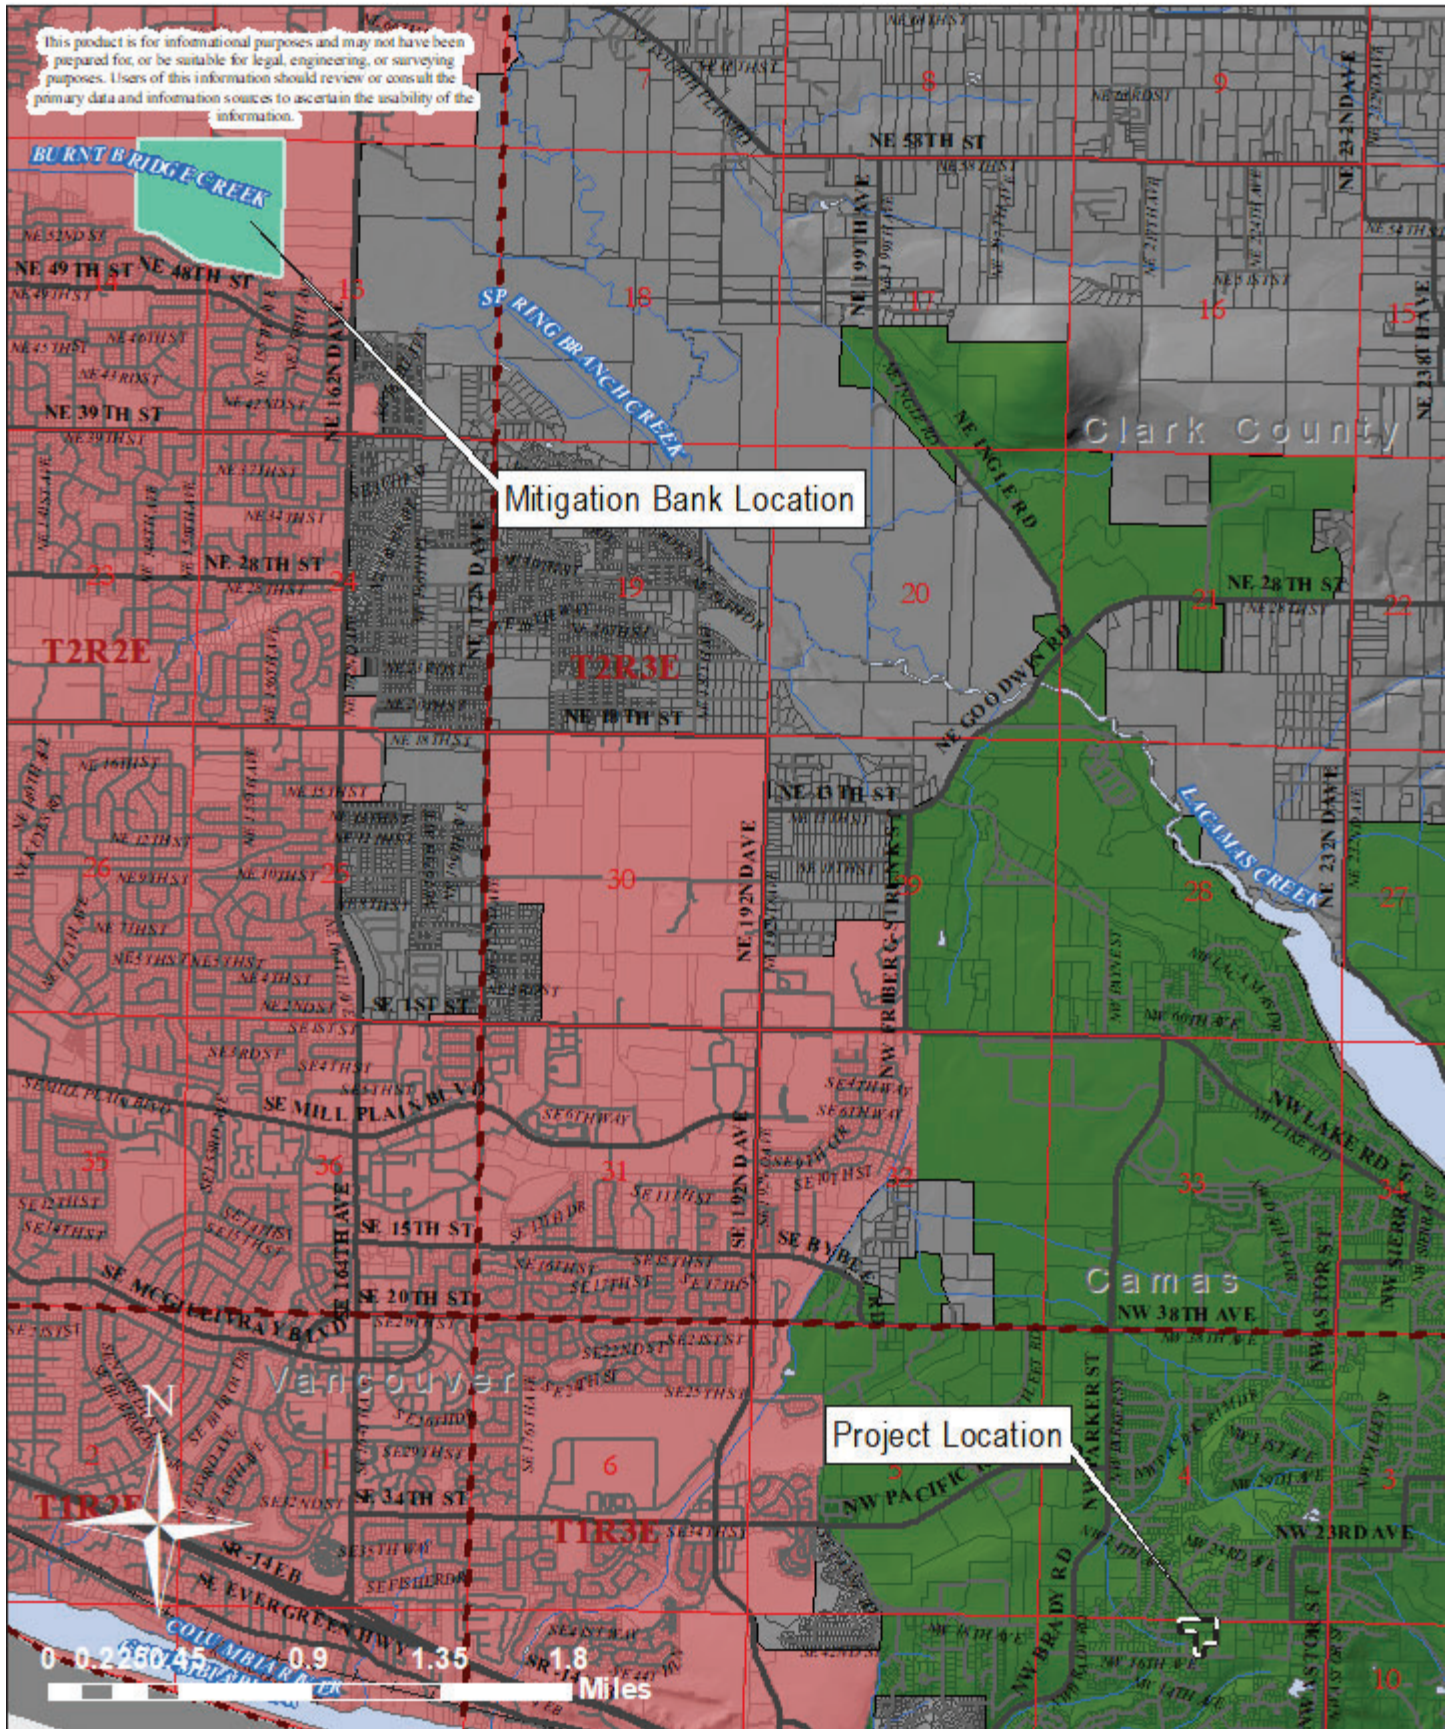
Figure 7

For the proposed permanent wetland impacts associated with the project, the Applicant is proposing the purchase of bank credits as a means of compensation. The direct and indirect impacts to Wetland A for the Hood Street Project will be compensated through the purchase of credits from the Terrace Wetland Bank (TWB). TWB is located approximately 5.7 miles northwest of the project area (Fig. 7), within the Burnt Bridge Creek Watershed.

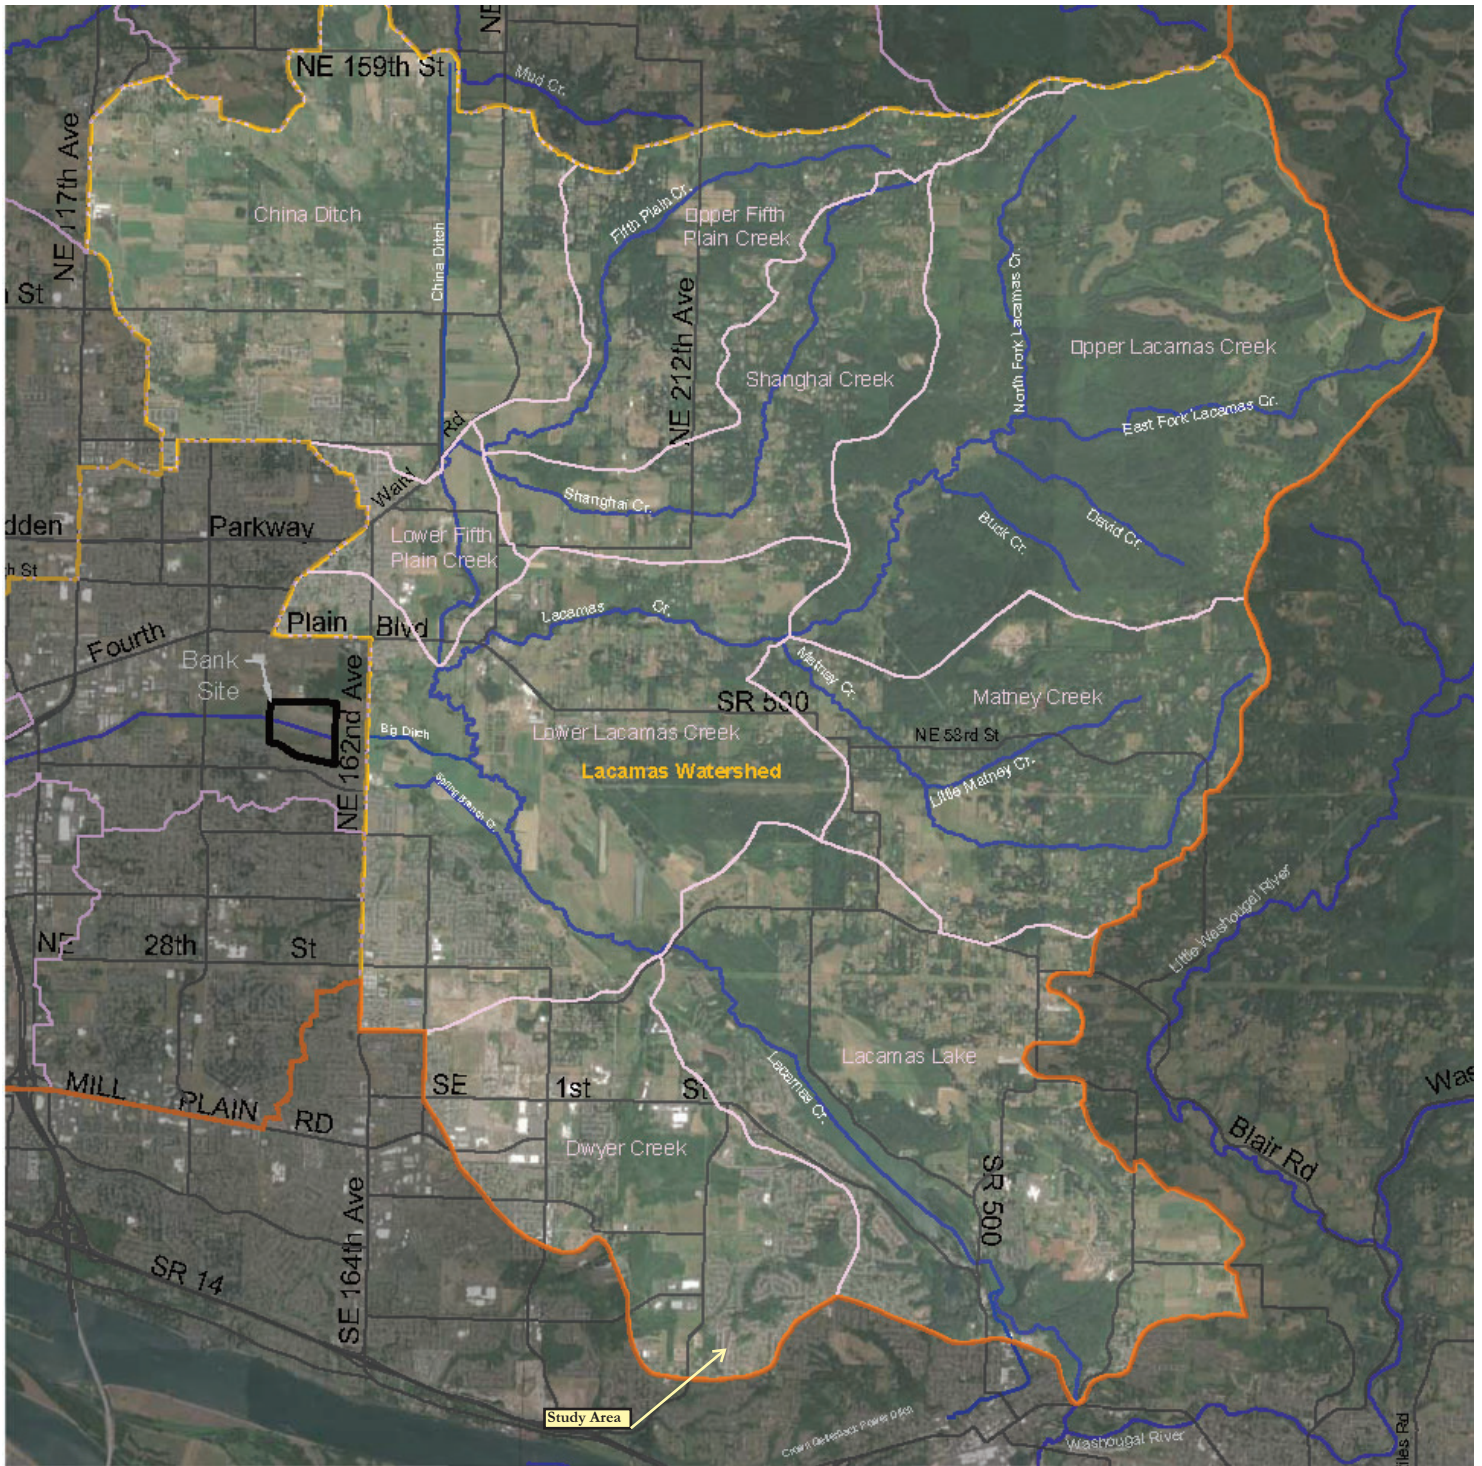
PROPOSED ACTIVITIES IN:
 Lacamas Creek Watershed
LEGAL: NE & NW 1/4 of S09, T1N, R3E
 W. M.
NEAR: Camas, Washington
COUNTY: Clark County
DATE: June 7, 2022
Figure 8

The bank site has been extensively farmed for at least 60 years, which has drastically altered all aspects of the wetland, including the hydrology through the installation of drain tiles, the soils through repetitive plowing, and the vegetation through continued agricultural production. There was the potential to create a significant amount of functional lift to wetlands and other aquatic resources on the project site, by reestablishing and restoring the historic wetland system and improving existing stream complexity. Ecology's Selecting Wetland Mitigation Sites Using a Watershed Approach (2009) was used to evaluate the mitigation potential of the site. The bank sponsor is proposing to re-establish 85.02 acres of wetland, rehabilitate 4.02 acres of wetland, enhance 0.10 acres of wetland, and the enhancement of 2.53 acres of open channel enhancement along Burnt Bridge Creek. The service area for TWB is shown in Figure 8 and includes the project area.

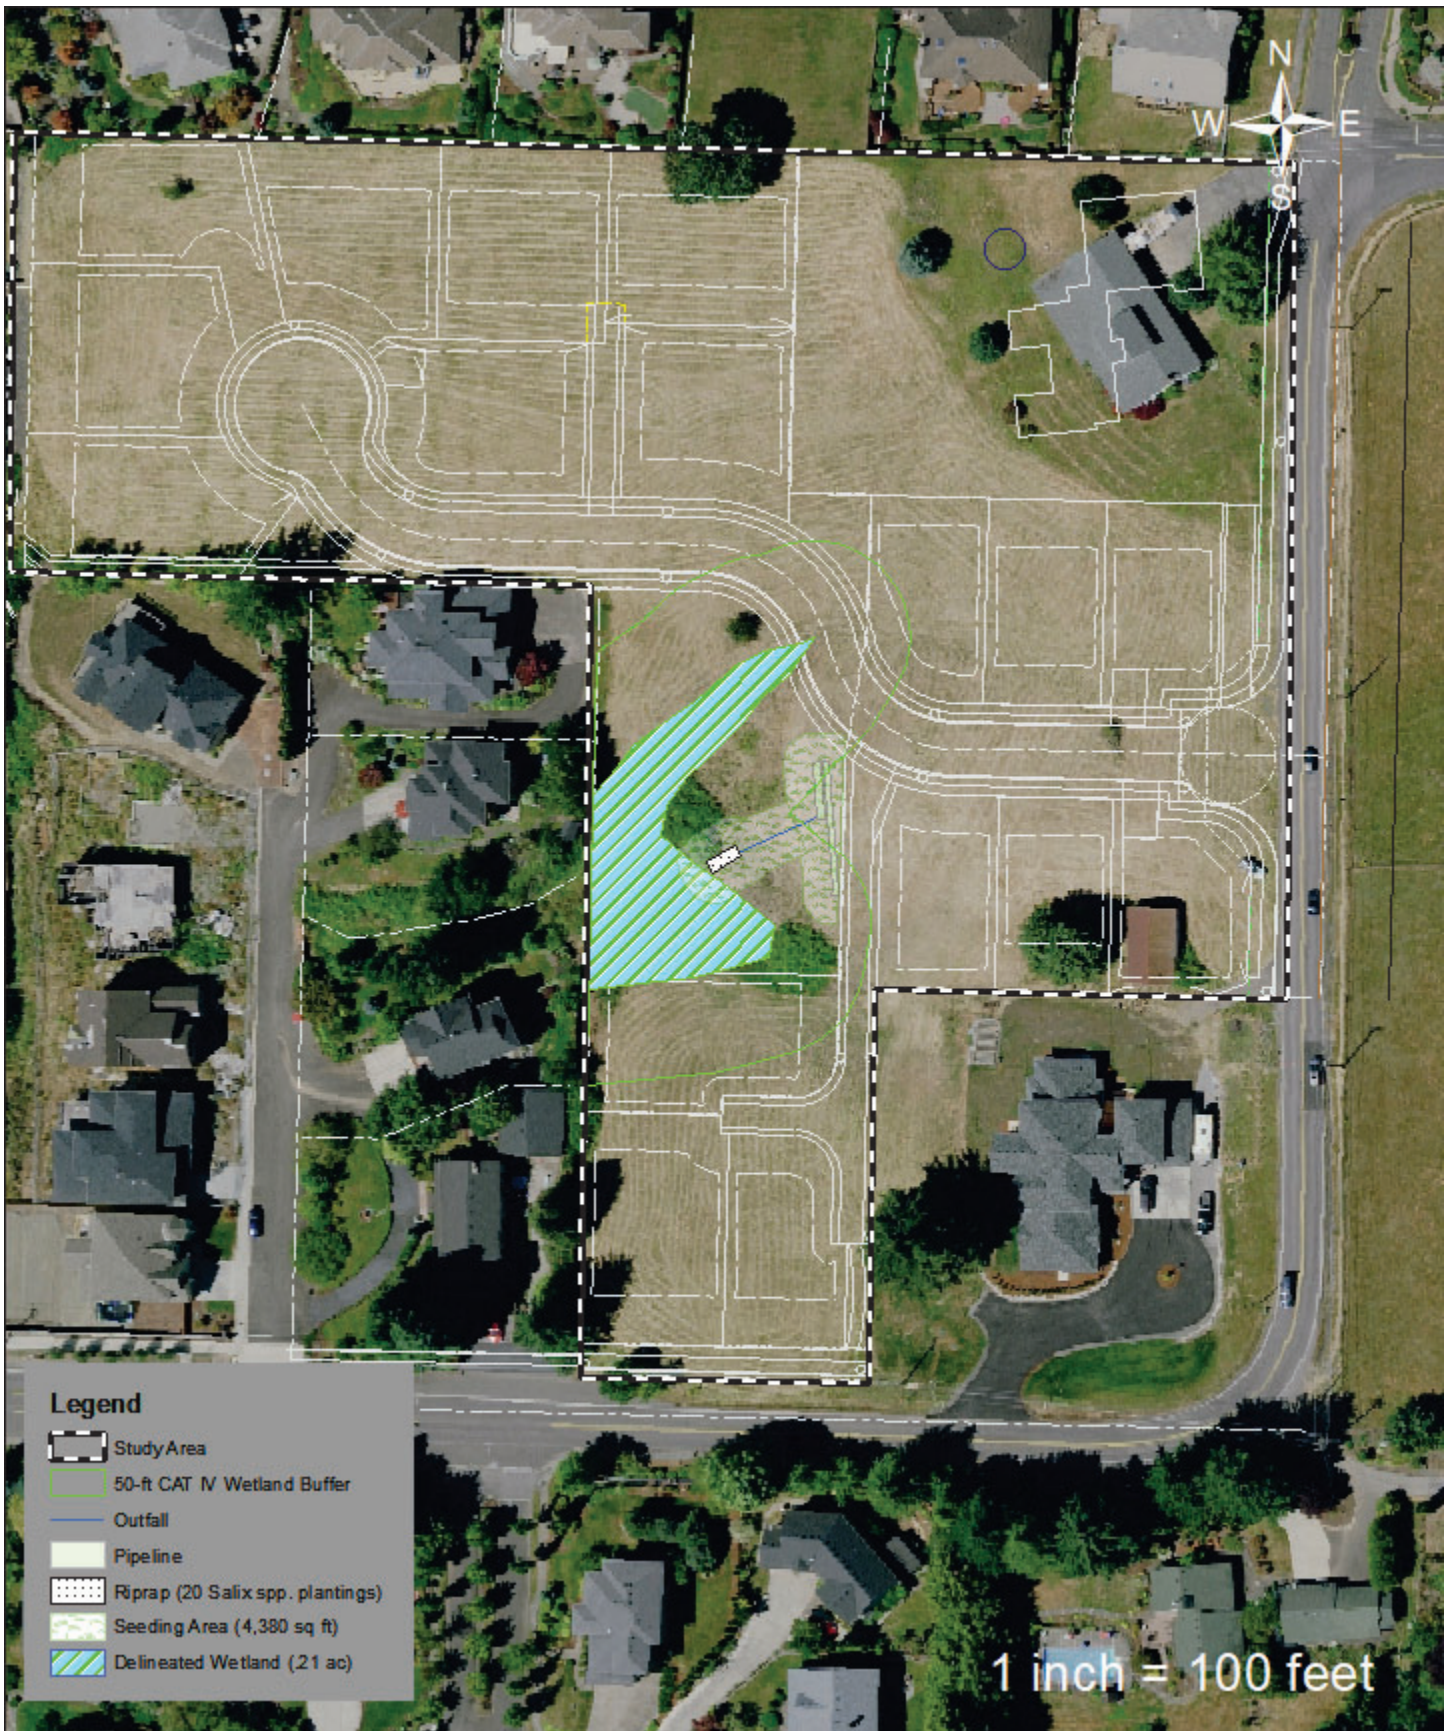
Figure 9

Permanent buffer impact resulting from the installation of the riprap pad will be restored through the planting of native willow saplings, as outlined in Table 8 and is depicted in Figure 9.

The footprint of the stormwater pipe and outfall in addition to a 15-foot construction buffer-zone within the wetland and buffer will be planted with a native seed mix, as outlined in Table 7 and depicted in Table 9.

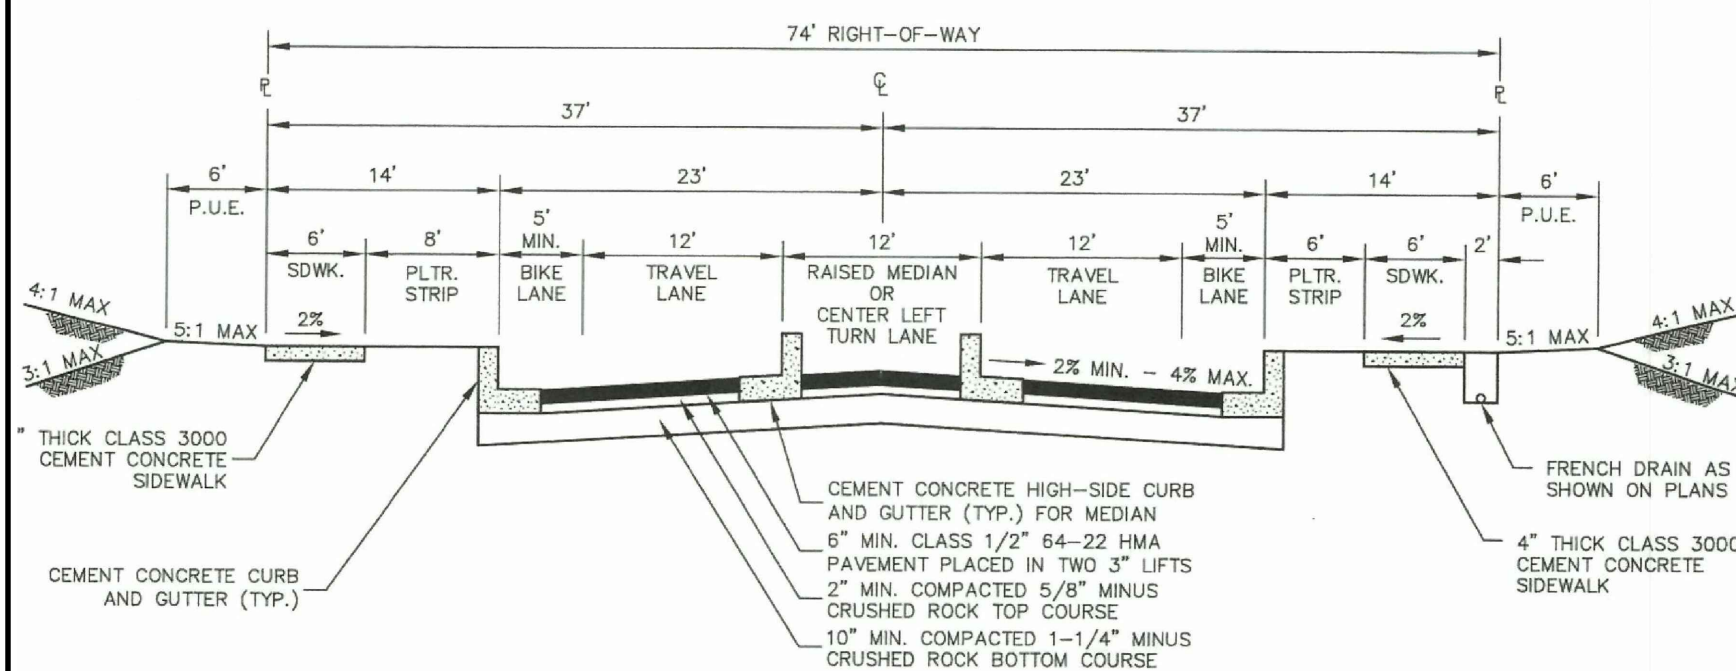
CITY OF CAMAS ROAD STANDARD DRAWING S75
3 LANE COLLECTOR/ARTERIAL (74' R.O.W.)
ACTUAL IMPROVEMENTS MAY DIFFER FROM STANDARD DETAIL
NW HOOD STREET HALF-WIDTH/NW 16TH AVE. HALF-WIDTH NOT TO SCALE
