December 22, 2021  
GeoPacific Project No. 21-5946

Subject: **PHASE I ENVIRONMENTAL ASSESSMENT  
CAMAS MEADOWS SUBDIVISION  
4525, 4555, 4615, AND 4711 NW CAMAS MEADOWS DRIVE  
CAMAS, WASHINGTON**

## Geotechnical Engineering Report

**Project Information:** Camas Meadows Subdivision, Phase 1 & 2  
GeoPacific Project No. 21-5938 & 21-5939  
December 28, 2021

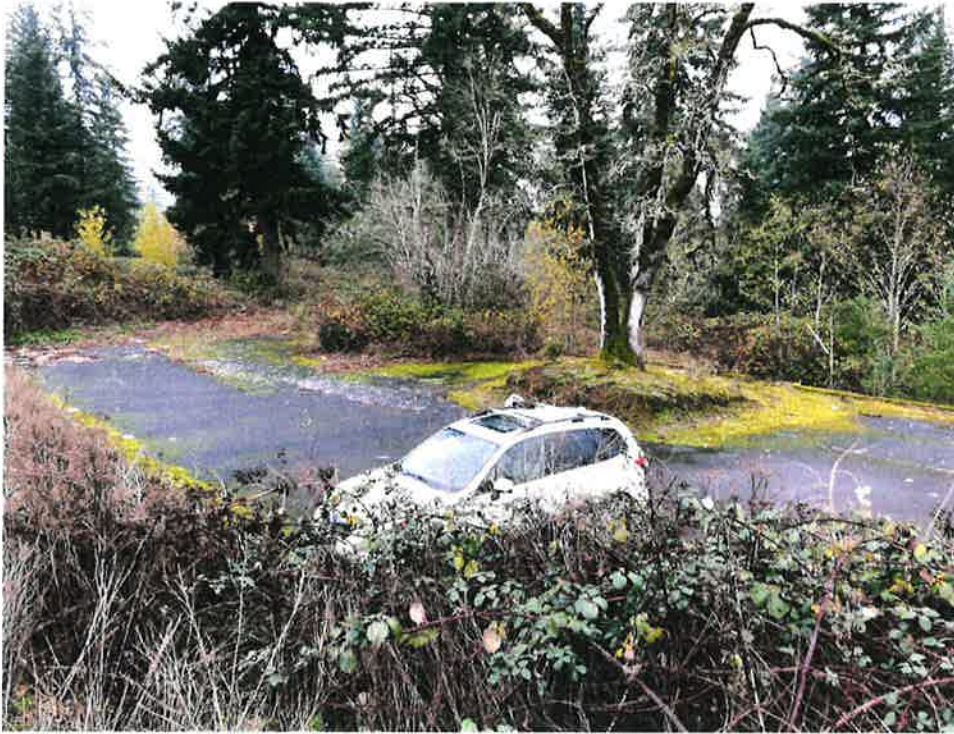
except for the northwest portion of the site which consists primarily of tall grasses, brush, and shrubs. A small asphalt parking area is located on the southeast corner of the site and was slightly overgrown at the time of this reconnaissance. A pad mounted electrical transformer was located in an area of brush off the southeast corner of the parking area. Multiple treated wooden poles were observed in a forest and brush area to the north of the parking lot on the eastern end of the site.

**Photo 1 – Parking lot on southeast portion of site**

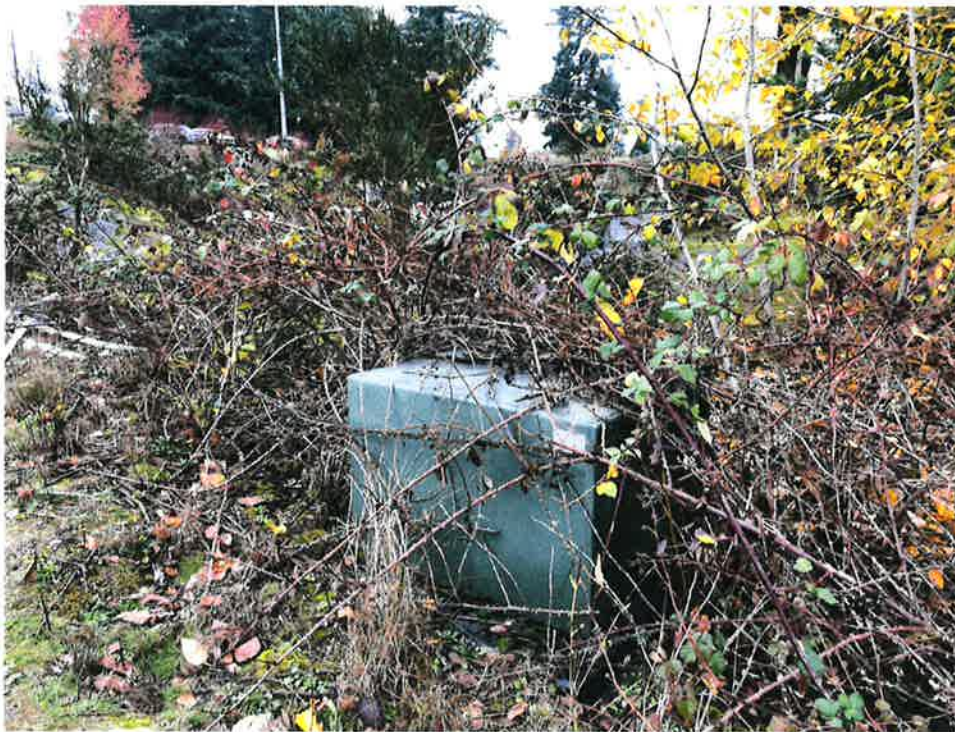
**Photo 2 – Pad mounted transformer in brush on southeast side of parking area**

- Verify that the existing pad-mounted transformer located off the southeast corner of the asphalt parking area does not contain PCBs when it is removed from the site. If the transformer is found to contain PCBs, disposal should conform to applicable state and federal requirements.

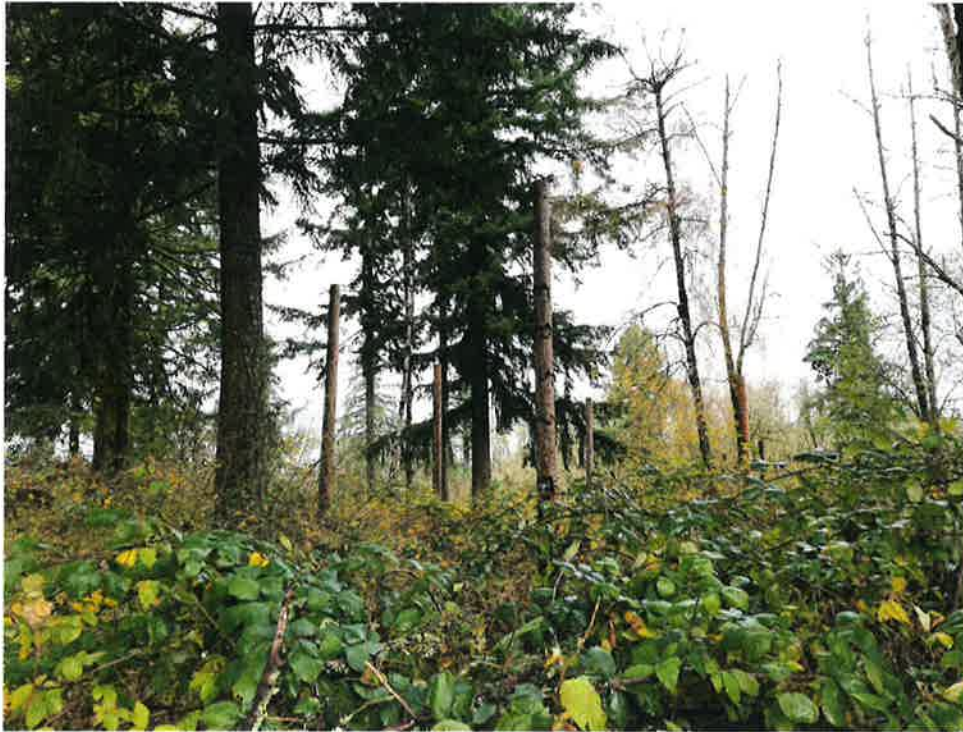
**Photo 3 – Utility poles in forest on southeast portion of site**

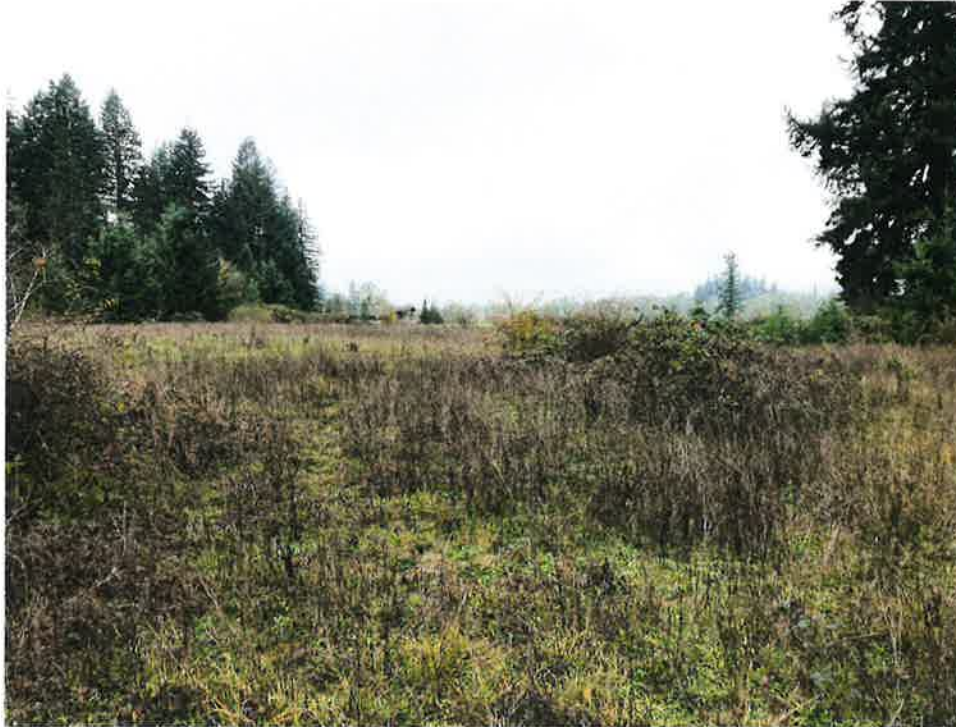
**Photo 5 – Grassy fields and brush on west side of site**

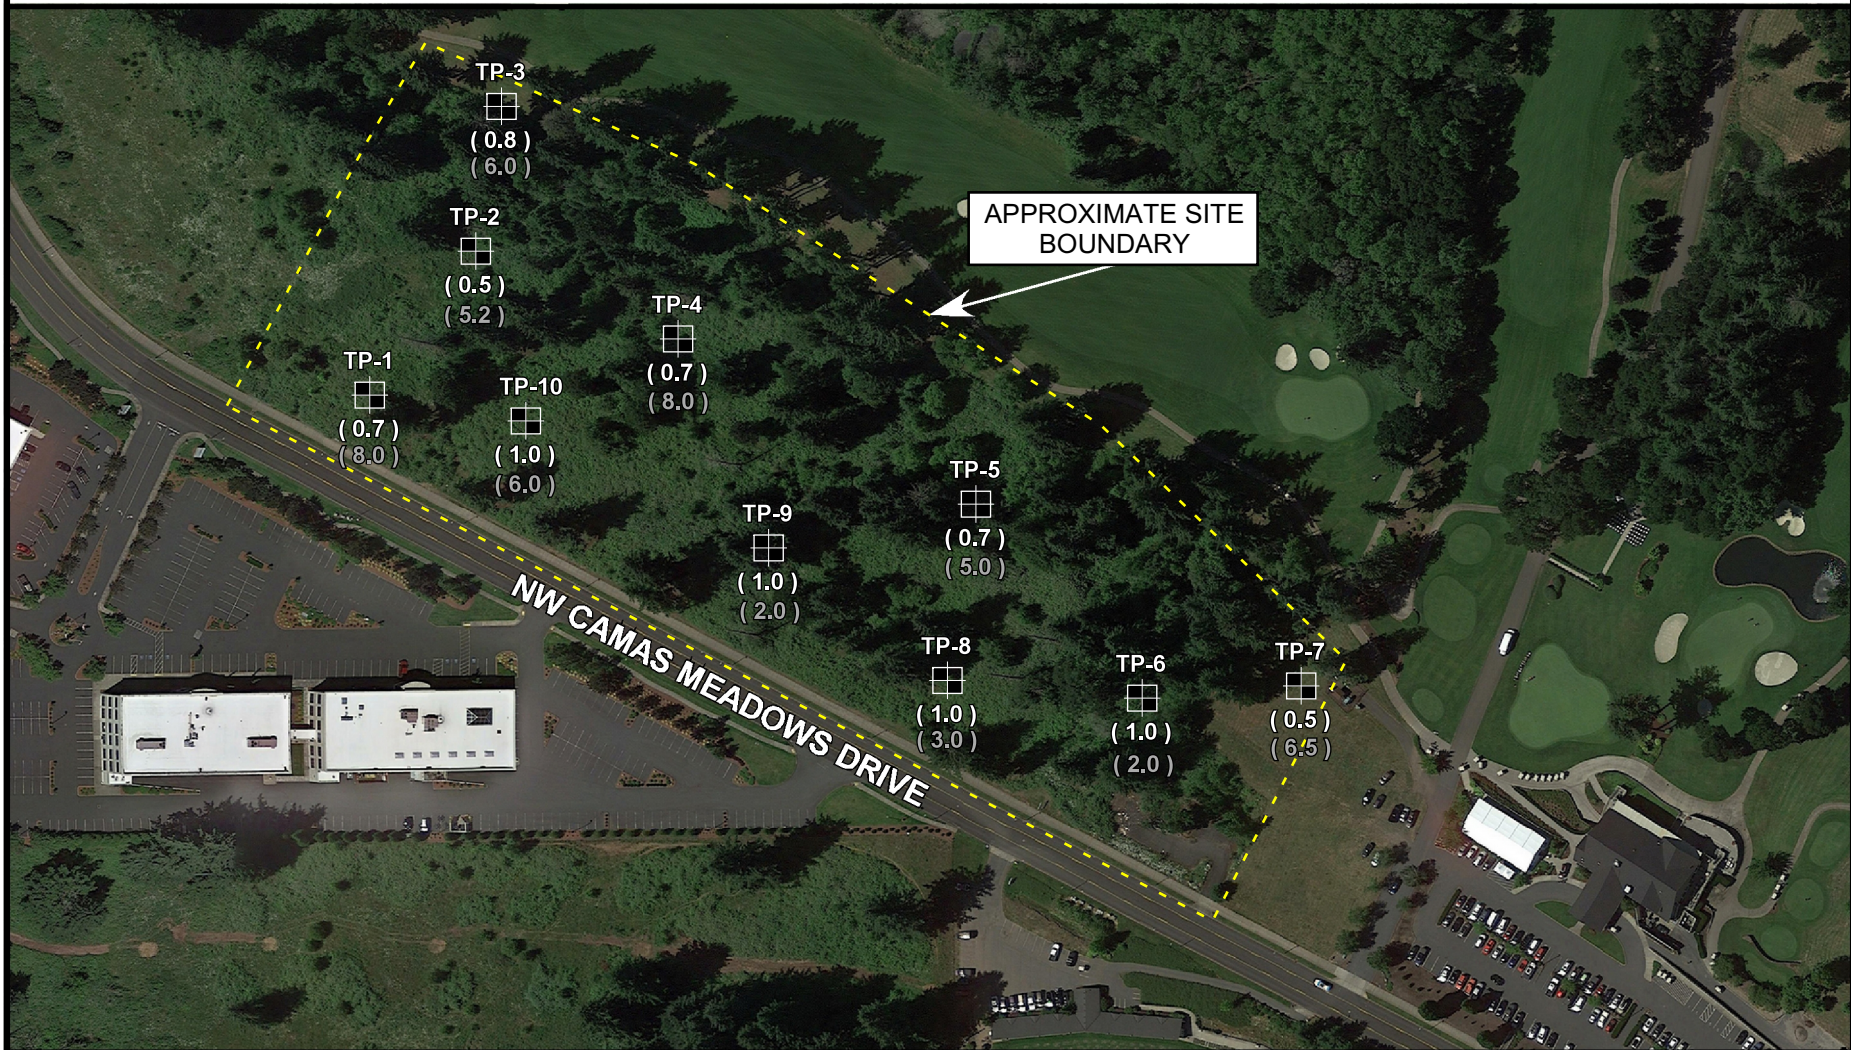
# SITE AERIAL AND EXPLORATION LOCATIONS

TP-1  
 Test Pit Designation and Approximate Location

**(1.5')** Approximate Depth of Observed Undocumented Fill or Topsoil, Feet  
**(1.5')** Approximate Depth of Dense to Very Dense Conglomerate, Feet

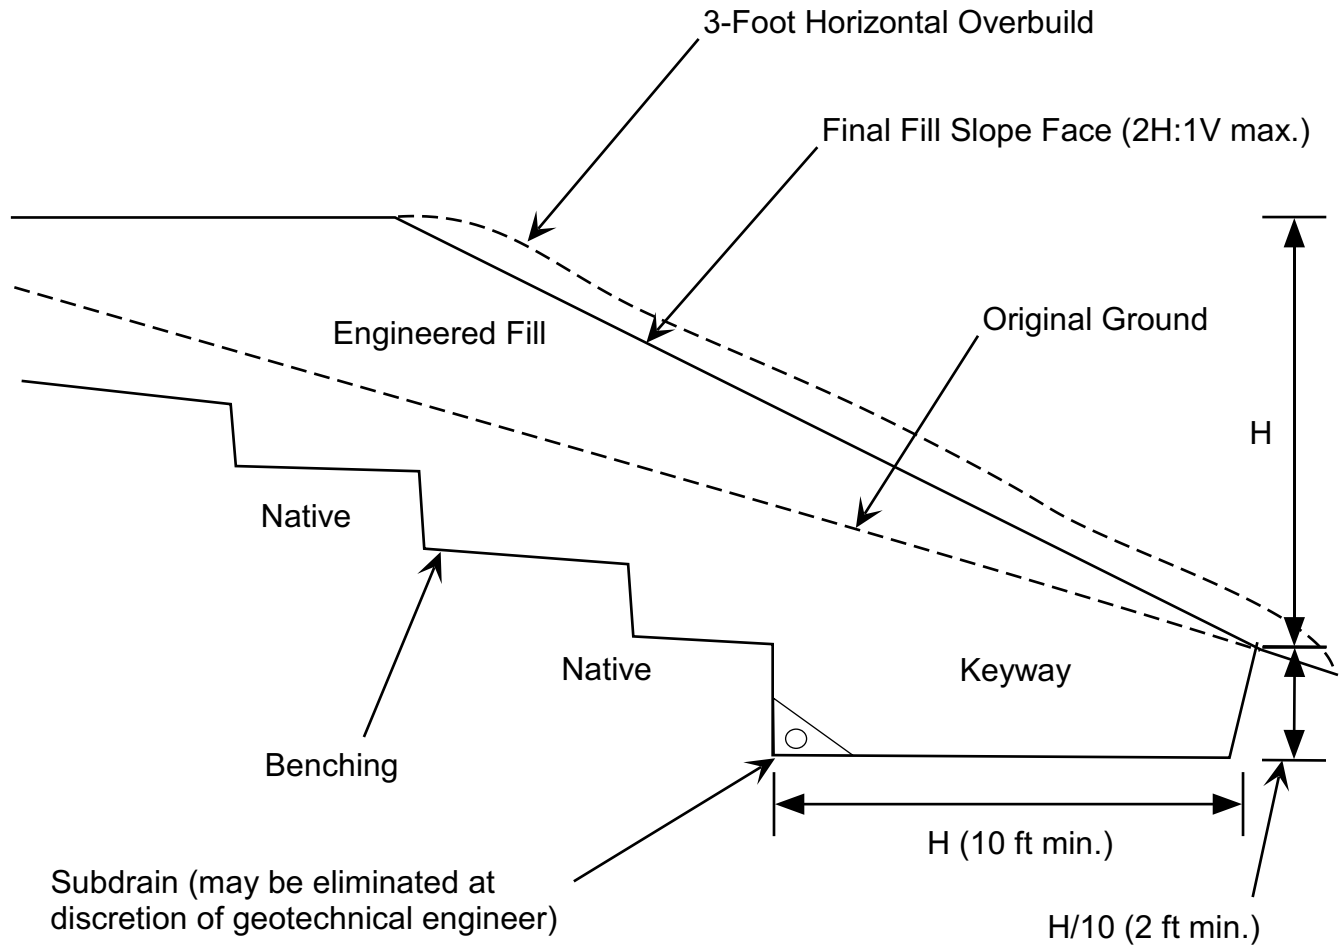
**TYPICAL KEYWAY, BENCHING & FILL SLOPE DETAIL**

Recommended subdrain is minimum 3-inch-diameter ADS Heavy Duty grade (or equivalent), perforated plastic pipe enveloped in a minimum of 3 cubic feet per lineal foot of 2" to 1/2" open-graded gravel drain rock wrapped with geotextile filter fabric (Mirafi 140N or equivalent).

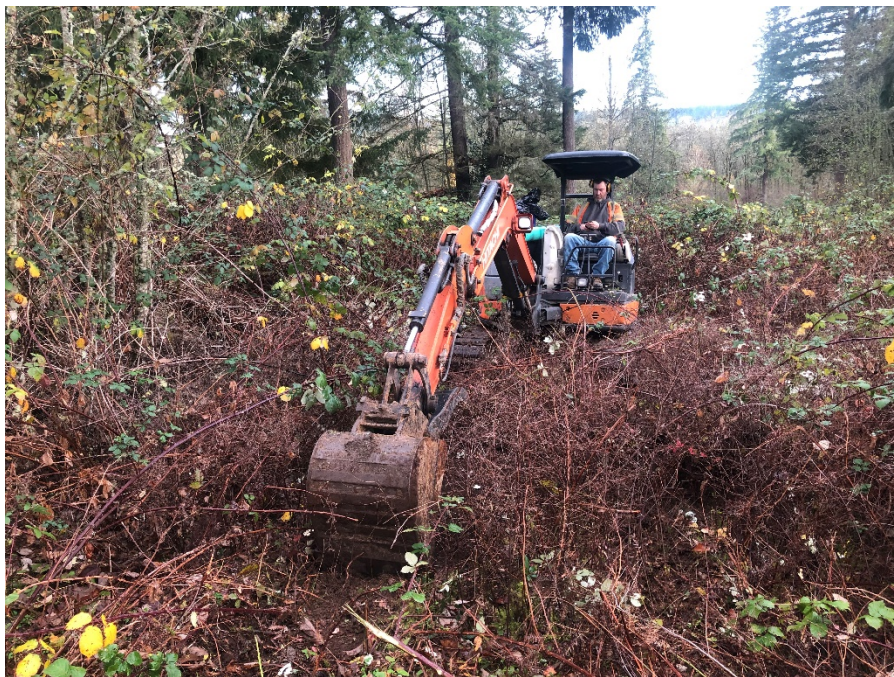
**Test Pit TP-8, Facing North**

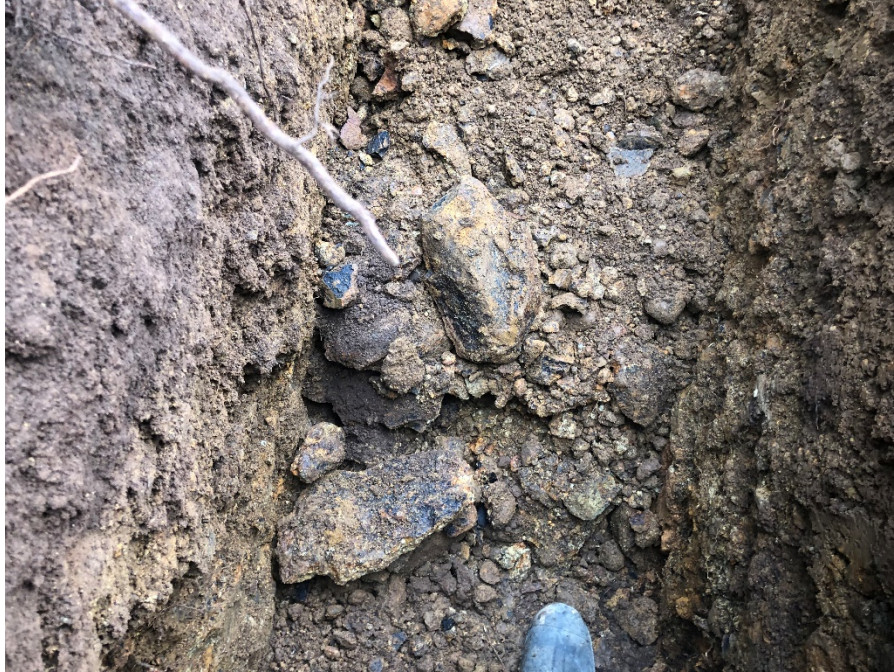
**Dense Conglomerate in Test Pit TP-8**

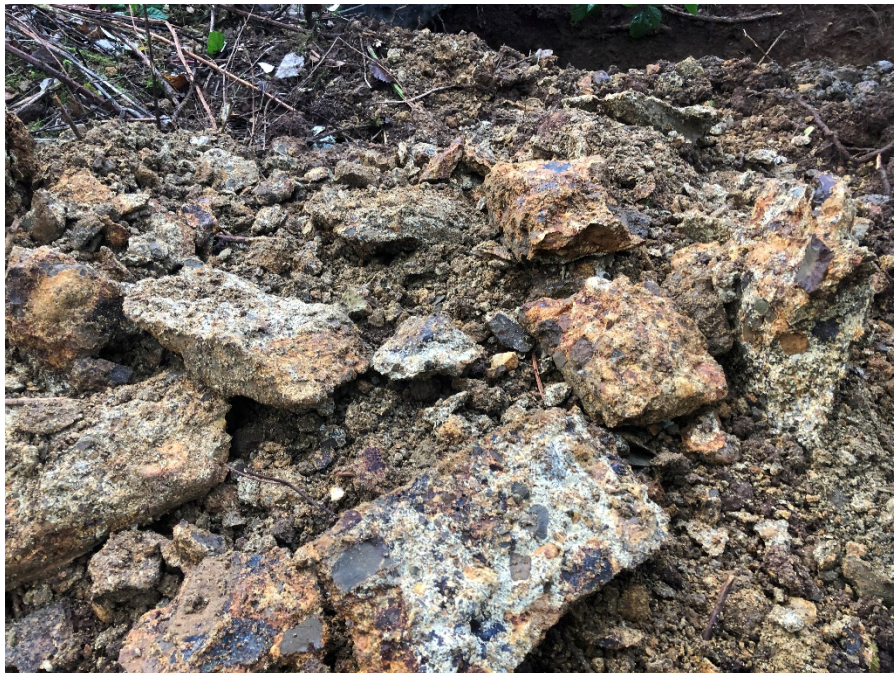
**Conglomerate Soils Excavated from Test Pit TP-8**

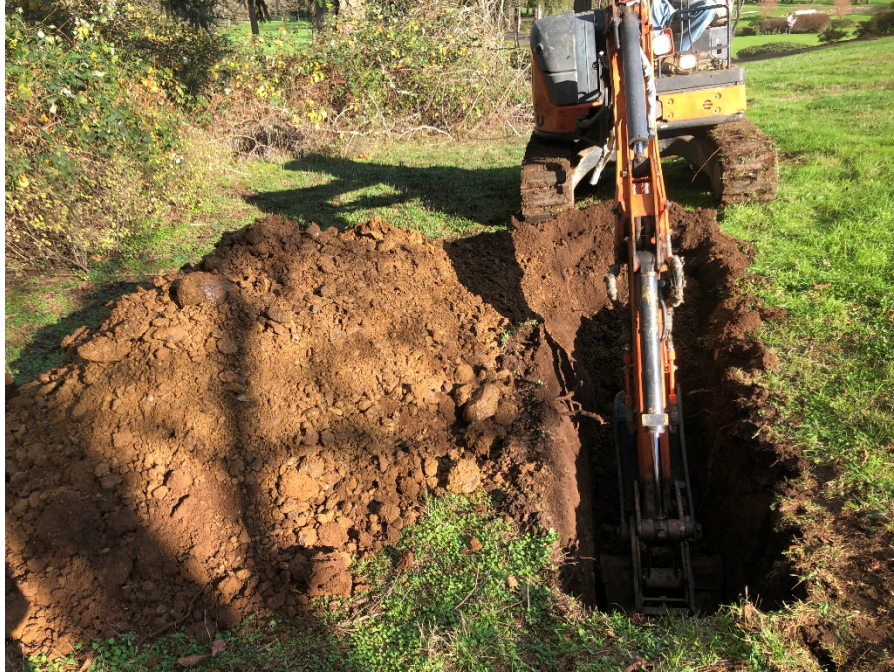
**Test Pit TP-7, Facing North**

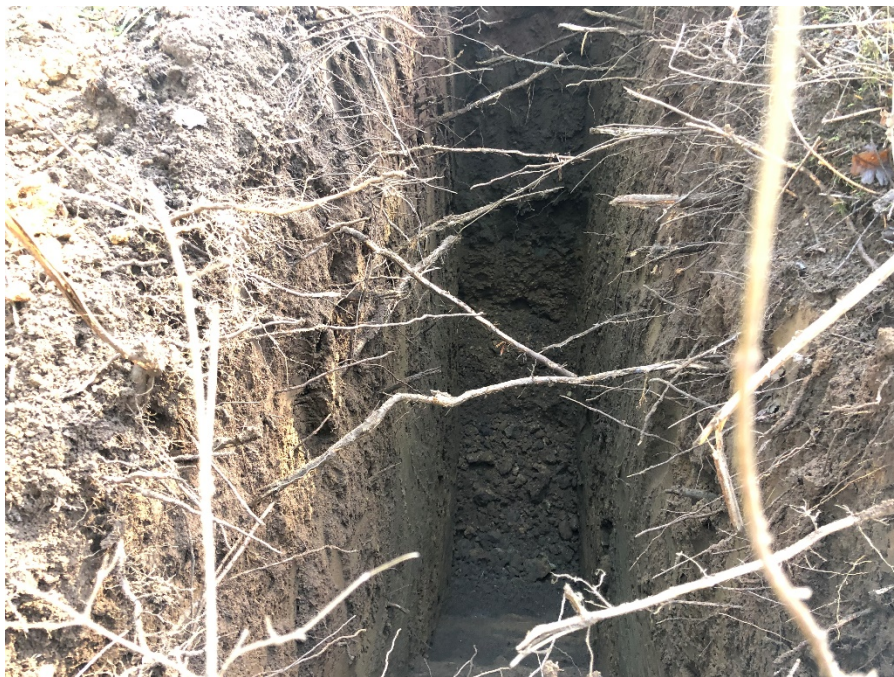
**Medium-Sized Roots within Test Pit TP-6**
