November 17, 2023

# **Geotechnical Site Investigation**

Mills Property Camas, Washington

Columbia West Project: HSR-1-01-1

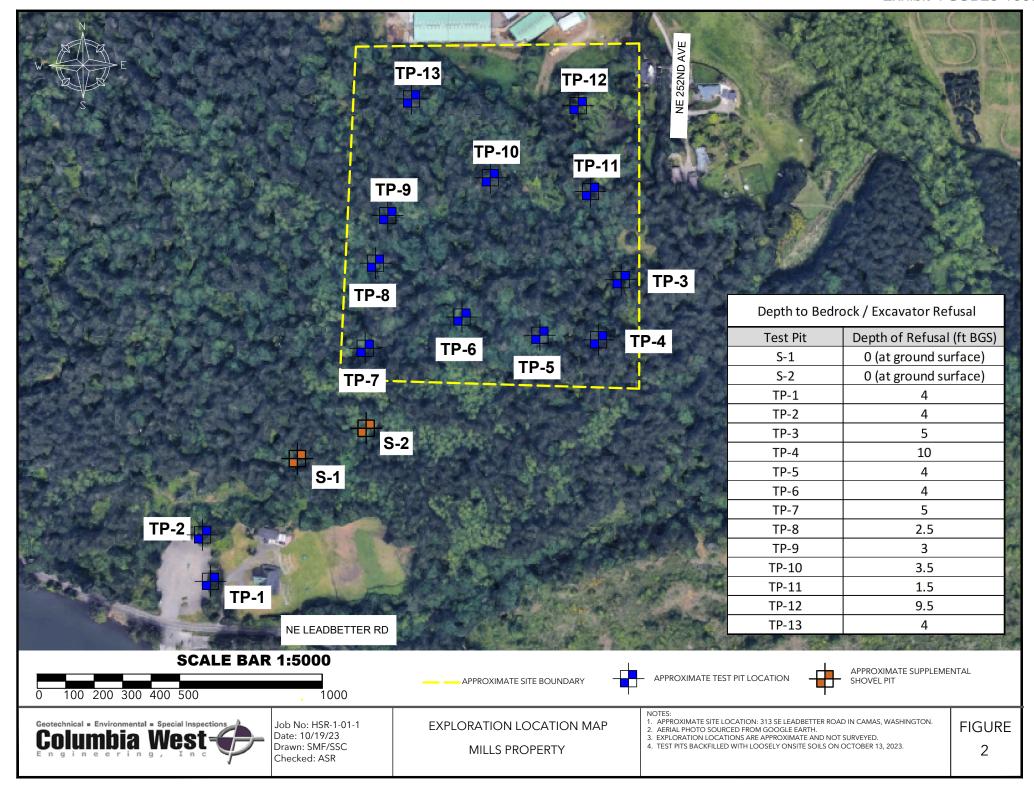
Subsurface conditions were explored by excavating thirteen test pits (TP-1 through TP-13) using a track-mounted excavator at the approximate locations shown on Figure 2. The test pits were excavated on October 13, 2023 to a maximum depth of 10 feet BGS. Two supplemental excavations (S-1 and S-2) were explored by shovel in an area proposed for sanitary sewer alignment which will connect the subdivision sewer to SE Leadbetter Road. No soil logs were produced for explorations S-1 and S-2, as bedrock was encountered within a few inches of the surface.

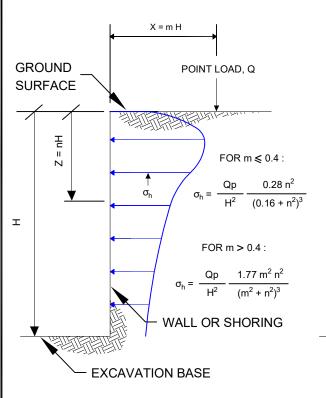
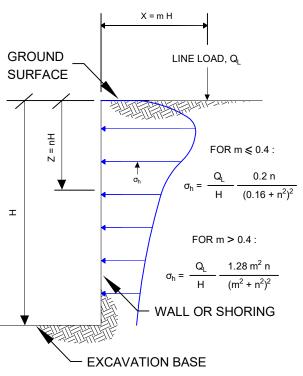
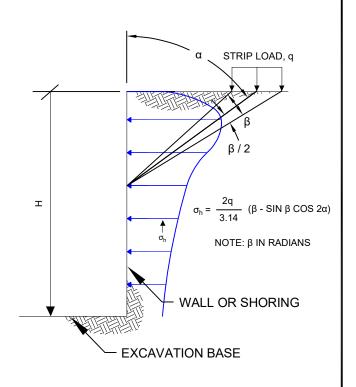
# VERTICAL POINT LOAD HORIZONTAL PRESSURE DISTRIBUTION

#### LINE LOAD PARALLEL TO WALL

#### STRIP LOAD PARALLEL TO WALL

- 1. FIGURE SHOULD BE USED JOINTLY WITH RECOMMENDATIONS PRESENTED IN THE REPORT TEXT.
- 2. LATERAL EARTH PRESSURES ASSUME RIGID WALLS WITH BACKFILL MATERIALS HAVING A POISSON'S RATIO OF 0.5.
- 3. TOTAL LATERAL EARTH PRESSURES RESULTING FROM COMBINED LOADS MAY BE CALCULATED USING SUPERPOSITION.
- 4. DRAWING IS NOT TO SCALE.

The recommended earth pressures assume a maximum wall height of 10 feet with level backfill. These values also assume that adequate drainage is provided behind retaining walls to prevent hydrostatic pressures from developing. Lateral earth pressures induced by surcharge loads may be estimated using the criteria presented on Figure 3.

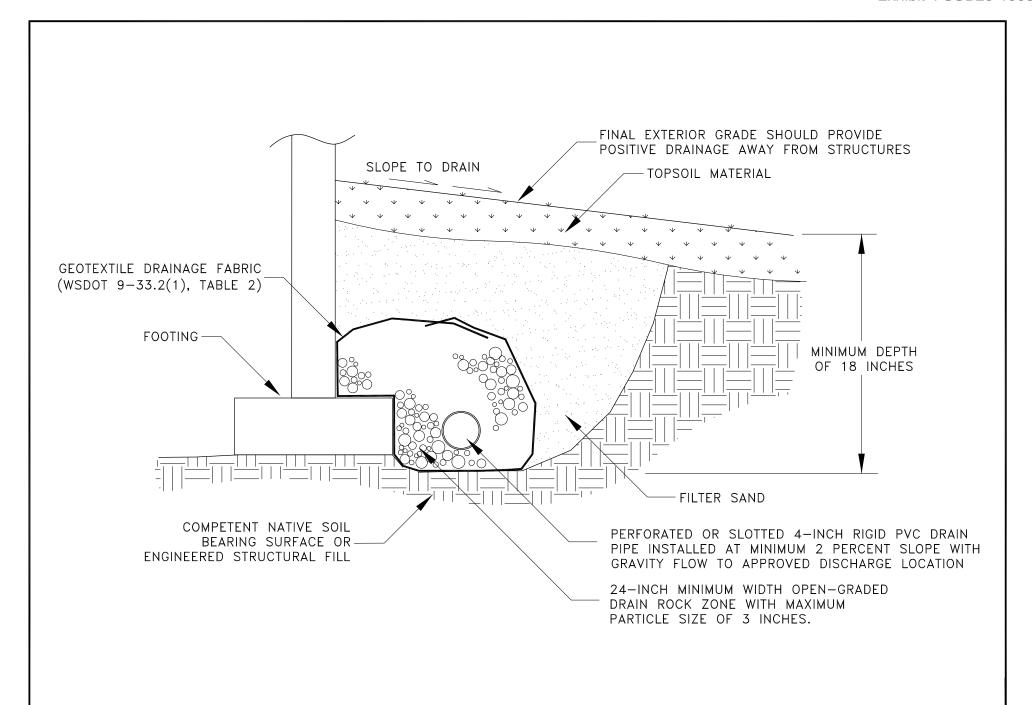
Foundation and roof drains, where installed, should consist of separate systems that gravity flow away from foundations to an approved discharge location. Perimeter foundation drains should consist of 4-inch perforated PVC pipe surrounded by a minimum 2-foot-wide zone of clean, washed drain rock wrapped with geotextile drainage fabric. The wrapped drain rock zone should extend up the sides of embedded walls to within 12 inches of proposed finished grade. Foundation drains should be constructed with a minimum slope of ½ percent. The drainpipe's invert elevation should be at least 18 inches below the elevation of the floor slab. Figure 4 presents a typical foundation drain detail.

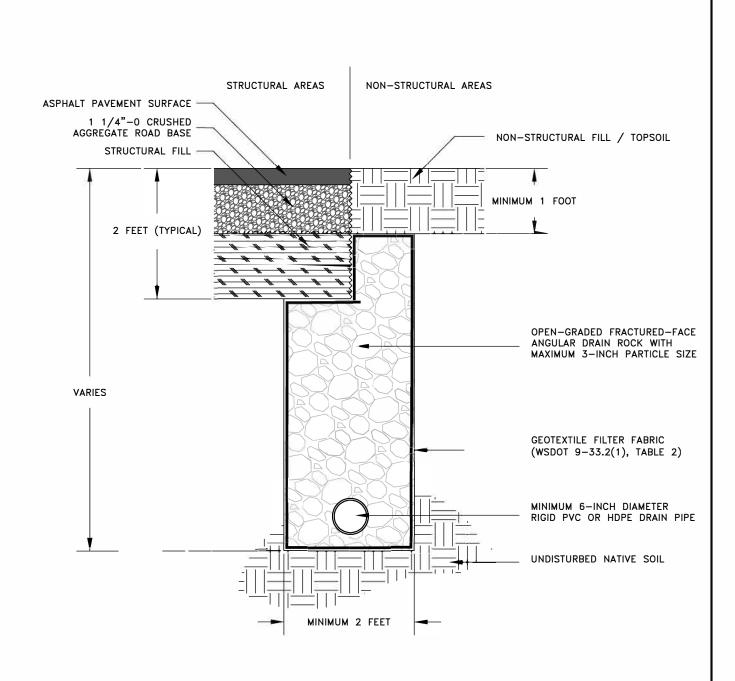
Subdrains should be considered if portions of the site are cut below surrounding grades. Shallow groundwater or seeps should be conveyed via drainage channel or perforated pipe into an approved discharge. Recommendations for design and installation of perforated drainage pipe may be performed on a case-by-case basis by Columbia West during construction. Failure to provide adequate surface and sub-surface drainage may result in soil slumping or unanticipated settlement of structures exceeding tolerable limits. A typical perforated drainpipe trench detail is presented in Figure 5.

NOTE: LOCATION, INVERT ELEVATION, DEPTH OF TRENCH, AND EXTENT OF PERFORATED PIPE REQUIRED MAY BE MODIFIED BY THE GEOTECHNICAL ENGINEER DURING CONSTRUCTION BASED UPON FIELD OBSERVATION AND SITE—SPECIFIC SOIL CONDITIONS.

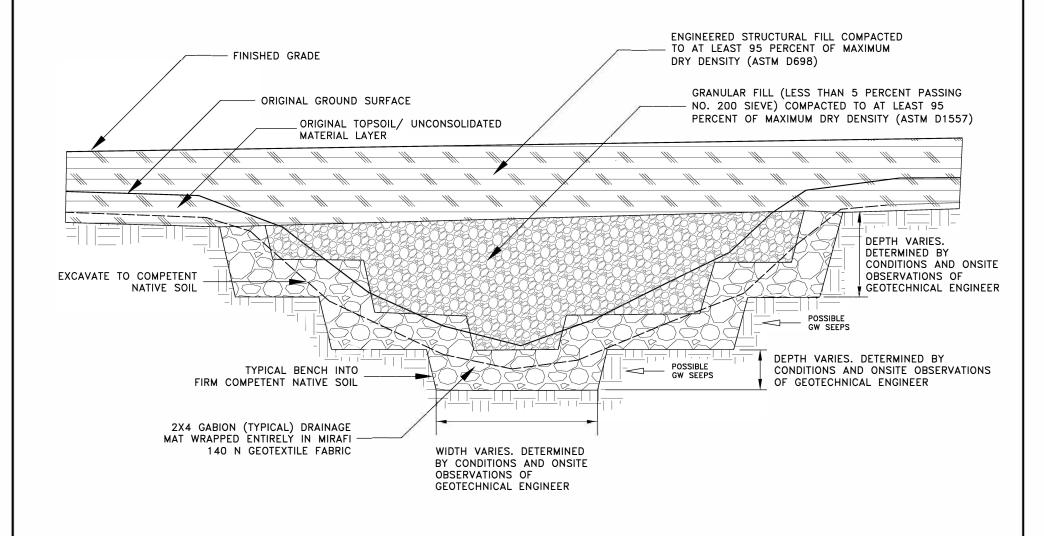
TYPICAL DRAINAGE MAT CROSS SECTION

Site improvements construction in some areas may occur at or near the shallow groundwater table, particularly if work is conducted during wet-weather conditions. A drainage mat is typically required in areas that require structural fill placed on top of a natural drainage swale or known seep or spring area. Dewatering may be necessary, and a drainage mat may be required to achieve sufficient elevation for fill placement. A typical drainage mat is shown on Figure 6. Columbia West should determine drainage mat location, extent, and thickness when subsurface conditions are exposed. Drainage mats may need to be constructed in conjunction with subdrains to convey captured water to an approved discharge location

2. DRAWING REPRESENTS TYPICAL DRAINAGE MAT SECTION AND MAY NOT BE SITE-SPECIFIC. **FIGURE**

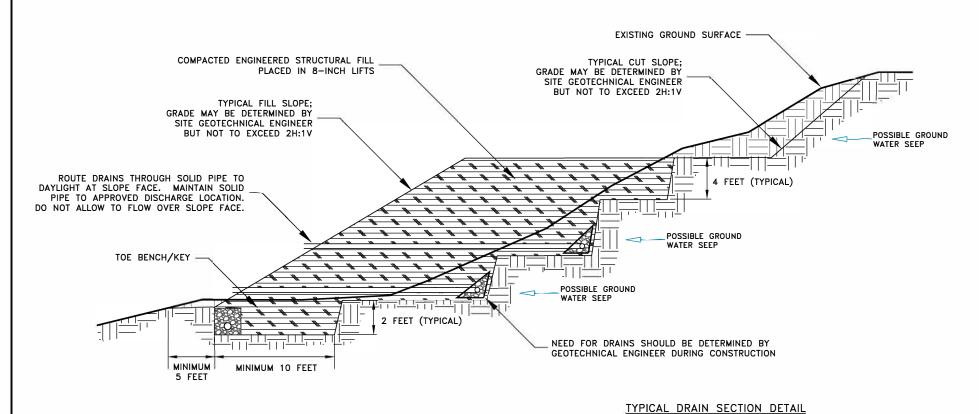
Concentrated drainage or water flow over the face of slopes should be prohibited, and adequate protection against erosion is required. Fill slopes should be overbuilt, compacted, and trimmed at least two feet horizontally to provide adequate compaction of the outer slope face. Proper cut and fill slope construction is critical to overall project stability and should be observed and documented by Columbia West.

DRAWING REPRESENTS TYPICAL CUT AND FILL SLOPE CROSS SECTION AND MAY NOT BE SITE—SPECIFIC.

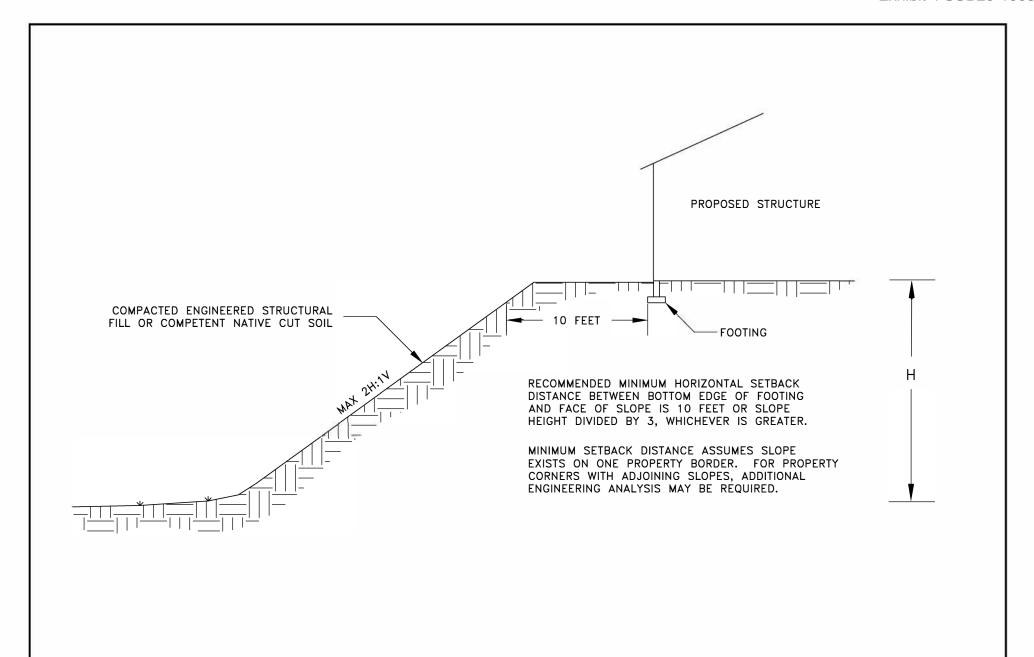
Lateral foundation loads can be resisted by passive earth pressure on the sides of the footing and by friction at the base of the footings. Recommended passive earth pressure for footings confined by native soil or engineered structural fill is 250 pcf. The upper 6 inches of soil should be neglected when calculating passive pressure resistance. Adjacent floor slabs and pavement, if present, should also be neglected from the analysis. The recommended passive pressure resistance assumes that a minimum horizontal clearance of 10 feet is maintained between the footing face and adjacent downgradient slopes.

1. DRAWING IS NOT TO SCALE.
2. SLOPES AND PROFILES SHOWN ARE APPROXIMATE.
3. DRAWING REPRESENTS TYPICAL FOUNDATION
SETBACK DETAIL AND MAY NOT BE SITE—SPECIFIC.
