RE: Critical Areas – Habitat Assessment

Site: PS25 Camas School Relo

Critical Areas Habitat Assessment

**for PS25 Camas School Relo
City of Camas
Clark County, Washington
Parcel # 91010000**

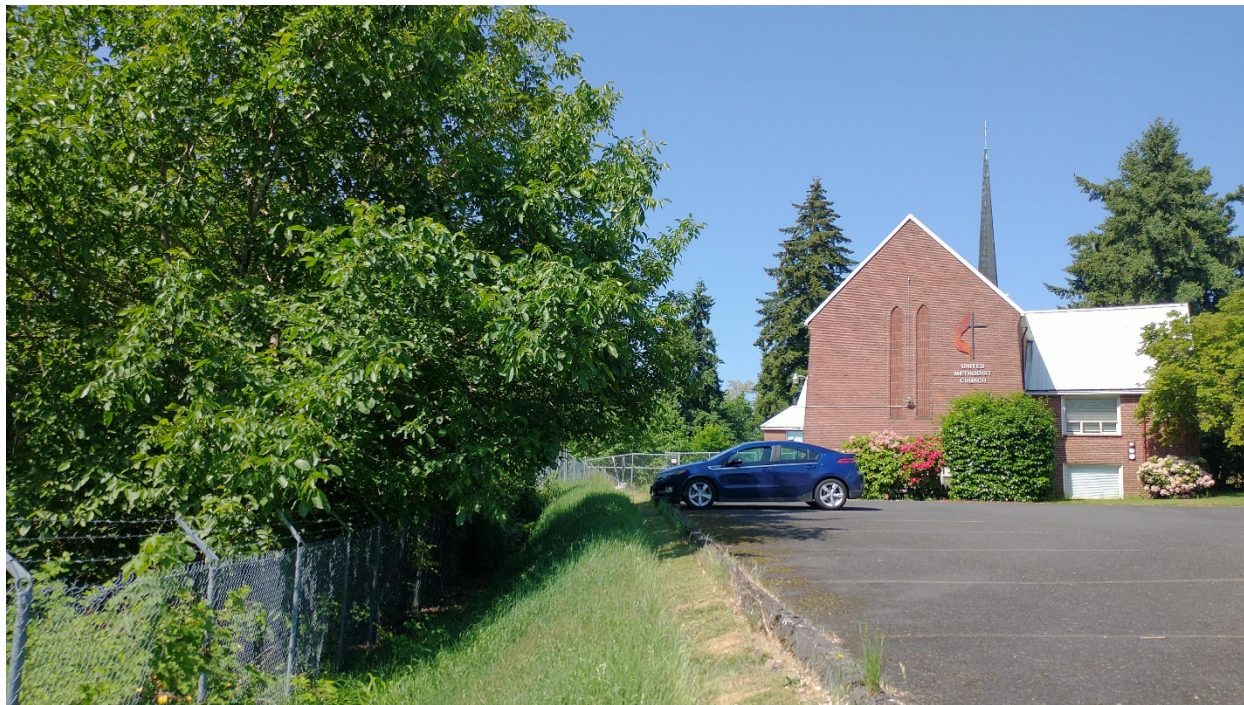
Figure 4. Project Site and Adjacent Overstory Vegetation

The riparian habitat bordering the ditch and project area have an overstory cover dominated by big leaf maple (*Acer macrophyllum*) with minor components of cascara buckthorn (*Rhamnus purshiana*), and beaked hazelnut (*Corylus cornuta*). The understory is predominantly Himalayan blackberry (*Rubus armeniacus*).

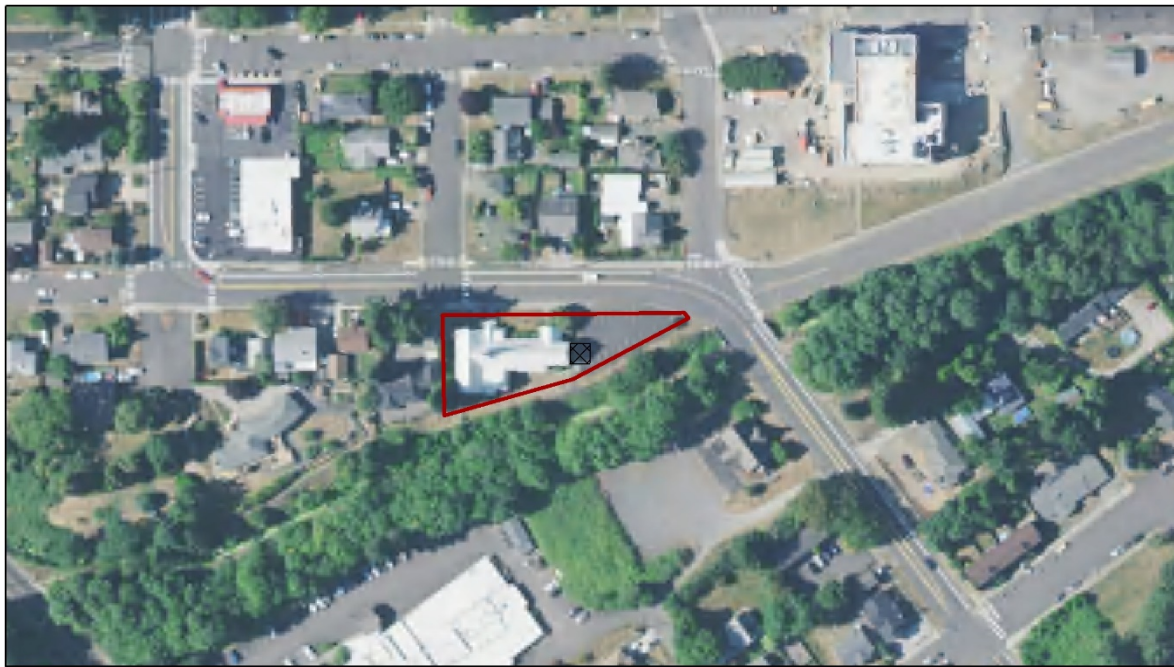
Project Area and Subject Property Relative to the Crown Zellerback Power Ditch

Figure 5. Aerial Photograph of the Proposed Project and Construction Limits

Turnstone Ecologist Stephanie James investigated the site on May 26, 2023. The proposed project would occur on a previously disturbed upland area that is currently used as a parking lot with landscaping plants and a sidewalk (Figure 5). Adjacent to the project area is a stream corridor. The riparian habitat is surrounded by urban residential and commercial land uses with high human presence.

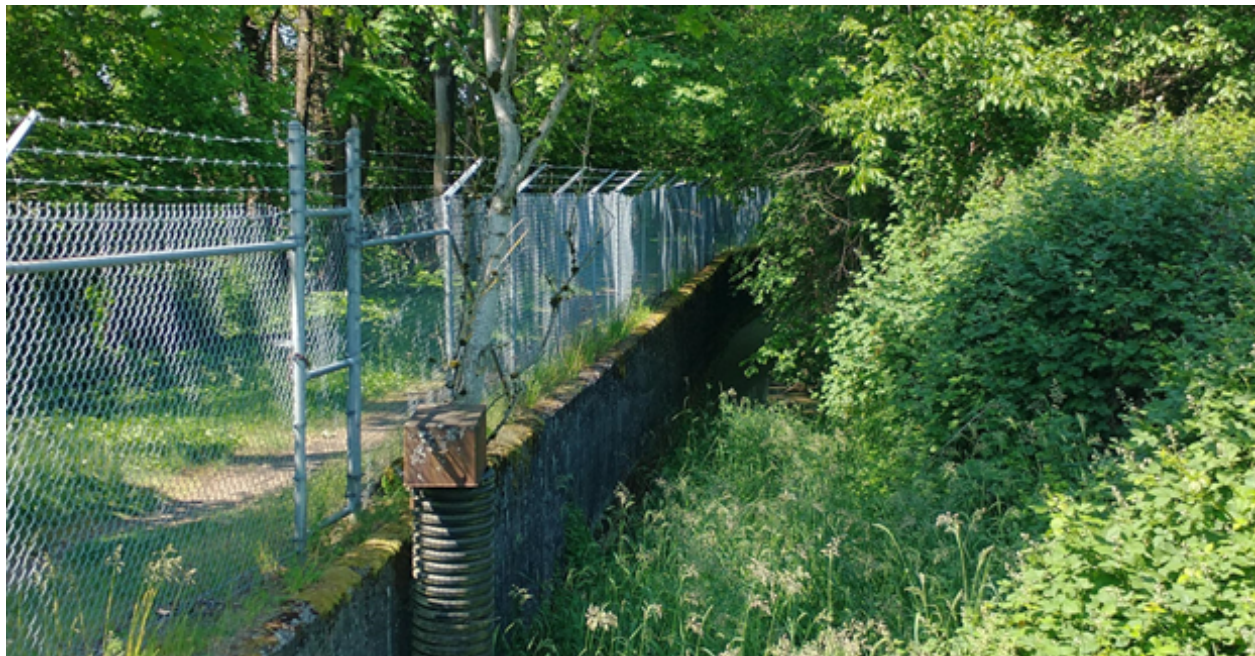
Figure 6. Crown Zellerback Power Ditch

The project site is adjacent to a canal ditch named the Crown Zellerback Power Ditch (#1223935455865), which is a channelized tributary to Lacamas Creek, a tributary to the Columbia River.

Fish, amphibians, and invertebrates are not likely present in this segment of Crown Zellerback Power Ditch. The riparian vegetation bordering the creek provides shade, woody debris, and leaf litter inputs that provide thermal regulation to downstream habitats.

No wetland delineation for the project site has been conducted. The site does not have any mapped hydric soils; however, the excavated streambed of the Crown Zellerback Power Ditch is mapped as intermittent, seasonally flooded, riverine wetlands (R4SBCx).
