City of Camas

Facility Condition Assessment Volume 1: Executive Summary Report

Prepared by MENG Analysis

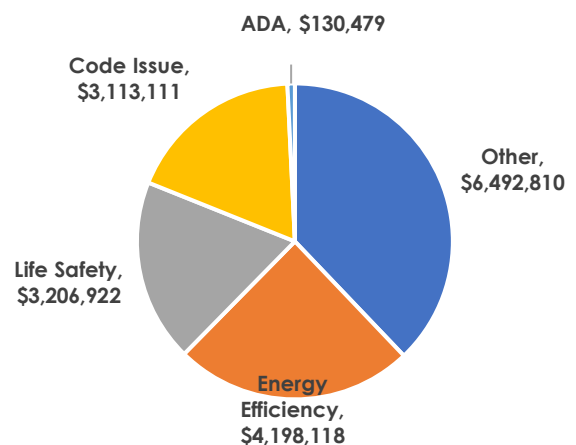
Figure 1. Deficiencies by Action Type

For a notable issue to be considered an Observed Deficiency (OD), the surveyor must think that the issue needs to be addressed within the next 5-year period, with an expected direct cost of \$5,000 or greater. Each deficiency is assigned an action type to help prioritize the order in which it should be addressed. The following pie chart shows the ODs broken out by action type.

For the 2021 FCA, ODs total approximately \$17M.

Priority ODs are those in the "Life Safety" and "Code Issue" categories, which total approximately \$6.3M. Detailed descriptions, photos, and cost estimates of these deficiencies can be found in the Facility Details Report (Volume 2).

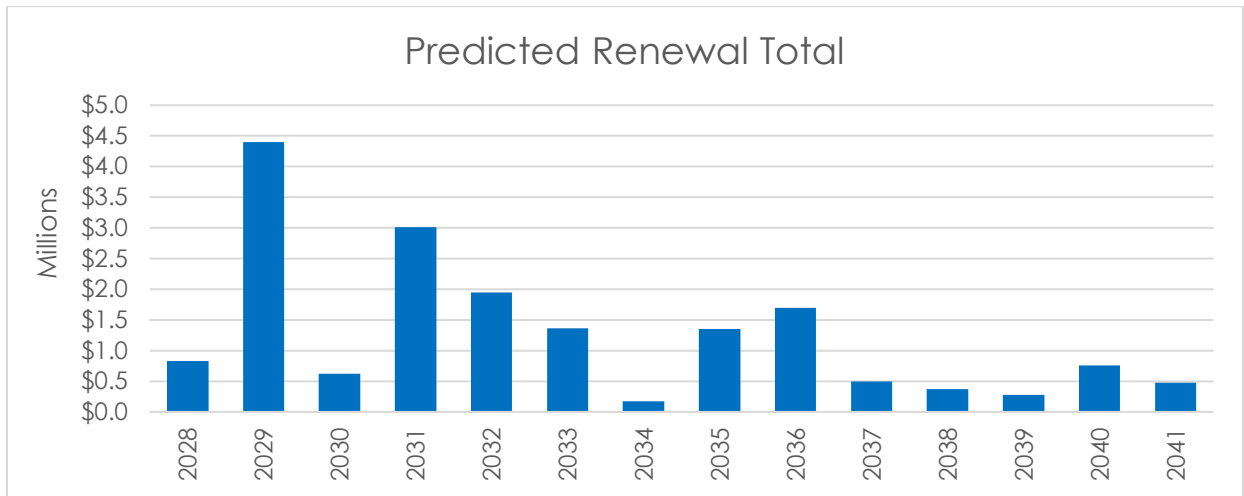
Figure 2. Predicted Renewal Totals by Year

Predicted Renewals (PRs) are modeled for the years 2028 – 2041, based on the system type, age, current condition, expected useful life, and anticipated replacement cost. These costs are based on predictive models, and therefore should be used as high-level long-term planning tool. Some systems may fail sooner or last longer than the model predicts based on maintenance practices, intensity of use, or extreme weather events.

For the time period of 2028 – 2041, the estimated PR cost is approximately \$18M. The highest cost year is expected to be 2029 at just under \$4.5M. The detailed PR table included in the Appendix shows these PRs broken out by facility, subsystem, and year.
