Staff Report

February 5, 2024 Council Workshop Meeting

PSA for Boulder Creek Intake Maintenance Improvements

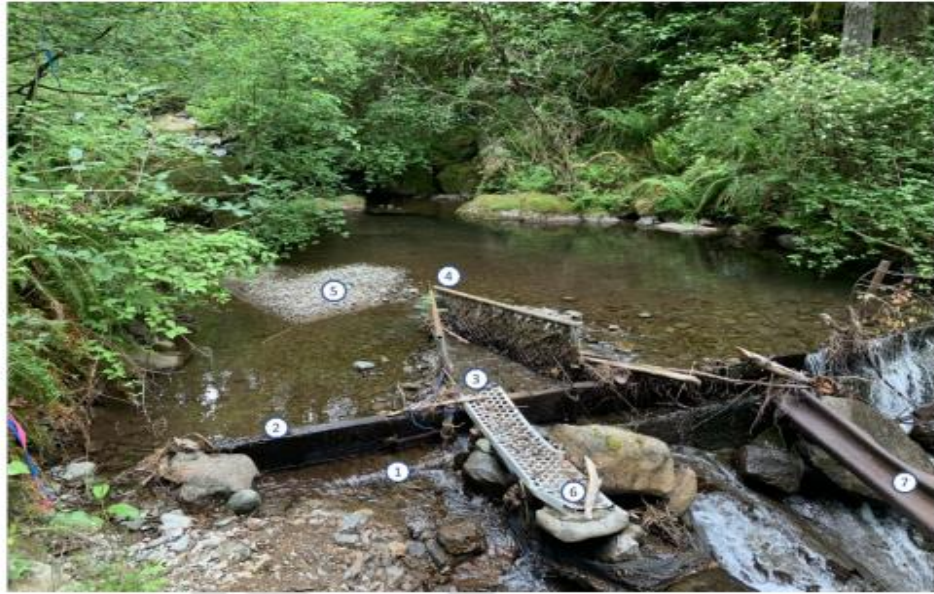
- ① Concrete dam tied-in to bedrock channel.
- ② 3" x 10" timber flashboard set atop dam.
- ③ Drain intake leading to 10" pipe
- ④ Chain link screen surrounding intake
- ⑤ Sediment deposits upstream of dam
- ⑥ Access platform
- ⑦ Metal guardrail in channel downstream of dam, presumed from eroded bank.

Figure 1: Photo of existing dam and intake structure from downstream of dam looking upstream

SUMMARY: To fully utilize the capacity of the intake, creek bed material will need to be pulled from the stream channel around the intake. This material can then be used to stabilize the creek bank and also be used to reconstruct the eroding maintenance road. Shell Engineering is proposing to coordinate with multiple agencies for permitting requirements to maintain this intake. In addition, a survey of the area will be completed to confirm the quantity of material which will be dredged from the creek. When plans and specifications are completed, the project will be bid and the low bid award will be brought back to council. The work window in the stream is limited to the month of August.

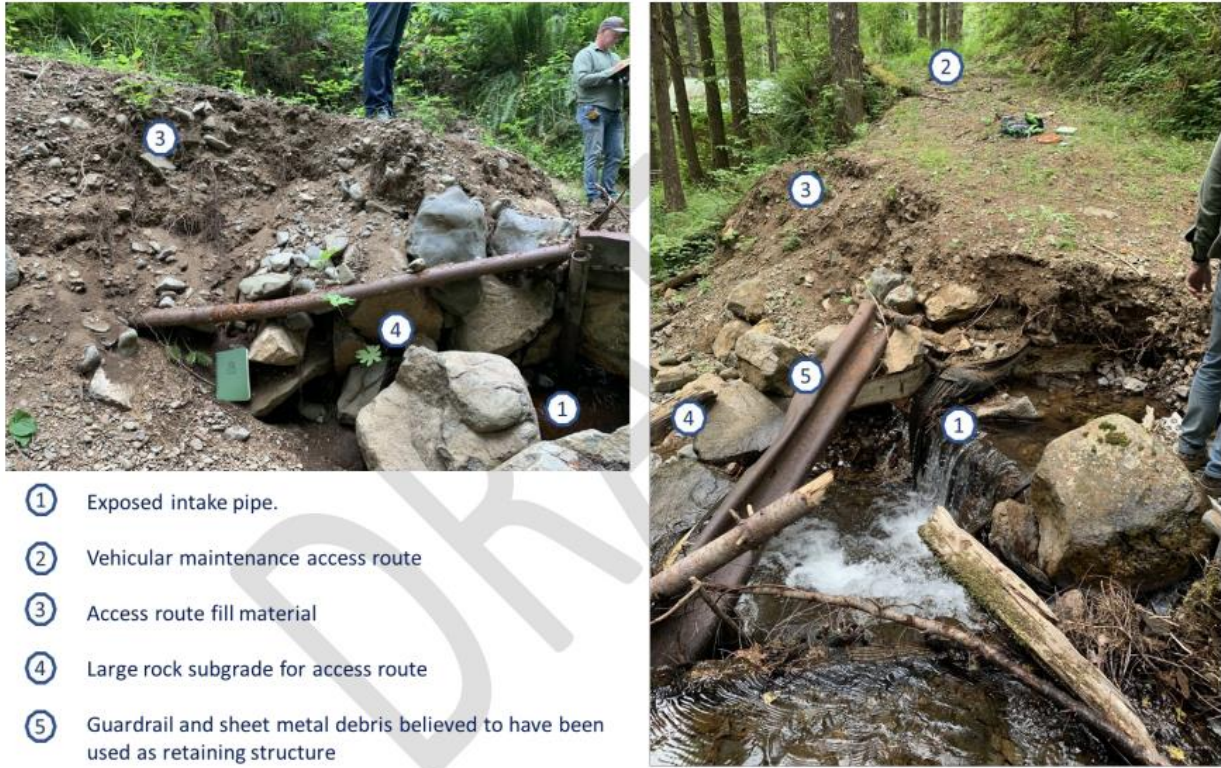
Figure 3: Existing bank erosion along right bank of Boulder Creek looking downstream in intake structure.
