ATTACHMENT A

Stockton Avenue Bridge Emergency Repair Project

Project Description

August 2, 2023

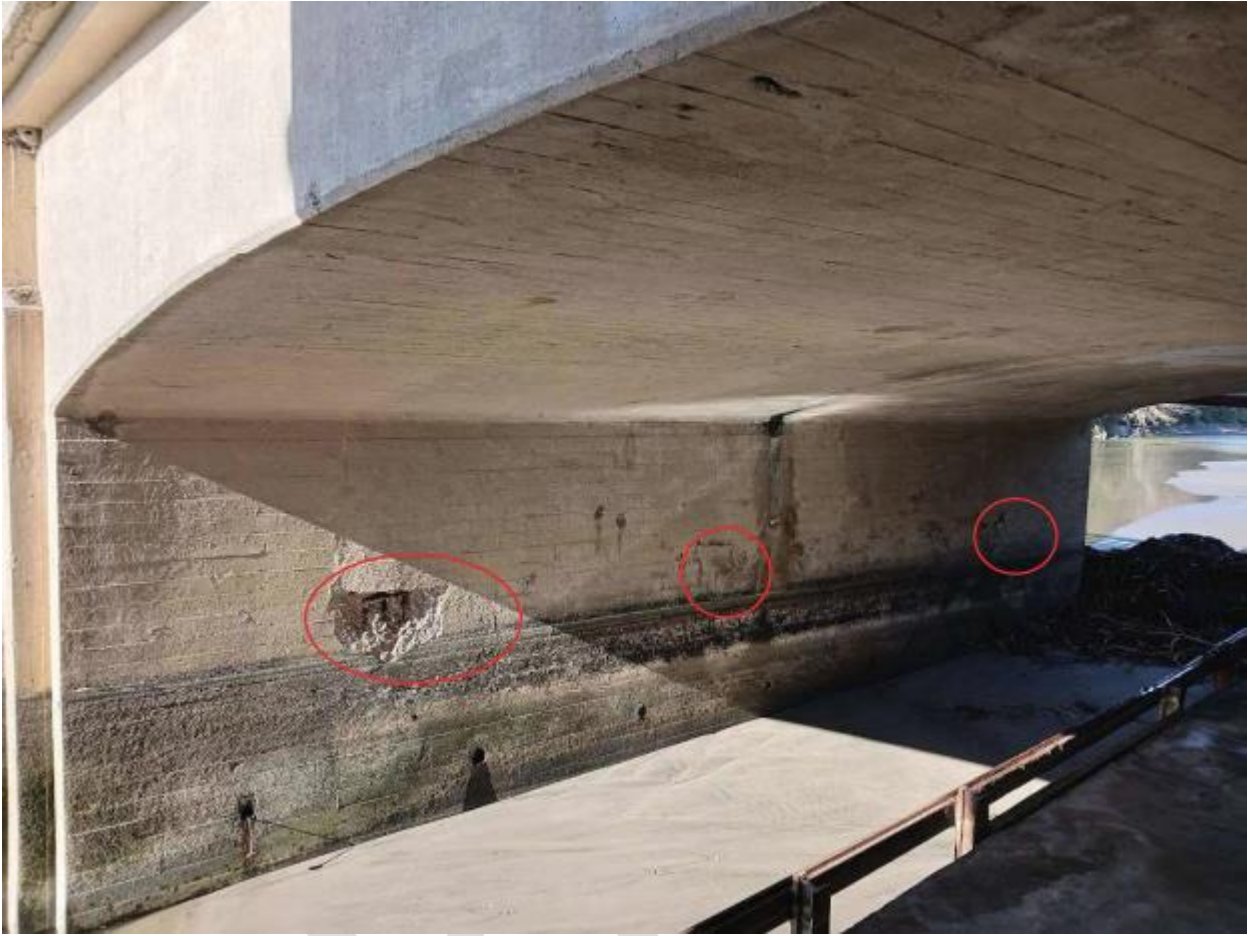
Spall repairs on the east face of the east pier involve cleaning exposed rebar and removing unsound concrete. Three different spalls measuring 3'x2.5', 2'x2', and 1'x1' will be cleaned and patched (Figure 2).

Figure 2: East Pier Wall During Very Low Tide with Spalled Areas Circled in Red

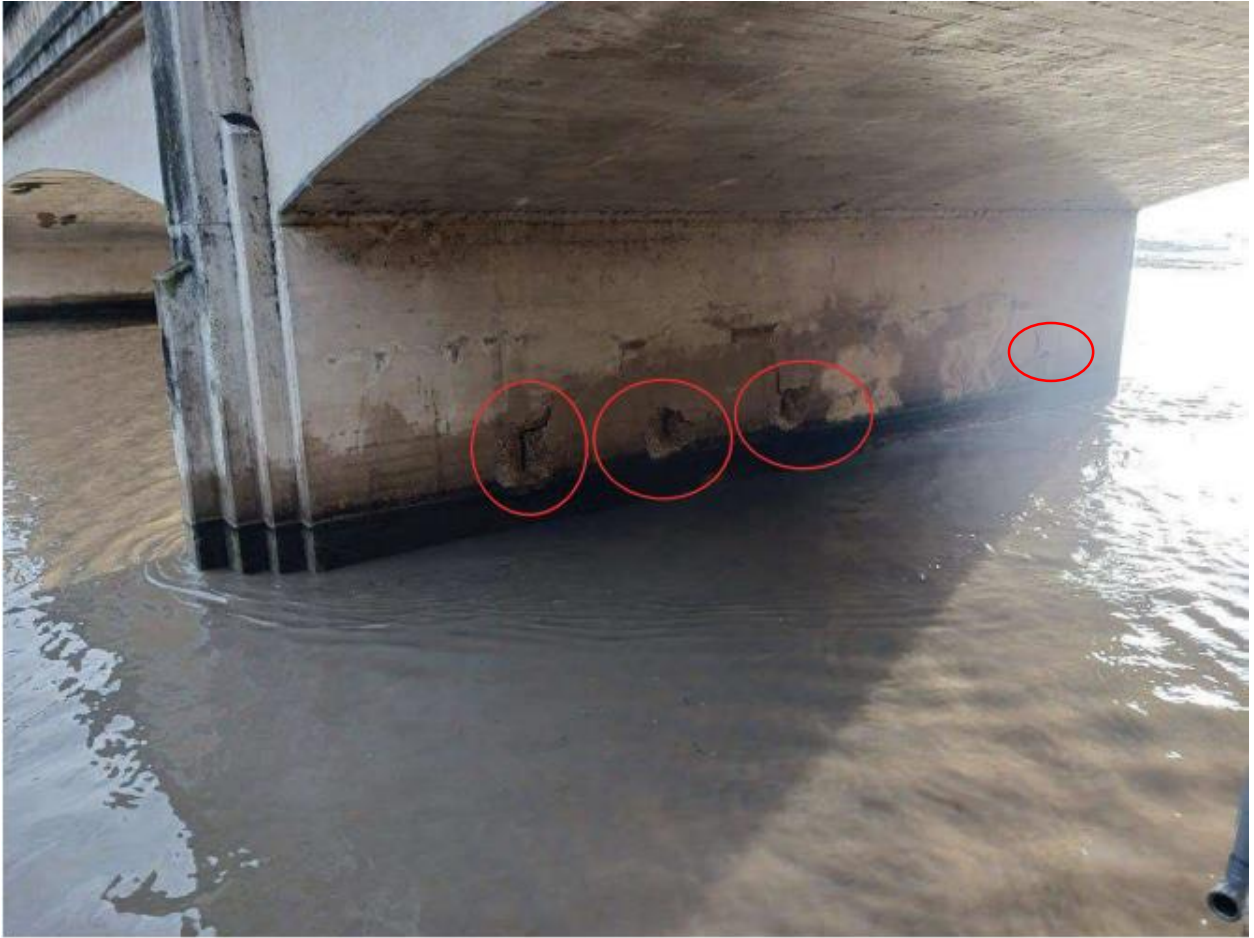
Similarly, on the west face of the west pier, a total of four spalls require similar cleaning and patching. Two of the four spalls in this location measure 3'x2.5', a third measures 5'x2.5', and the fourth measures 3'x2' (Figure 3). There is no damage observed to the west abutment face or the inside face of the east pier.

Figure 3: West Pier Wall in Post Storm Condition with Spalled Areas Circled in Red

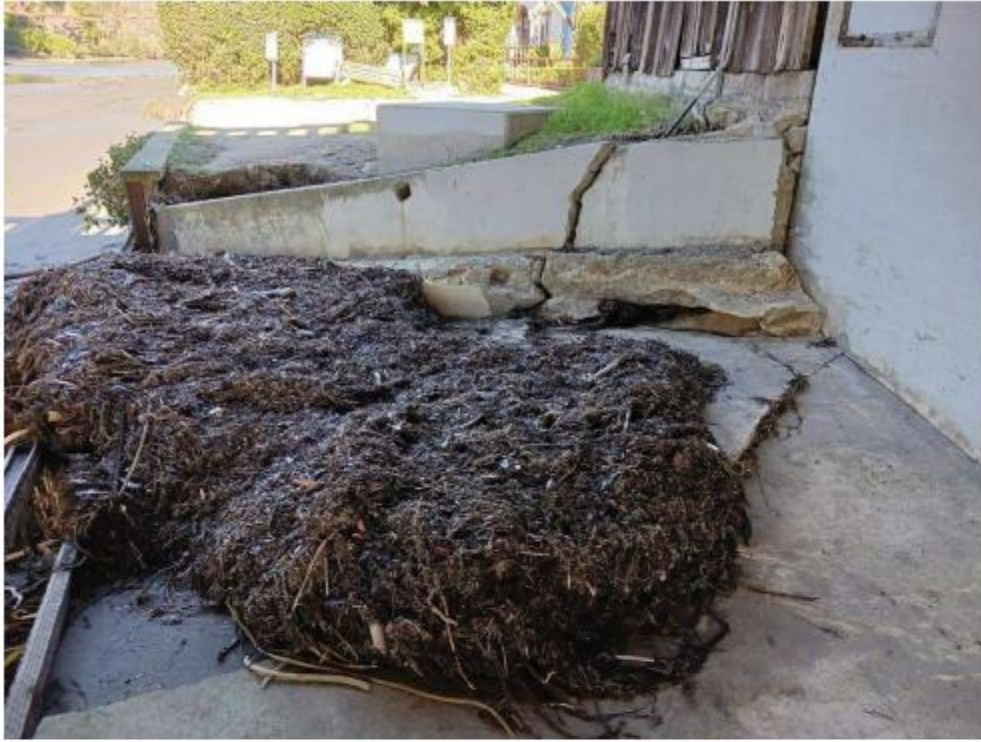
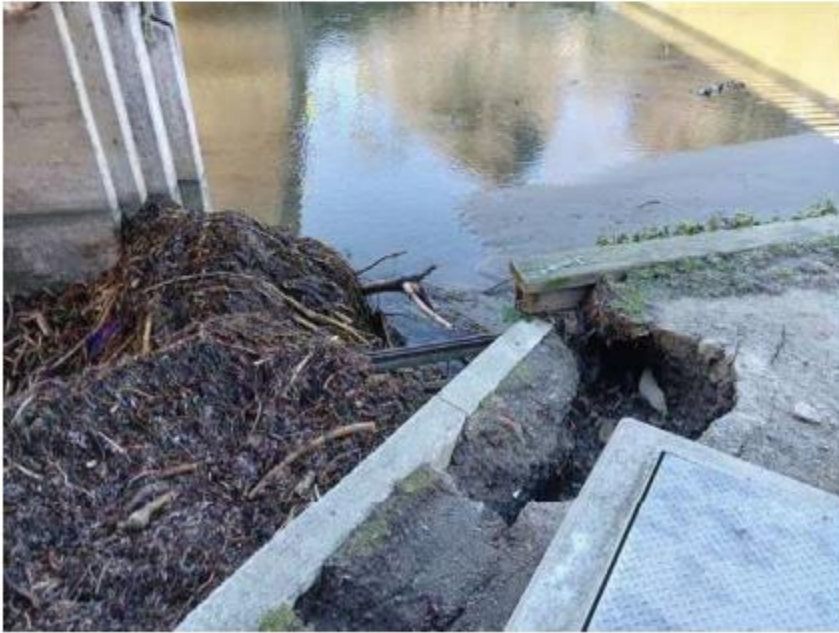
The walkway slab underneath the bridge is 10 inches thick and 12 feet 6 inches to the north narrowing to 7 feet to the south. This slab has cracked and the concrete will be removed and replaced. The adjacent retaining wall is cracked and has a large amount of debris (Figures 4 & 5).

Figure 4 & 5: Retaining Wall During Very Low Tide Showing Debris Accumulation

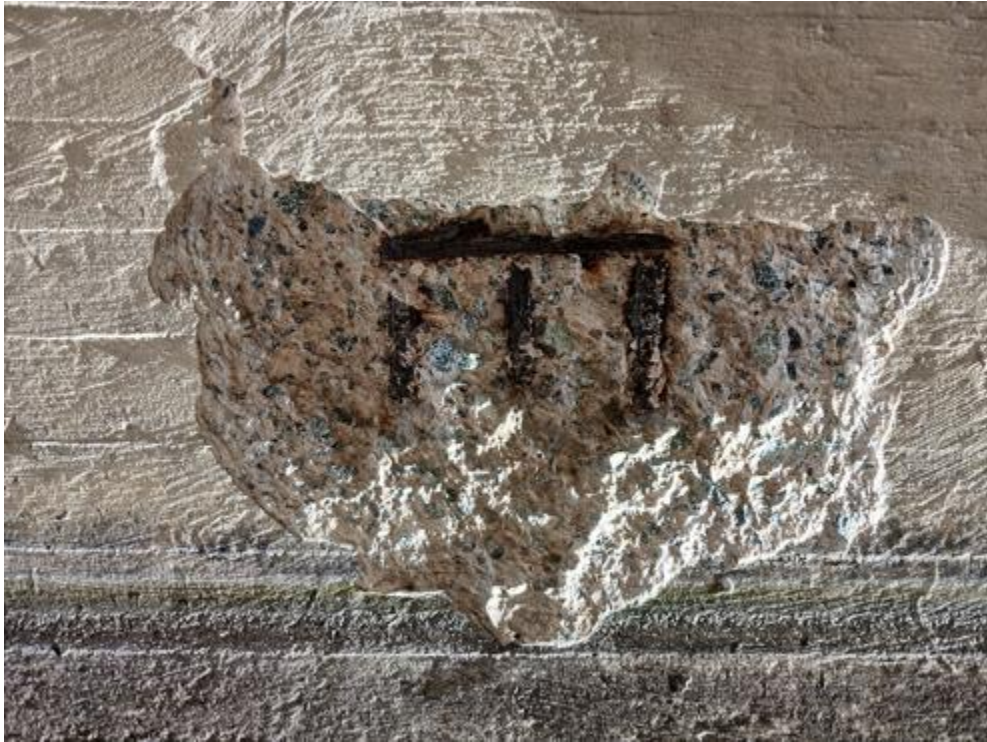
Figure 6: Close-up of Exposed Rebar Under Spall on East Pier Wall
