MEMORANDUM

DATE: April 1, 2026 **Job No.:** 2300338

RE: **STOCKTON AVENUE BRIDGE EXISITING CONDITION MEMORANDUM**

This memorandum is a summary of the existing condition of the Stockton Avenue Bridge in Capitola, California.

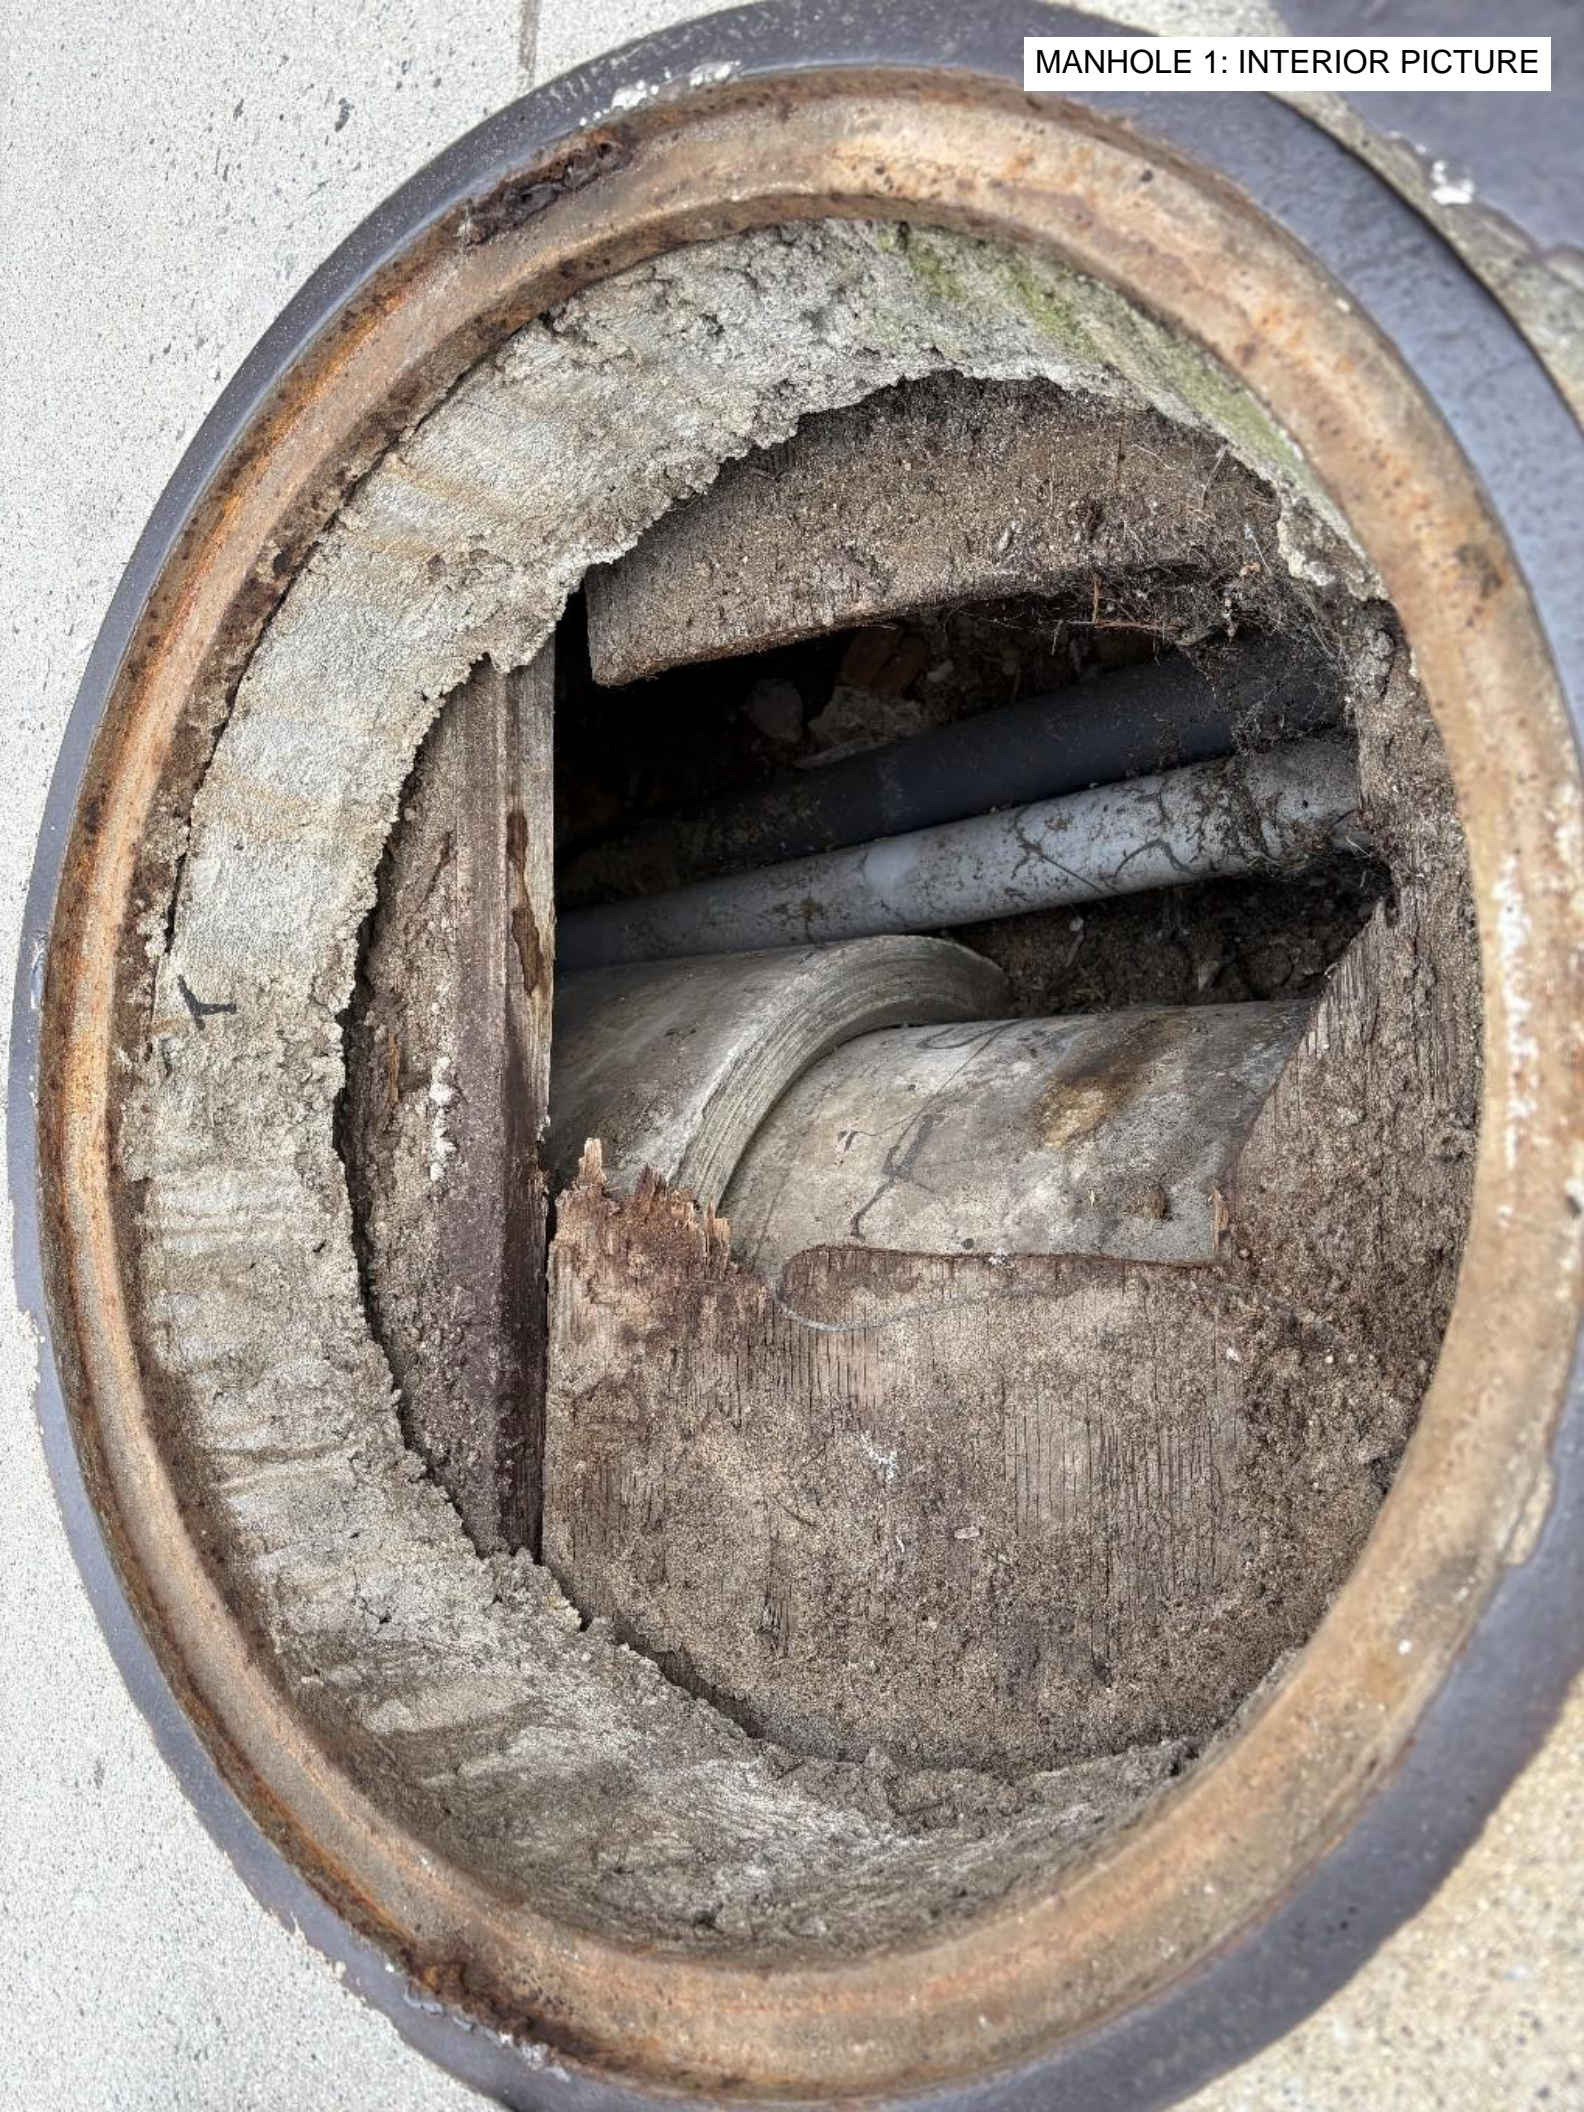
MANHOLE 1: INTERIOR PICTURE

Manhole 1			
Pipe Size	Utility Type	Material	Condition
18"	Sanitary Sewer Force Main	Asbestos Cement Pipe	Visible cracking and spalling in several sections of the outer encasement.
3"	Unknown	Polyvinyl Chloride (Dark Gray)	No visible signs of deformation, stress, or leaks.
3"	Unknown	Polyvinyl Chloride (Light Gray)	No signs of deformation, stress, or leaks.

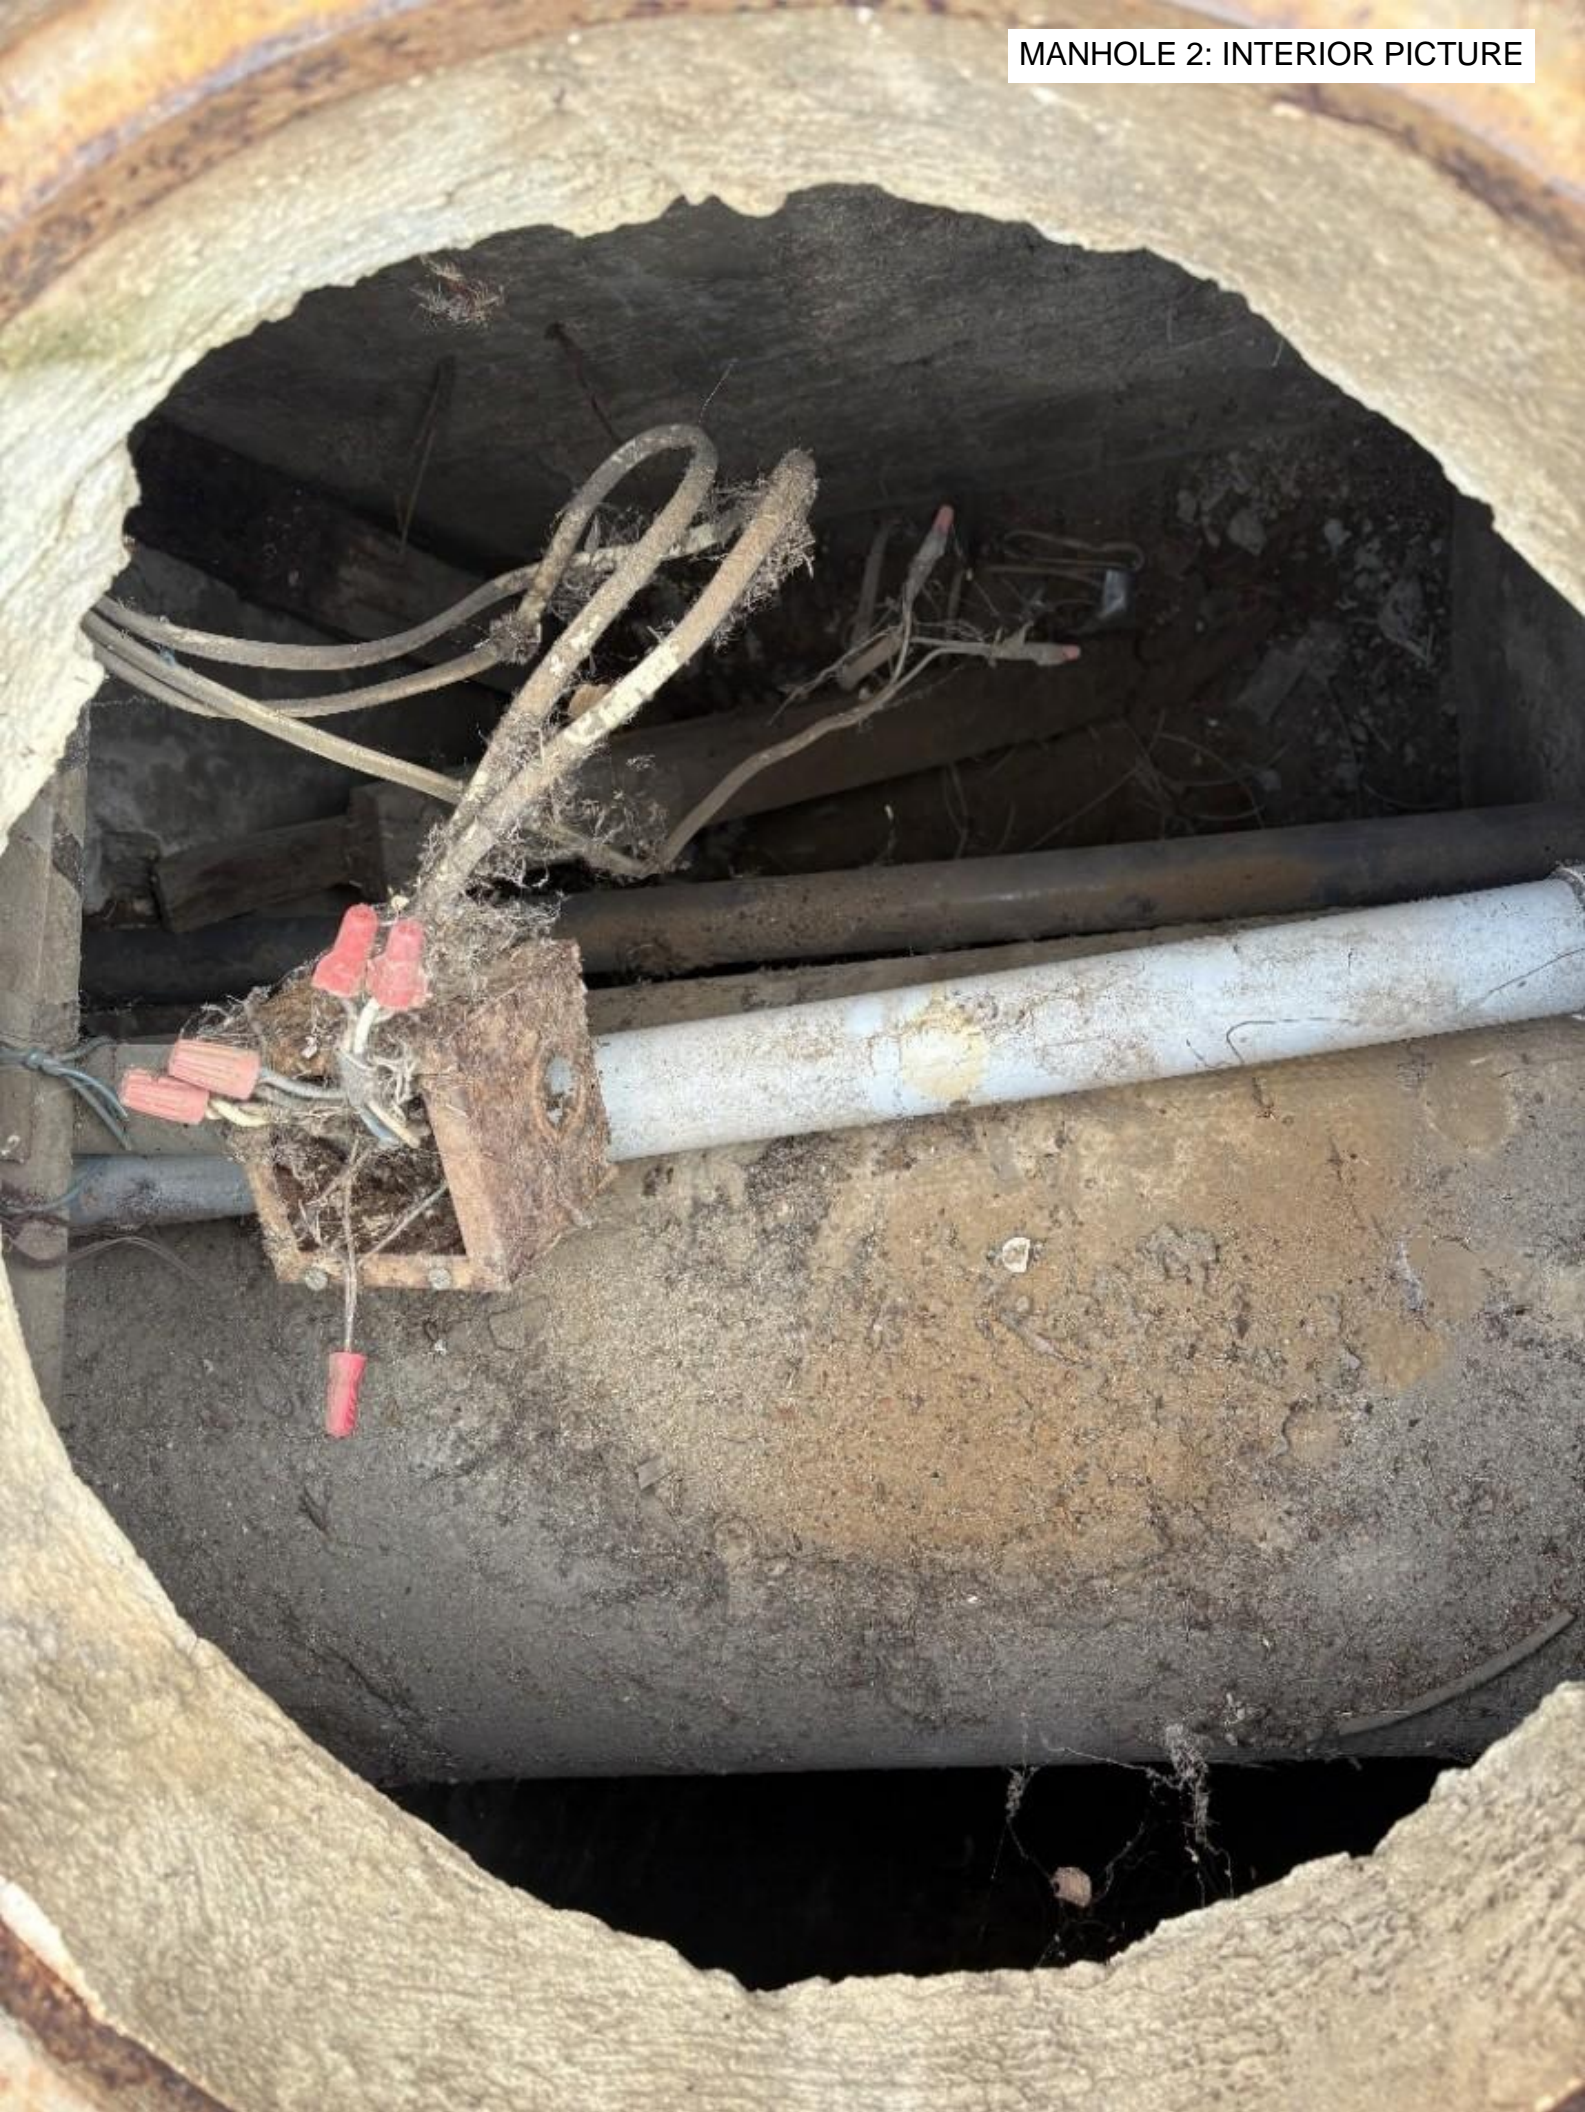
MANHOLE 2: INTERIOR PICTURE

Manhole 2			
Pipe Size	Utility Type	Material	Condition
18"	Sanitary Sewer Force Main	Asbestos Cement Pipe	Exterior is encrusted in sand. No visible cracks or fractures.
3"	Unknown	Polyvinyl Chloride (Dark Gray)	Surface is dirty. No visible signs of structural damage.
2"	Electrical	Polyvinyl Chloride (White)	Conduit is intact. Wires are exposed and appear tangled and aged.

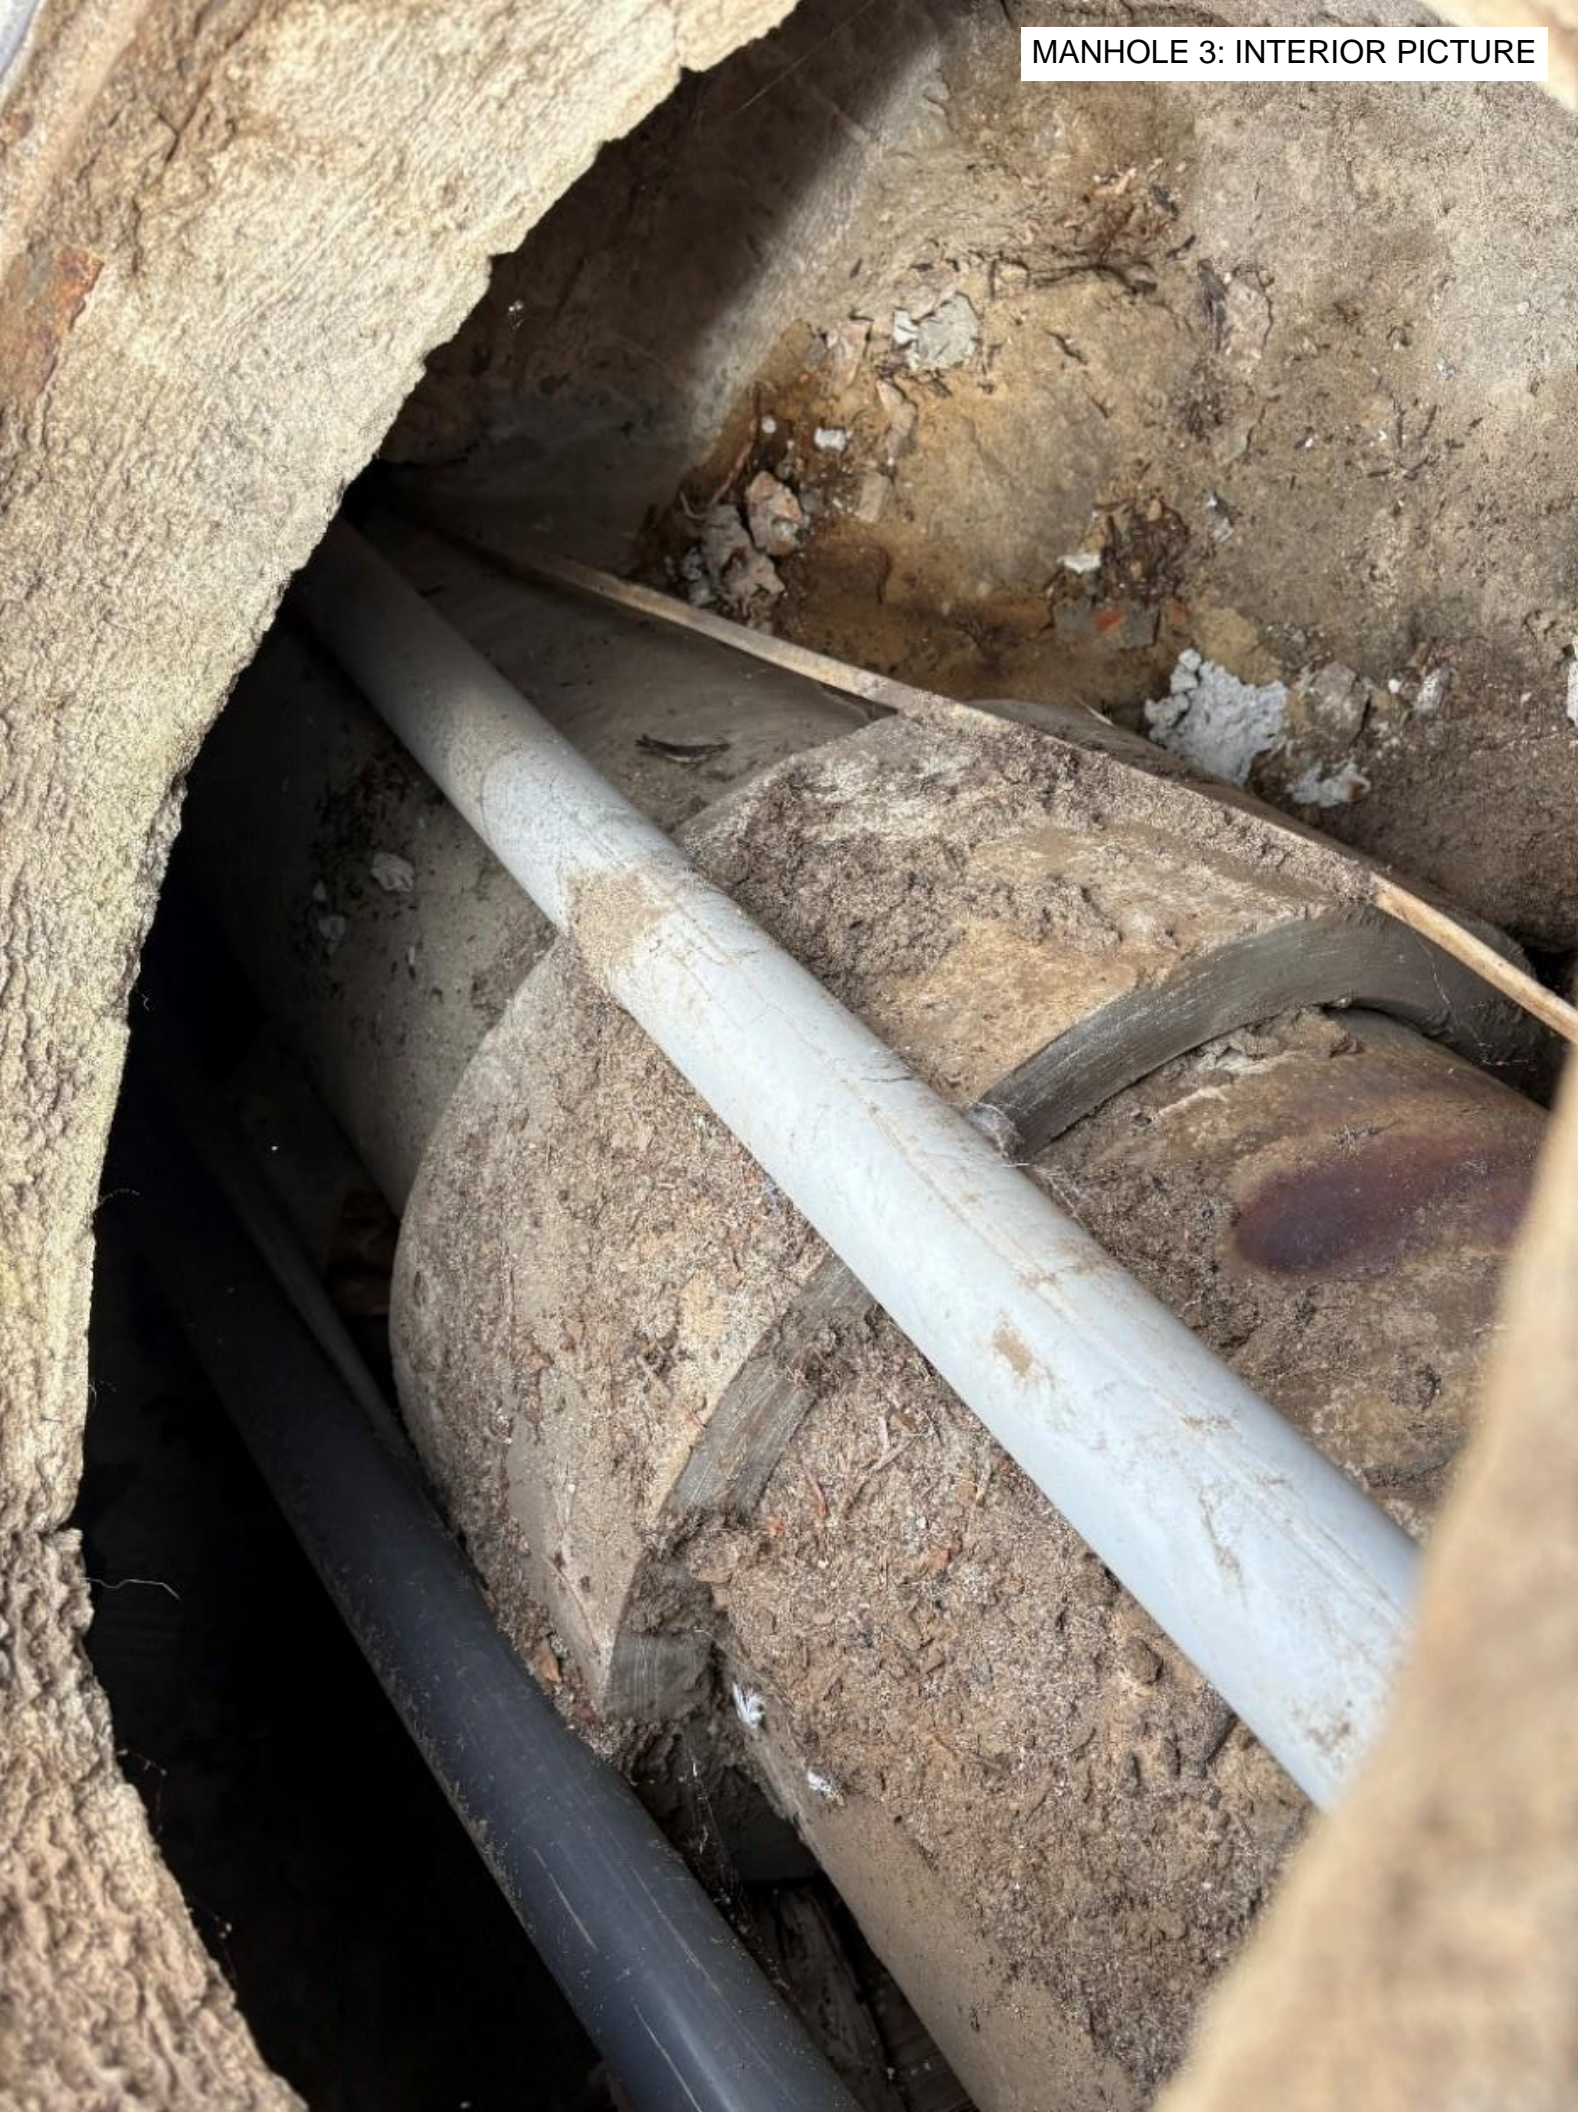
MANHOLE 3: INTERIOR PICTURE

Manhole 3			
Pipe Size	Utility Type	Material	Condition
18"	Sanitary Sewer Force Main	Asbestos Cement Pipe	Visible cracking and spalling in several sections of the outer encasement.
3"	Unknown	Polyvinyl Chloride (Dark Gray)	Joints and fittings intact. No visible evidence of leaking or stress.
3"	Unknown	Polyvinyl Chloride (Light Gray)	Joints and fittings intact. No visible evidence of leaking or stress.
2"	Electrical	Polyvinyl Chloride (White)	Joints and fittings intact. No visible evidence of stress.

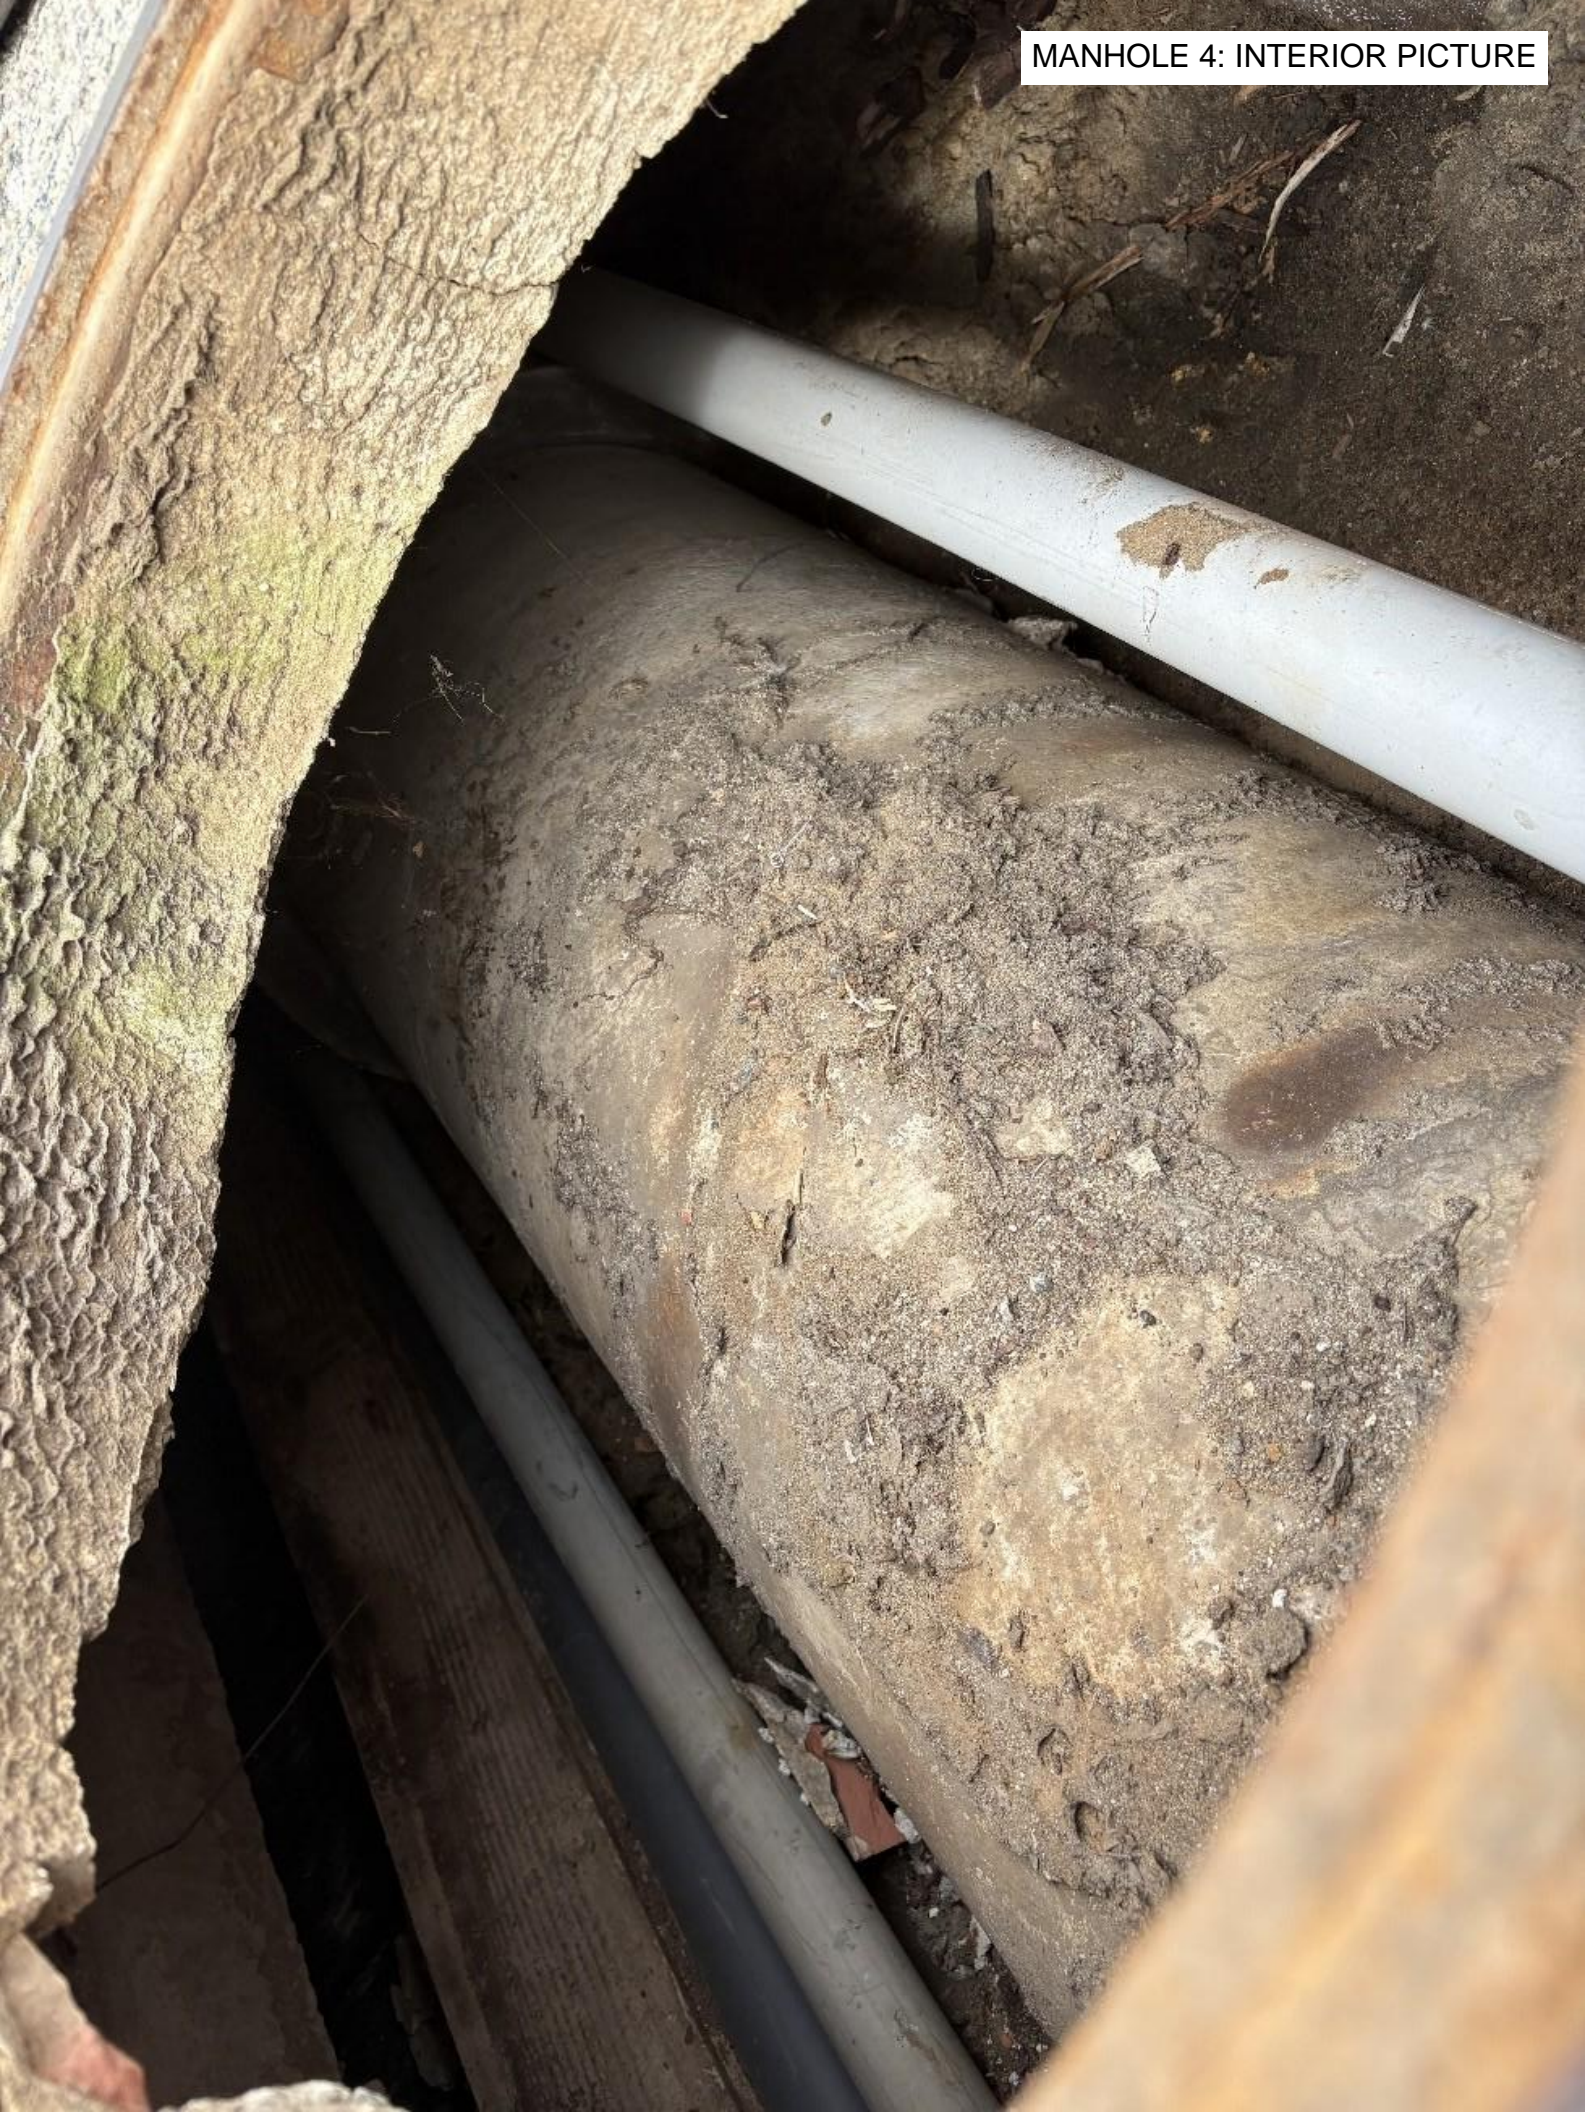
MANHOLE 4: INTERIOR PICTURE

Manhole 4			
Pipe Size	Utility Type	Material	Condition
18"	Sanitary Sewer Force Main	Asbestos Cement Pipe	Visible cracking and spalling in several sections of the outer encasement.
3"	Unknown	Polyvinyl Chloride (Dark Gray)	Joints and fittings intact. No visible evidence of leaking or stress.
3"	Unknown	Polyvinyl Chloride (Light Gray)	Joints and fittings intact. No visible evidence of leaking or stress.
2"	Electrical	Polyvinyl Chloride (White)	Joints and fittings intact. Minor surface wear.

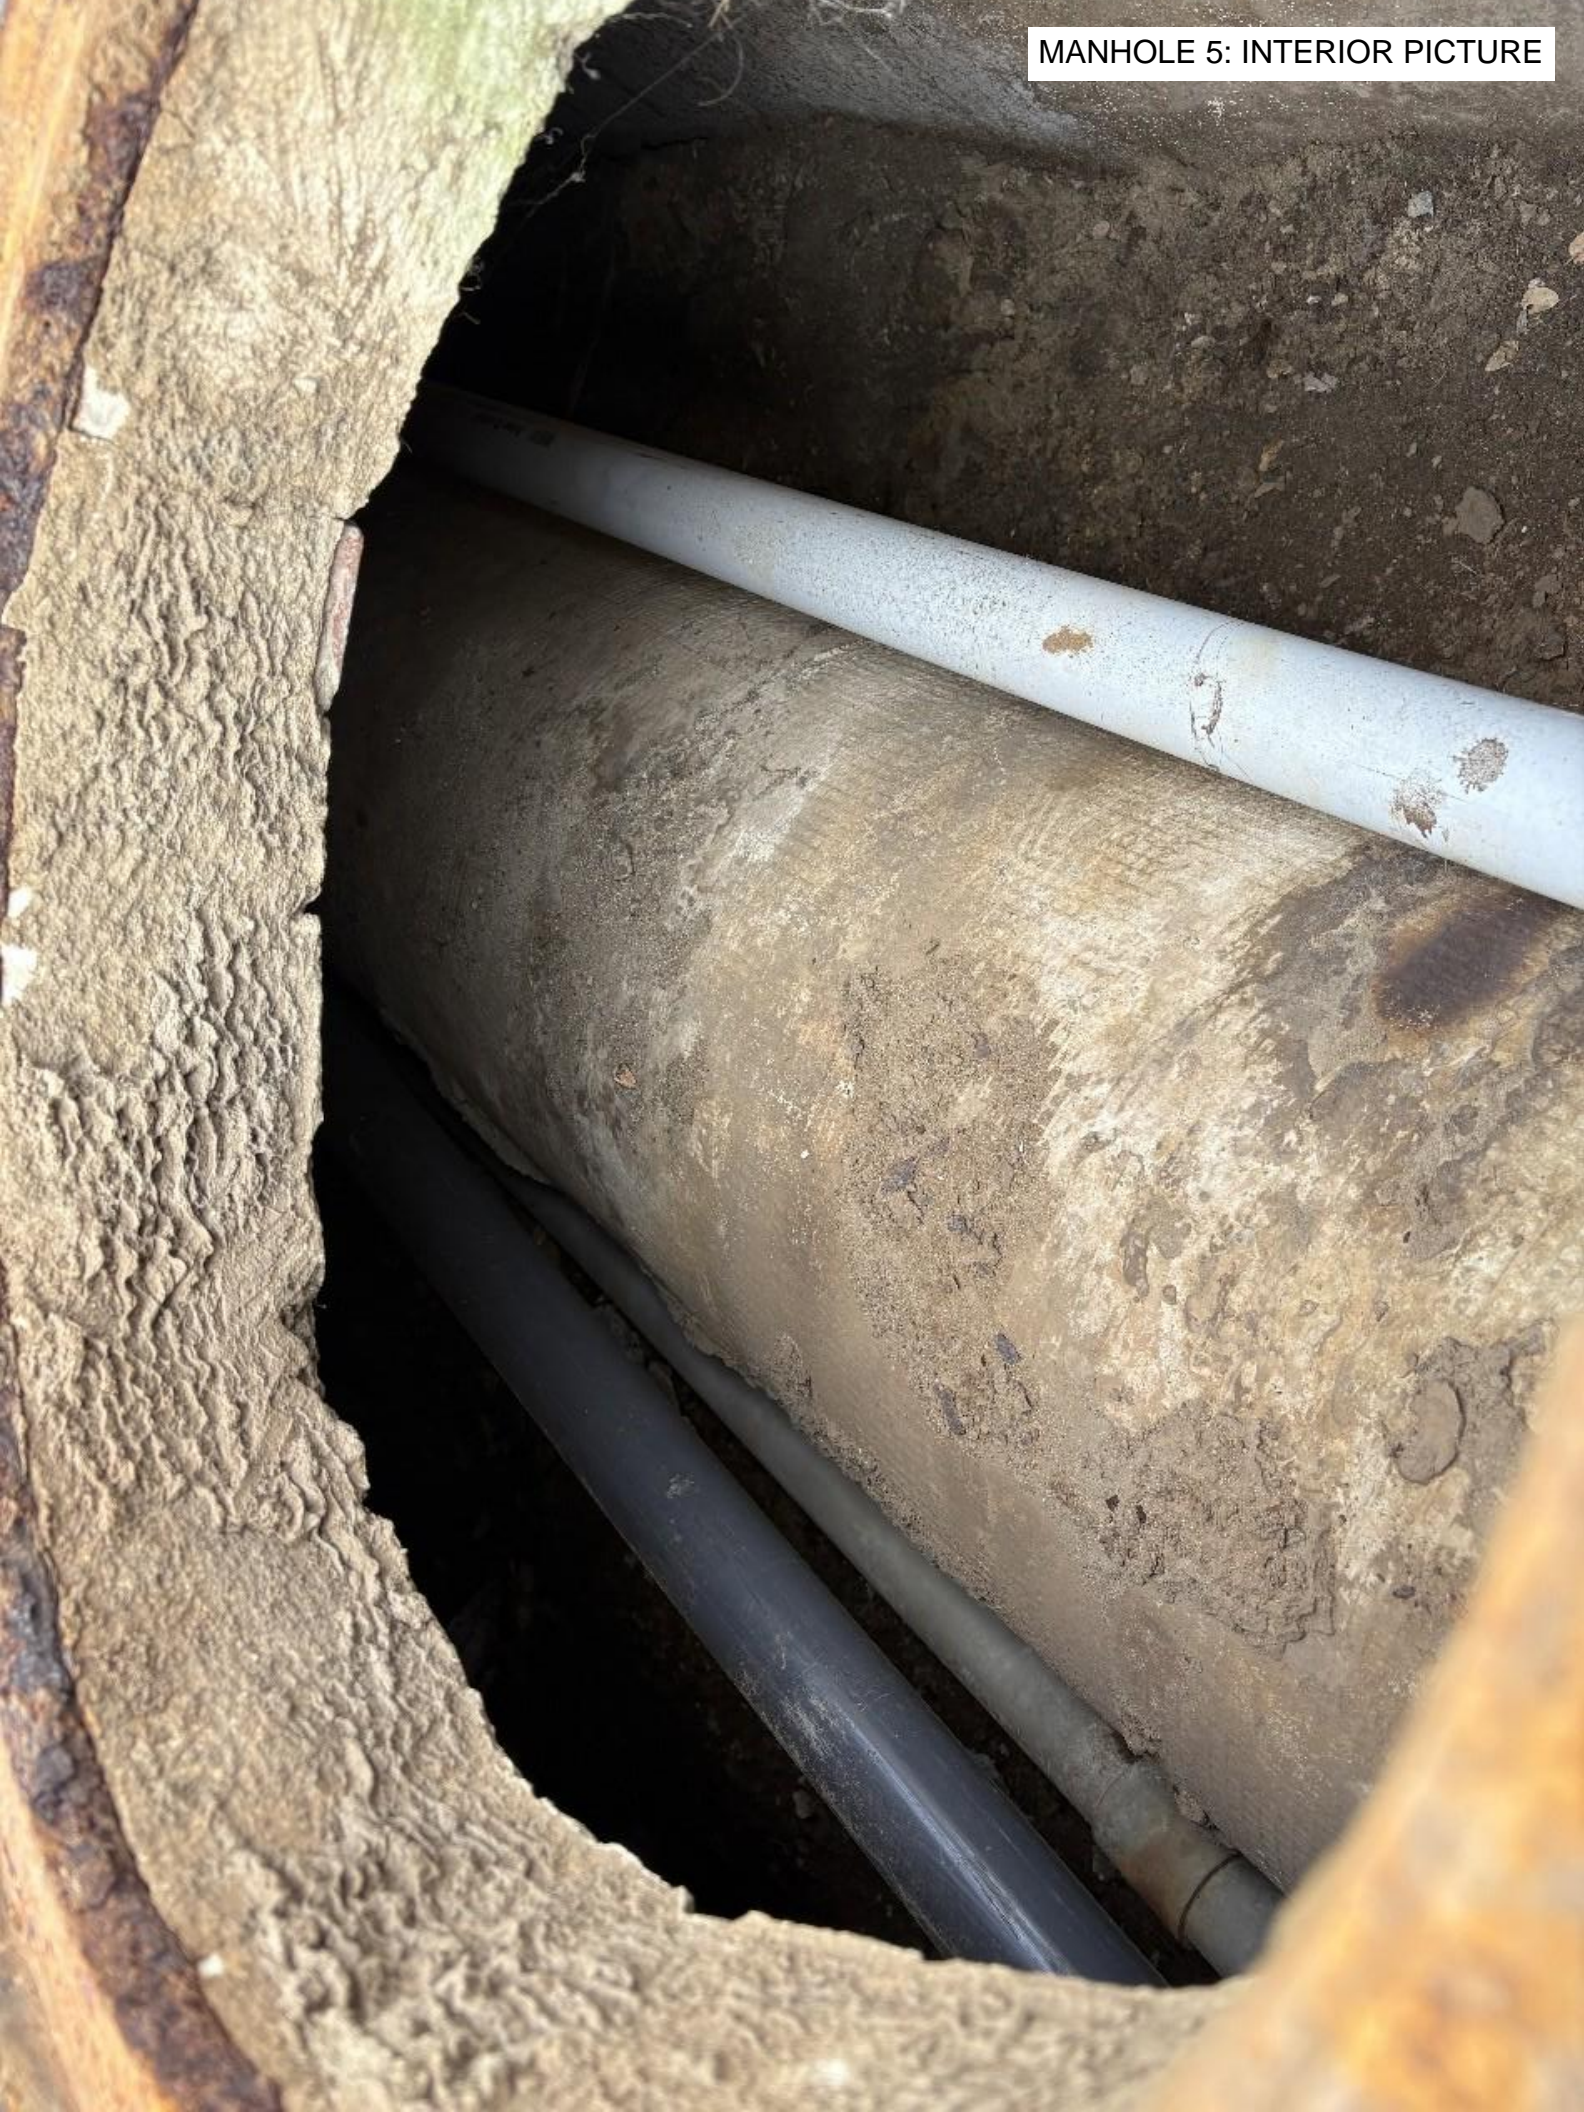
MANHOLE 5: INTERIOR PICTURE

Manhole 5			
Pipe Size	Utility Type	Material	Condition
18"	Sanitary Sewer Force Main	Asbestos Cement Pipe	Visible cracking and spalling in several sections of the outer encasement.
3"	Unknown	Polyvinyl Chloride (Dark Gray)	Joints and fittings intact. No visible evidence of leaking or stress.
3"	Unknown	Polyvinyl Chloride (Light Gray)	Joints and fittings intact. No visible evidence of leaking or stress.
2"	Electrical	Polyvinyl Chloride (White)	Minor surface wear. No visible evidence of stress.

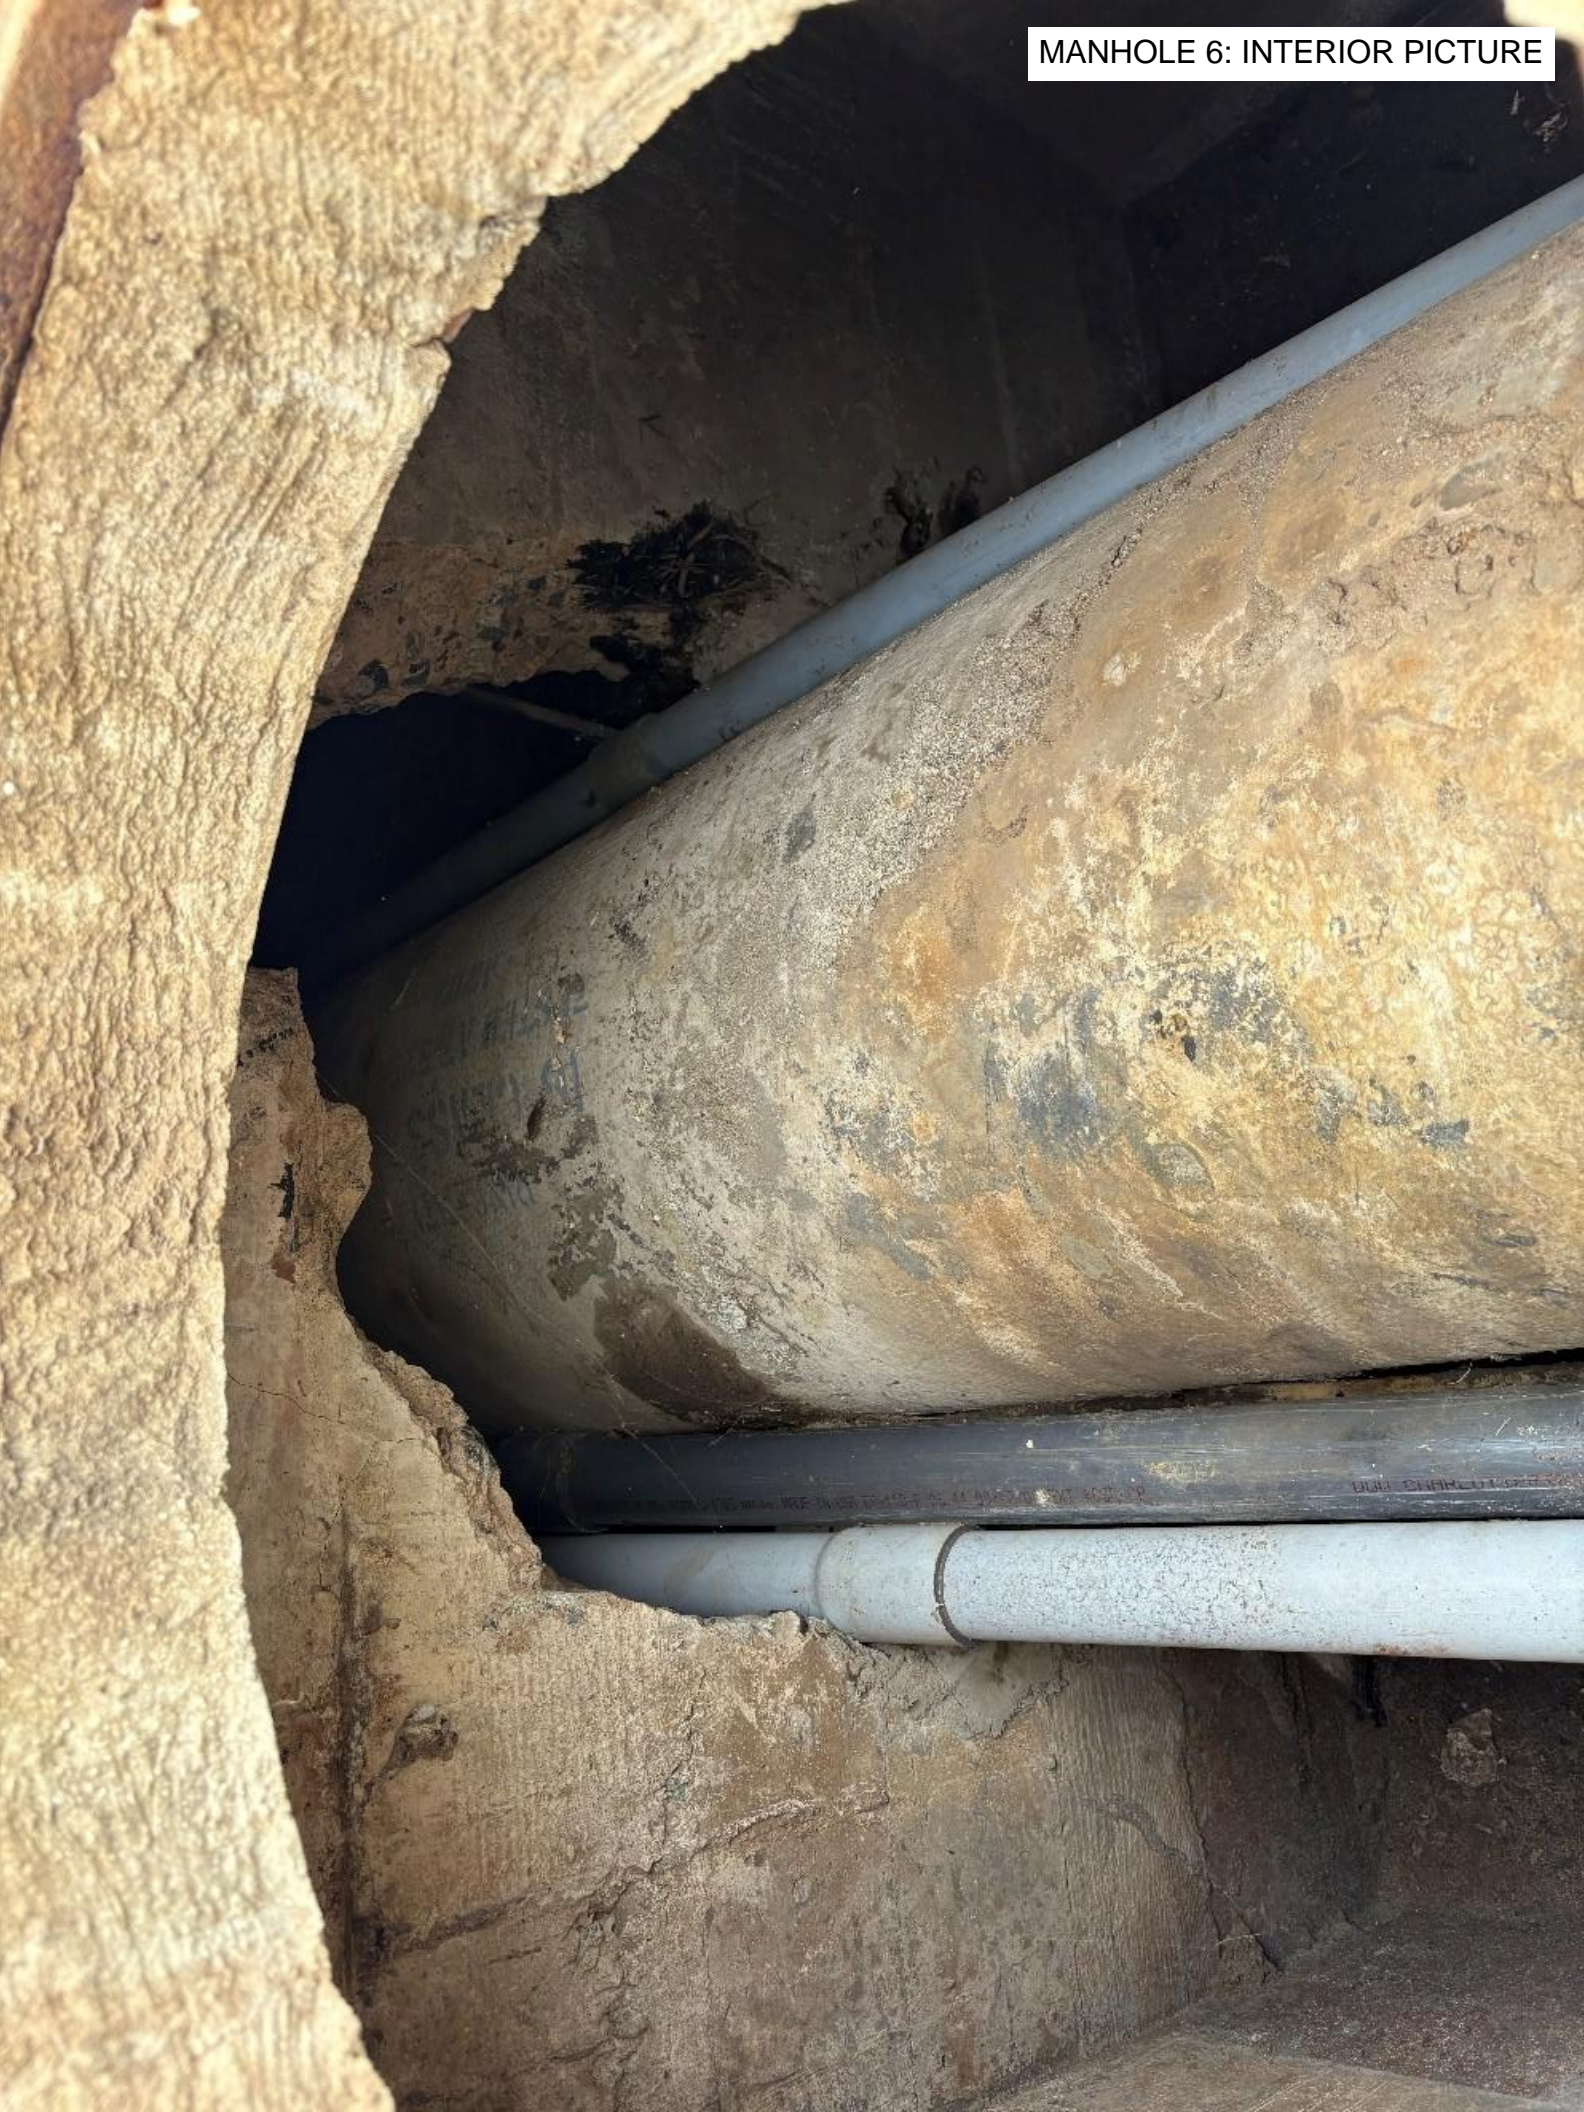
MANHOLE 6: INTERIOR PICTURE

Manhole 6			
Pipe Size	Utility Type	Material	Condition
18"	Sanitary Sewer Force Main	Asbestos Cement Pipe	Minor surface wear. Water leaking onto pipe, source untraceable.
3"	Unknown	Polyvinyl Chloride (Dark Gray)	Joints and fittings intact. No visible evidence of leaking or stress.
3"	Unknown	Polyvinyl Chloride (Light Gray)	Joints and fittings intact. No visible evidence of leaking or stress.
2"	Electrical	Polyvinyl Chloride (White)	Joints and fittings intact. No visible evidence of stress.
