MEMORANDUM

DATE: April 1, 2026 **Job No.:** 2300338

RE: **STOCKTON AVENUE BRIDGE EXISITING CONDITION MEMORANDUM**

This memorandum is a summary of the existing condition of the Stockton Avenue Bridge in Capitola, California.

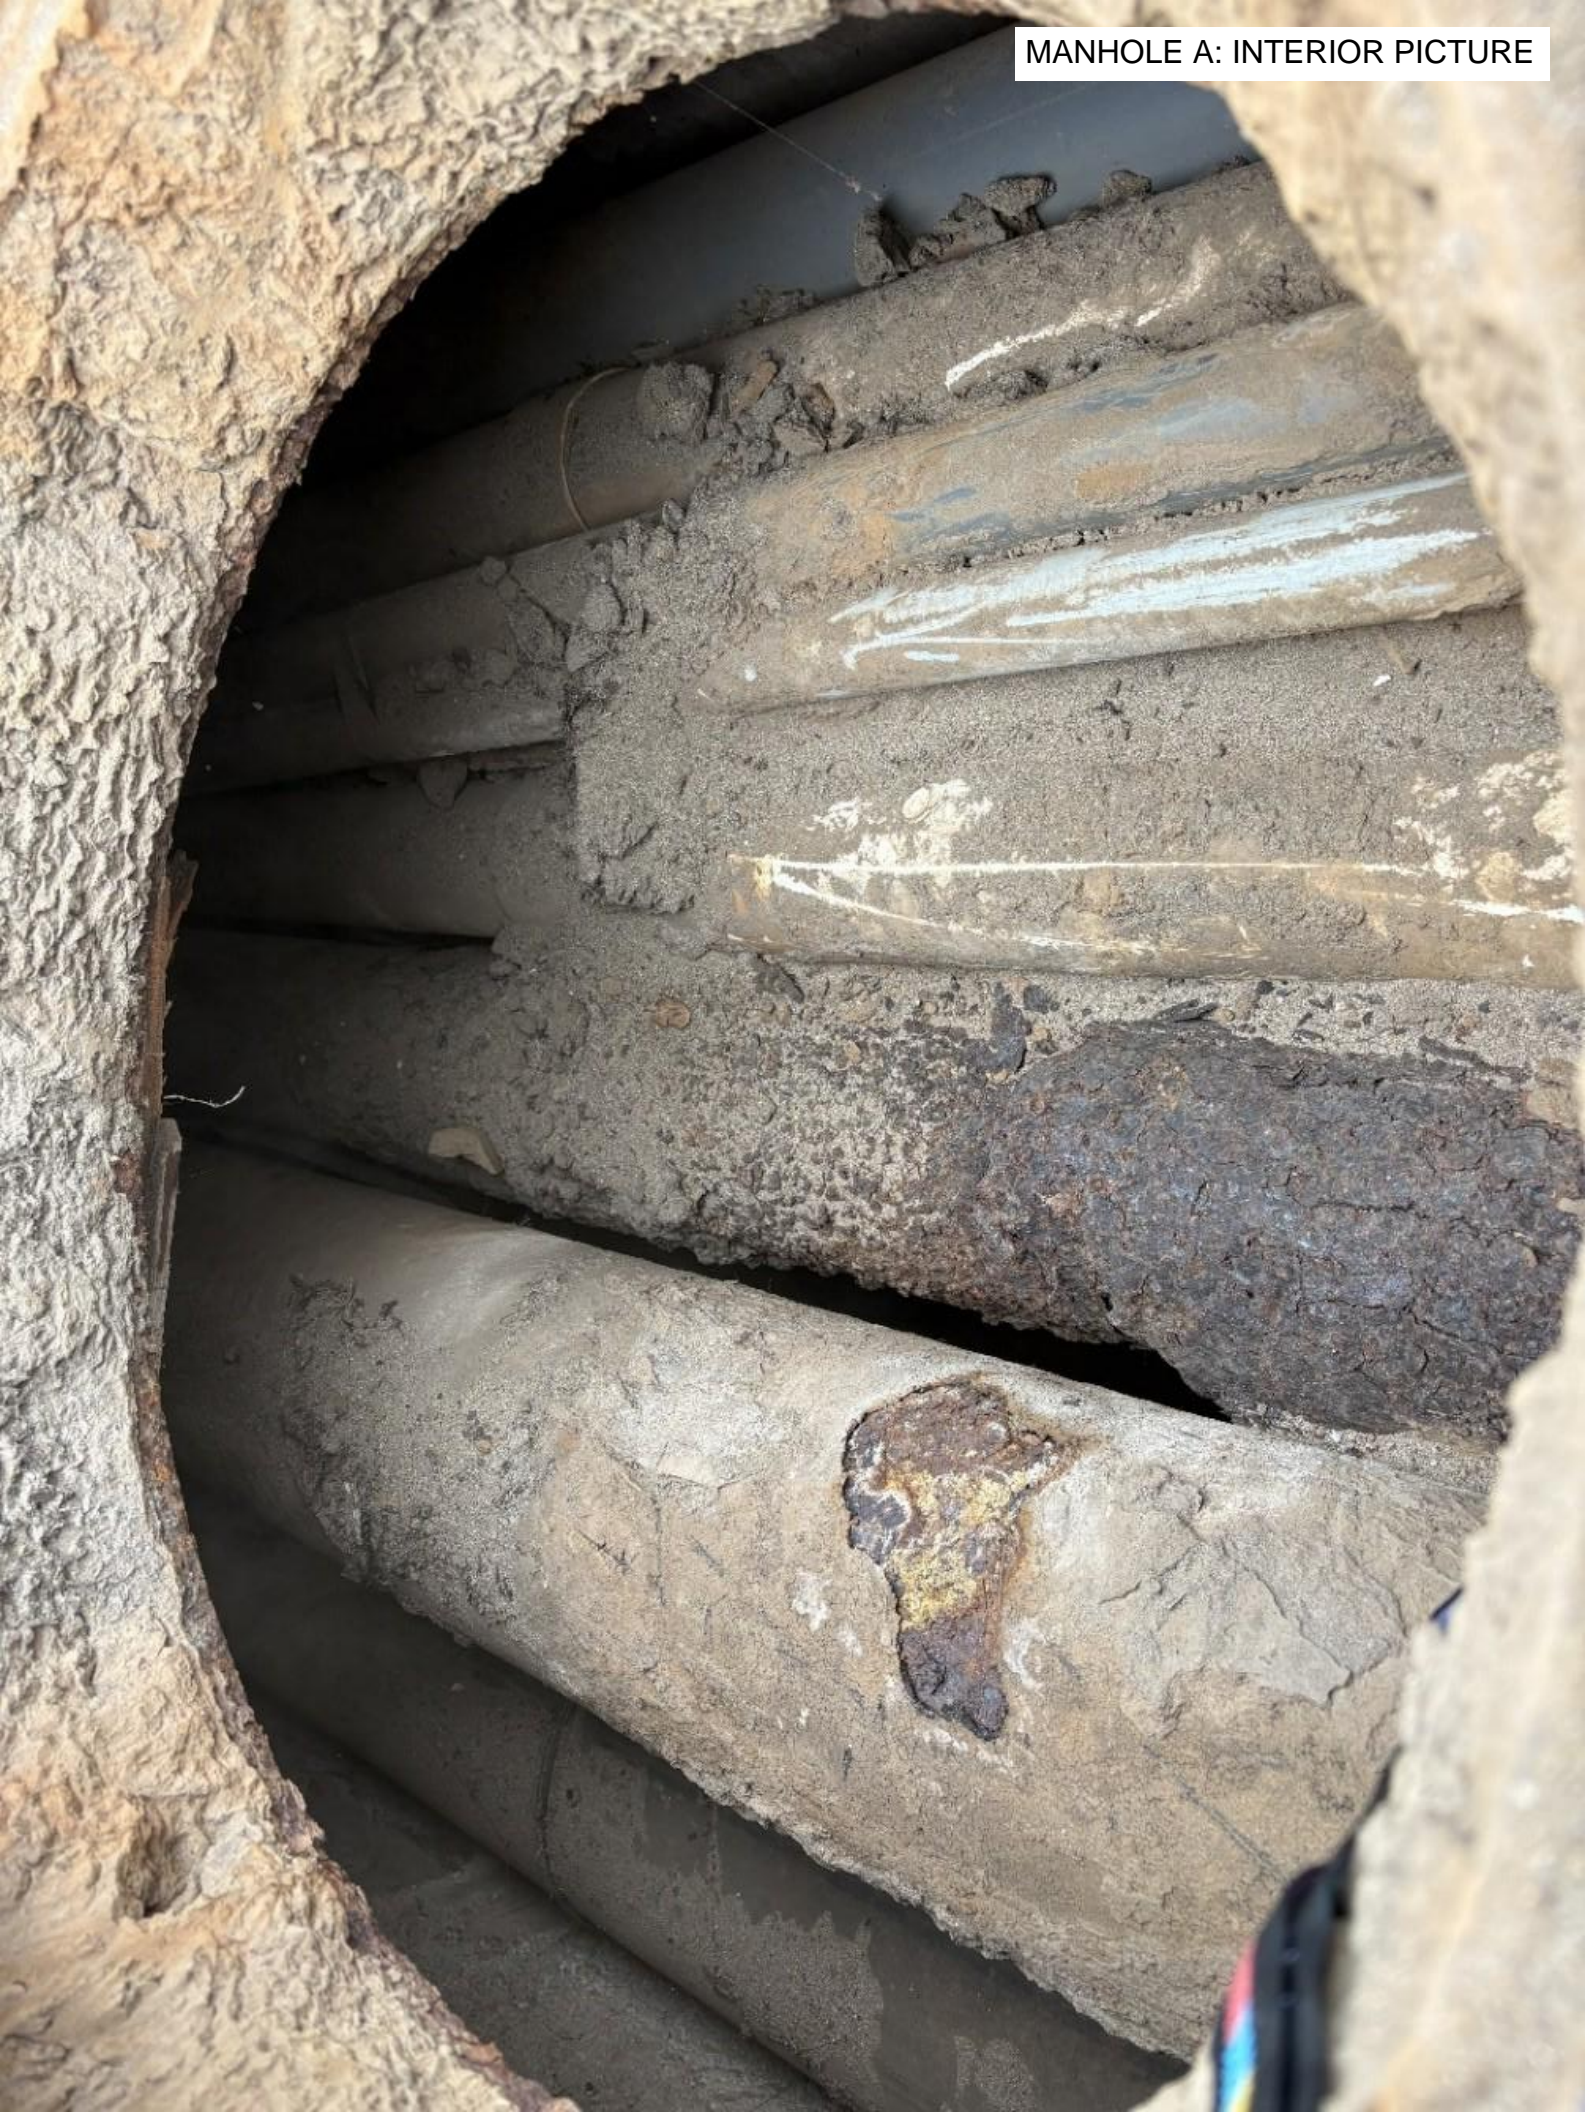
MANHOLE A: INTERIOR PICTURE

Manhole A			
Pipe Size	Utility Type	Material	Condition
4"	Water	Polyvinyl Chloride (Dark Gray)	Joints and fittings intact. No visible evidence of leaking or stress.
6"	Unknown	Polyvinyl Chloride (White)	Surface is dusty but intact. No visible deformation or major damage.
5"	Unknown	Polyvinyl Chloride (White with Gray joints)	Covered in soil; no visible damage, but full condition not assessable.
5"	Unknown	Polyvinyl Chloride (White with Gray joints)	Buried in soil. No visible defects from exposed sections.
3"	Unknown	Polyvinyl Chloride (Dark gray)	Coated in dust. Appears structurally intact. No visible signs of stress.
2"	Unknown	Polyvinyl Chloride (White)	Mostly buried. Visible section intact, but condition uncertain.
6"	Sanitary Sewer Force Main	Ductile Iron	Surface heavily corroded and flaking. Likely abandoned.
10"	Sanitary Sewer Force Main	Ductile Iron	Outer surface shows some wear. Moderate corrosion present.

8"	Unknown	Polyvinyl Chloride (Gray)	Minor joint staining.

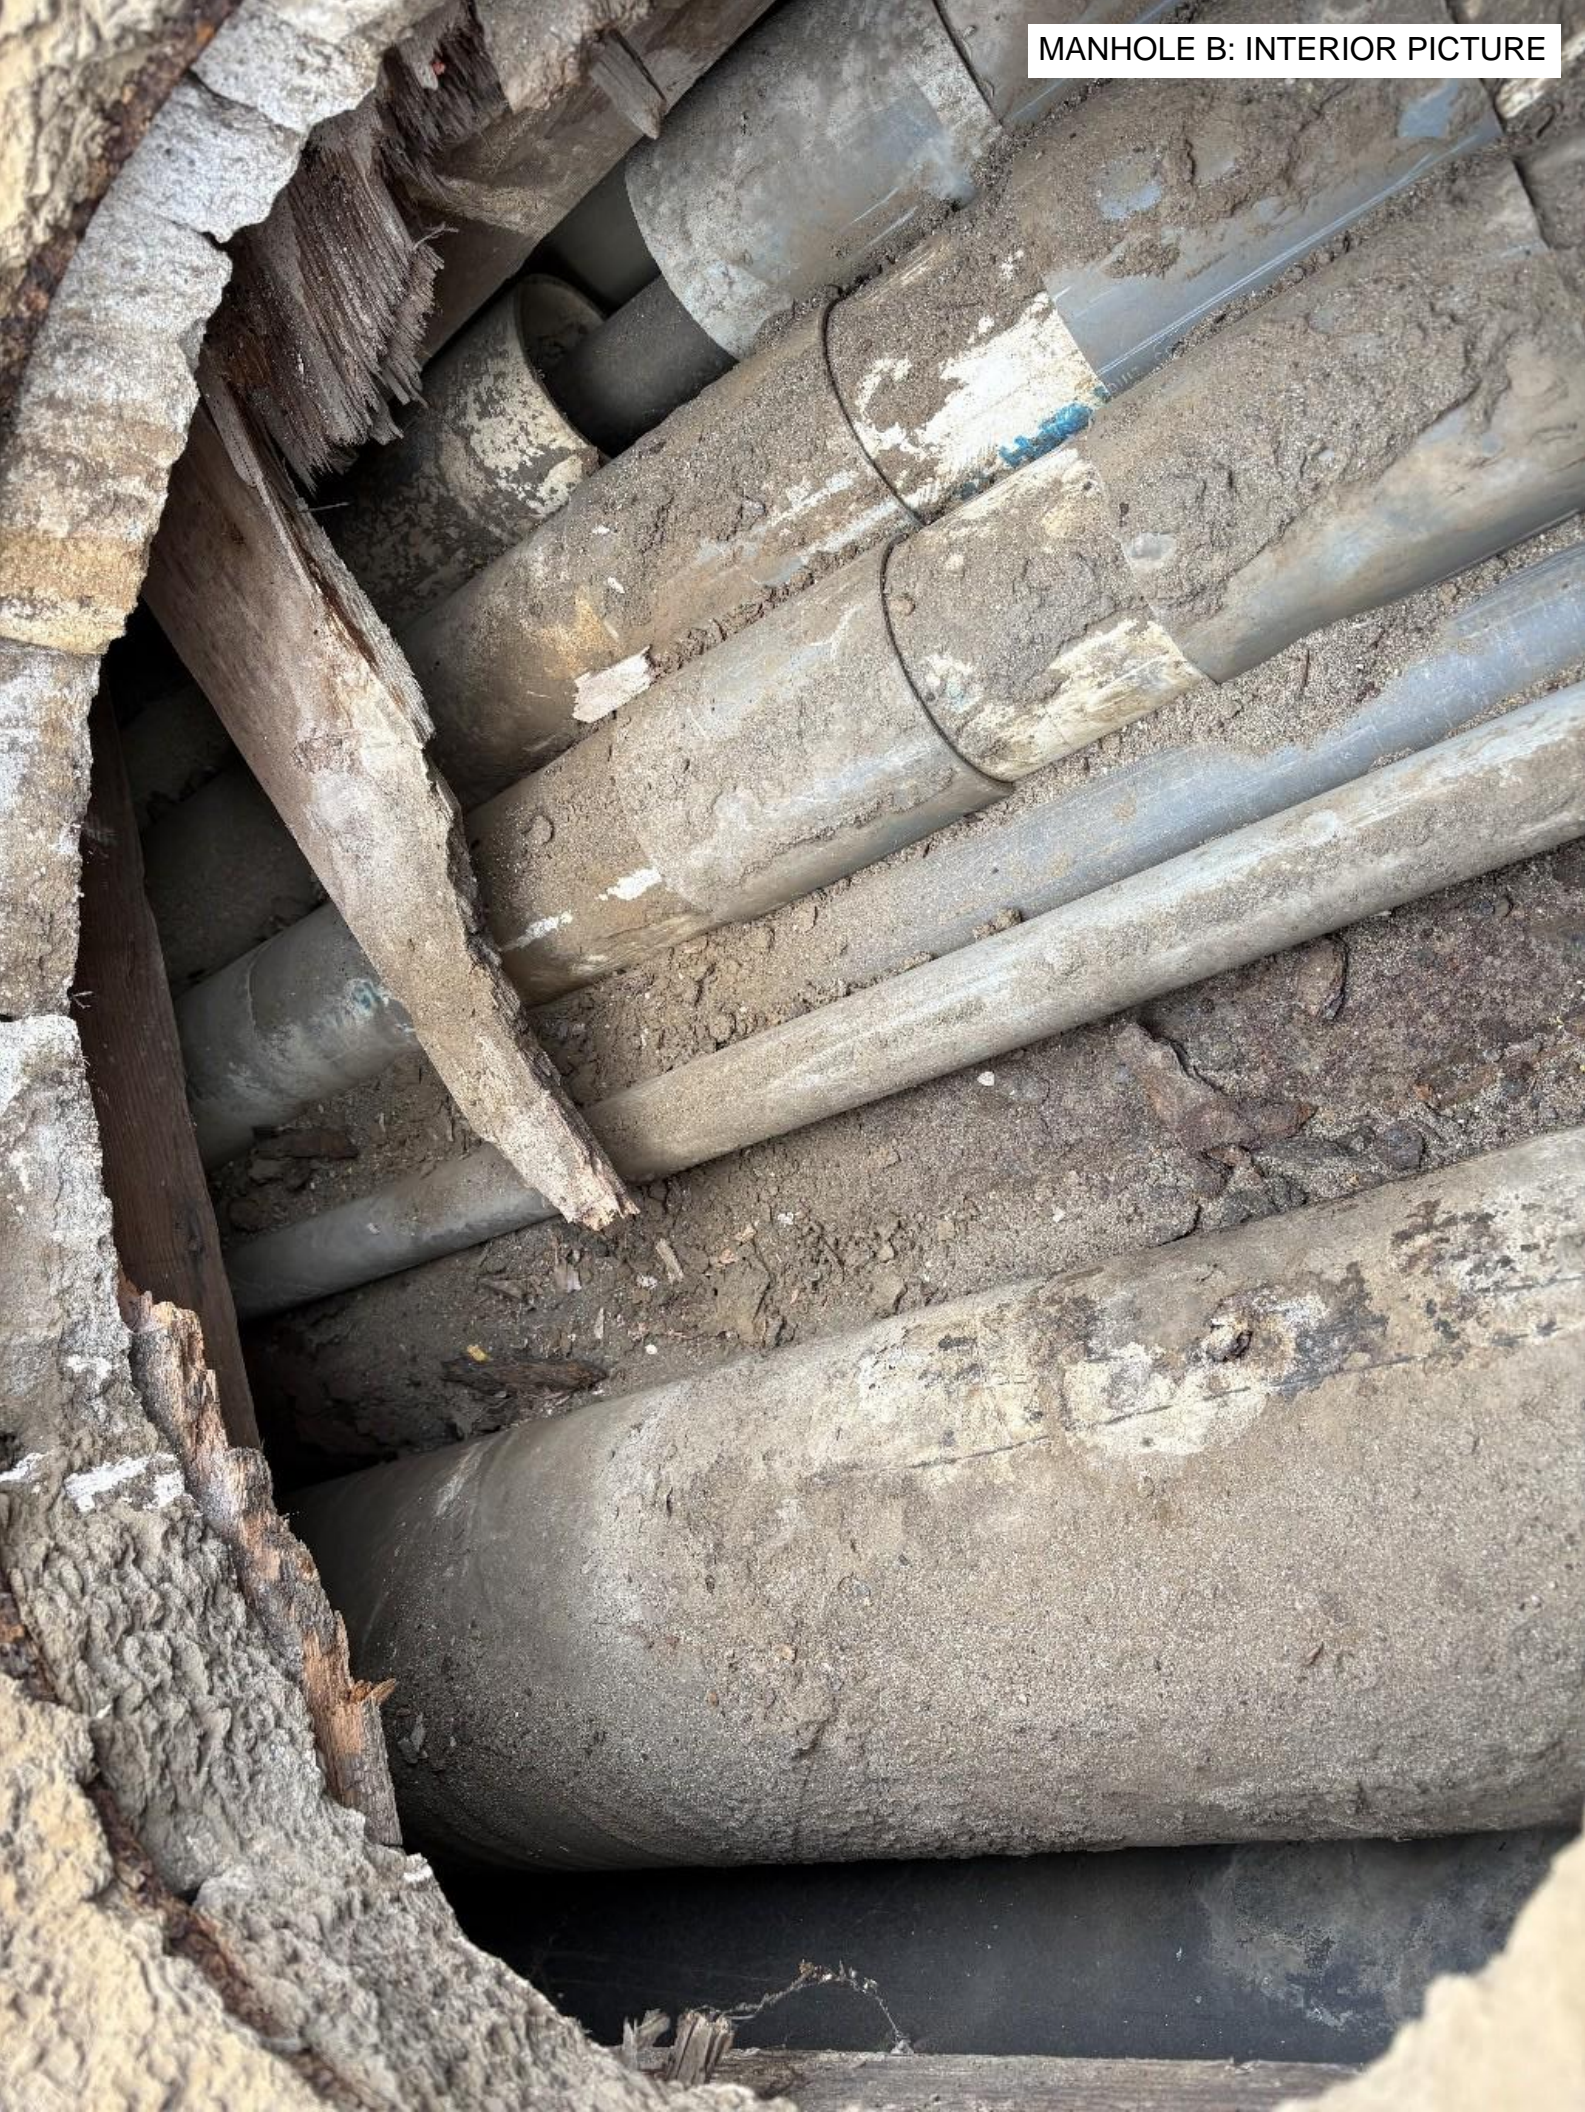
MANHOLE B: INTERIOR PICTURE

Manhole B			
Pipe Size	Utility Type	Material	Condition
4"	Water	Polyvinyl Chloride (Dark Gray)	Hidden mostly behind other pipes. Visible section intact.
6" (3")	Unknown	Polyvinyl Chloride (White; interior pipe - Dark Gray)	Surface is dusty but intact. 6" pipe encasing 3" pipe. Both pipes visibly intact.
5"	Unknown	Polyvinyl Chloride (White with Gray joints)	Covered in soil. No visible damage. Joints and fittings intact.
5"	Unknown	Polyvinyl Chloride (White with Gray joints)	Covered in soil. No visible damage Joints and fittings intact.
3"	Unknown	Polyvinyl Chloride (Dark gray)	Buried in dust. Appears structurally intact. No visible signs of stress.
2"	Unknown	Polyvinyl Chloride (White)	Minor dirt and grime. No visible signs of damage.
6"	Sanitary Sewer Force Main	Ductile Iron	Buried in soil. Surface heavily corroded and flaking.
10"	Sanitary Sewer Force Main	Ductile Iron	Outer surface shows some wear. Minor corrosion present.

8"	Unknown	Polyvinyl Chloride (Gray)	Minor staining. No visible signs of damage.

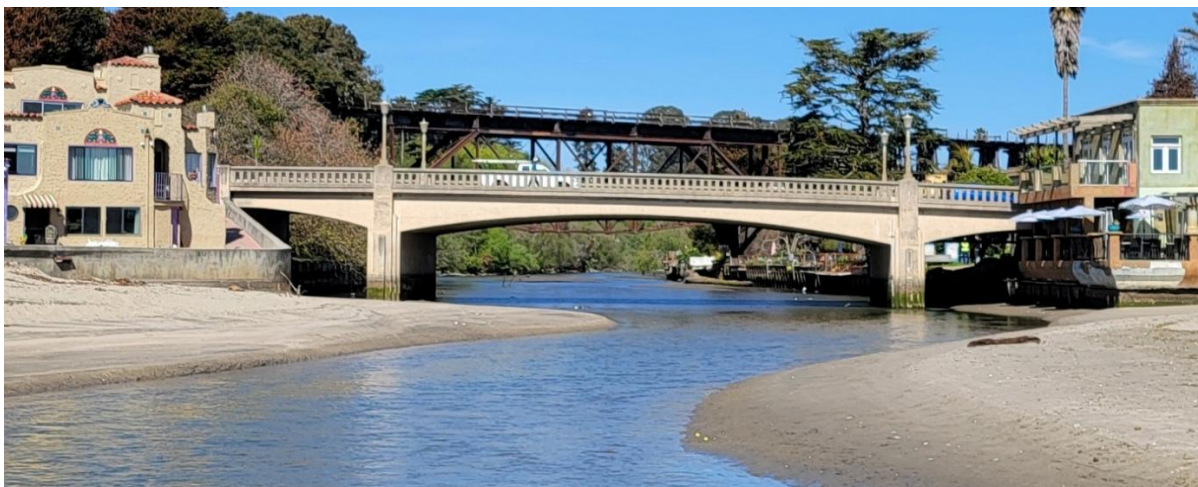
Figure 1: Stockton Avenue Bridge Looking Upstream

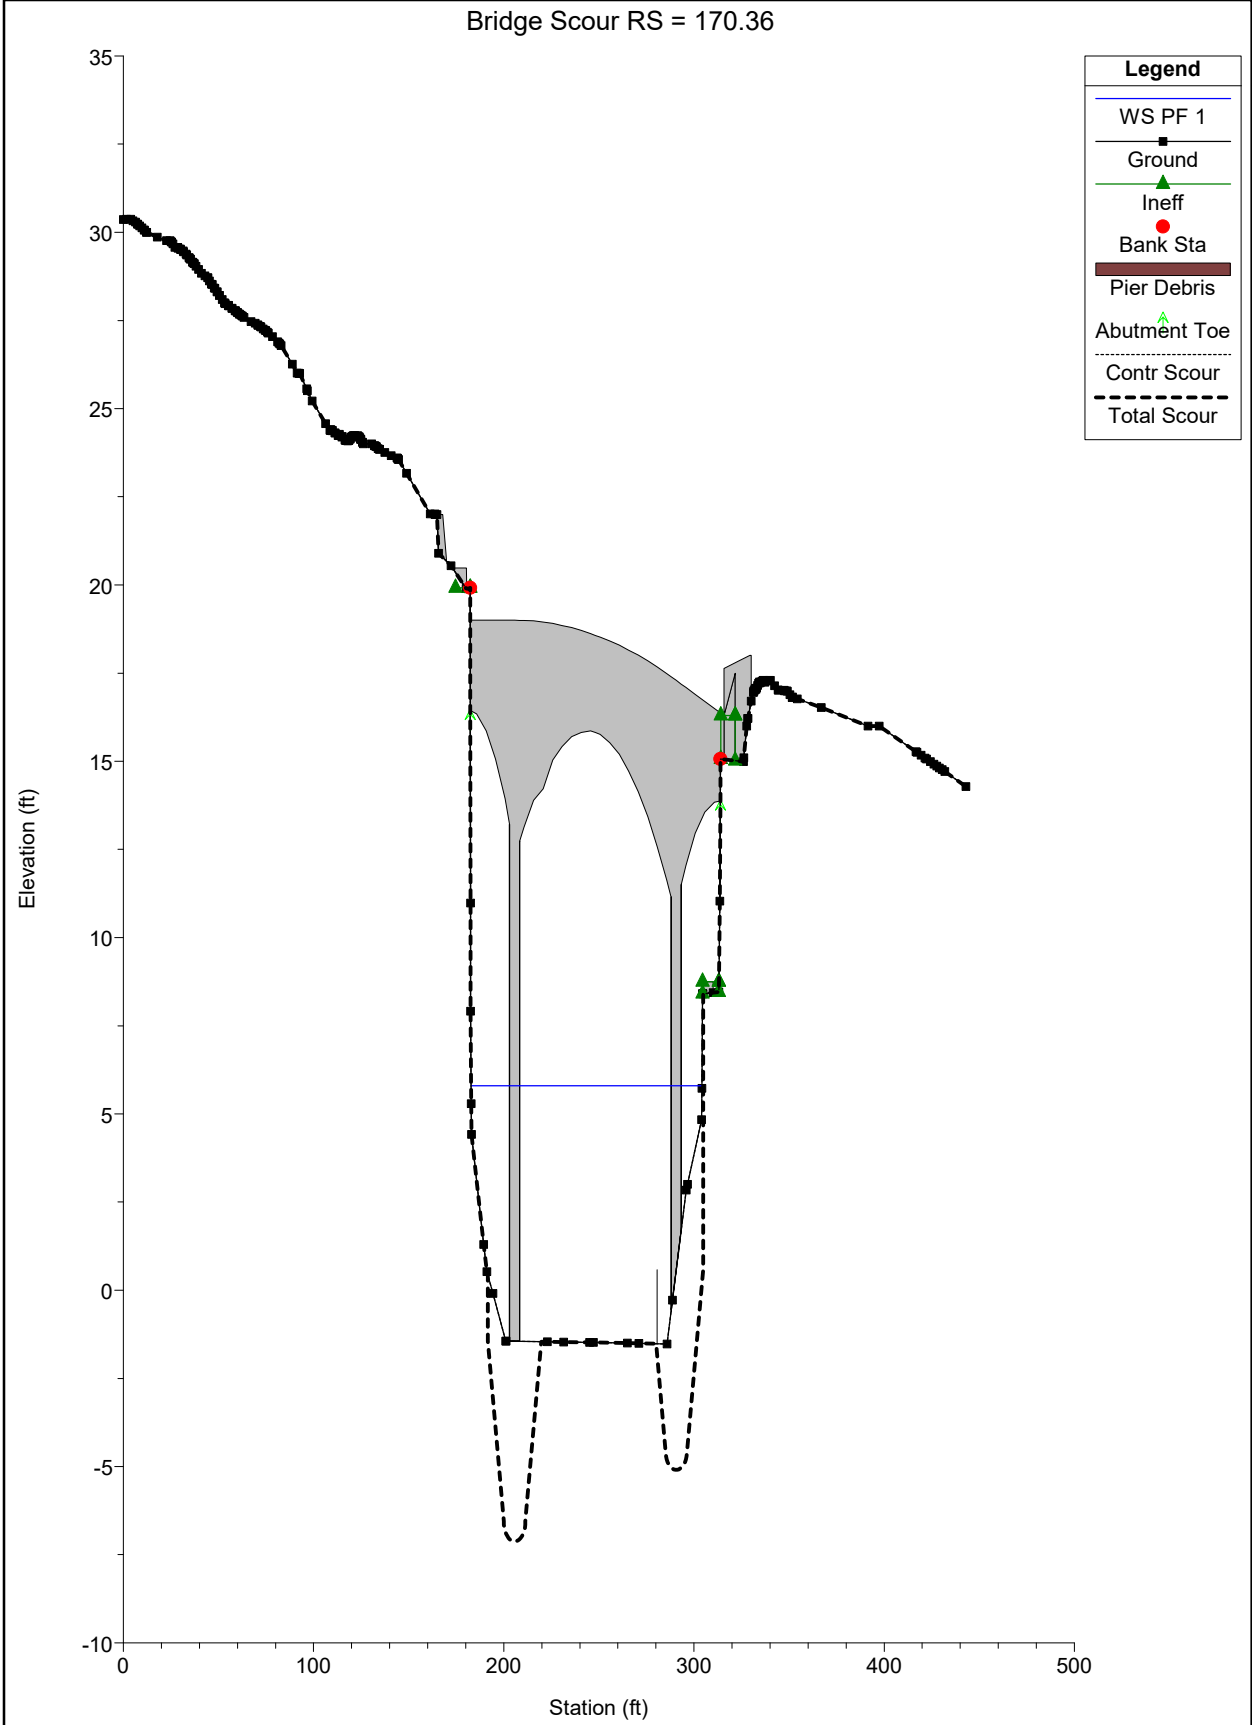
HEC-RAS Model Bridge Scour Section Plots

From the HEC-RAS analysis, the scour depth is adjusted for the approximate channel invert and an actual approximate scour depth elevation is calculated which is compared to the bridge pier elevations. Table 2 below shows the pier scour depth results from the analysis and adjustment to approximate scour elevation. As shown in Table 1 below, in the low flow condition (Q=1,200 cfs), large woody debris does not impact the scour analysis. In the high flow condition (Q=17,500 cfs), the large woody debris increases the scour depth.

As shown in Table 4 below, for all flow scenarios, the entire pier caps are exposed. In the low flow condition (Q=1,200 cfs), the length of pier exposure may vary over the course of a storm event with the possible variance in the channel bed elevation at the piers. The scour depth falls between the top of the pile cap and the bottom of the pile but near the pile cap which, per FHWA Item 113 is coded as 3 or 5 meaning additional structural analysis is required to determine whether the bridge foundations are stable or not and additional measures to protect the exposed foundations may be required.

Per the as-built drawings, the length of the pier pile timbers is approximately 25' long. As such, in the high flow conditions (Q=17,500 cfs), the scour depth falls in the bottom half of the exposed pier pile. Per Item 113 (FHWA NBIP), the bridge is coded as 3 which indicates the bridge is scour critical and additional foundation structural analysis is needed.

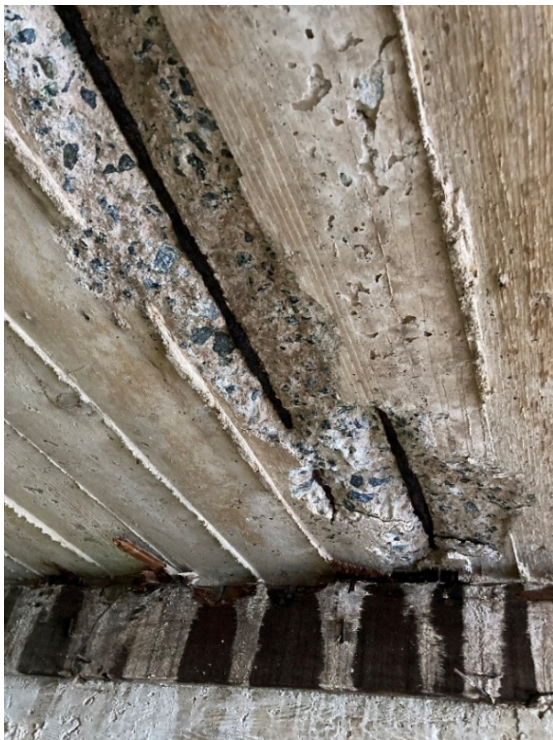
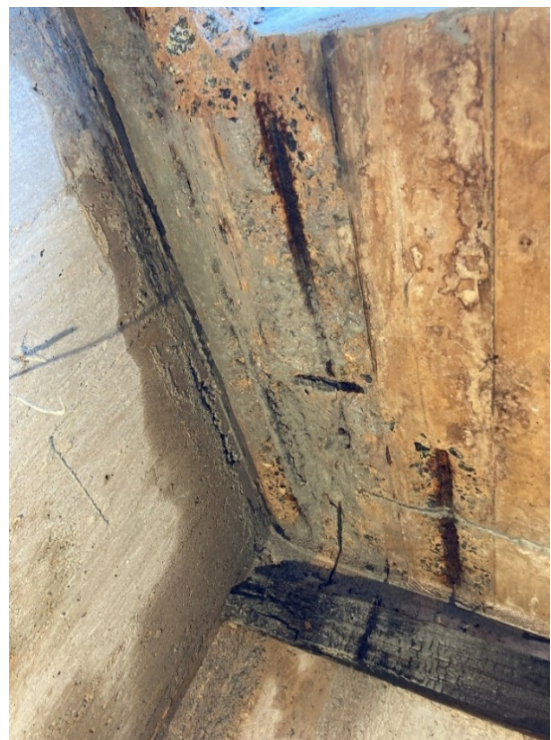
Roadway Deck Soffit Spalls and Corrosion

At a minimum, the widespread loss of a significant percentage of transverse deck reinforcement from corrosion requires a full deck slab replacement. Since the lost reinforcing bars are the bottom transverse

bars, their repair cannot be addressed with a deck overlay or methacrylate treatment. The recent records for the bridge indicate substantially increased frequency and cost for structural repairs to address corrosion and corrosion related spalls. Given the advanced age of the bridge (93 years), hydraulic and seismic deficiencies, and the substantial cost to restore the deck slab, a full bridge replacement is recommended. In the interim, a load rating reduction is not regarded as necessary since the lost reinforcement alone will not lead to a collapse risk. The deck will continue to deteriorate showing more numerous and wider surface cracks. Cracking should be monitored and recorded. The deck should be re-assessed if cracking is found to be significantly increased.

Based on the 2022 Caltrans bridge inspection report, this bridge is currently eligible for Bridge Preventive Maintenance Program (BPMP) funding to repair the bridge deck. With the benefit of the photos from our March 2026 observations, Caltrans may reassess the deck and superstructure resulting in HBP funding for rehabilitation and potentially for replacement based on the results of a feasibility study.

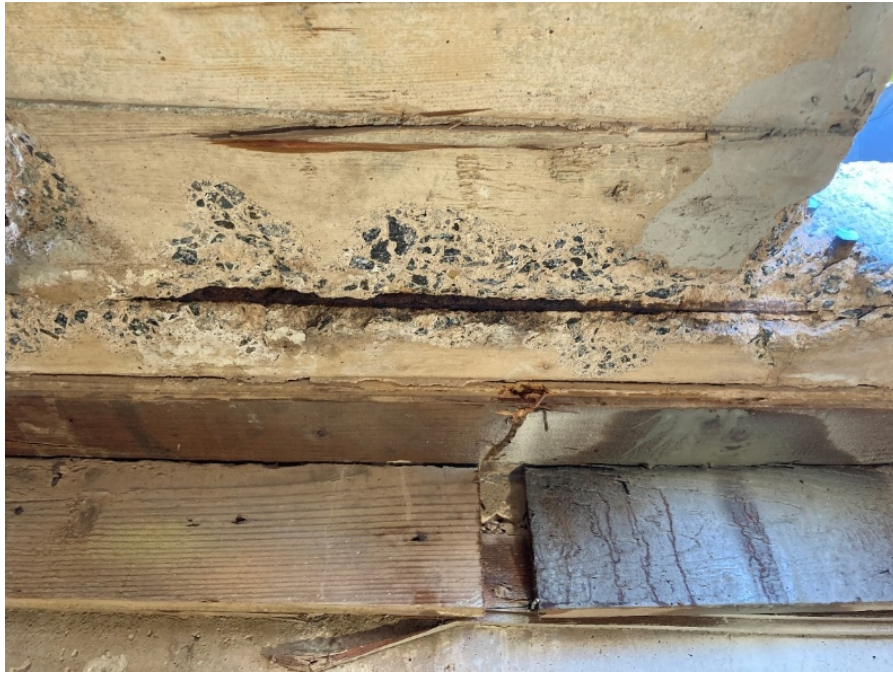
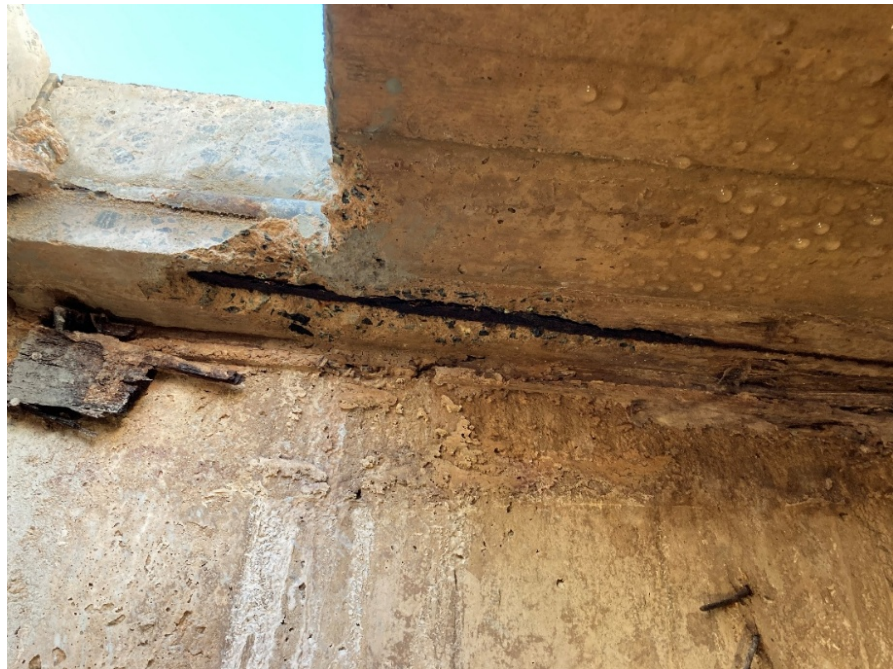
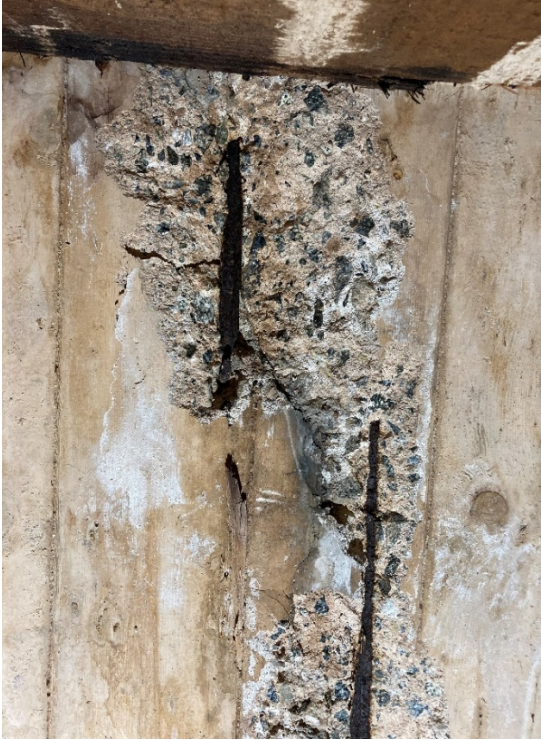
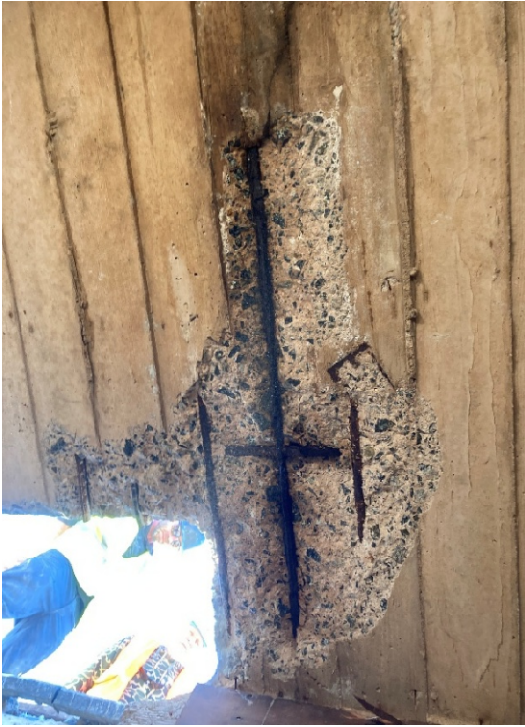
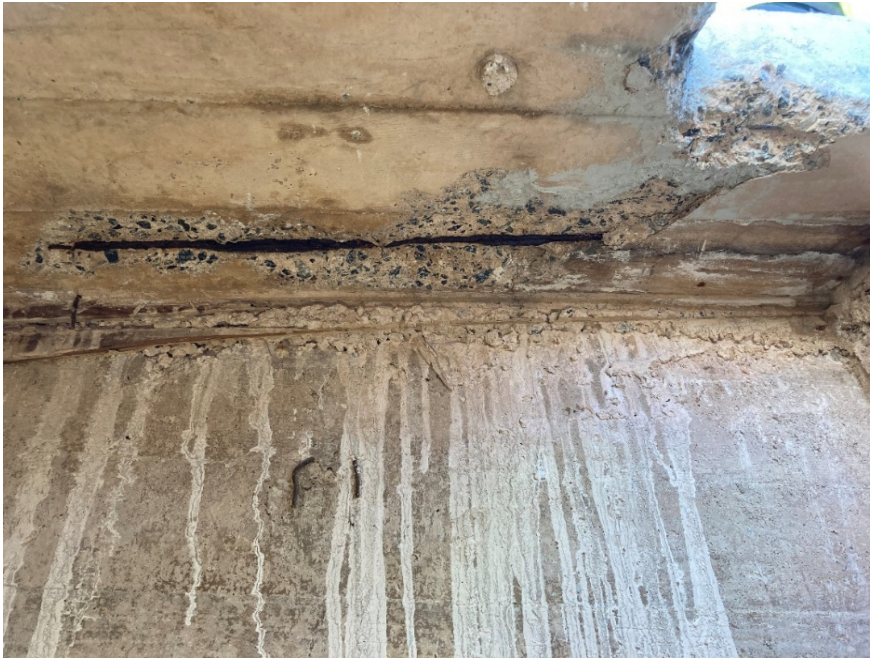
Roadway Deck Soffit Spalls and Reinforcing Corrosion

Deck Soffit Spalls and Reinforcing Corrosion

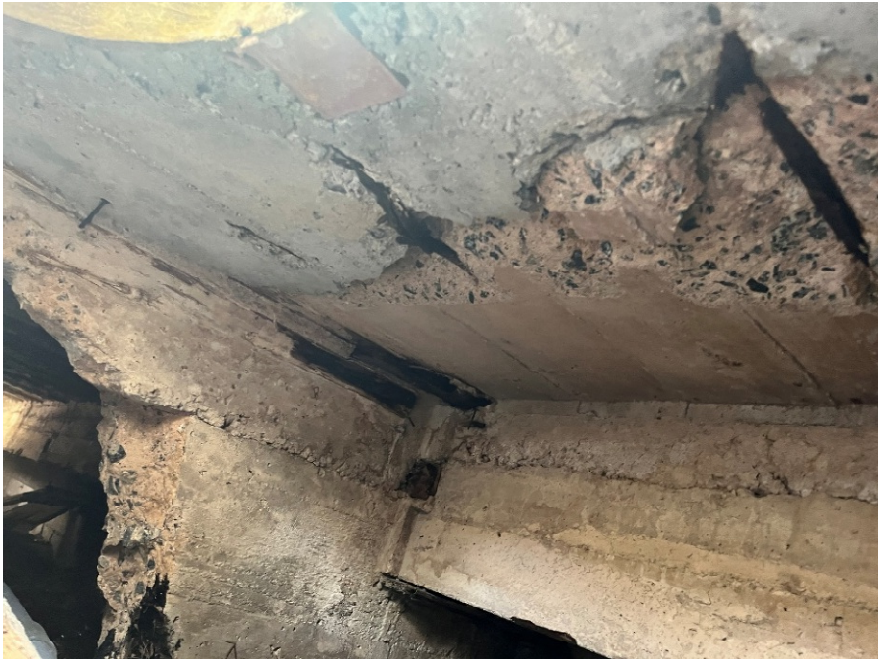
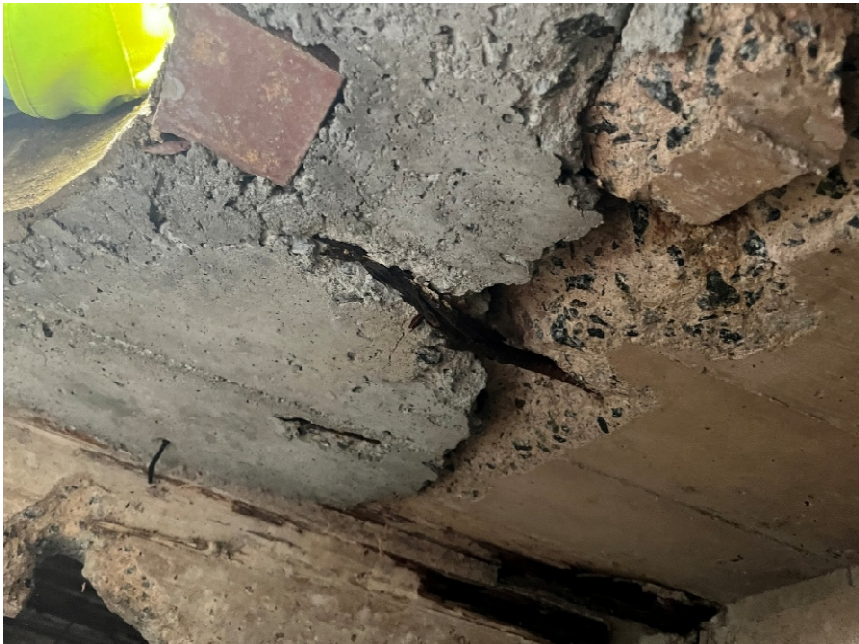
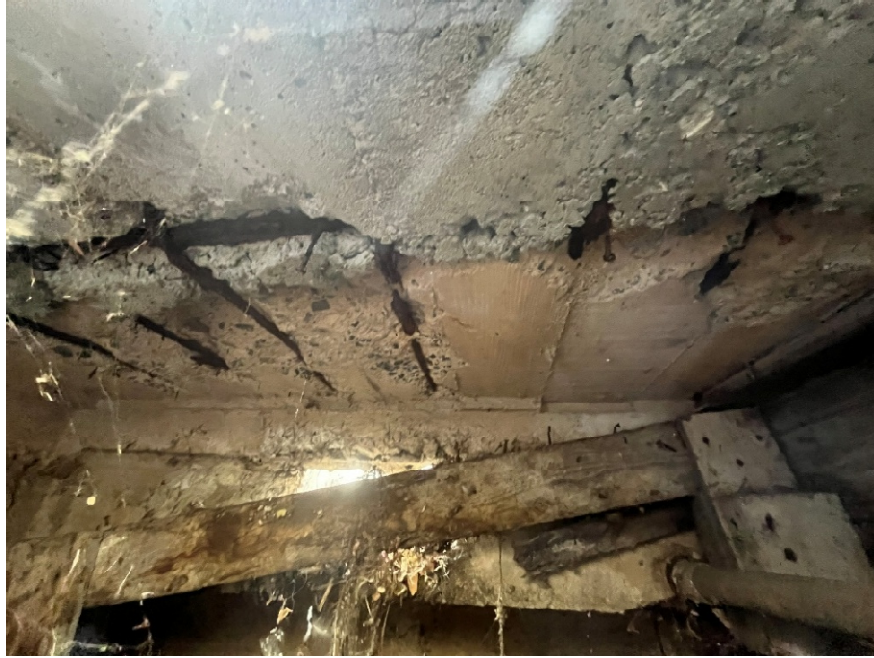
Sidewalk Slab Soffit Spalls and Reinforcing Corrosion
