Ad Hoc Committee to Study Depot Hill Bluff Pathway

Interim Report to City Council

23-October-2025

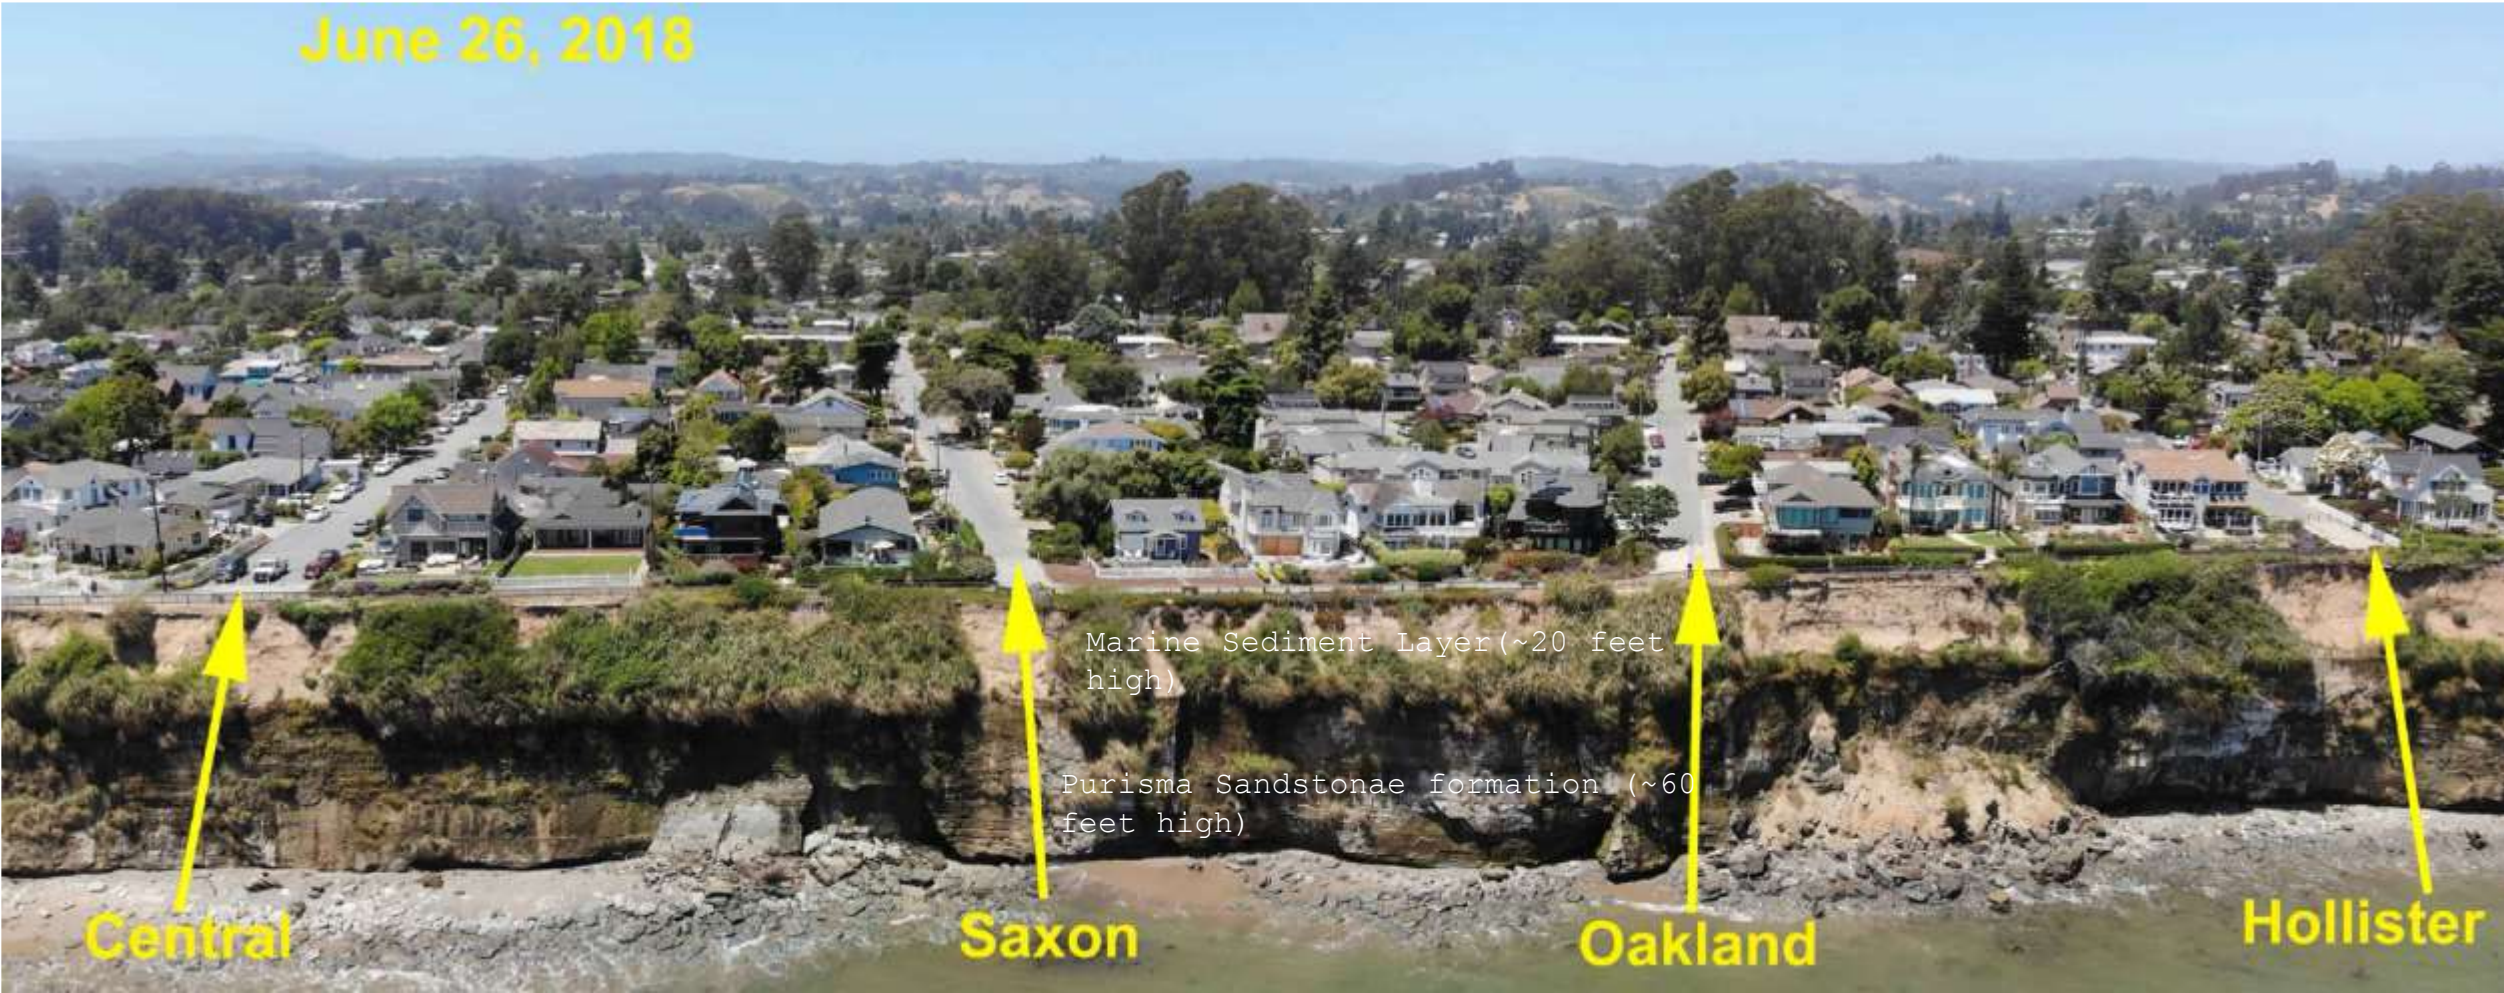
Overview of the Bluff

Marine Sediment Layer (~20 feet high)

Purisma Sandstonae formation (~60 feet high)

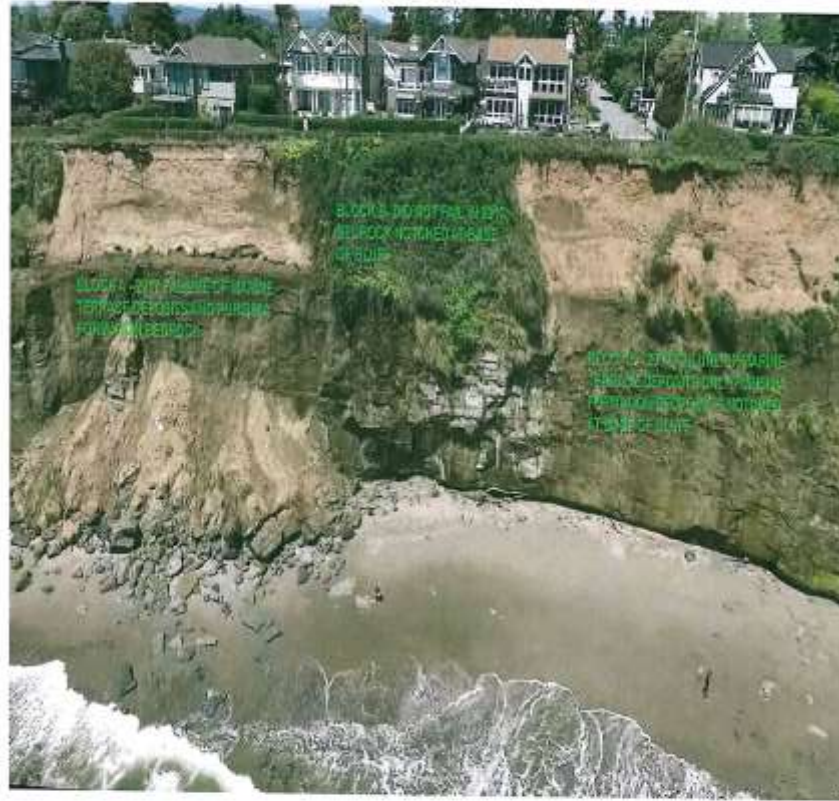
Photo Credit : Snapshot taken from video shot on 19 April 2017, provided by Misha Burch. Original video can be seen on Youtube at <https://youtube.be/Y1kqzLPhk>

Pathway Fails between Oakland and Hollister, April 2017

- Path closed
- Some synthetic netting place over marine sediment layer

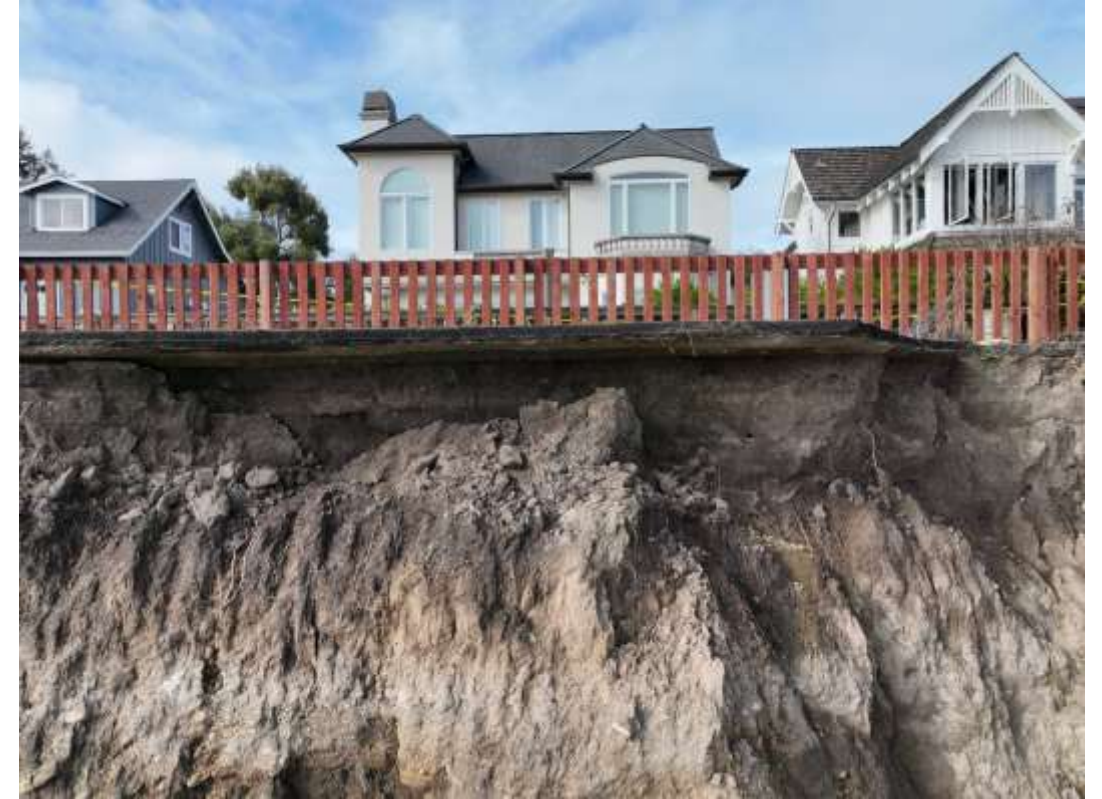
FIGURE #
1
JOB #
2017015-G-SC

Oblique Photo Of Study Area On 19 April 2017
City of Capitola
Grand Avenue Coastal Bluff Footpath
Capitola, California

Saxon to Oakland
section

Oakland to Hollister
section

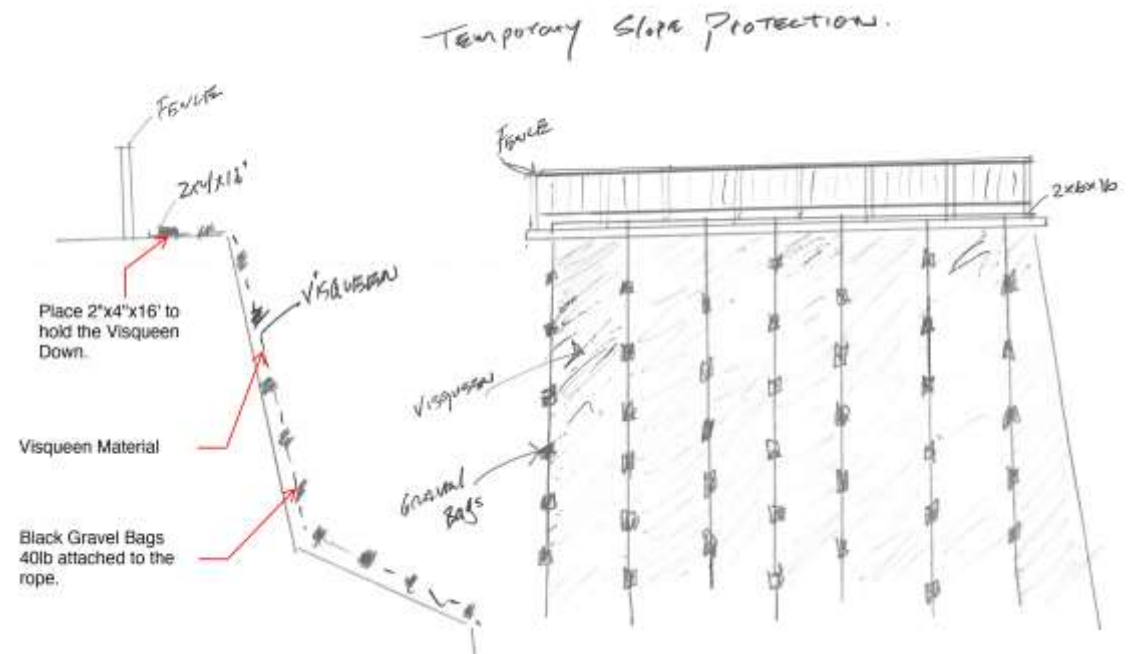
Netting Retention Concept

Similar concept installed on Bluff at Sacramento

1. Do nothing
2. Move pathway onto the city's easement:
 - a. Improve drainage at Saxon Avenue & 302 Grand
 - b. Install pathway on the city's easement (8 houses)
 - c. Move fence to edge of pathway
 - d. Add simple retention system over the latest landslide (between 304 and 308 Grand)
3. Add reinforcement to the bluff at the top to protect the marine layer
4. Implement full Depot Hill drainage plan
5. Install a protective seawall
